# Copper Intrauterine Device Filament Breakage Visualized on Ultrasound

Carolina Martins, João Seixas, Ana Almeida, Clara Vieira, Filipe Vieira, Igor Mello; *Centro de Ensino Superior de Valença, Faculdade de Medicina de Valença, Valença -RJ, Brazi*

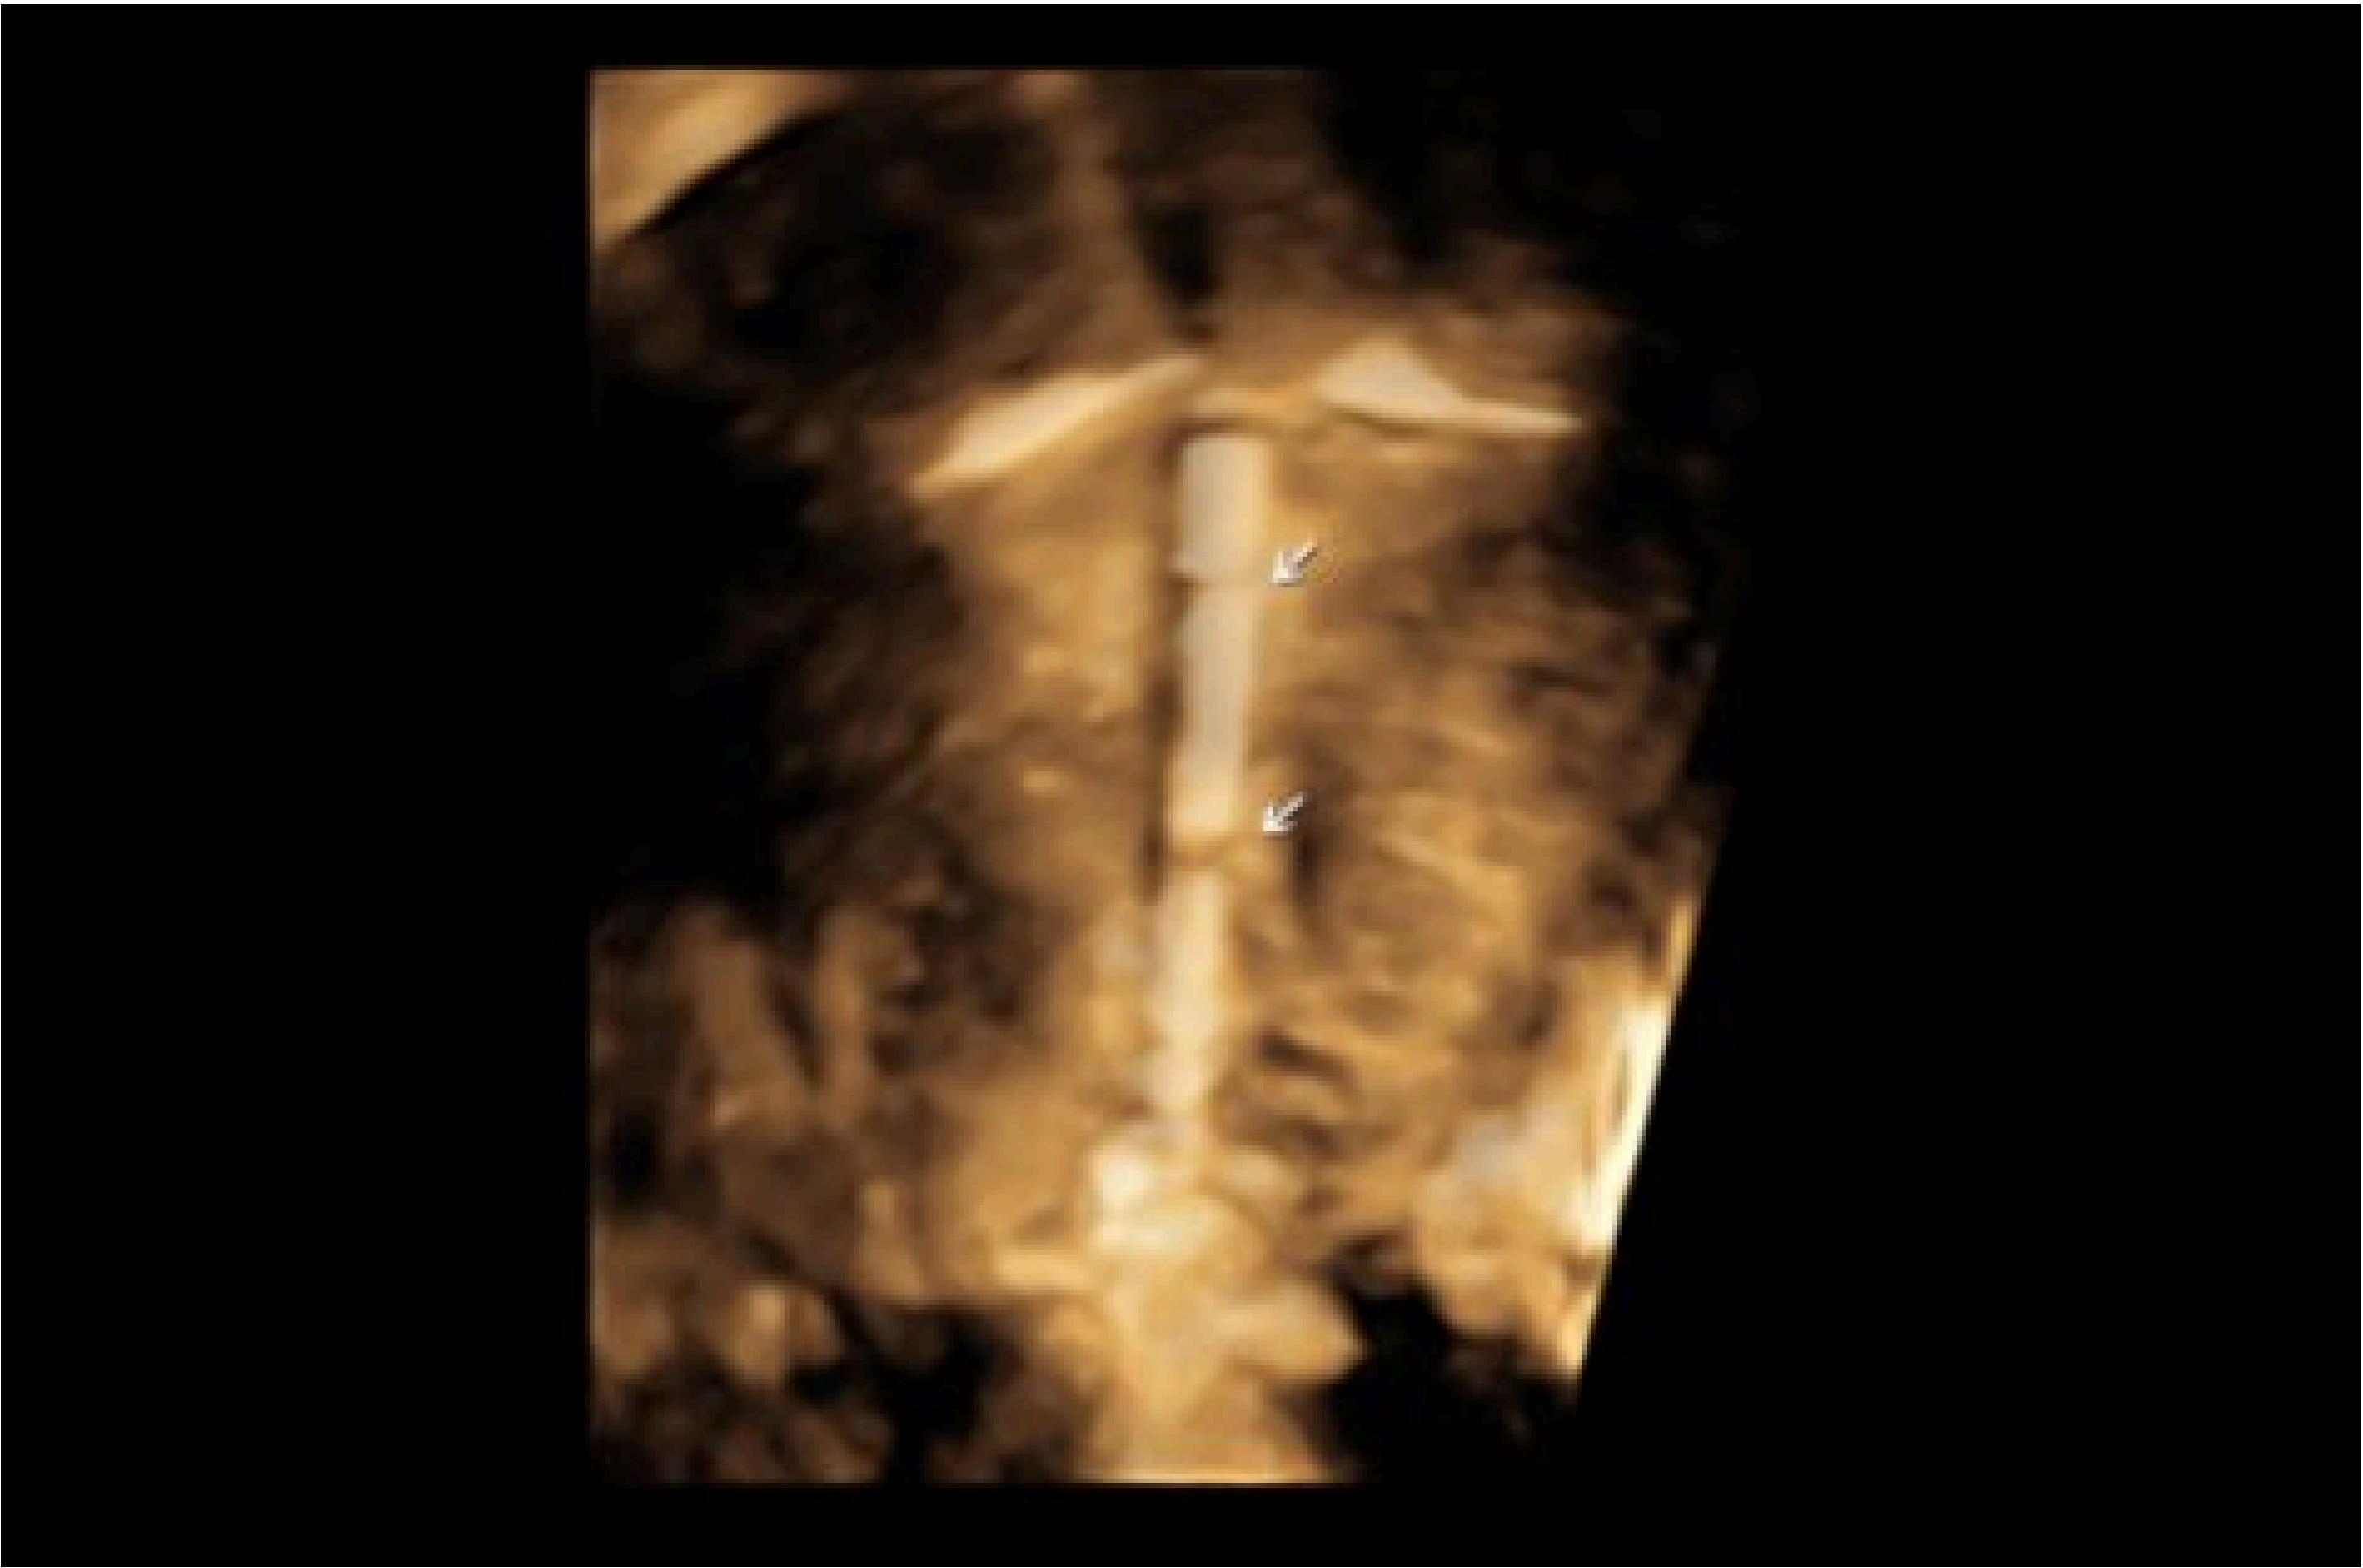
Figure 1. Three-dimensional ultrasound reconstruction of copper IUD in utero demonstrating structural discontinuity of copper wire loops (arrows indicate fracture sites).

**3D ultrasound (Figure 1):** Clear structural rupture at TWO distinct points at junction between vertical stem and horizontal arms, visible gaps in copper wire loops, normal surrounding tissues

**Pathophysiology:** Electrolyte environment, pH fluctuations during menstrual cycles, mechanical fatigue from uterine contractions create stress concentration at junction points.

**Management:** Hysteroscopic removal

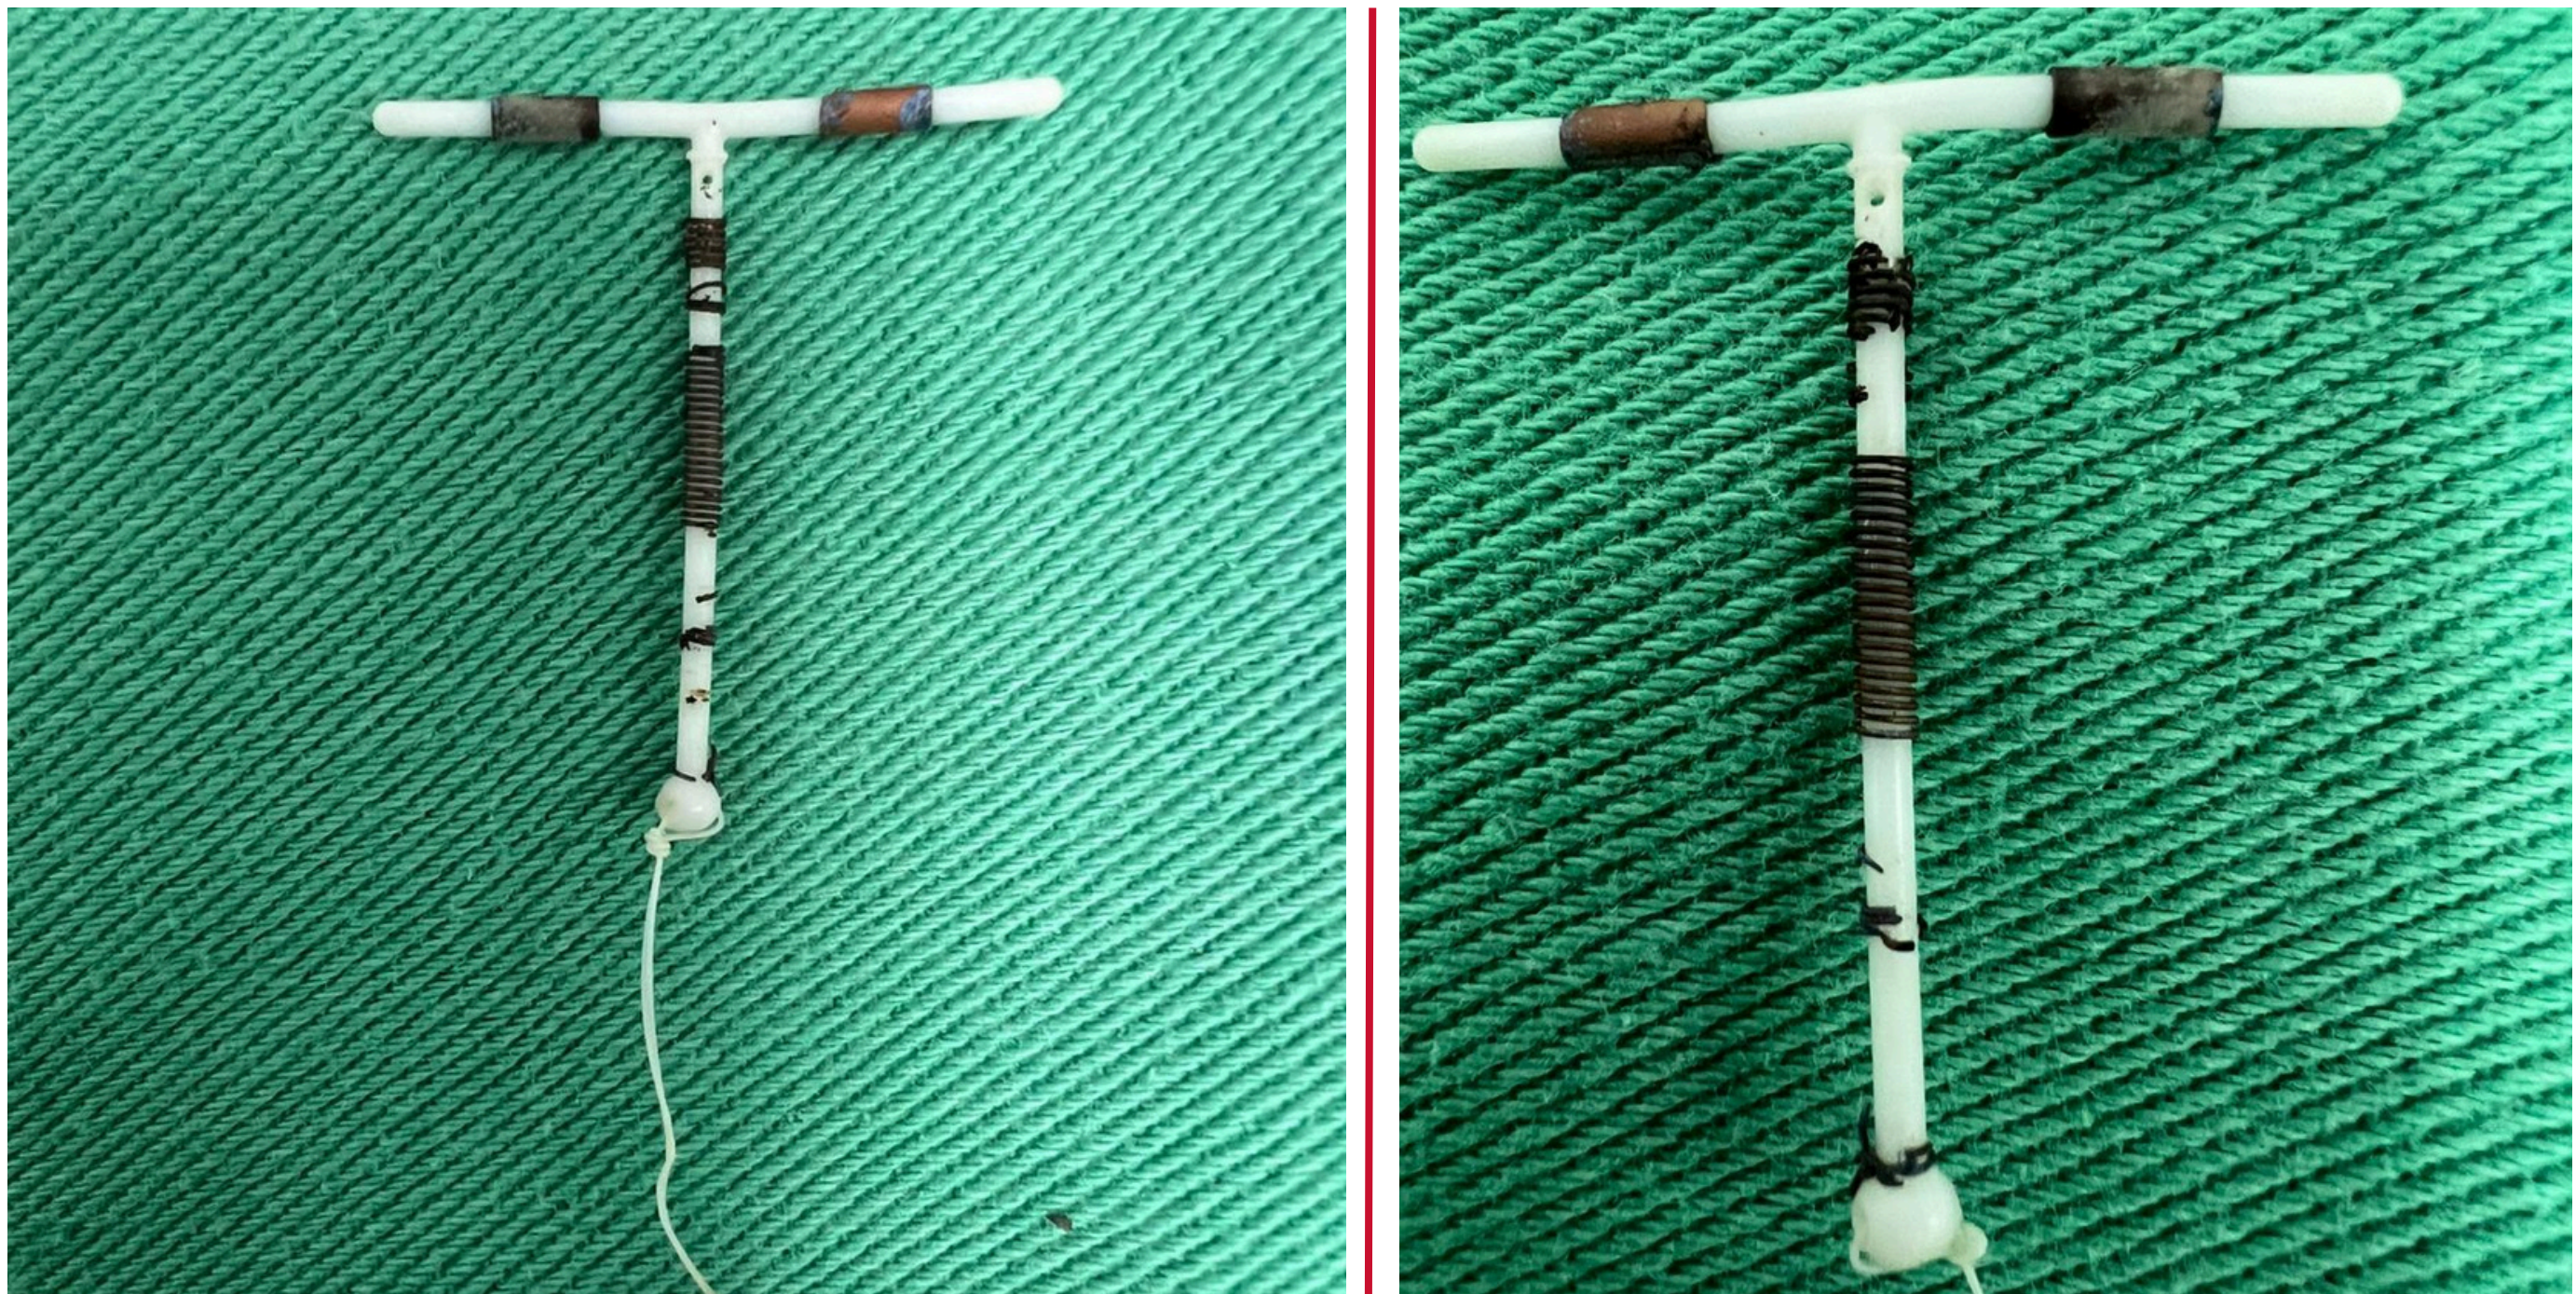
**Device Analysis (Figure 2):** Confirmed copper filament fracture with corrosion and clean breaks at stress points

Figure 2. Macroscopic examination of extracted copper IUD showing multiple copper filament fractures. Note the discontinuity of copper wire at junction points between vertical stem and horizontal arms, with intact white polyethylene core.
