# Implant Platform Deformation as a Complication of Guided Implant Surgery

Hyun Jae Cho<sup>1\*</sup>, Rafael Delgado-Ruiz<sup>2</sup>, Seyed Hossein Bassir<sup>1</sup>, Georgios E. Romanos<sup>1</sup>

<sup>1</sup>Dept. of Periodontology, <sup>2</sup>Dept. of Prosthodontics and Digital Technology,  
School of Dental Medicine, Stony Brook, NY

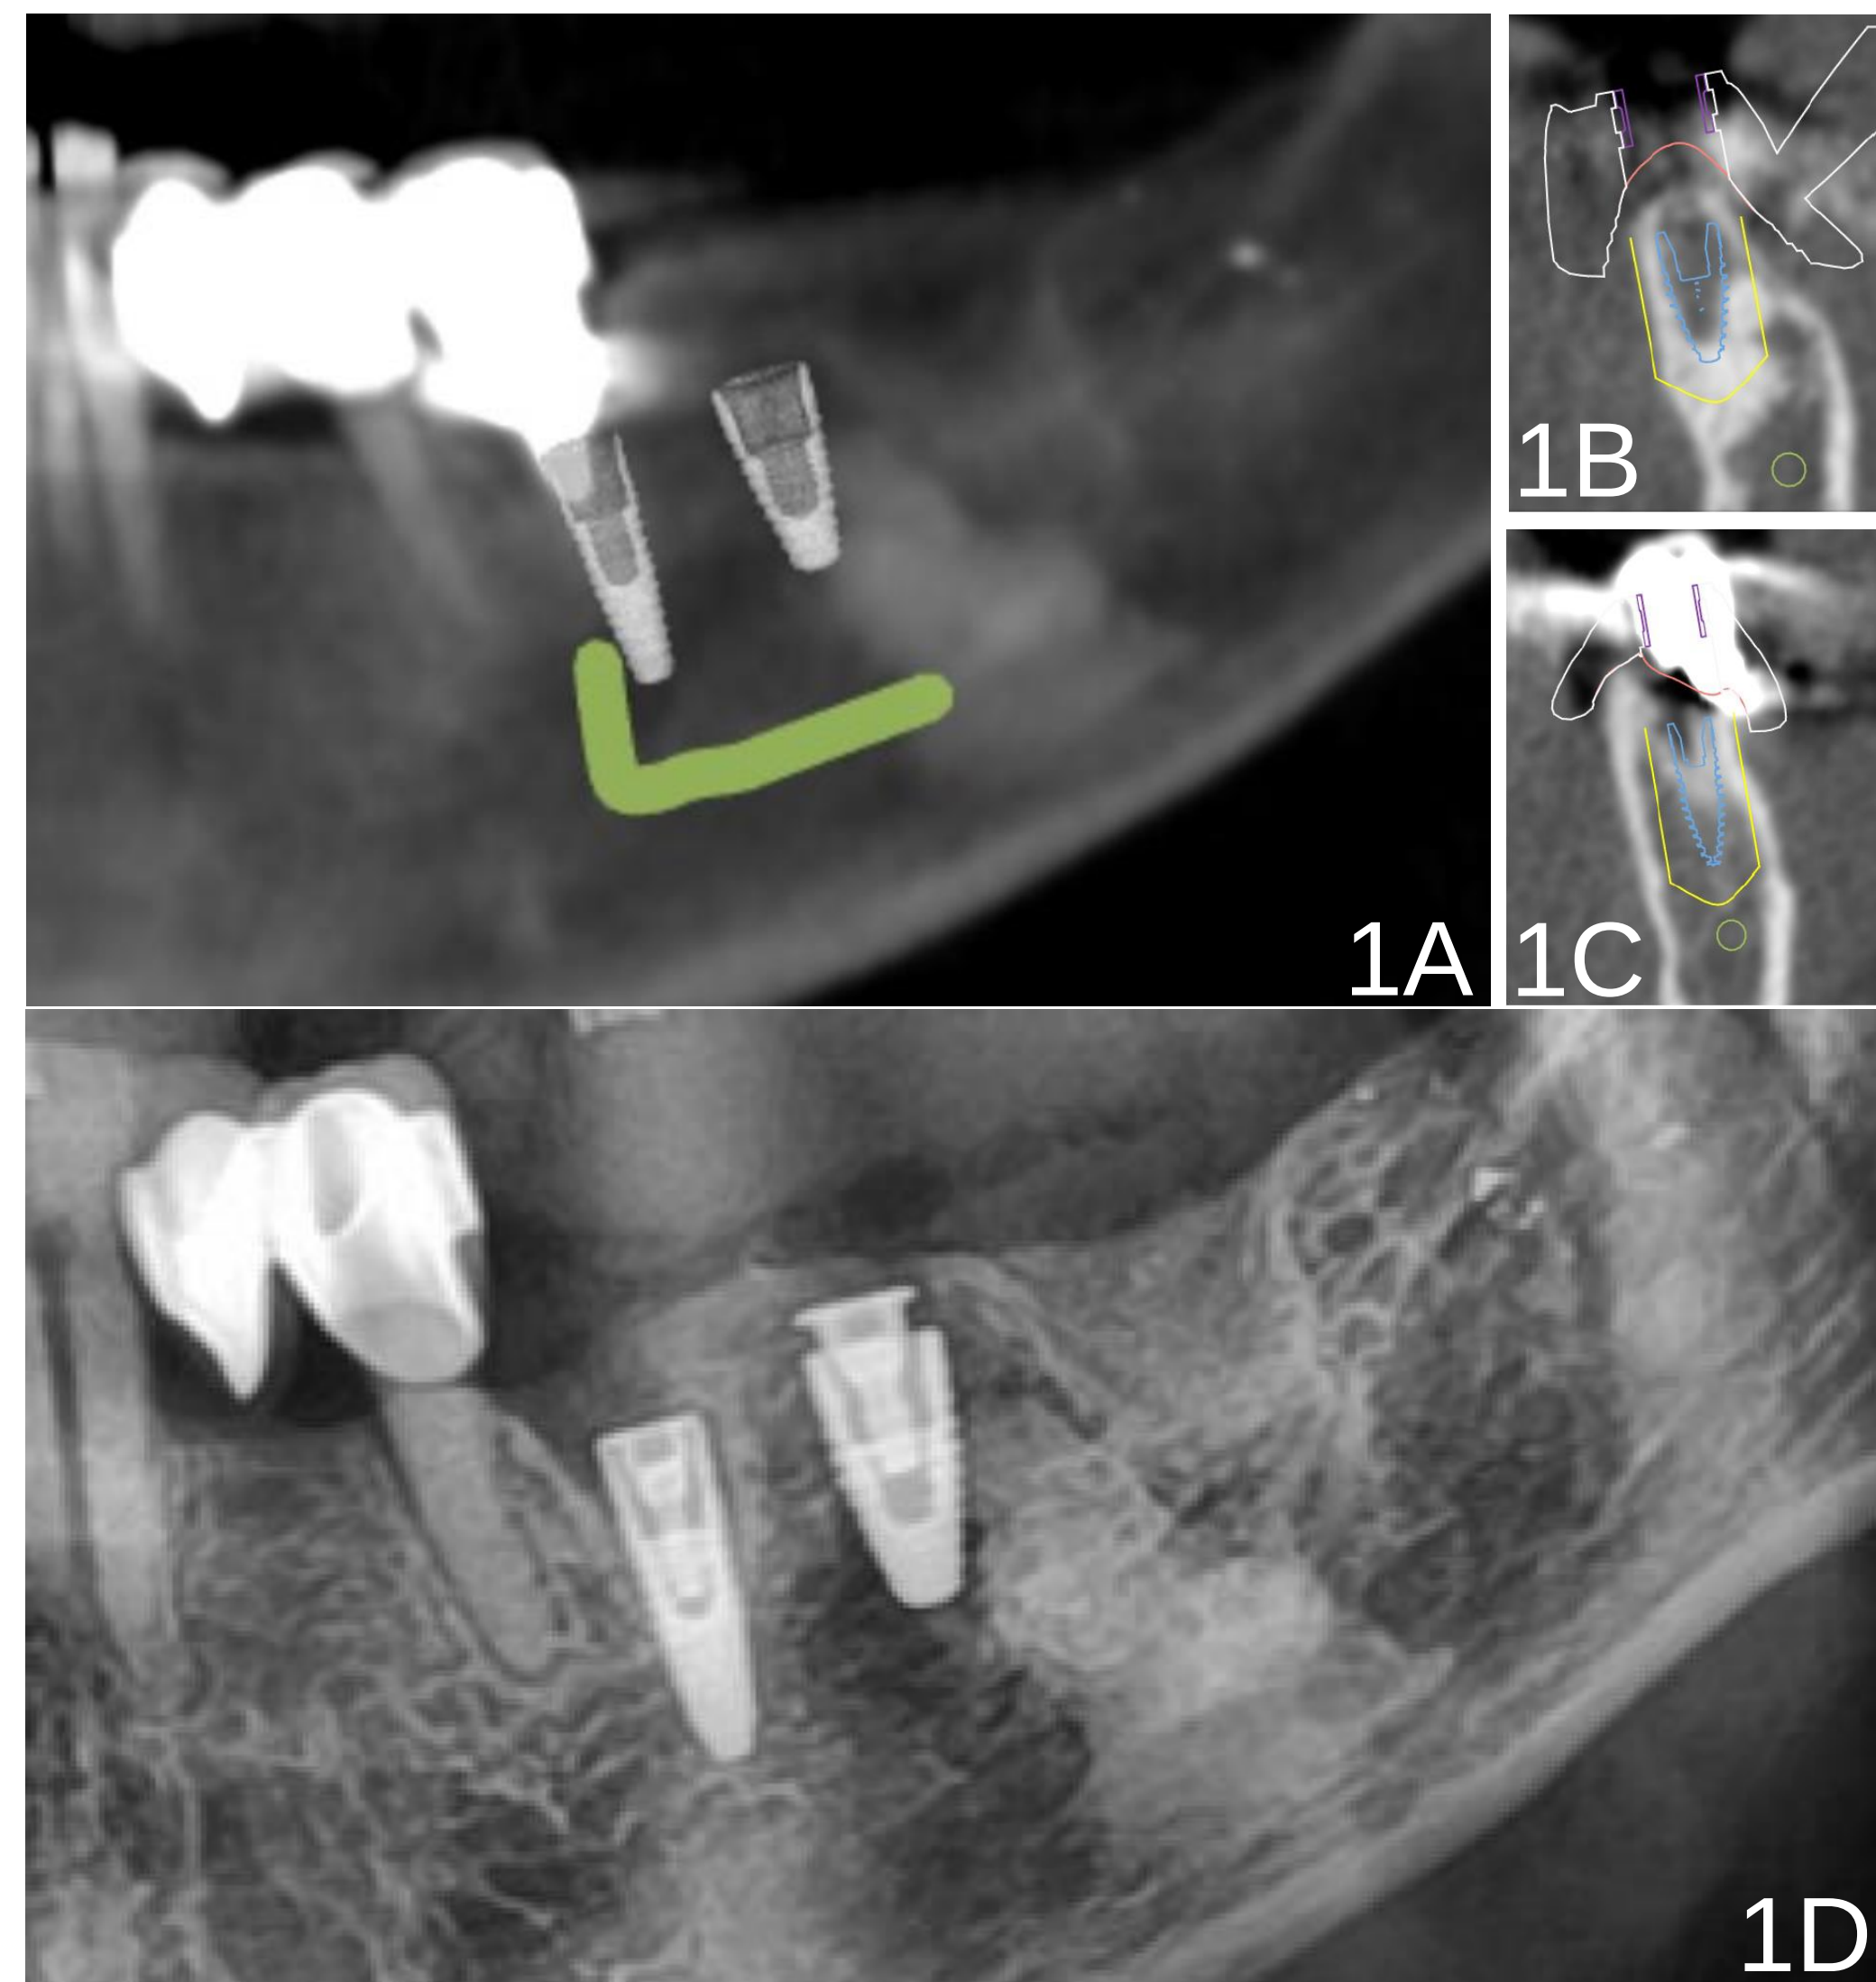
Fig. 1A/B/C: Digital planning of implant placement. Panoramic view, #19i, and 20i respectively; Fig. 1D: Immediate postoperative radiograph. The implants were placed at the desired positions and path. However, the cover screw of implant #19 is not fully seated.

The postoperative control radiograph presented insufficient fit of the cover screw in implant #19i (Figs. 1D, 3A/B). Because the source of this complication was deemed to be interference from the bone, the peri-implant crestal bone was reduced with special attention using hand and rotary instruments. Despite repeated attempts and eventual complete removal of surrounding crestal bone, radiographs consistently demonstrated the same complication. The problem persisted when using a different cover screw.

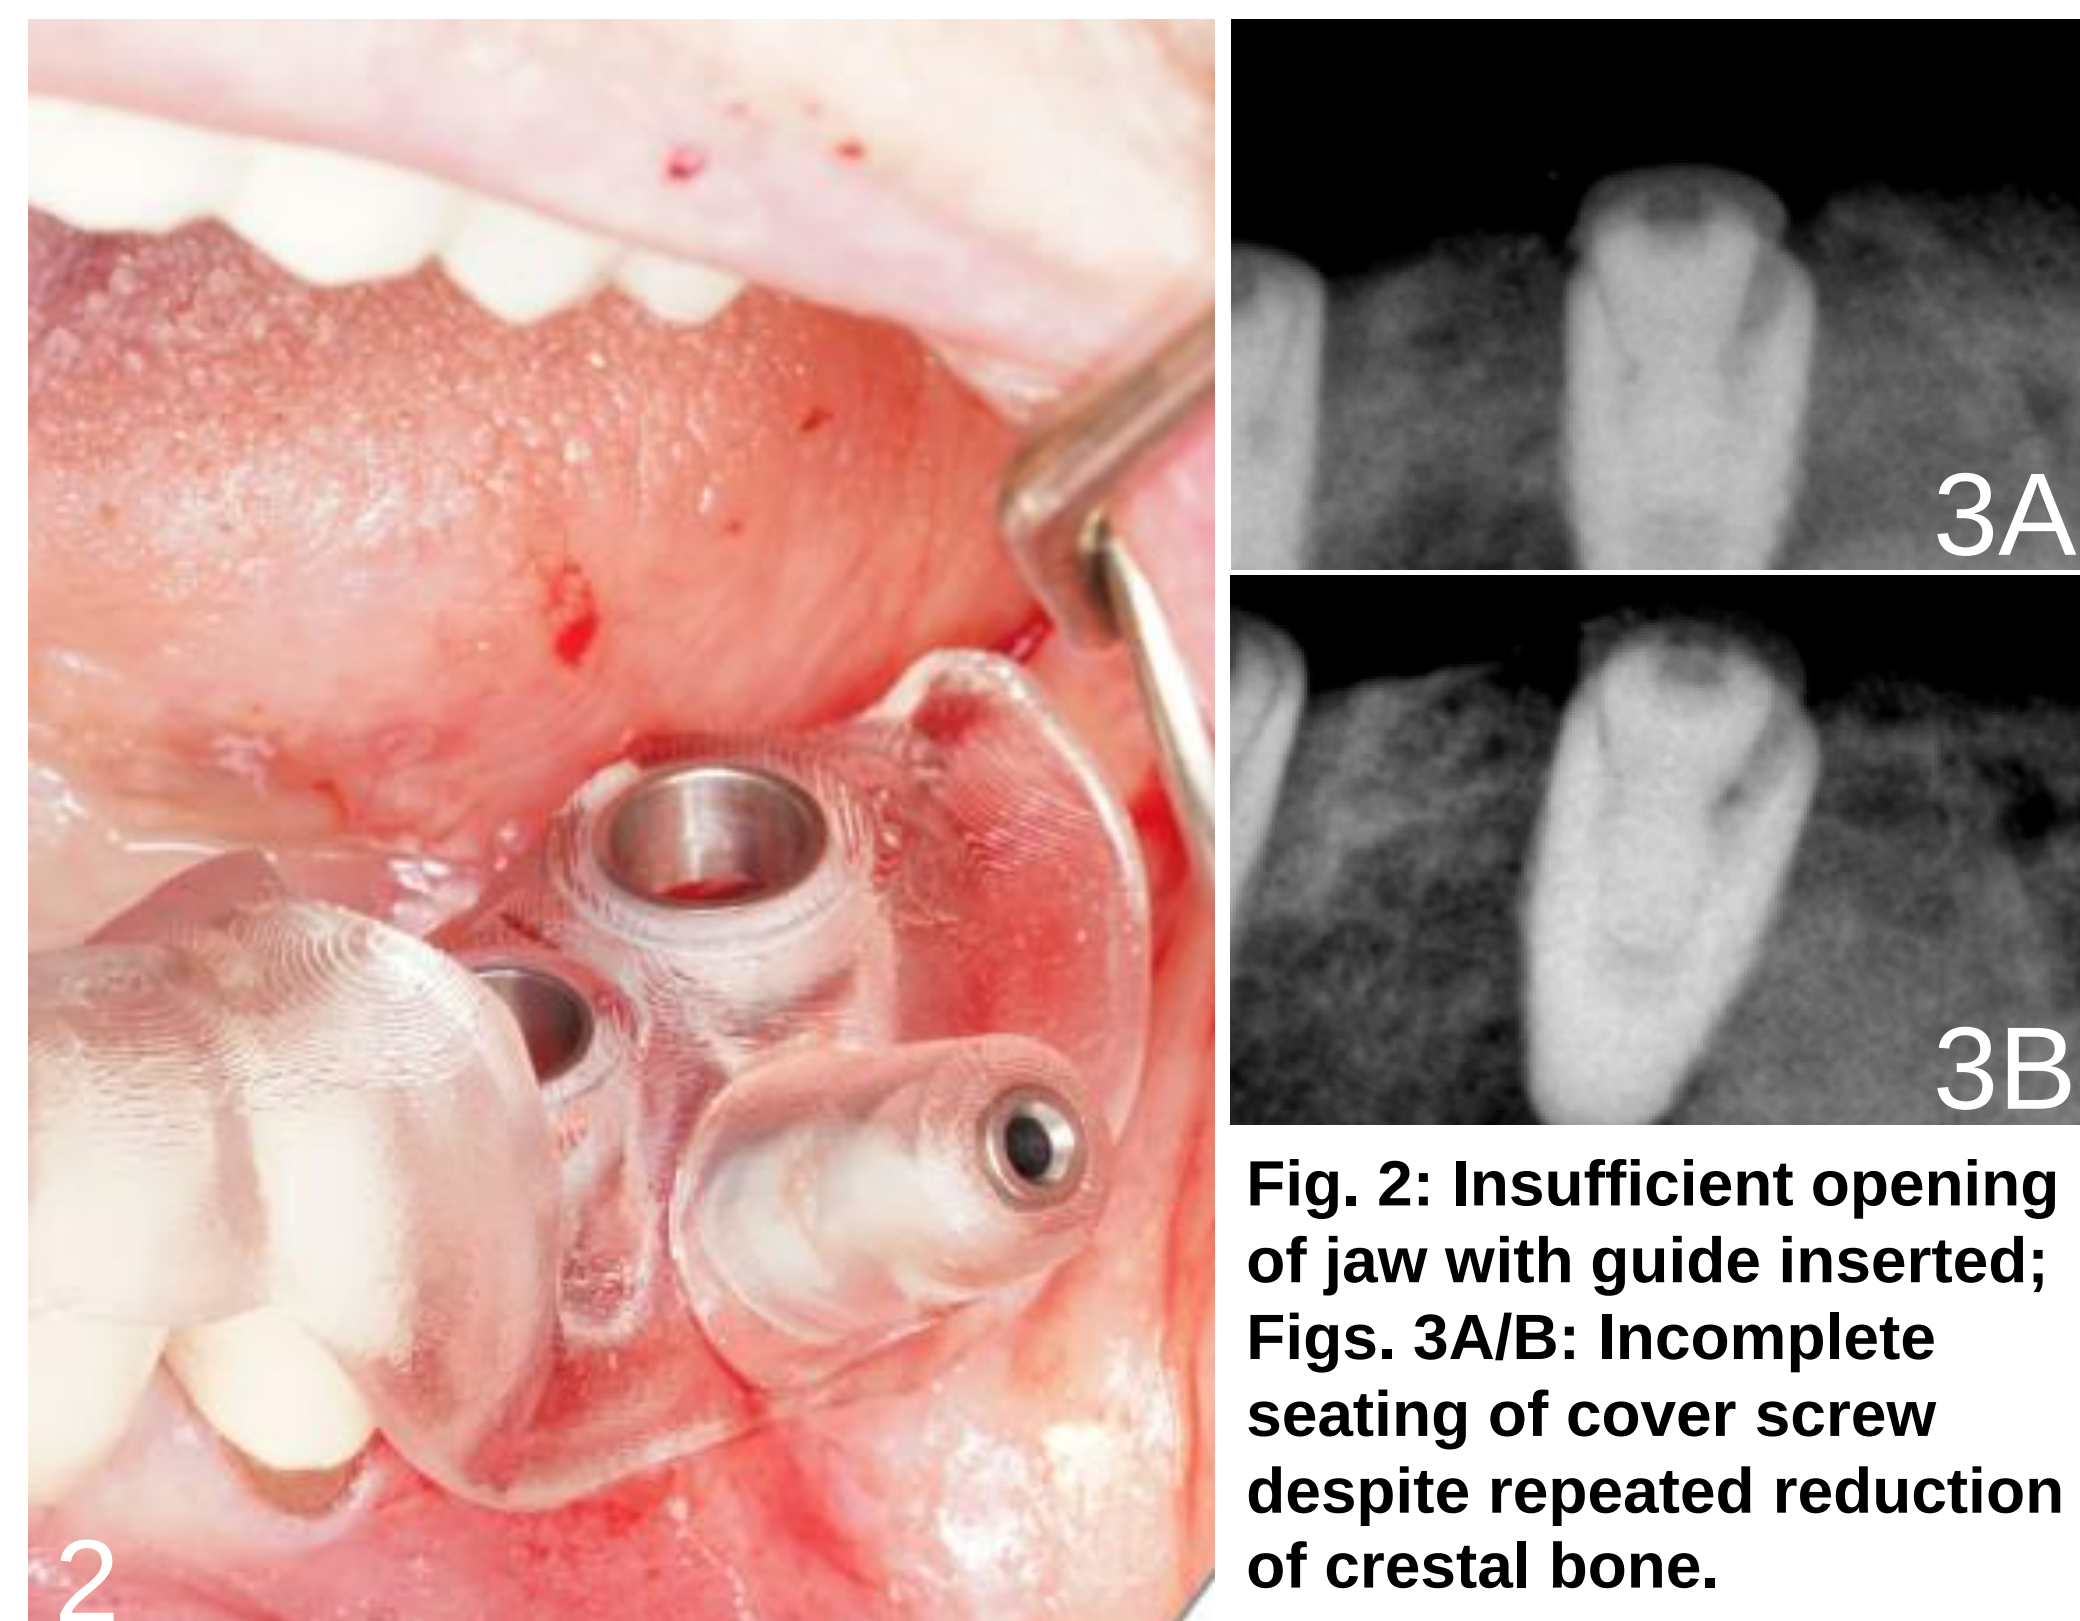
Fig. 2: Insufficient opening of jaw with guide inserted; Figs. 3A/B: Incomplete seating of cover screw despite repeated reduction of crestal bone.

A 70-year-old female patient was undergoing implant therapy on sites #19 and #20. The tooth #19 was previously missing, and #20, hopeless, was extracted and immediately replaced with an implant. The surgery was performed under sedation, utilizing a digitally fabricated guide (Fig. 1). Throughout the procedure difficulties arose because the sedated patient could not open her mouth as wide as needed to accommodate the extended length of the guided drill. The two implants (4.3x8 mm and 3.5x10mm) were placed subcrestally with acceptable implant stability. Patient had difficulties in opening her mouth sufficiently, providing difficulties in removing the implant mount and the guide (Fig. 2). The cover screws were placed, and a postoperative control radiograph was taken.

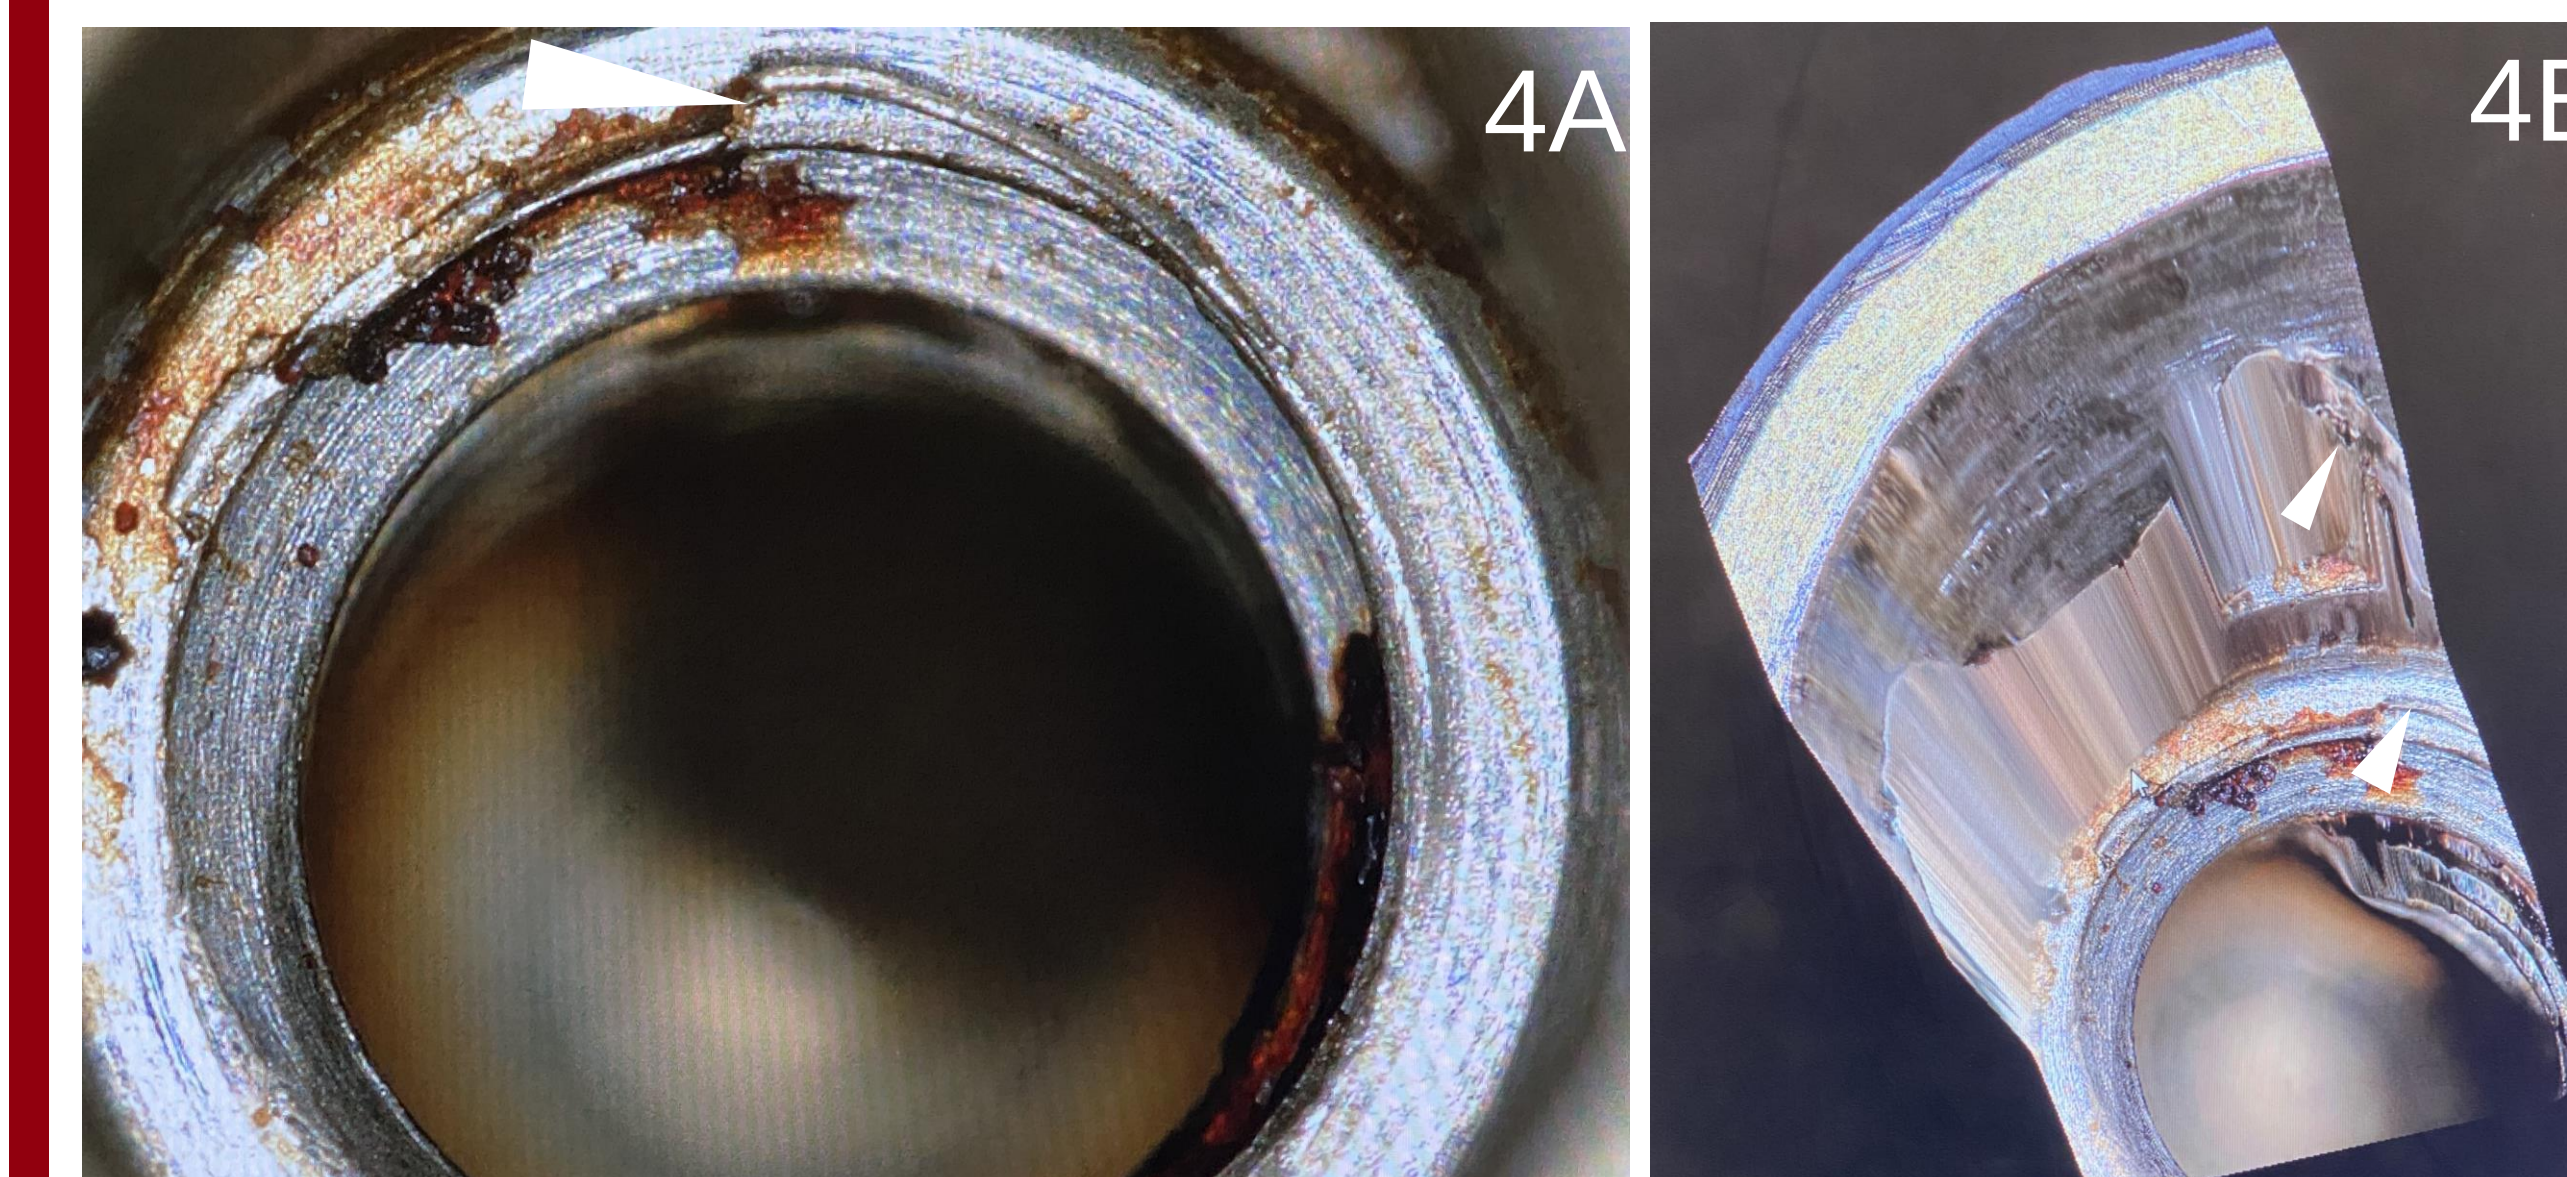
A thorough clinical examination of the implant revealed damage of the internal connection. The implant was retrieved, and a new implant was placed. The retrieved implant was examined under laser confocal microscope which verified a significant platform deformation (Fig. 4).

Examination under laser confocal microscope demonstrated deformation of the implant platform. Such damage to the connection seems to have occurred during the forceful removal of the mount from the guide. The implant mount was made of surgical grade CP Cold-worked titanium which is much stronger than grade IV titanium used for the implant fixture.

Figs. 4A/B: Deformations of implant internal connection elucidated under laser confocal microscopy (arrows).
