# Misplaced Dental Implants Removal and New Implants Placement: Case Report

<sup>1</sup> Edemar Fronchetti Jr DDS MSc <sup>2</sup> Orlando Luiz do Amaral Júnior DDS PhD <sup>3</sup> Paola Spessato DDS, MSc <sup>4</sup> Salmeron Samira DDS, PhD

1, 2, 3 Unidade Central de Educação FAI Faculdades – UCEFF, School of Dentistry, Department of Oral Health, Itapiranga, SC, Brazil.

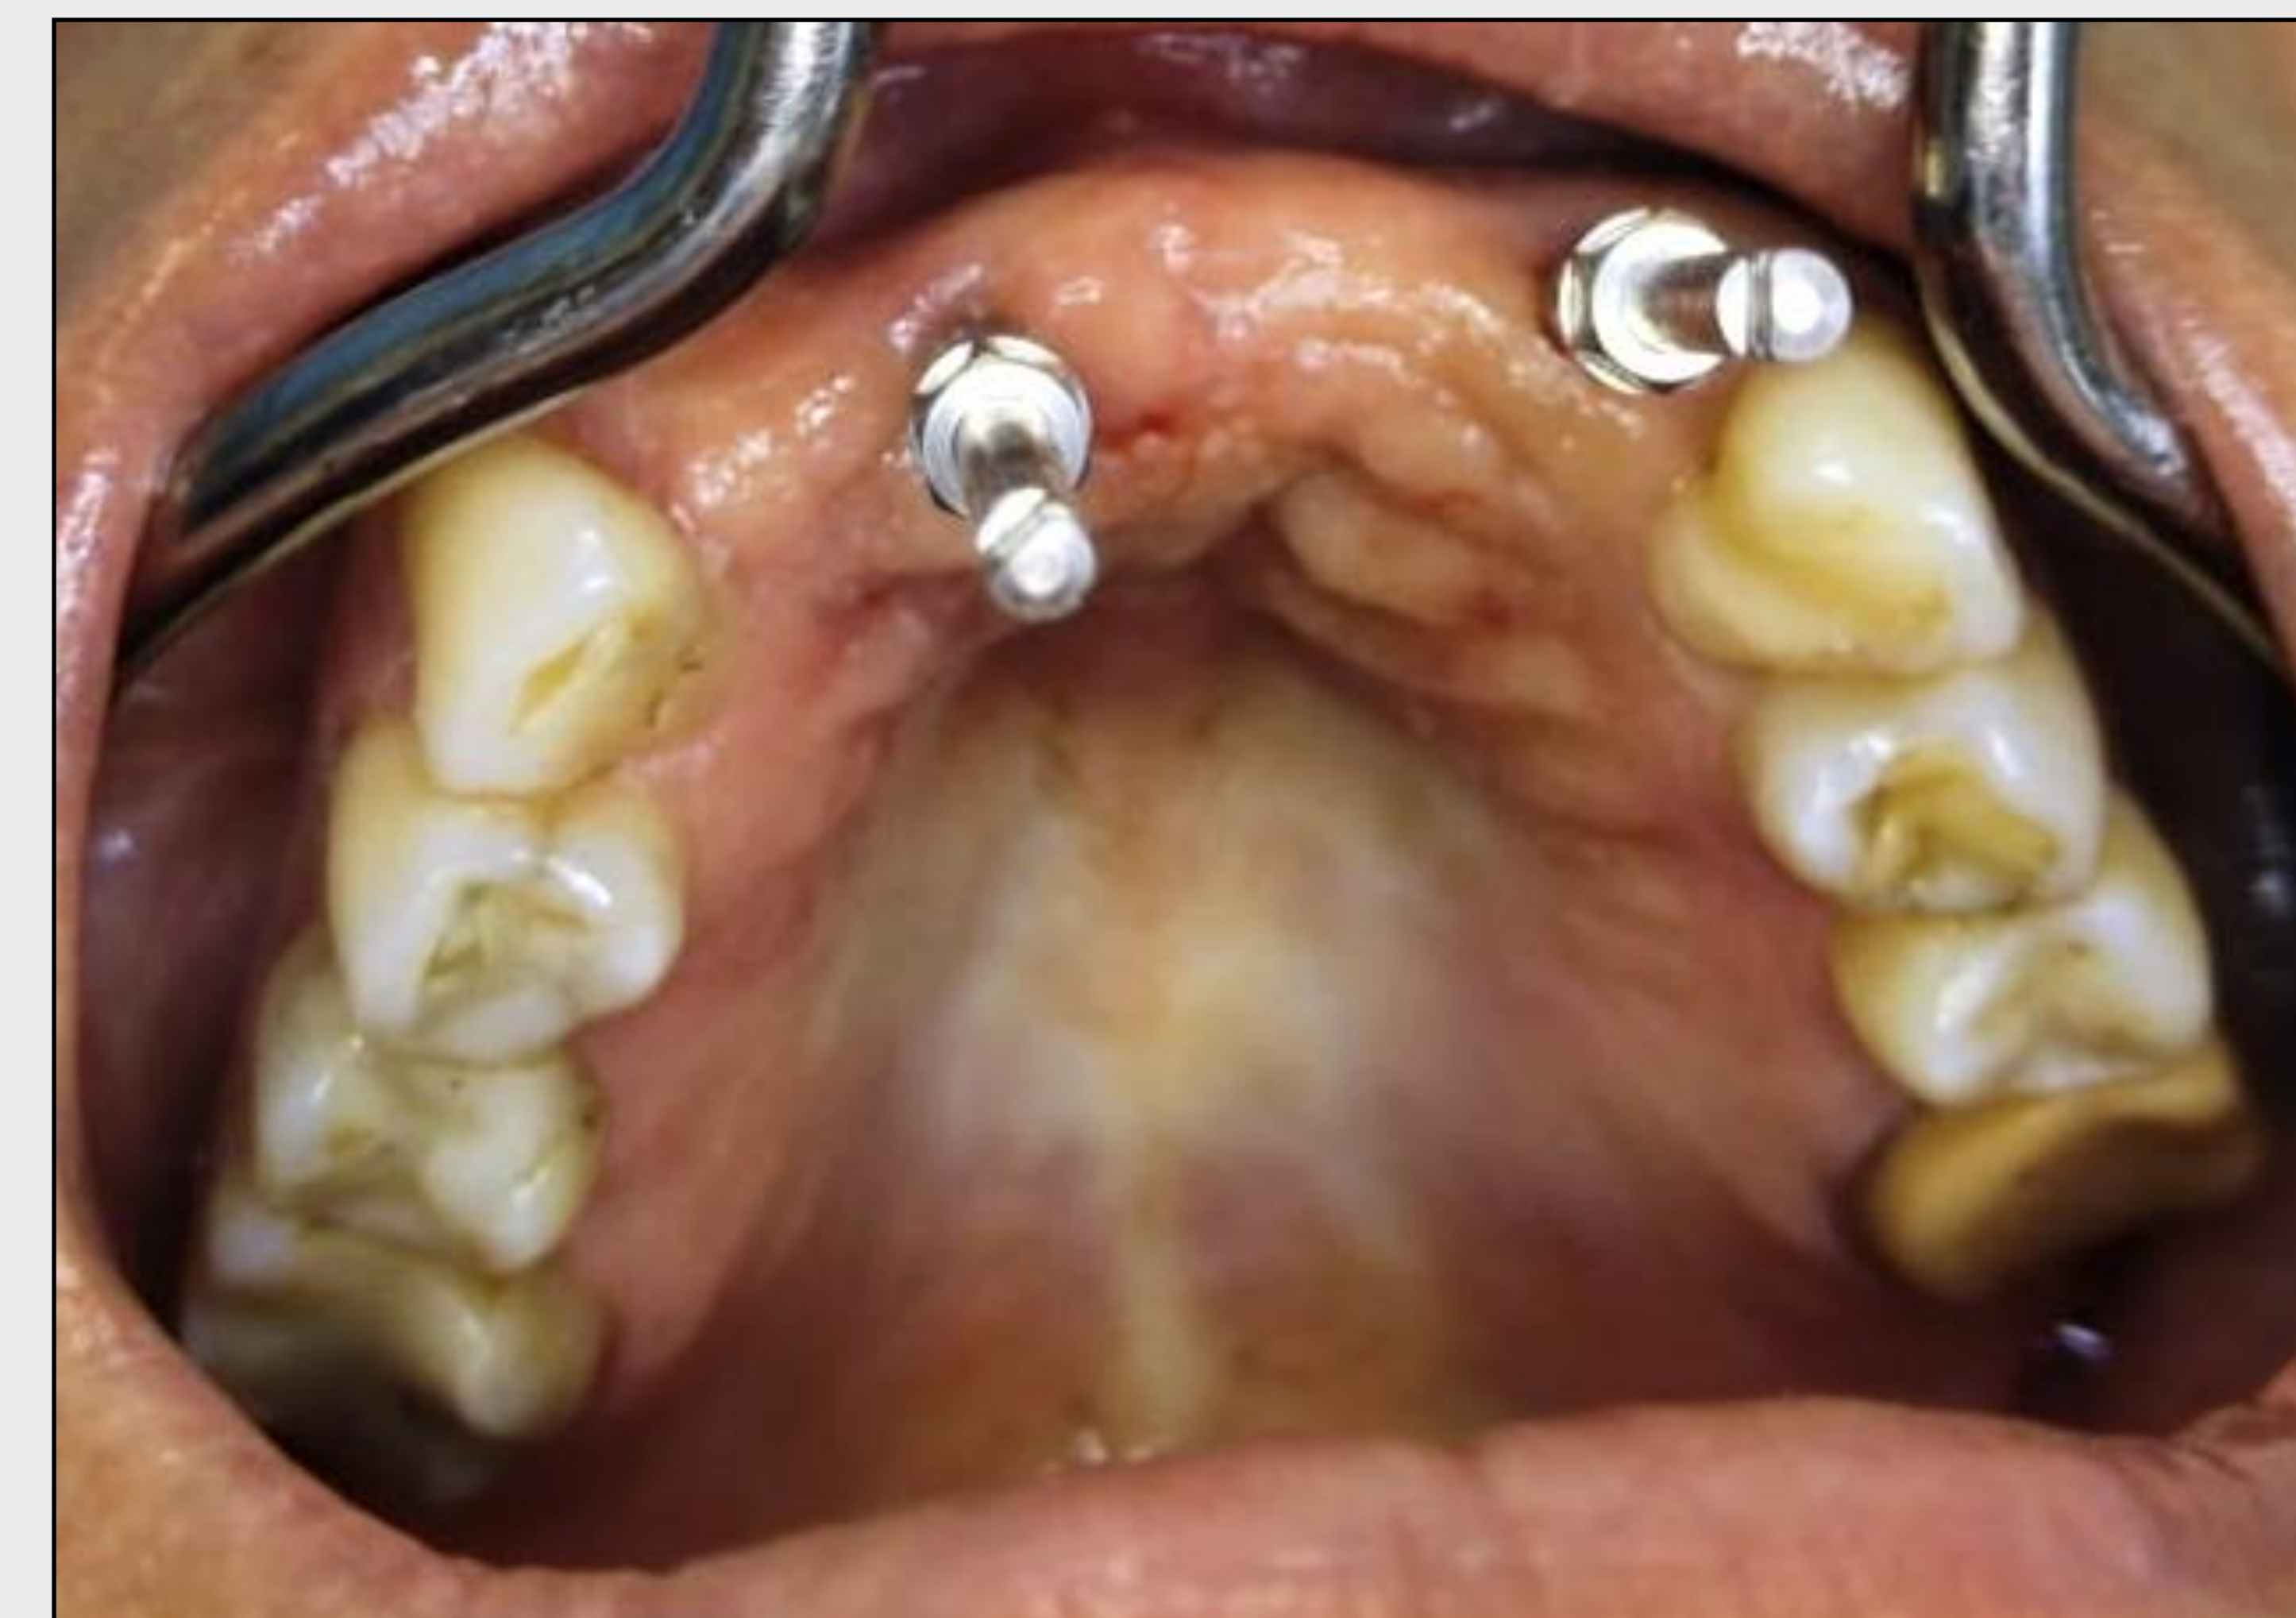
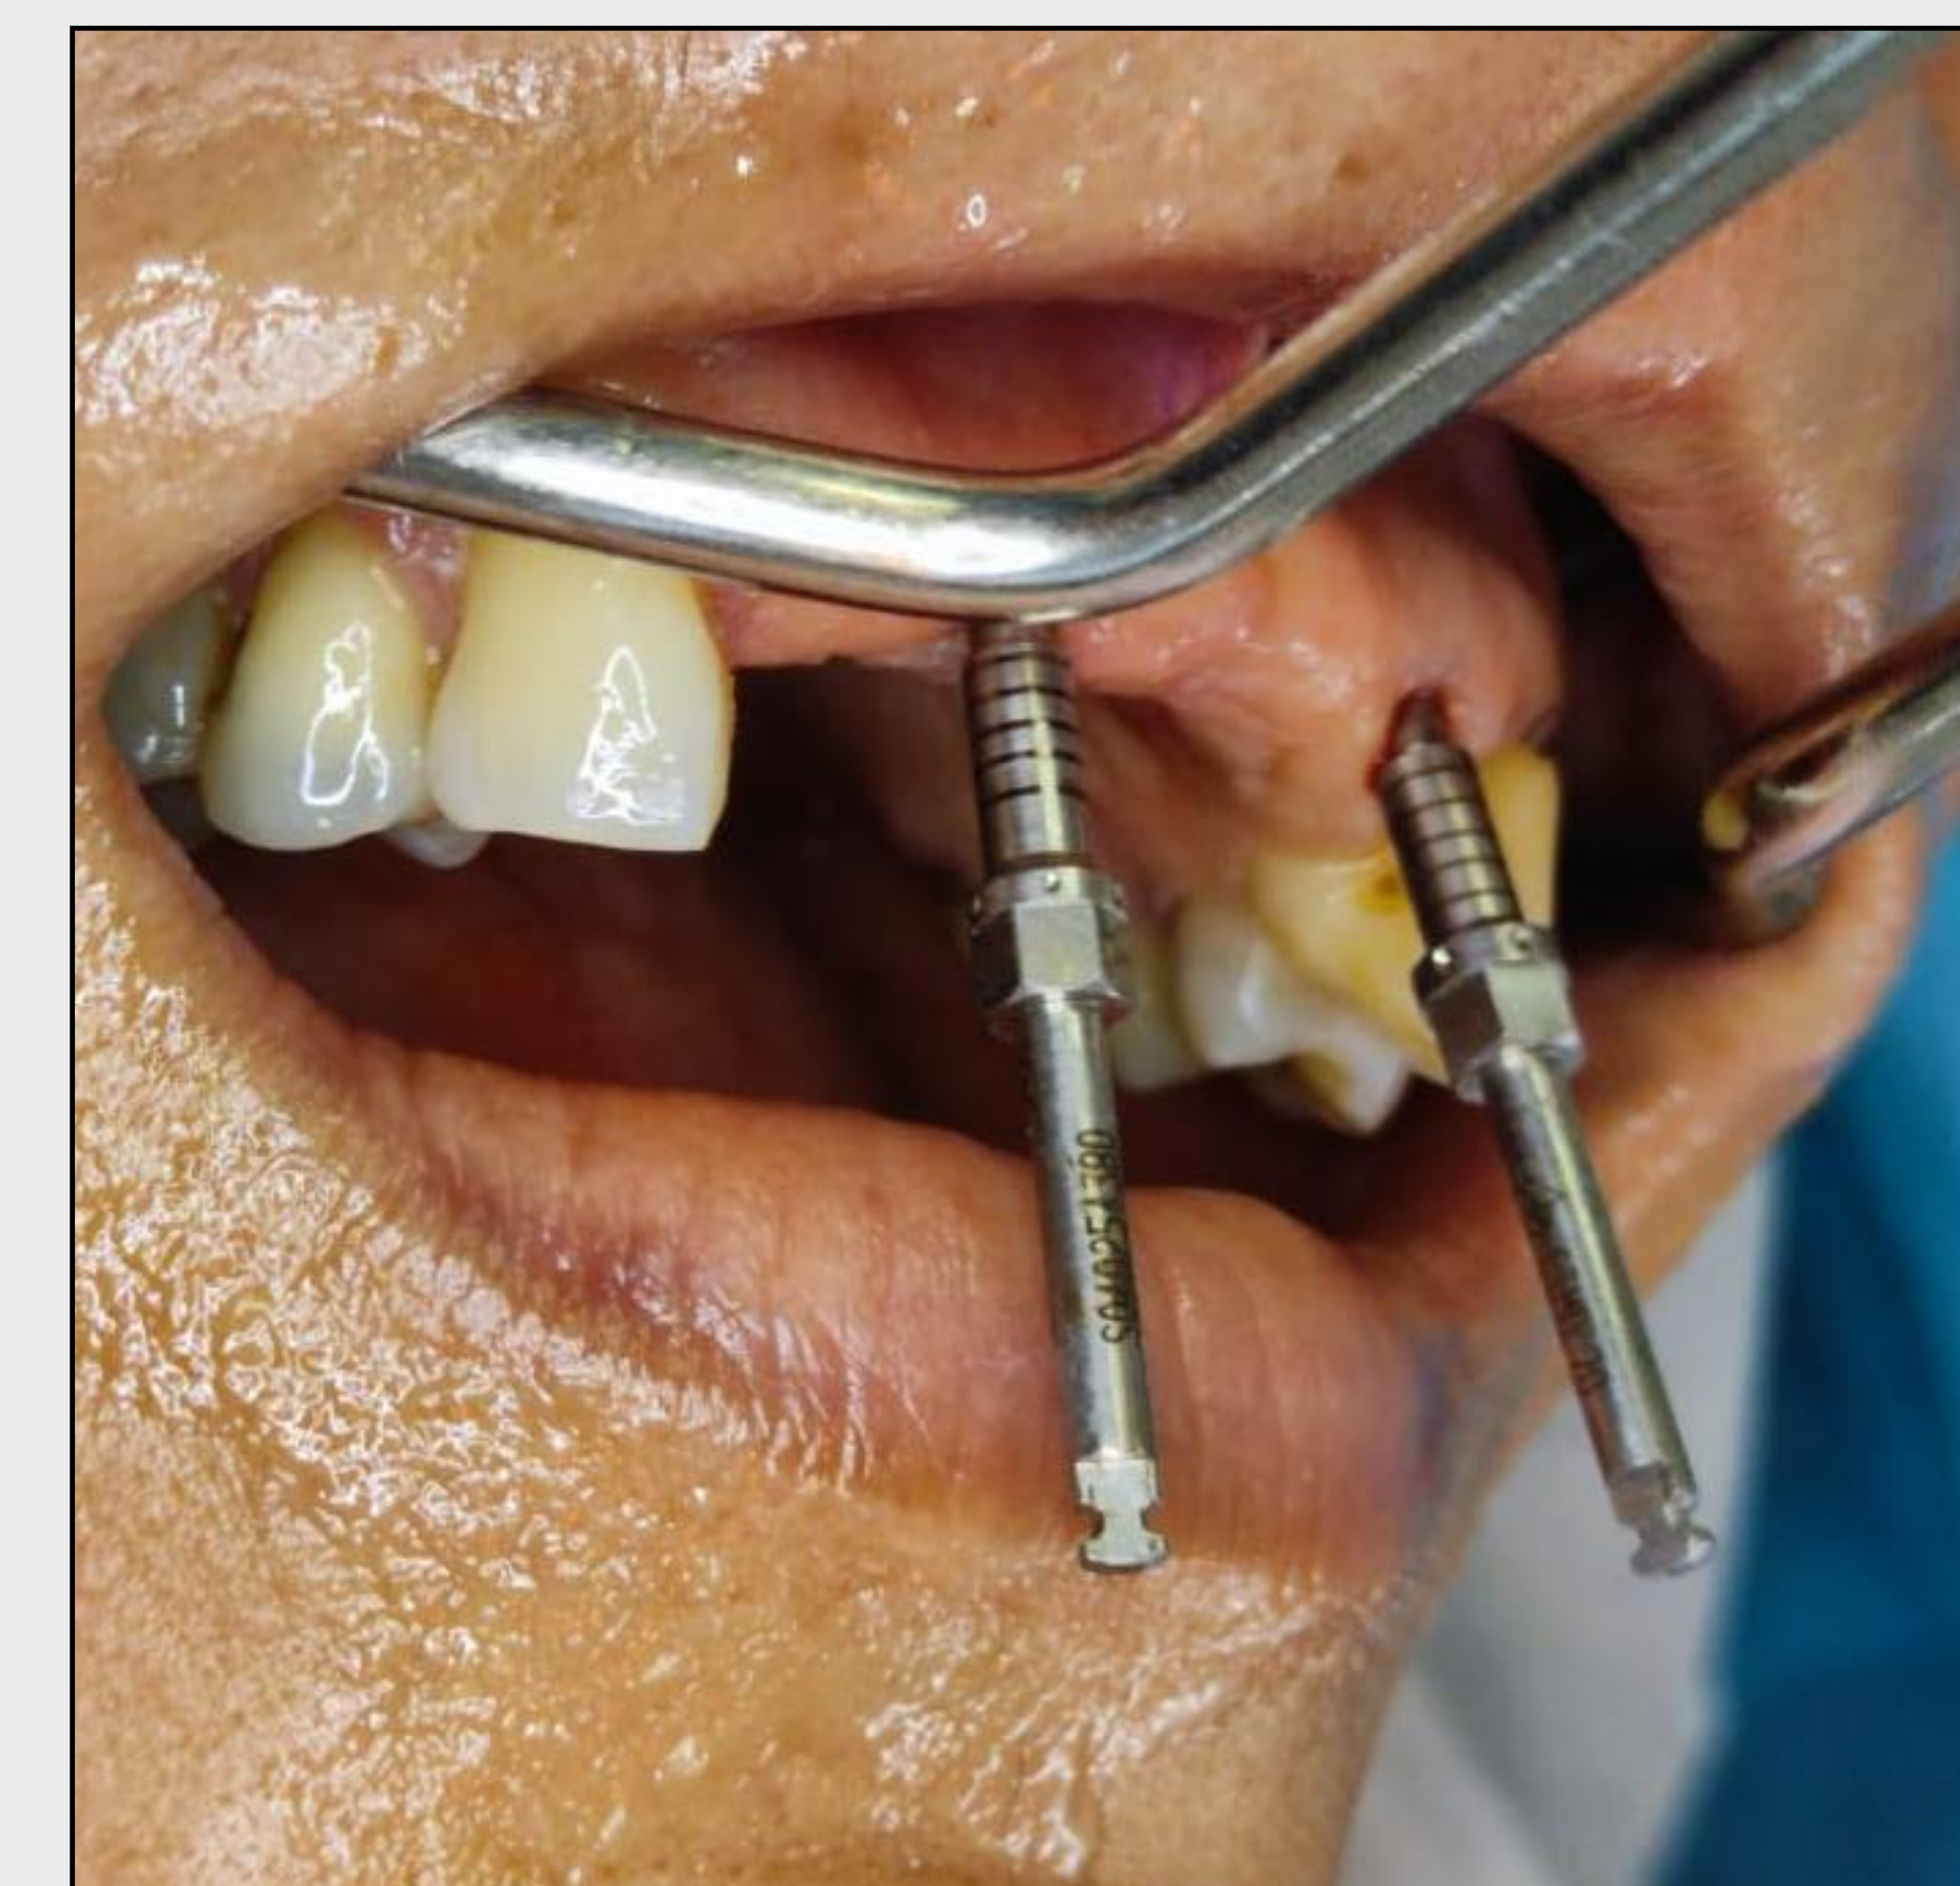
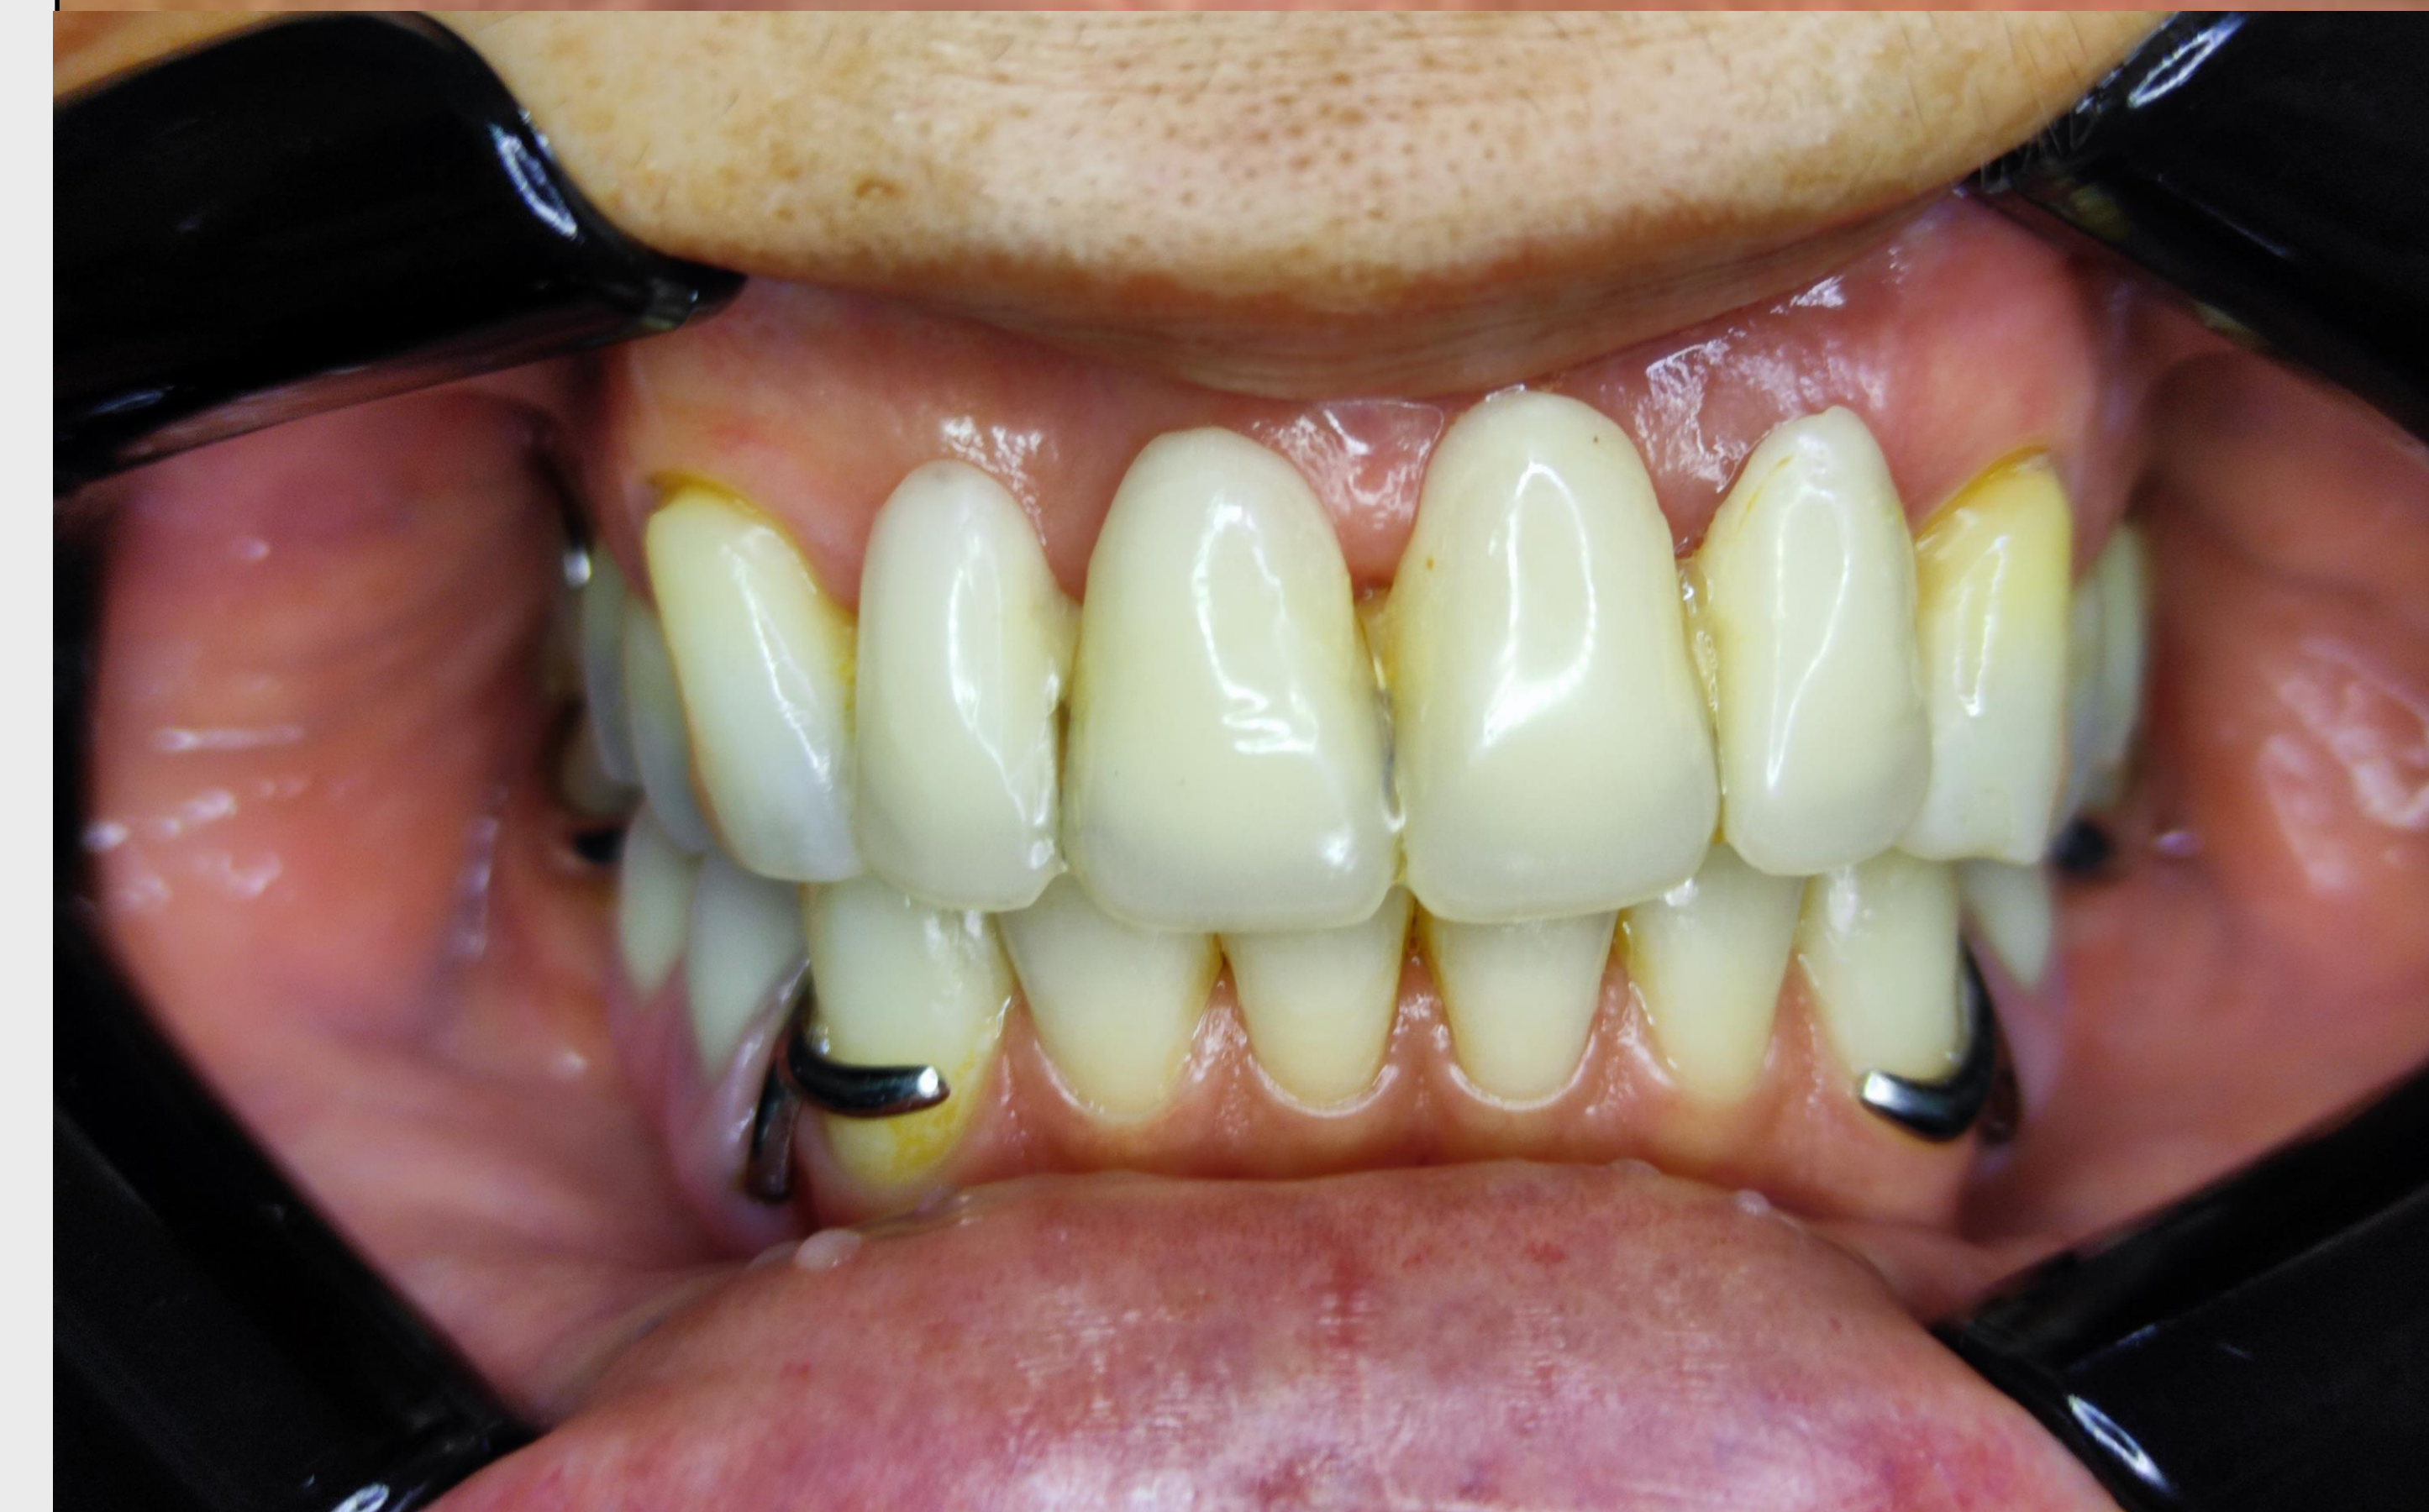
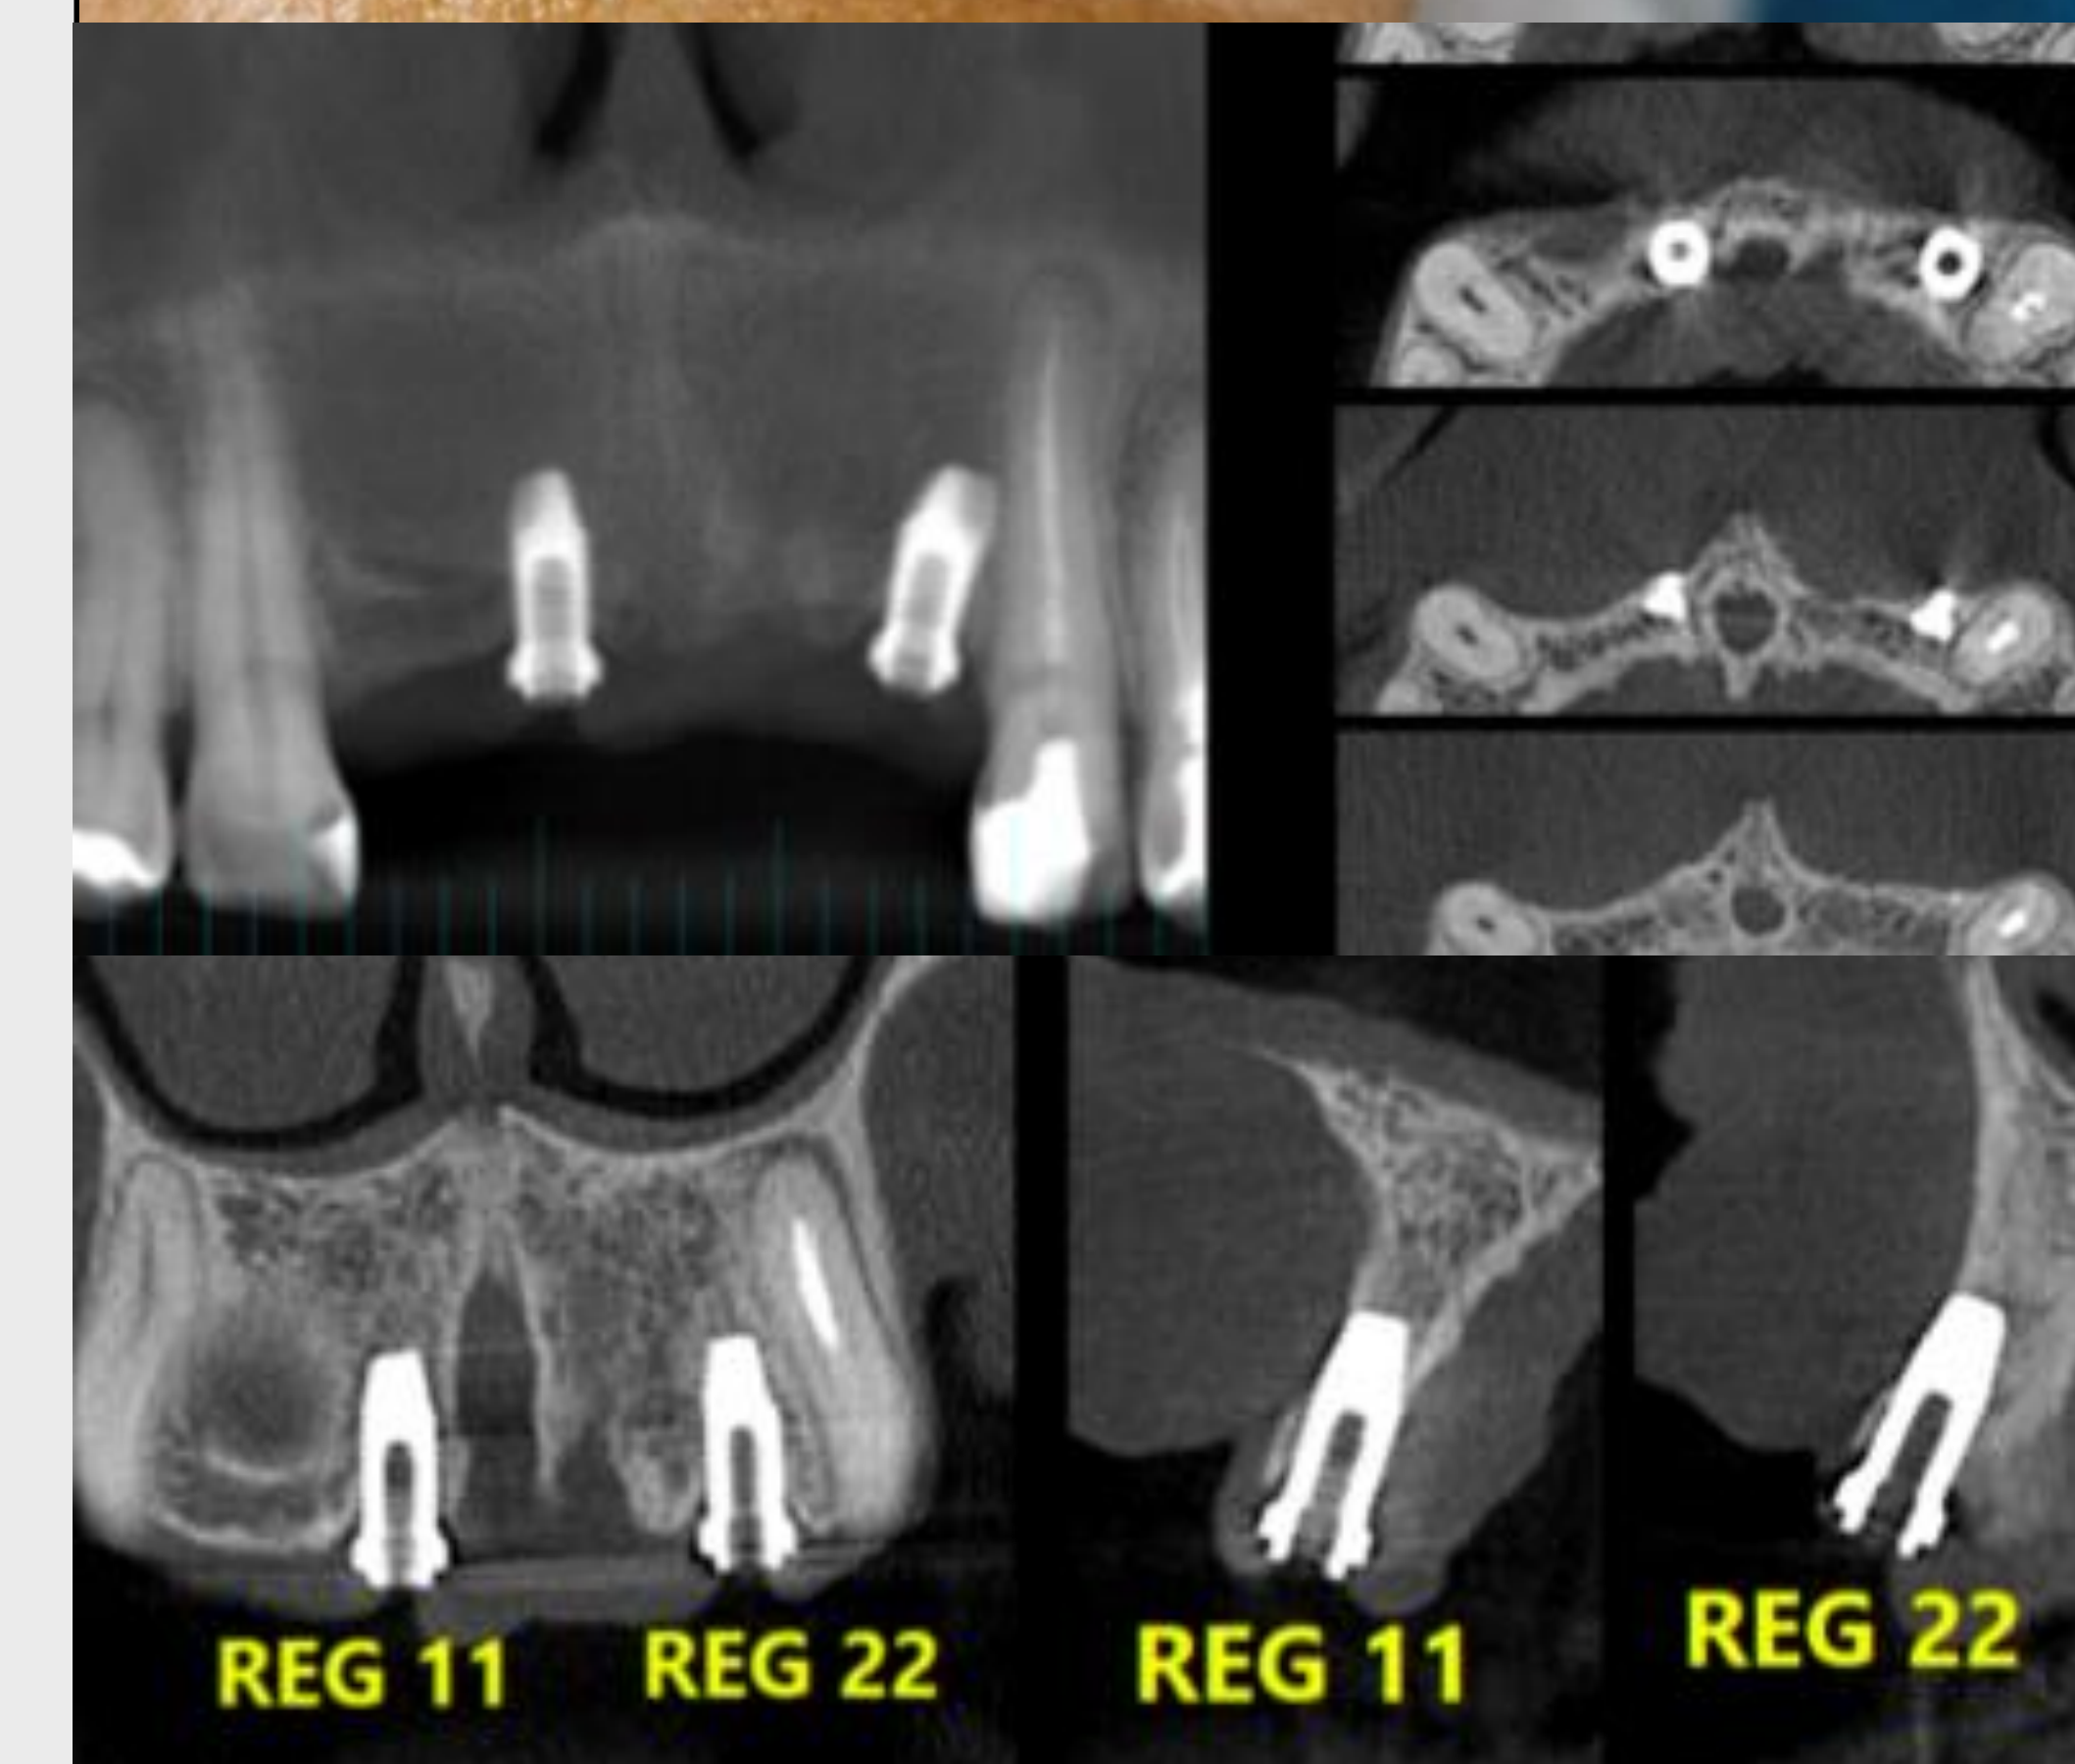
**CASE REPORT:** A 45-year-old female came to dental care complaining of “elongated and unnatural teeth”. The unsatisfactory prosthesis had one year function and were supported two osseointegrated dental implants placed in #7, 8, 9 and 10 dental region. Clinical and CBCT scan evaluation revealed that the dental implants were buccally misplaced, which makes it impossible to accomplish a successful prosthesis from an esthetic point of view. The treatment plan consisted on removal of the dental implants using a retrieval tool, followed by bone graft and the placement of two new dental implants by 3.5x11.5mm on the ideal arch position, covered by L-PRF.
