# Misplaced Dental Implants Removal and New Implants Placement: Case Report

<sup>1</sup> Edemar Fronchetti Jr DDS MSc <sup>2</sup> Orlando Luiz do Amaral Júnior DDS PhD <sup>3</sup> Paola Spessato DDS, MSc <sup>4</sup> Salmeron Samira DDS, PhD

1, 2, 3 Unidade Central de Educação FAI Faculdades – UCEFF, School of Dentistry, Department of Oral Health, Itapiranga, SC, Brazil.

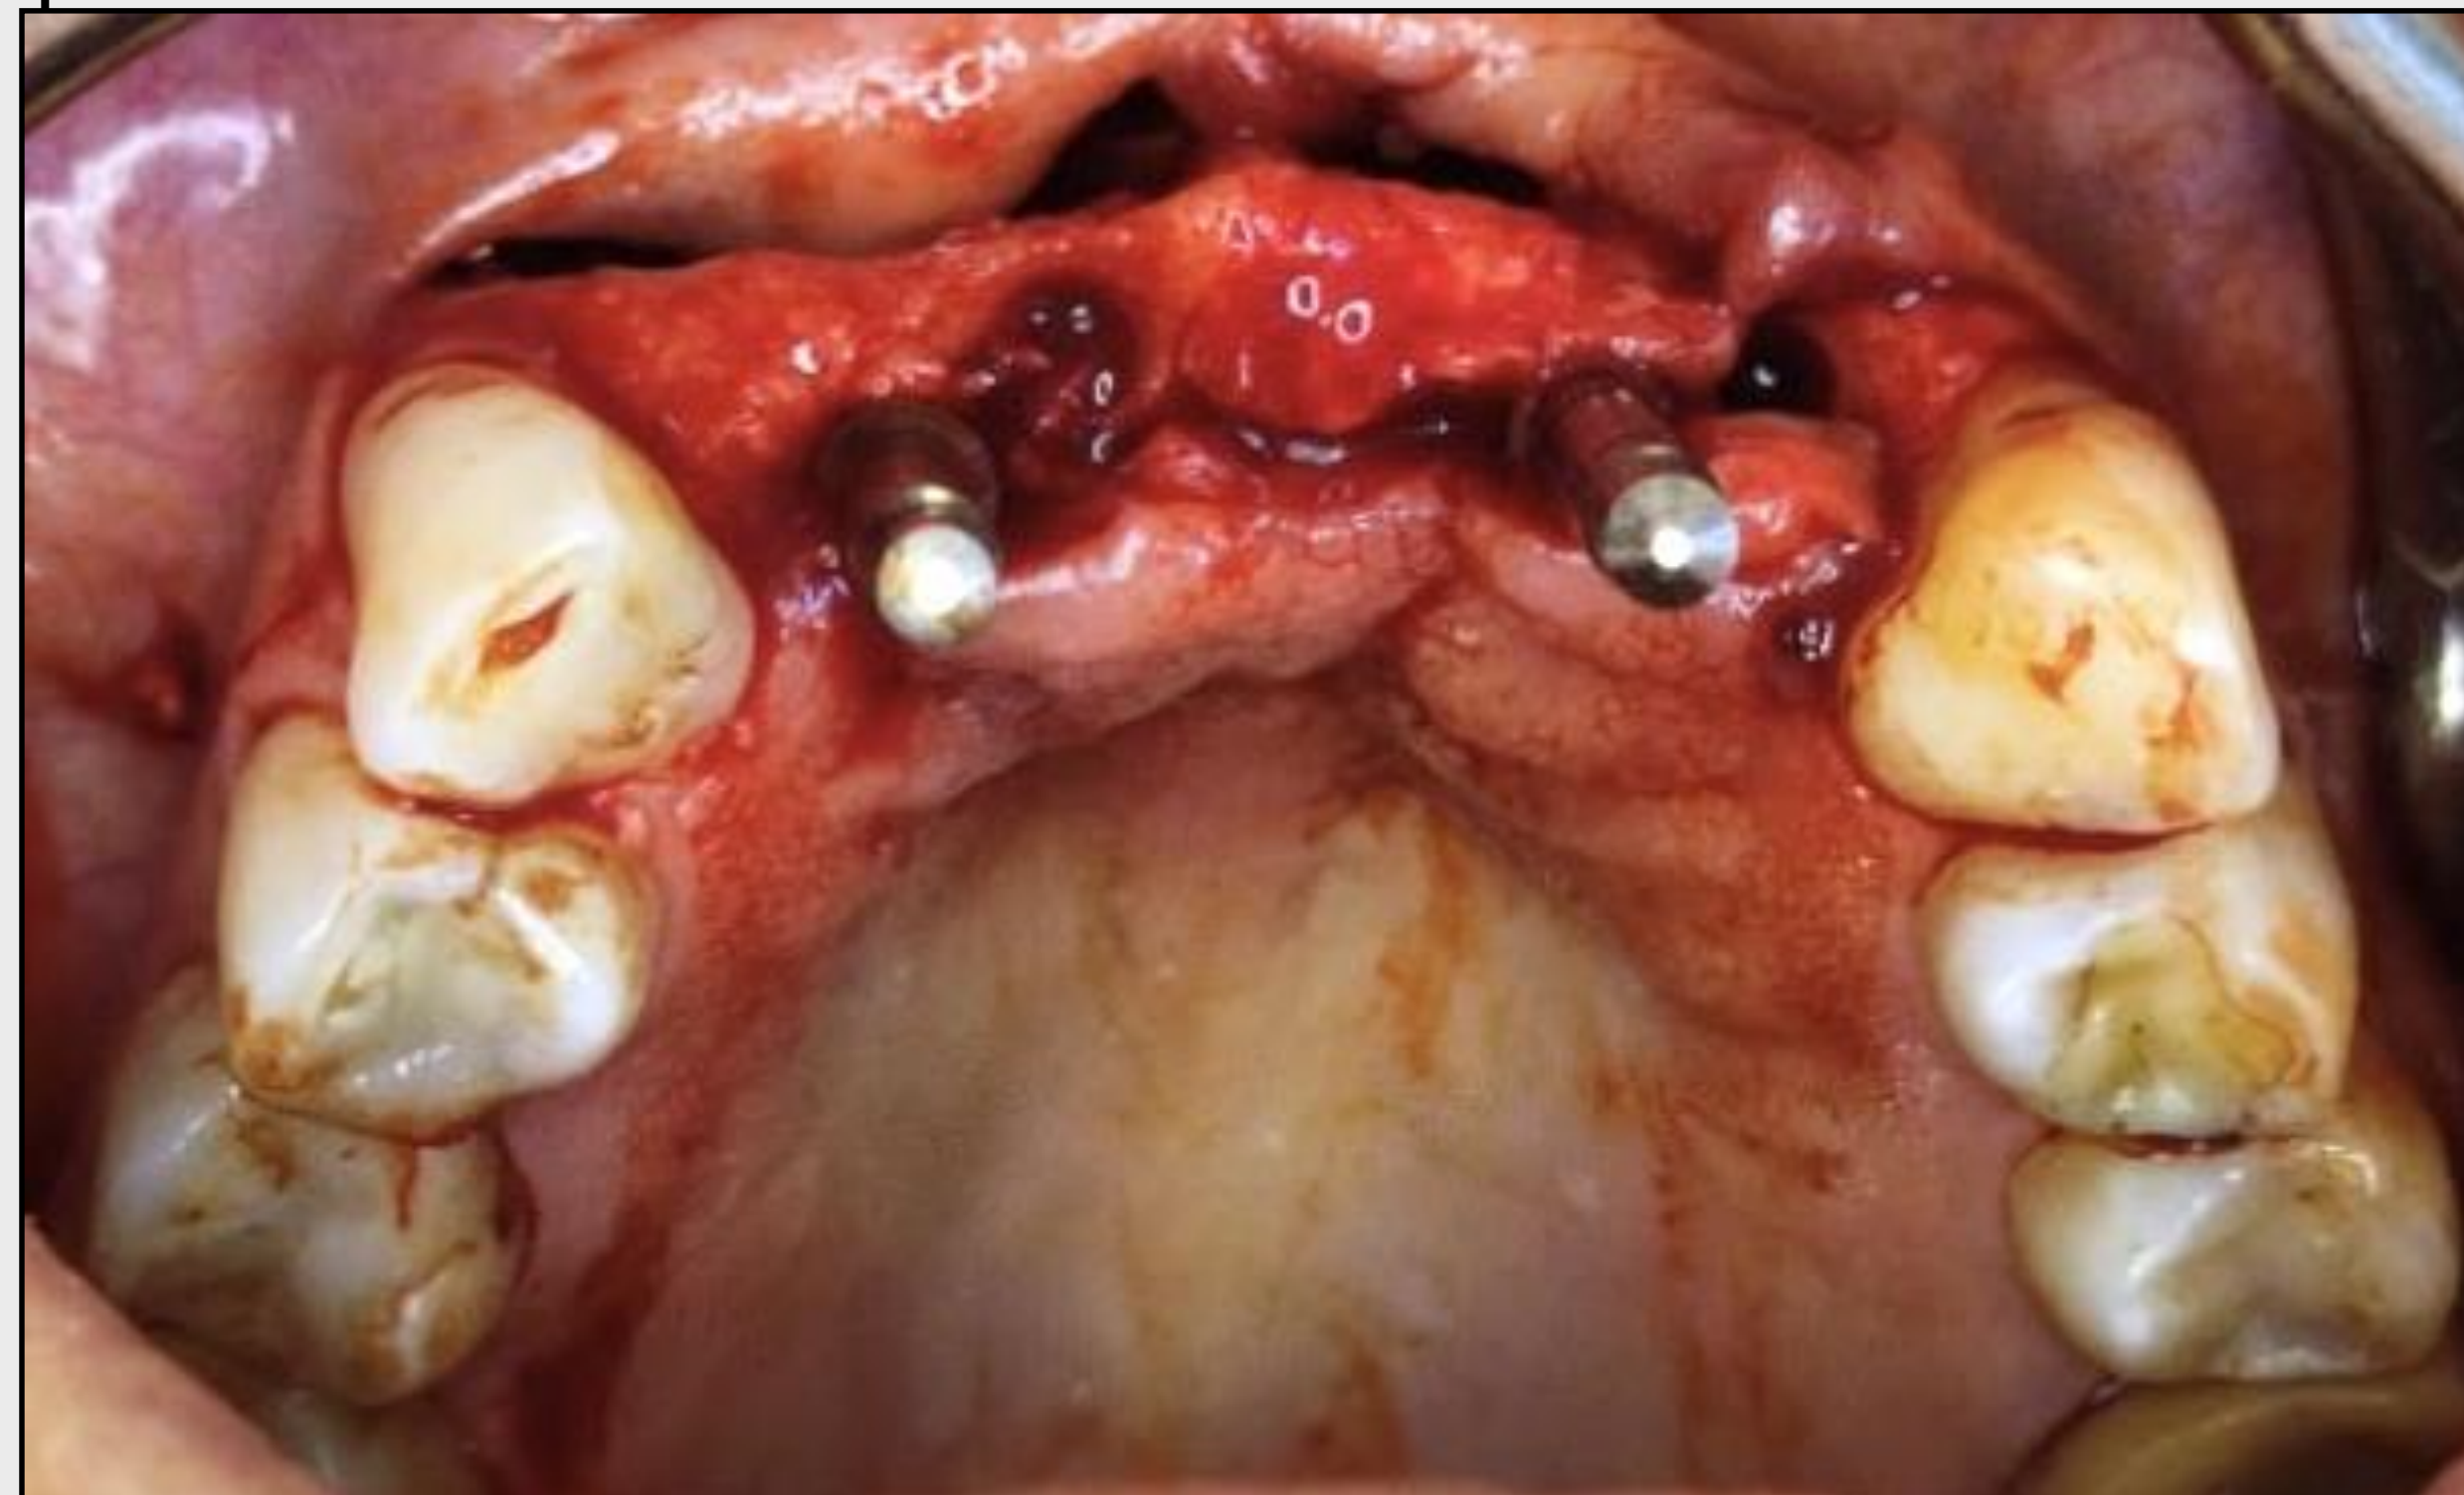
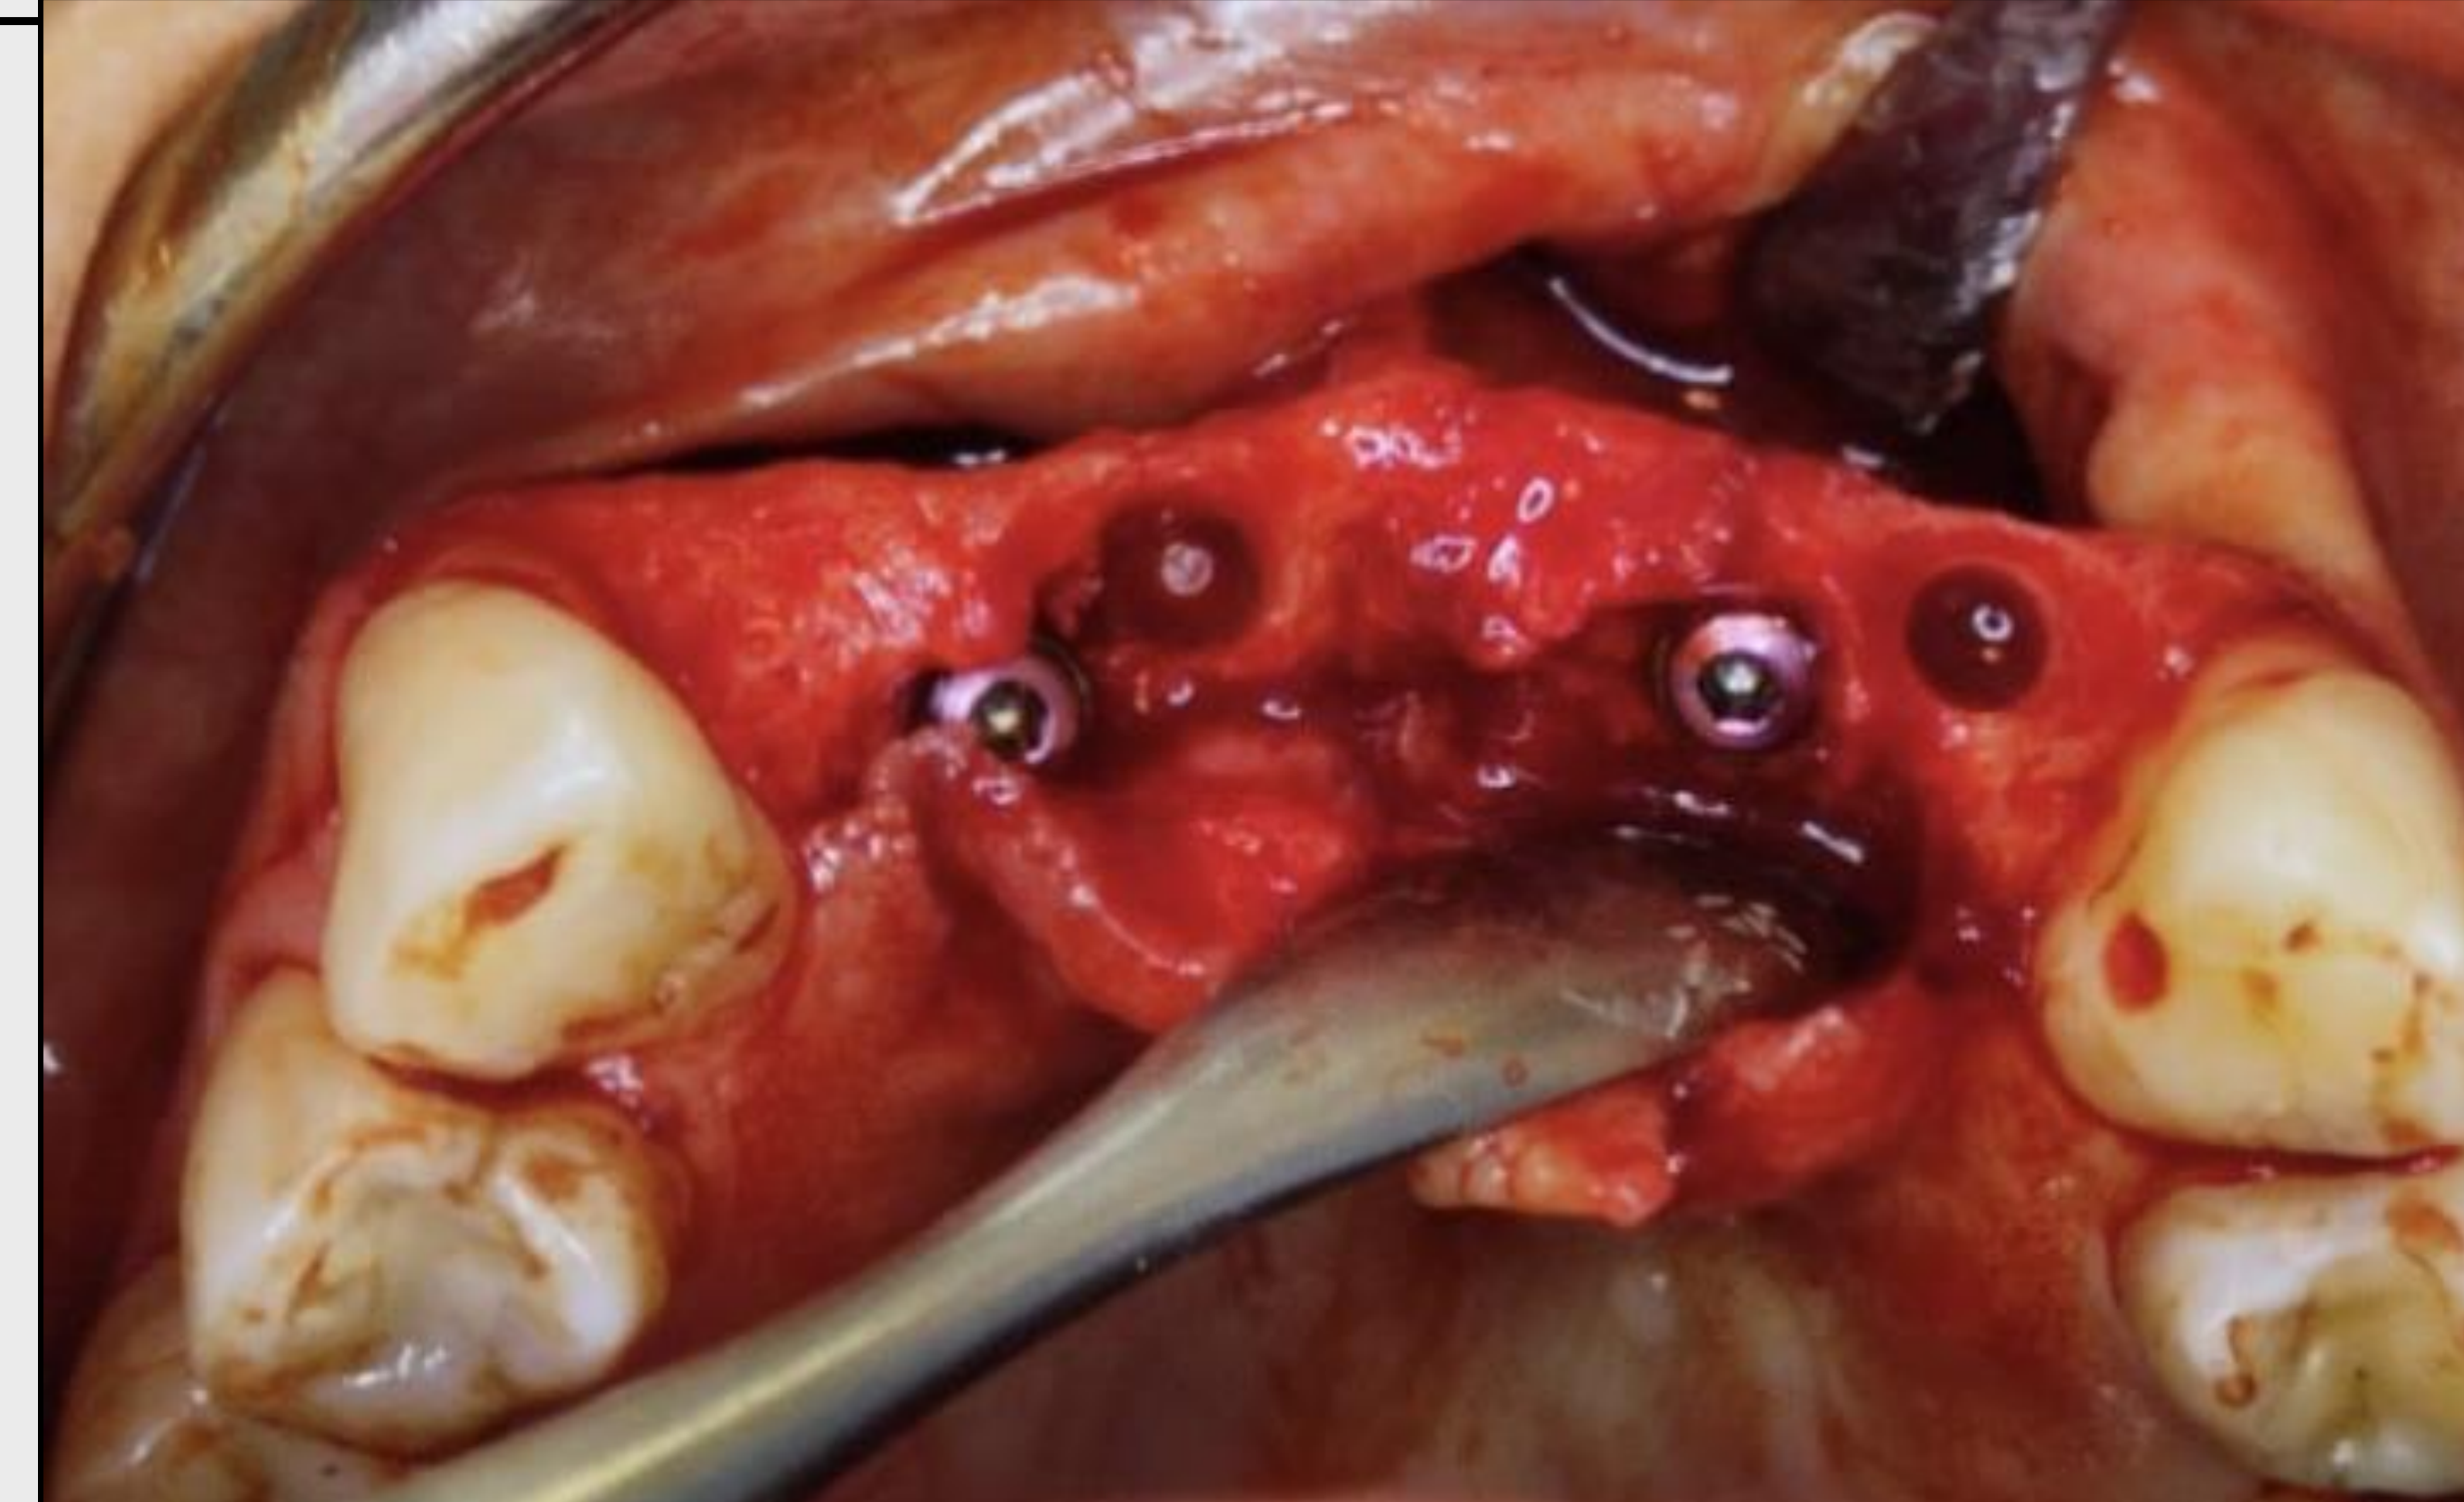
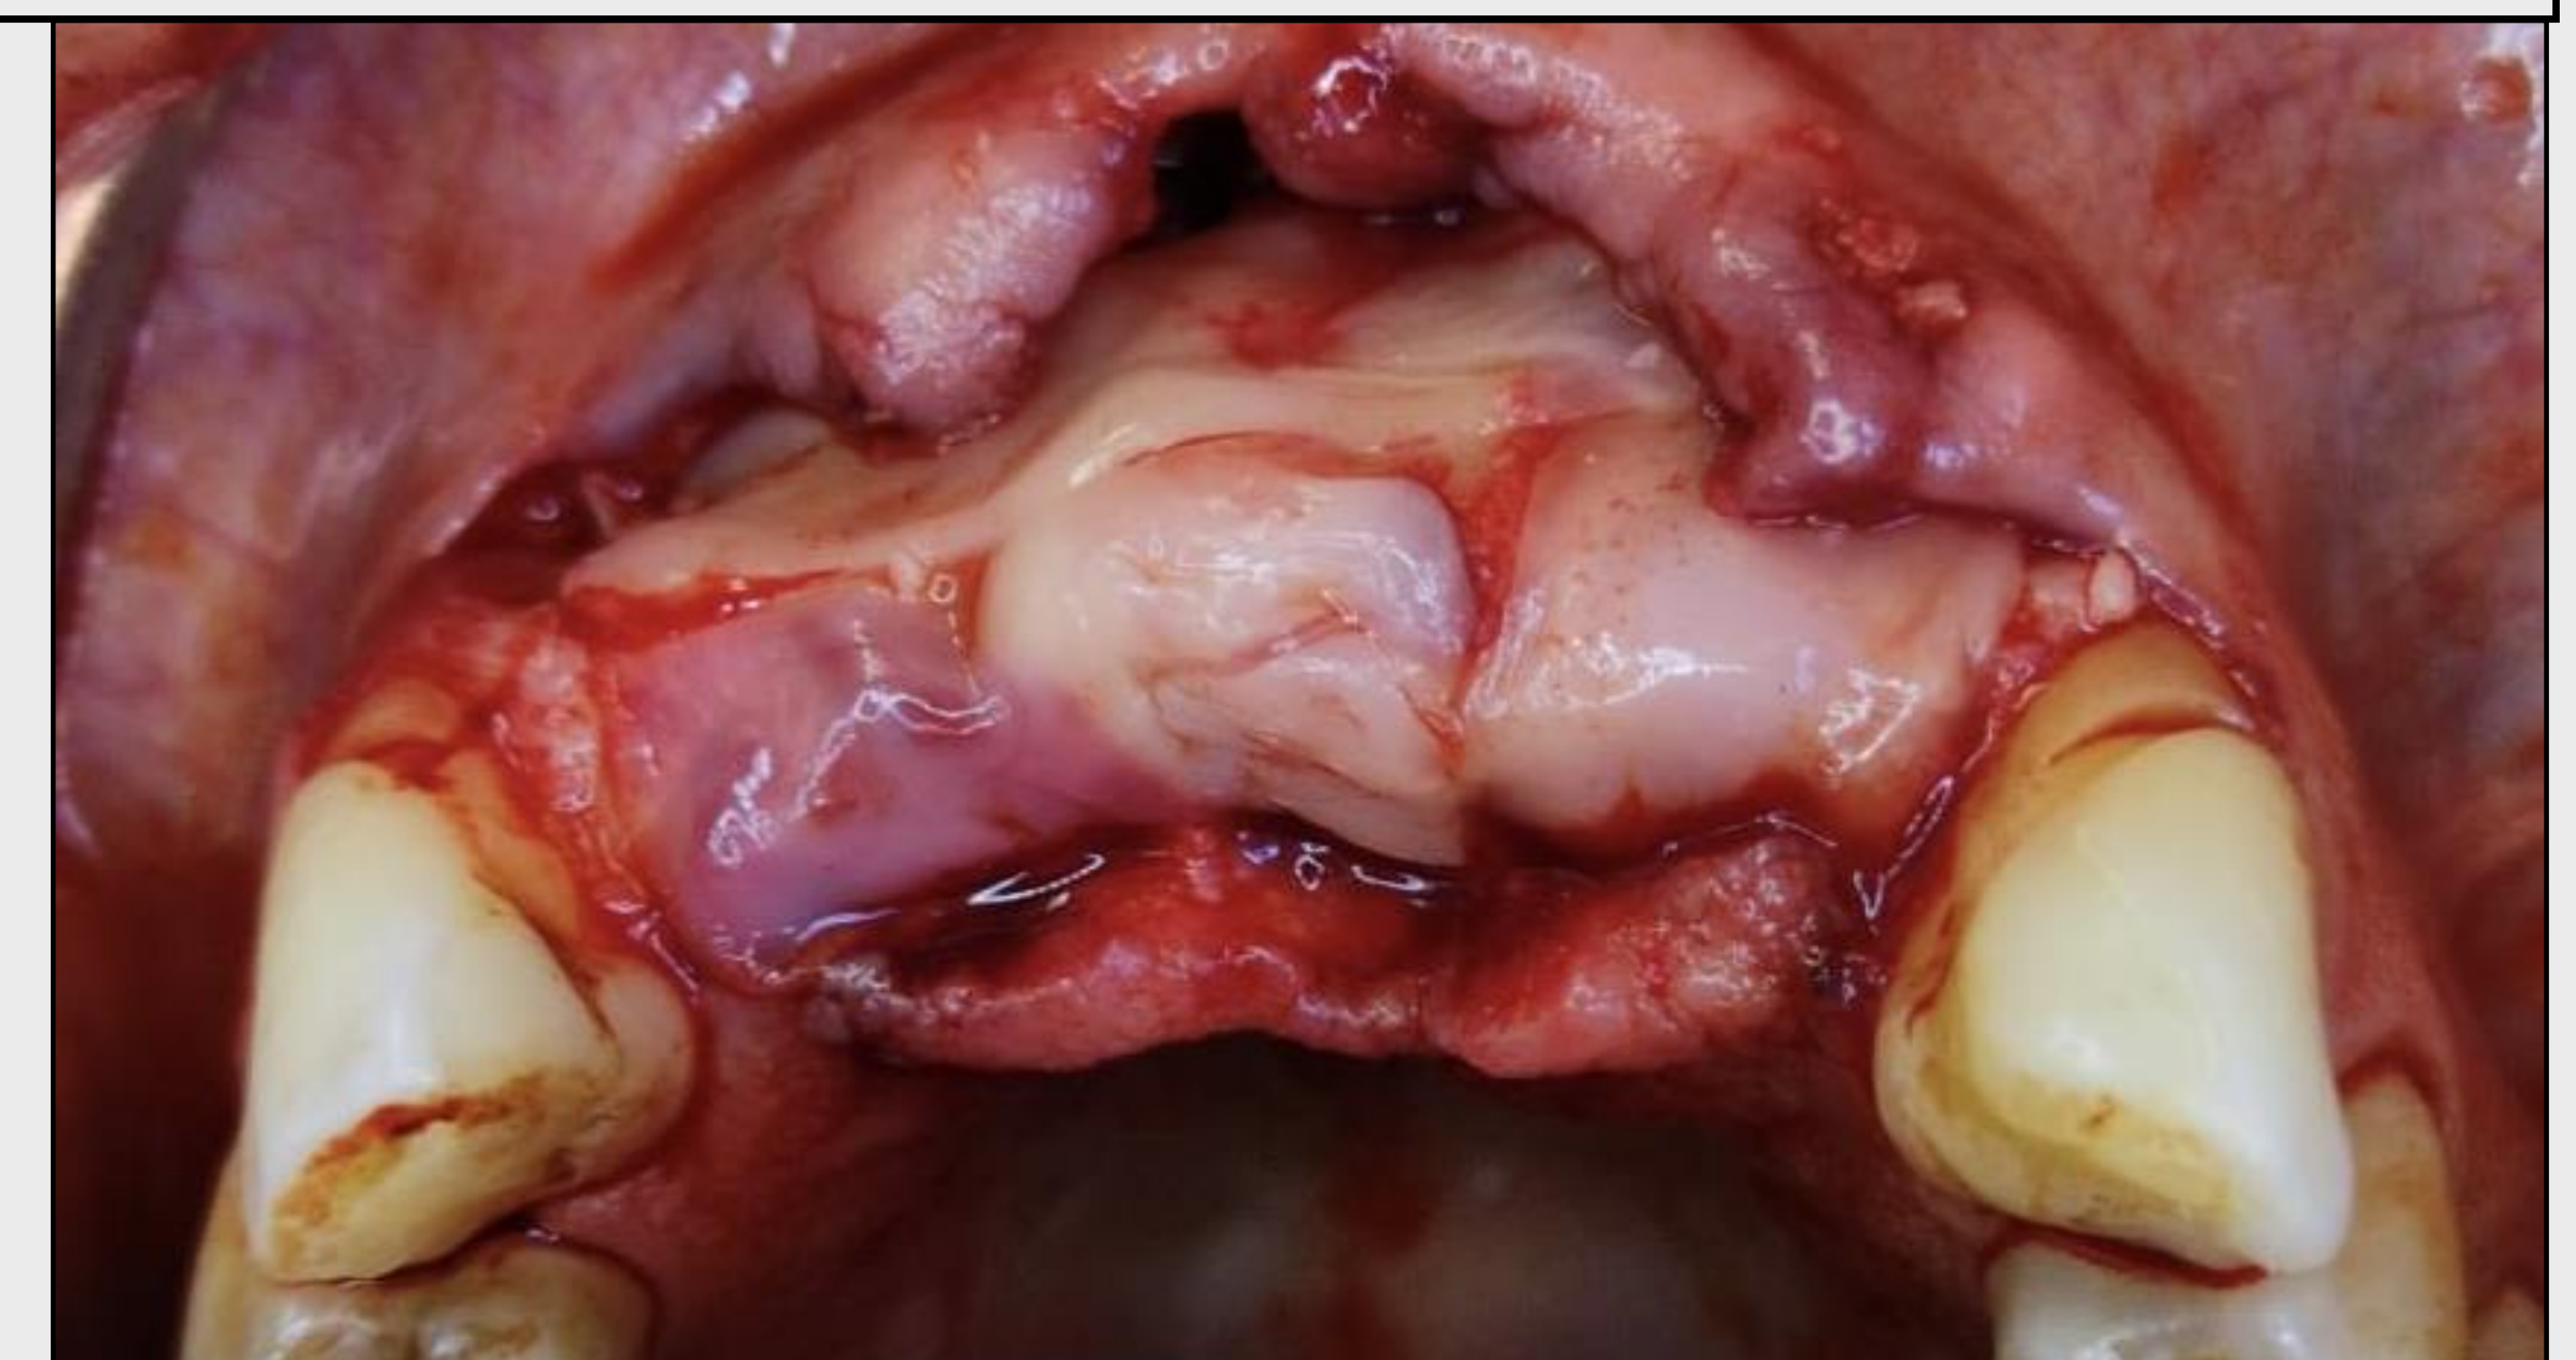
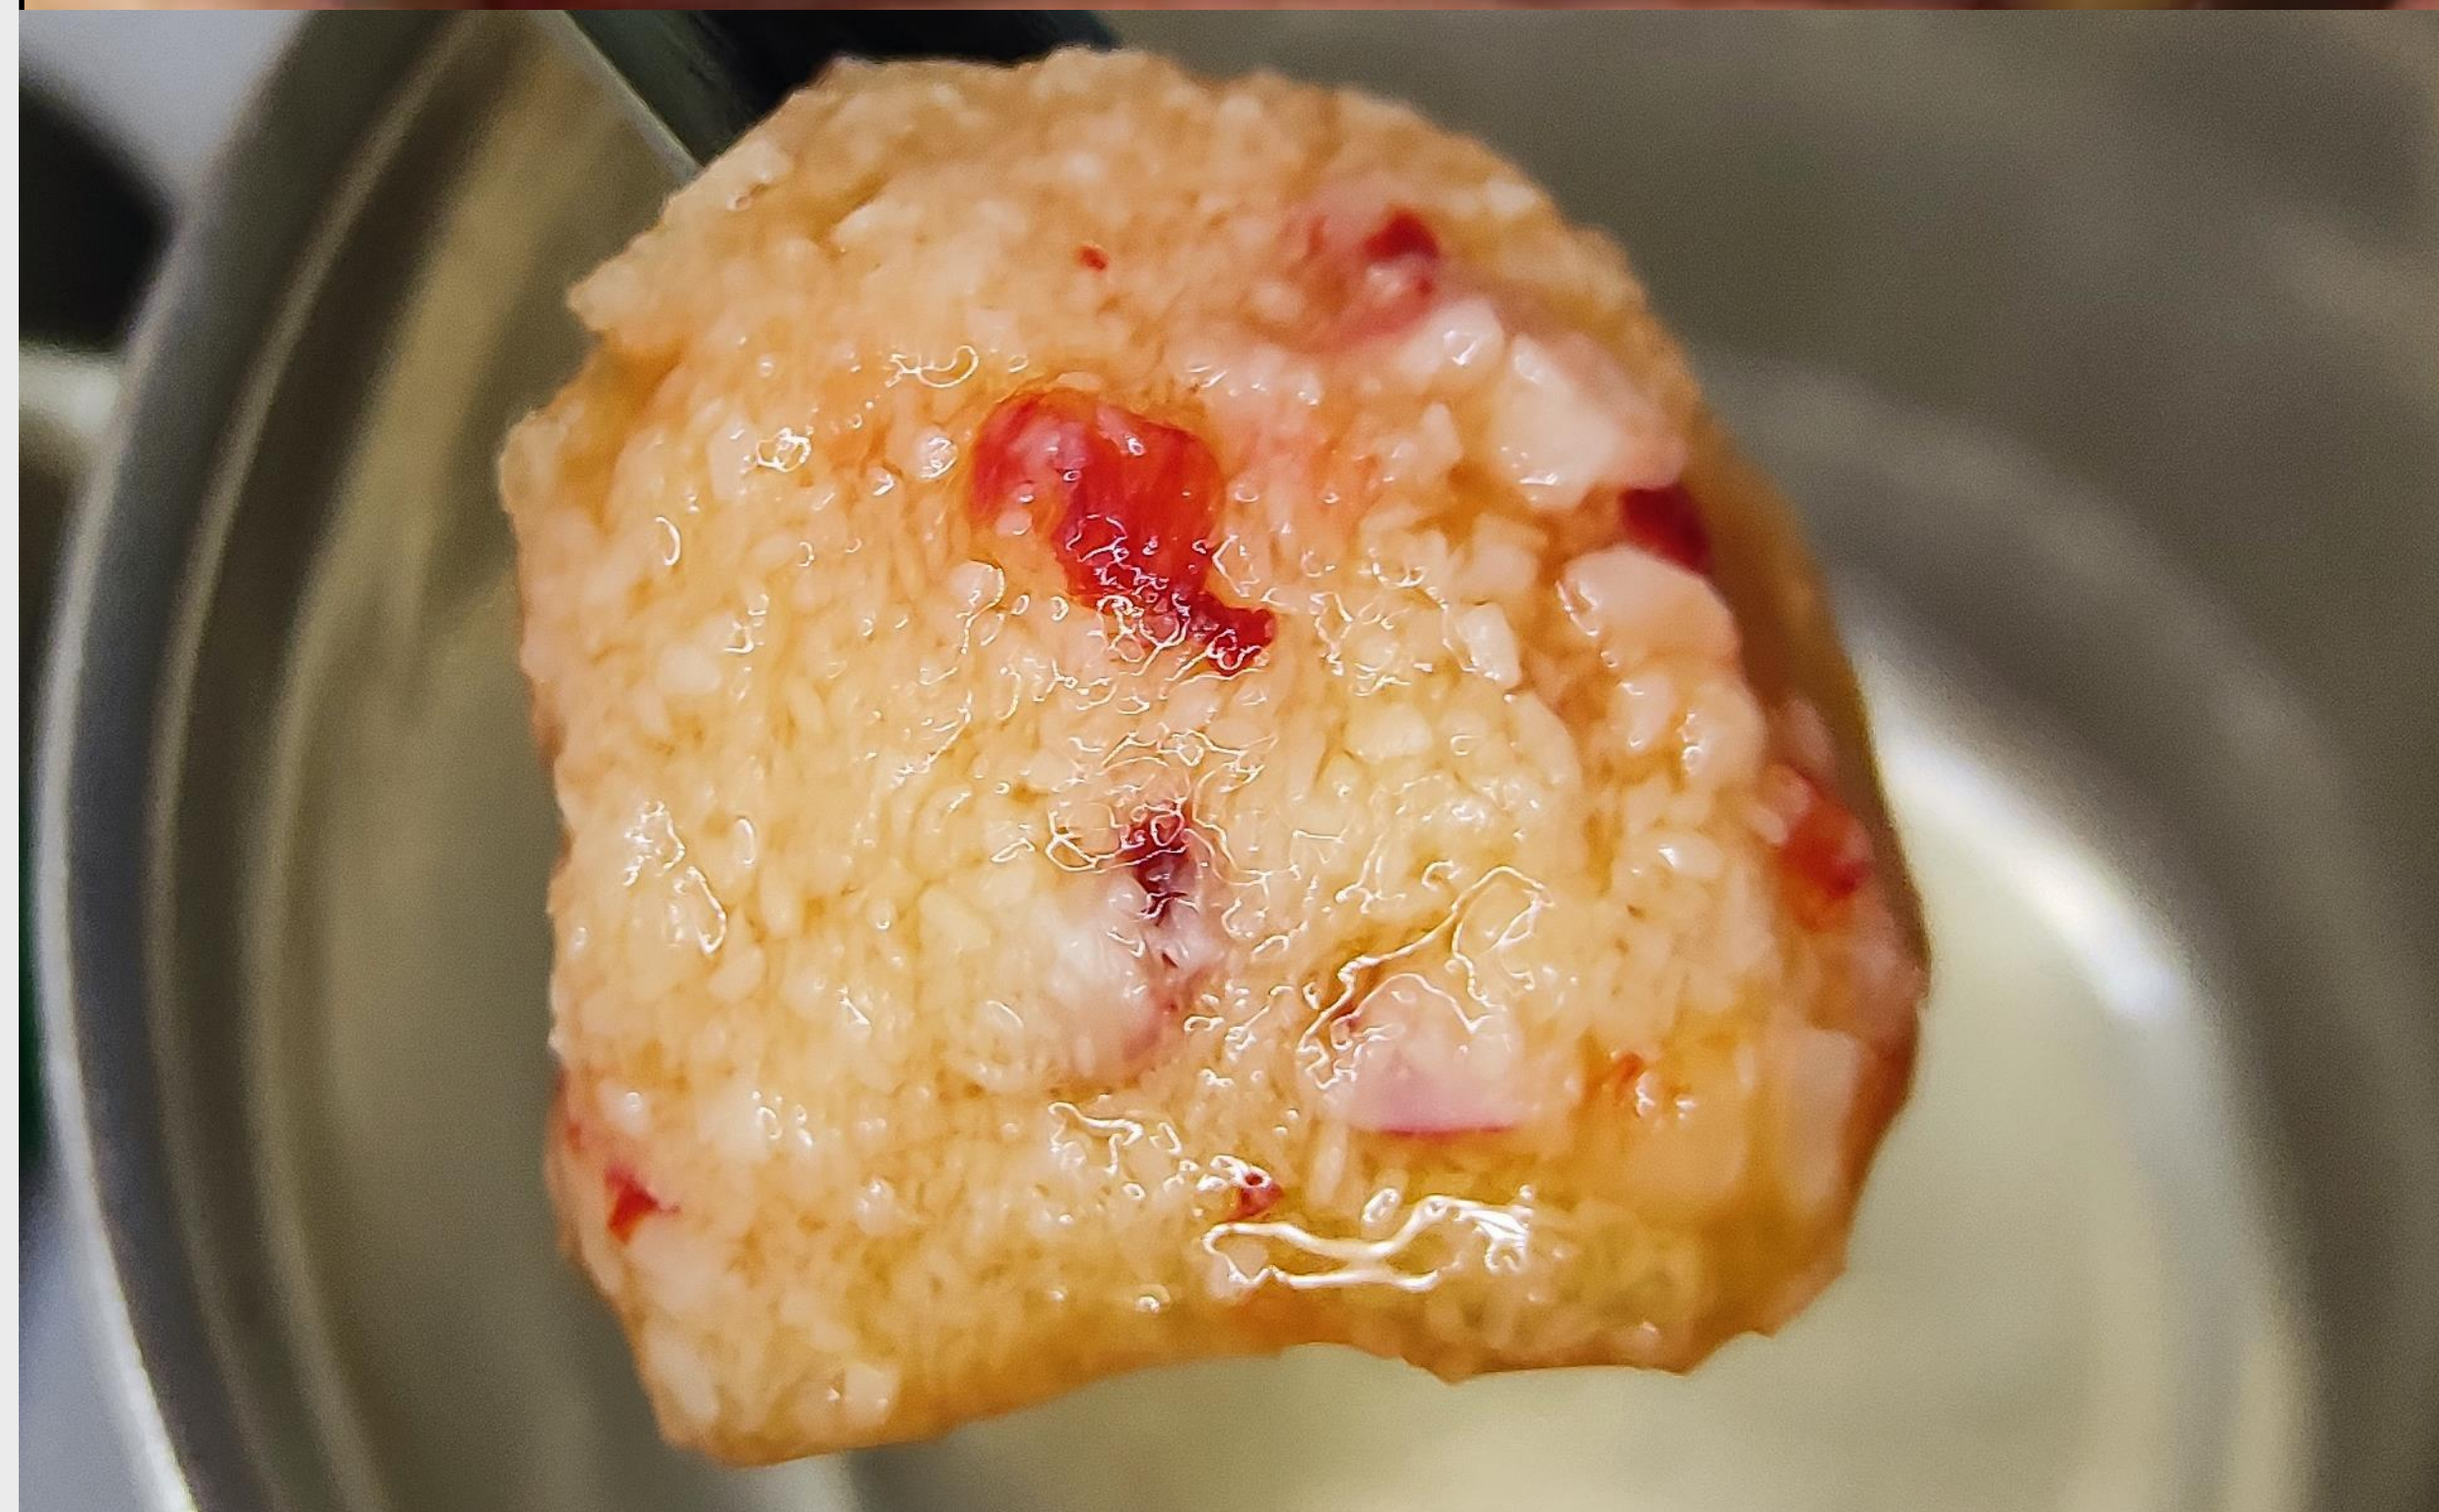
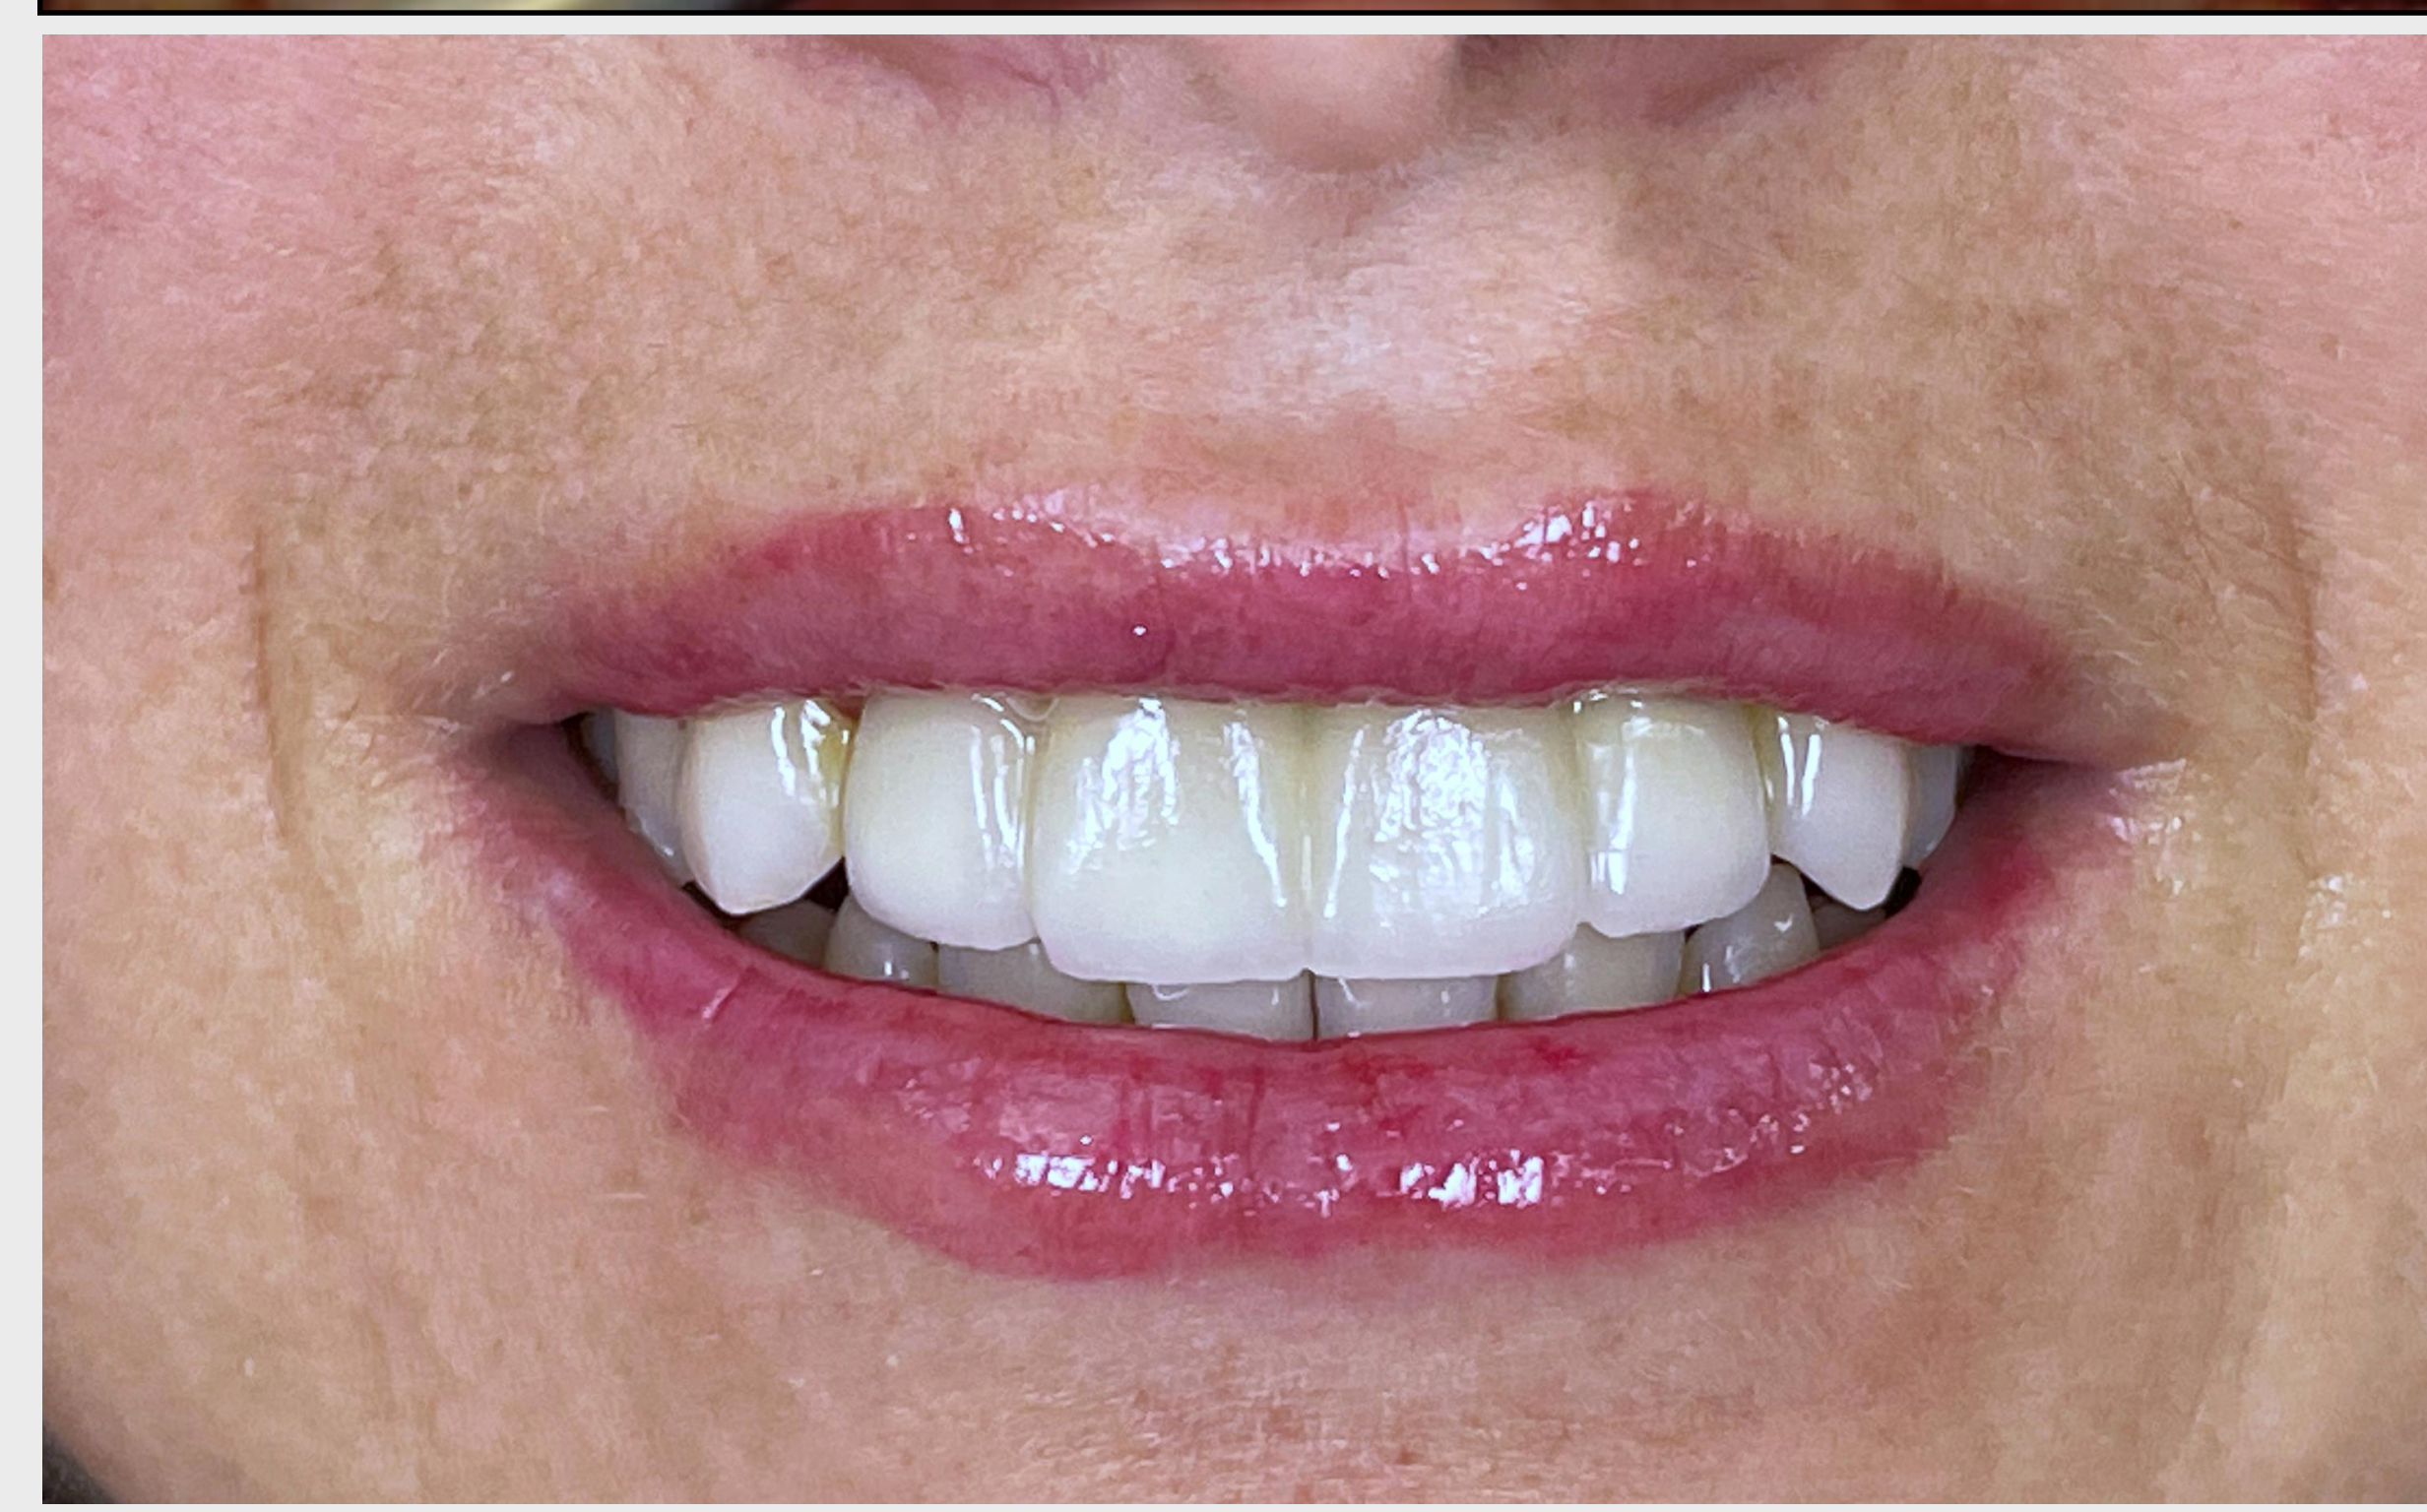
**Results:** After four months using a temporary removal prosthesis, the patient presented good clinical outcomes and a favorable soft tissue condition. CBCT scan showed osseointegration around the dental implants allowing the prosthetic phase to be concluded. The new crowns, made by zirconia, achieved satisfactory esthetic and occlusal function. The patient is in 18 months follow-up and contemplate health and function. No esthetic complains were reported
