# Polymer Infiltrated Ceramic Network: A Literature Review

Mohammed Alyami BDS, MS, Thomas Giugliano DDS, Mijin Choi DDS, MS, MBA, FACP

Jonathan and Maxine Ferencz Advanced Education Program in Prosthodontics New York University College of Dentistry

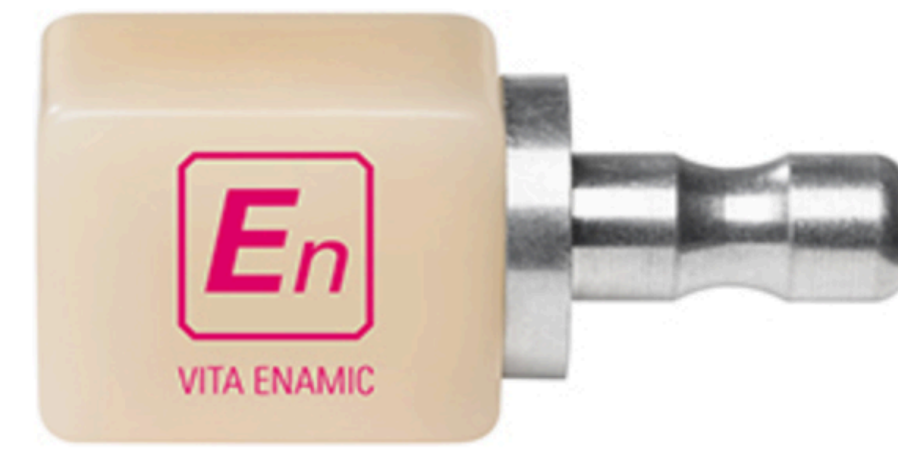
Fig 1. VITA ENAMIC® CAD/ CAM Block

A hybrid ceramic material, Polymer Infiltrated Ceramic Network (PICN) (Vita Enamic, Vita Zahnfabrik, Bad Sachingen, Germany) is a recently introduced material that combines the benefits of ceramic and composite materials.<sup>1</sup>(Figs1,2). PICN is comprised of an 86% inorganic phase, including feldspathic ceramic as the dominant phase, and a 14% organic phase composed of dimethacrylates.<sup>2</sup> This material can be used with minimal tooth preparation of 0.5 - 1 mm. Also because of its high bond strength it can be used to correct occlusal wear with minimal thickness.<sup>3,4,5</sup>

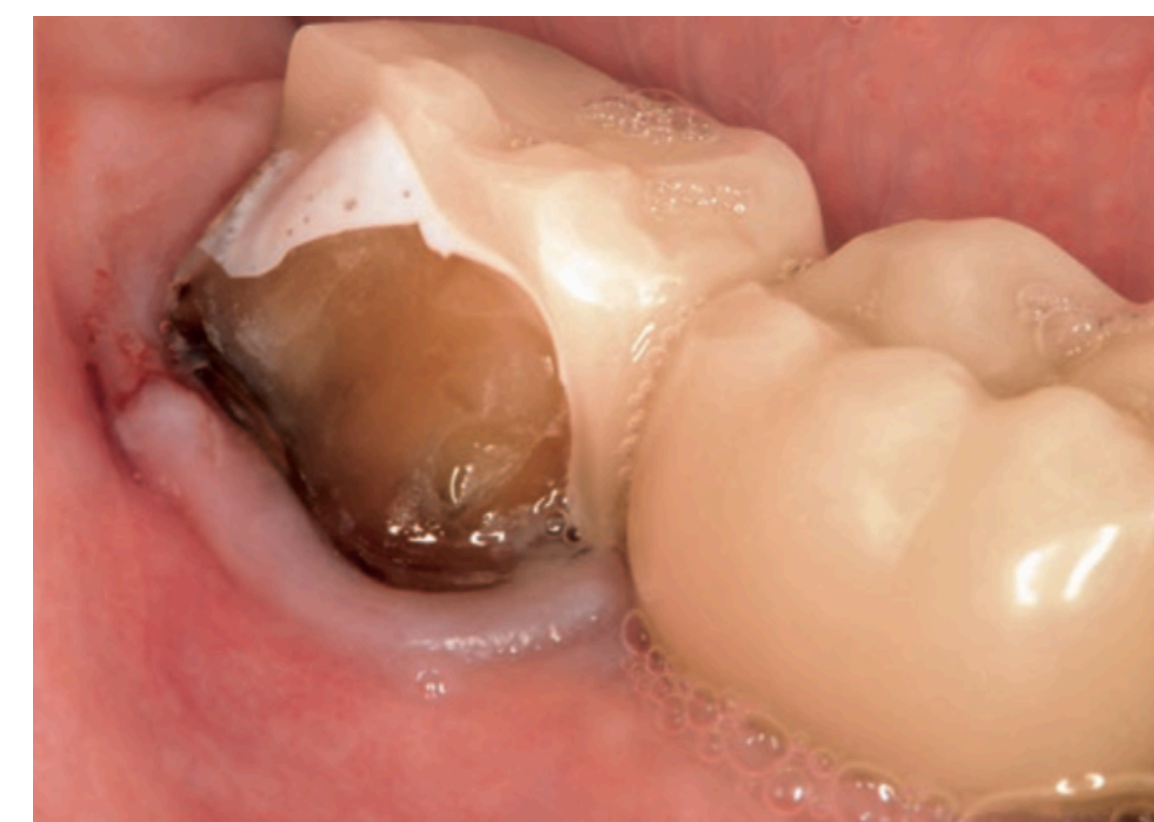
Fig 3. Fracture of PICN crown

In the single crown trials a total of 145 Vita Enamic crowns were studied. Five crowns failed due to fracture (3.4%) (Fig 3) and 2 due to debonding (1.3%). Of the 109 partial coverage PICN restorations studied, 3 failed due to fracture (2.7%) (Fig 4) and 1 due to debonding (<1%). Preliminary clinical data on PICN partial coverage restoration survival rates appear promising. However, based on the nature of the failures being catastrophic fractures and debonding, the brittleness of the material under occlusal load seems high. The debonding of the material suggests that bond strength of PICN requires further investigation. Since there is still a scarcity of in-vivo studies on PICN restorations, a further clinical evaluation of Enamic restorations is necessary to identify any limitations with this material and assess its clinical performance.

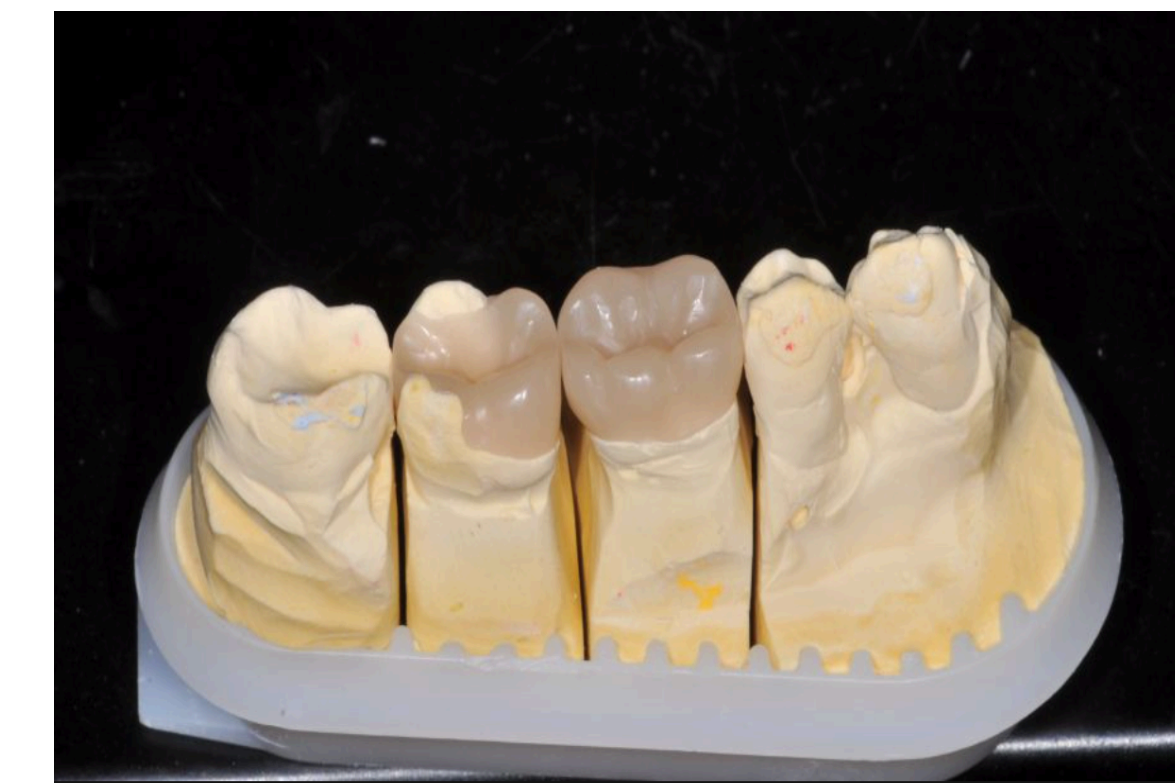
Fig 2. PICN crown and onlay# 30,31
