**IN VITRO STUDY TO ANALYZE CHANGES IN PRELOAD IN ABUTMENT SCREWS WITH TIGHTENING/LOOSENING ONCE DAILY FOR 10 DAYS**

**DR. NIKITA SINHA, DR. GEOFFREY A. THOMPSON, DR. CARL DRAGO**

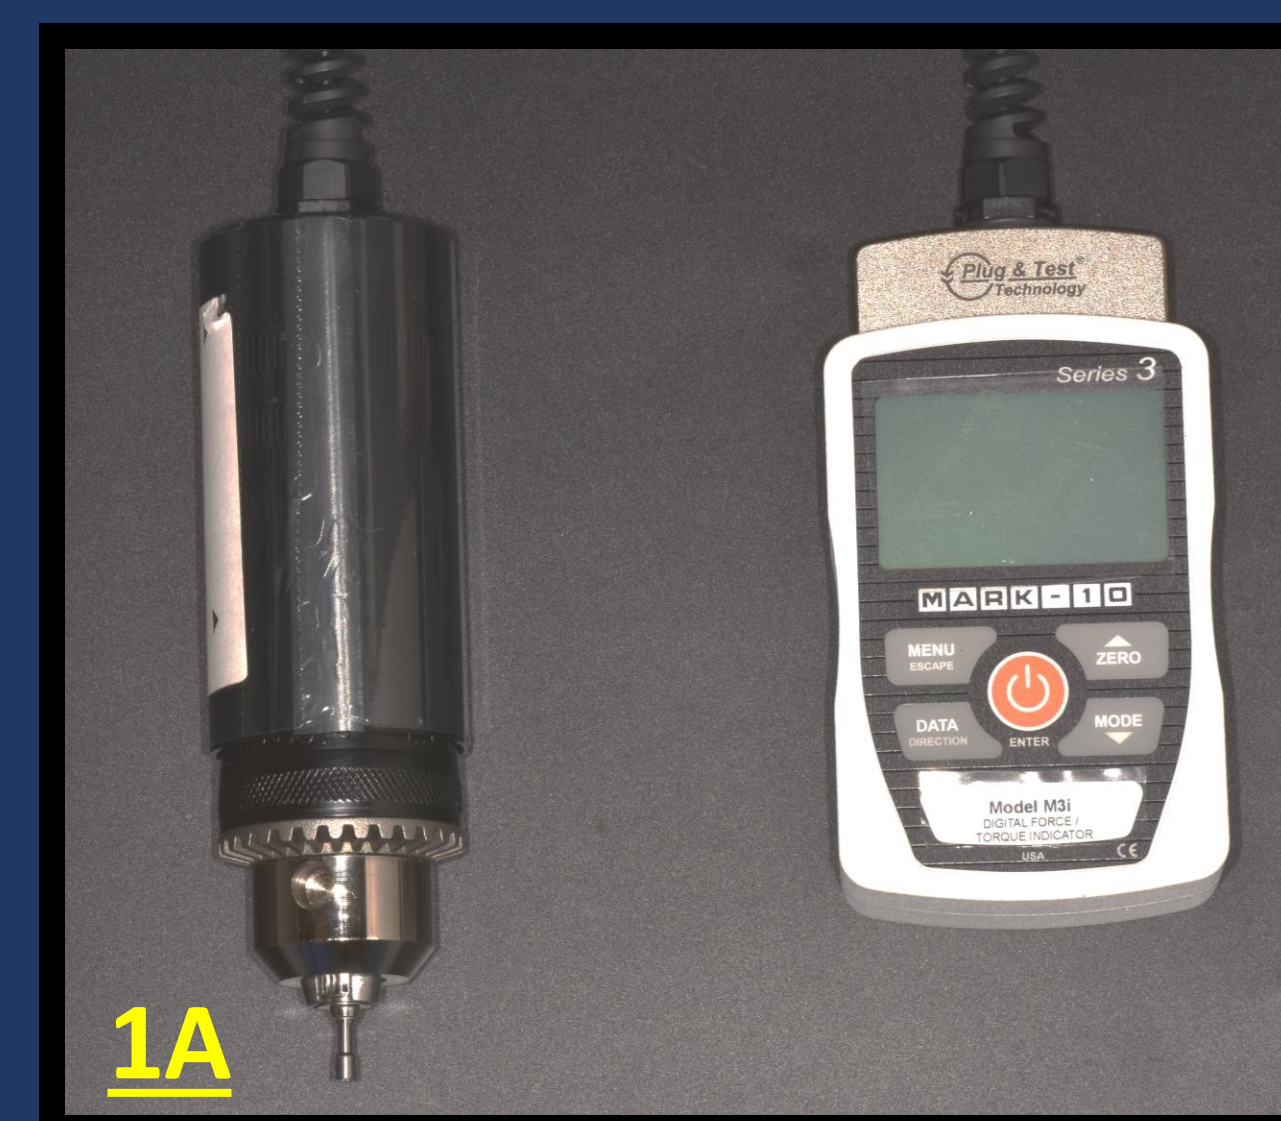
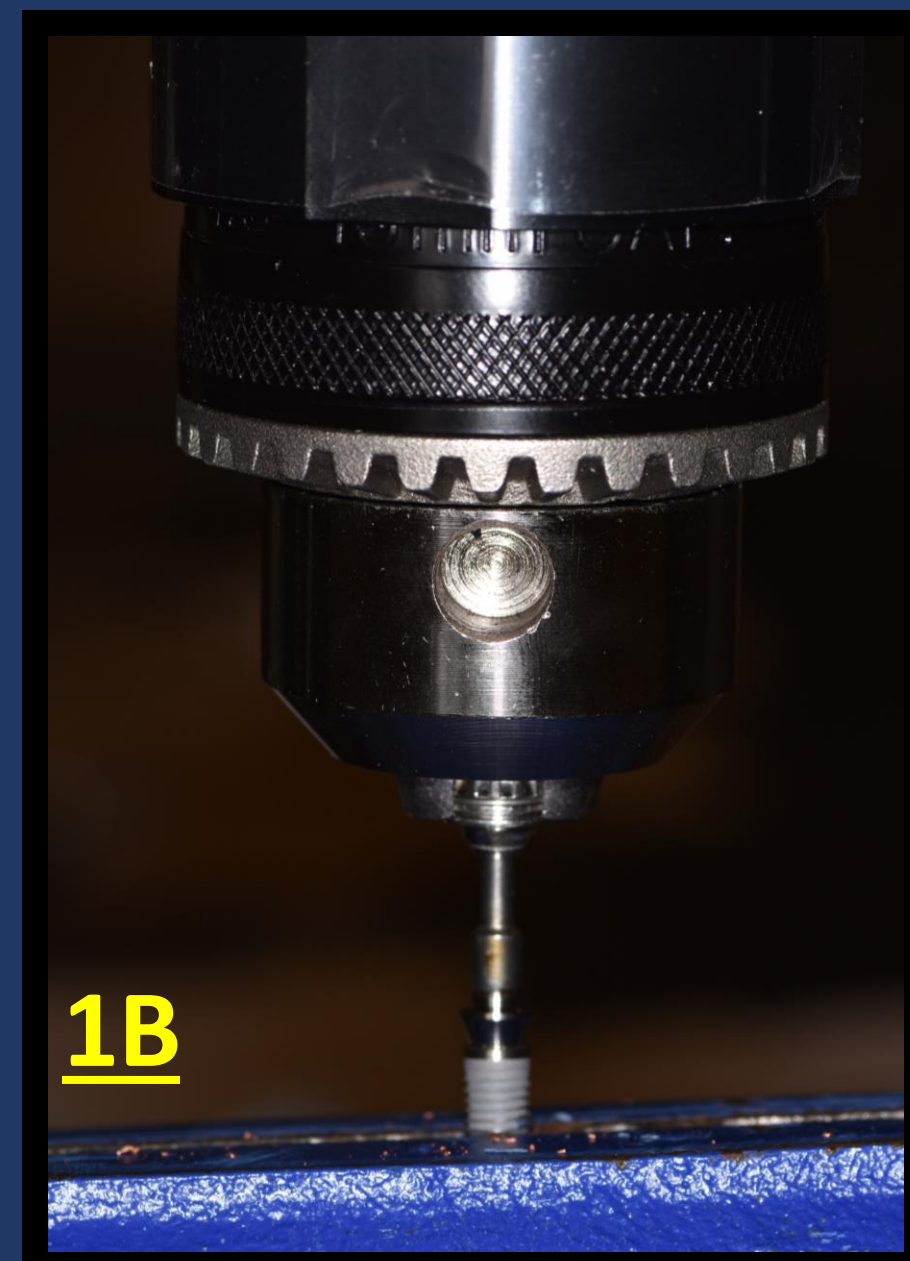
The implant systems used were Nobel Biocare, Straumann, Biohorizons and Astratech. Implant drivers, specific for each manufacturer, fit inside the torque controller chuck were selected. (Fig 1A).The drivers were inserted into the torque gauge chuck with jaws and the jaws were tightened with a drill chuck for stability. (Figs. 1A and 1 B). Implant, abutment and a new abutment screw were inserted in a vice and the abutment screw was torqued to required torque specified by each company and recorded as the PCW. According to the manufacturer's recommendations- Nobel Biocare and Straumann screws were torqued to 35 N-Cm and Zimmer and Astratech were tightened to 30 and 25 N-Cm respectively. The abutments were torqued to 35 N-Cm as ( PCW) everyday and stored in water at a temperature of 37 °C in a Heratherm OMH180- S for 24h to simulate oral environment. The next day, the PCCW measurement was made, which signified the detorque value. This process was repeated for 10 days to simulate 10 different clinical tighten/loosen situations. The implant restorative platforms were imaged after the 10th cycle.

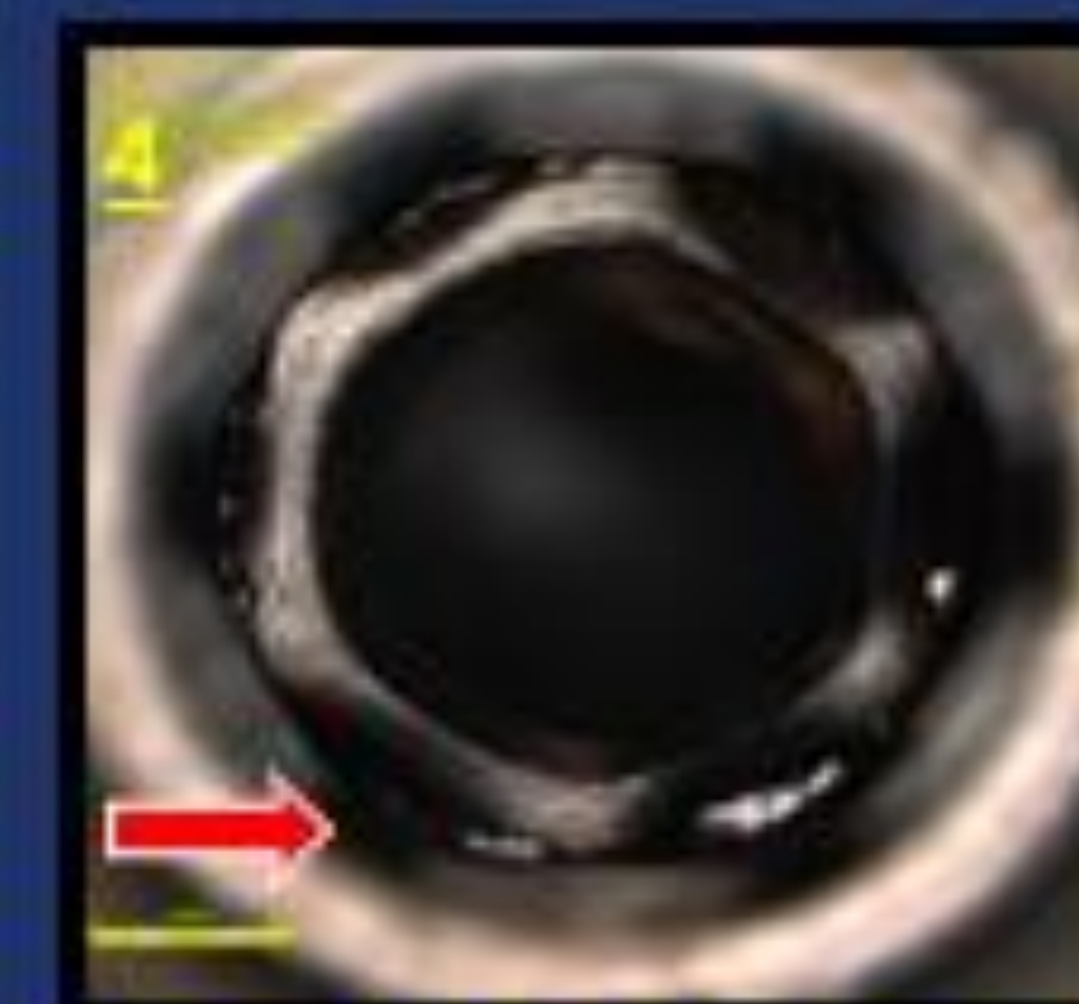
**A) NOBEL BIO CARE**

The PCW and PCCW values obtained over a 10 day period were tabulated the average values obtained were as follows; the corresponding screw head under 300X magnification were

The microscopic images of the implant restorative platforms demonstrated wear at the 10<sup>th</sup> day. (Fig 4,5, 6 and 7)

The microscopic images however showed a relationship between the geometrical factors of the Implant abutment connection interface and the wear at 10<sup>th</sup> day, (Figs. 4- 7).
