# Management of Repeatedly Fractured Monolithic Zirconia Complete Arch Fixed Implant- Supported Prosthesis with Differing Implant Components

KAROLINA M. MIGUS, DMD, AVINASH S. BIDRA, BDS, MS, FACP  
UNIVERSITY OF CONNECTICUT SCHOOL OF DENTAL MEDICINE, POST-GRADUATE PROSTHODONTICS, FARMINGTON, CT

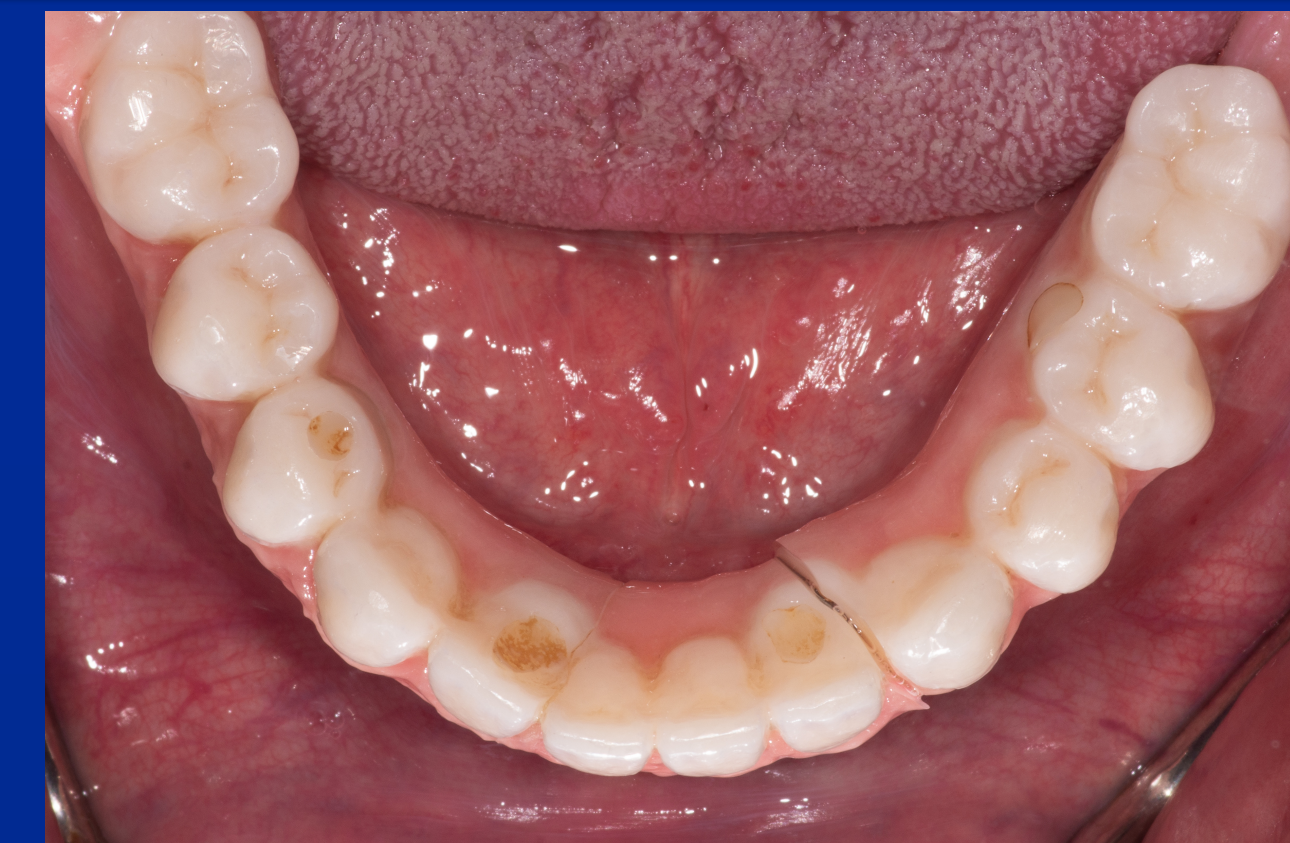
Figure 2. First fractured monolithic zirconia prosthesis between #22-23 & 25-26

- The initial fracture of the mandibular prosthesis that occurred September 2020 was attributed to inadequate final prosthesis thickness around cylinders and misfit due to diverse implant components. The subsequent fracture of the mandibular prosthesis which occurred October 2021, is theorized to have been a result of inadequate prosthesis thickness around cylinders, patient's parafunctional habits and lack of occlusal guard usage, and/or mandibular flexure.
- Mandibular flexure is an important consideration in this patient but could not be attributed to a direct etiology in the presence of severe bruxism and prosthetic design issues.

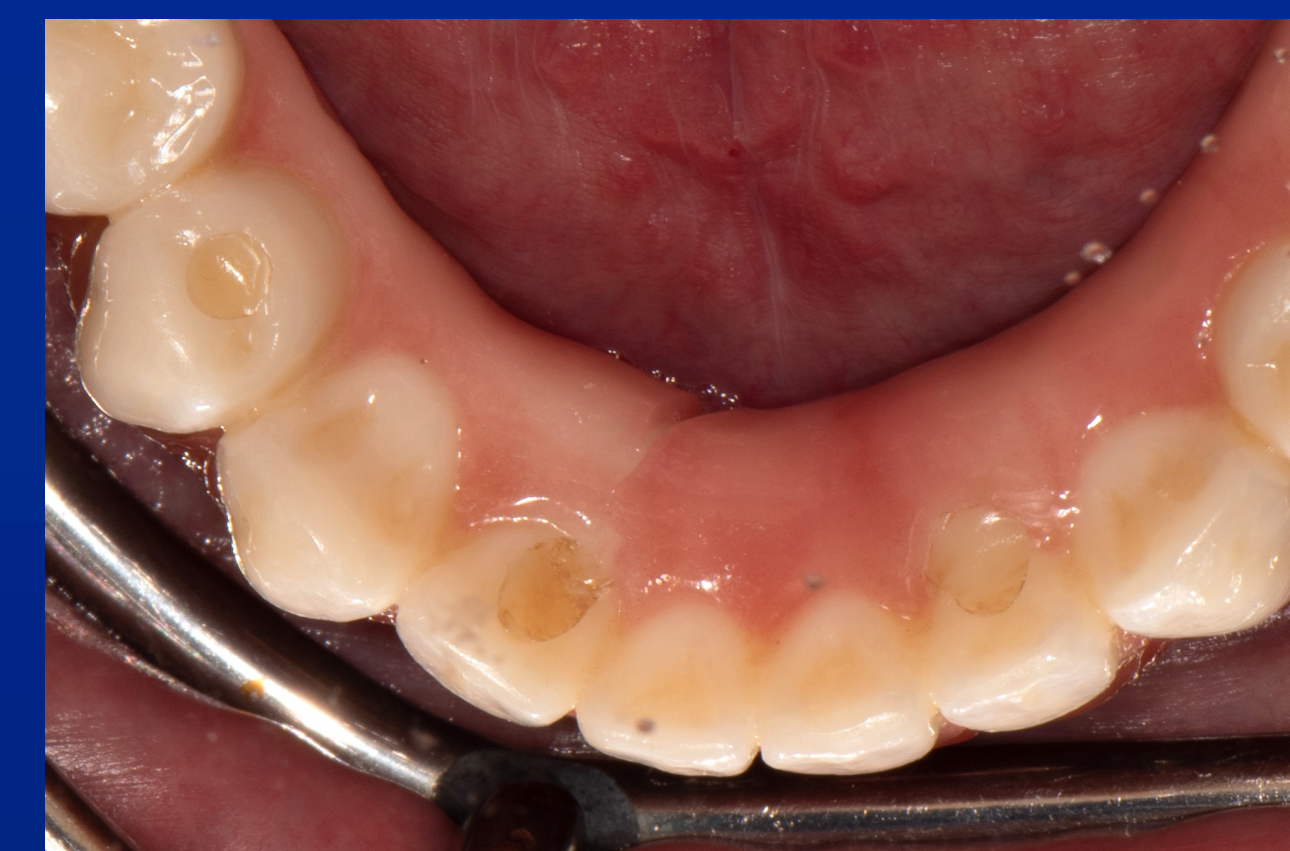
Figure 3. Second fractured monolithic zirconia prosthesis between #25-26

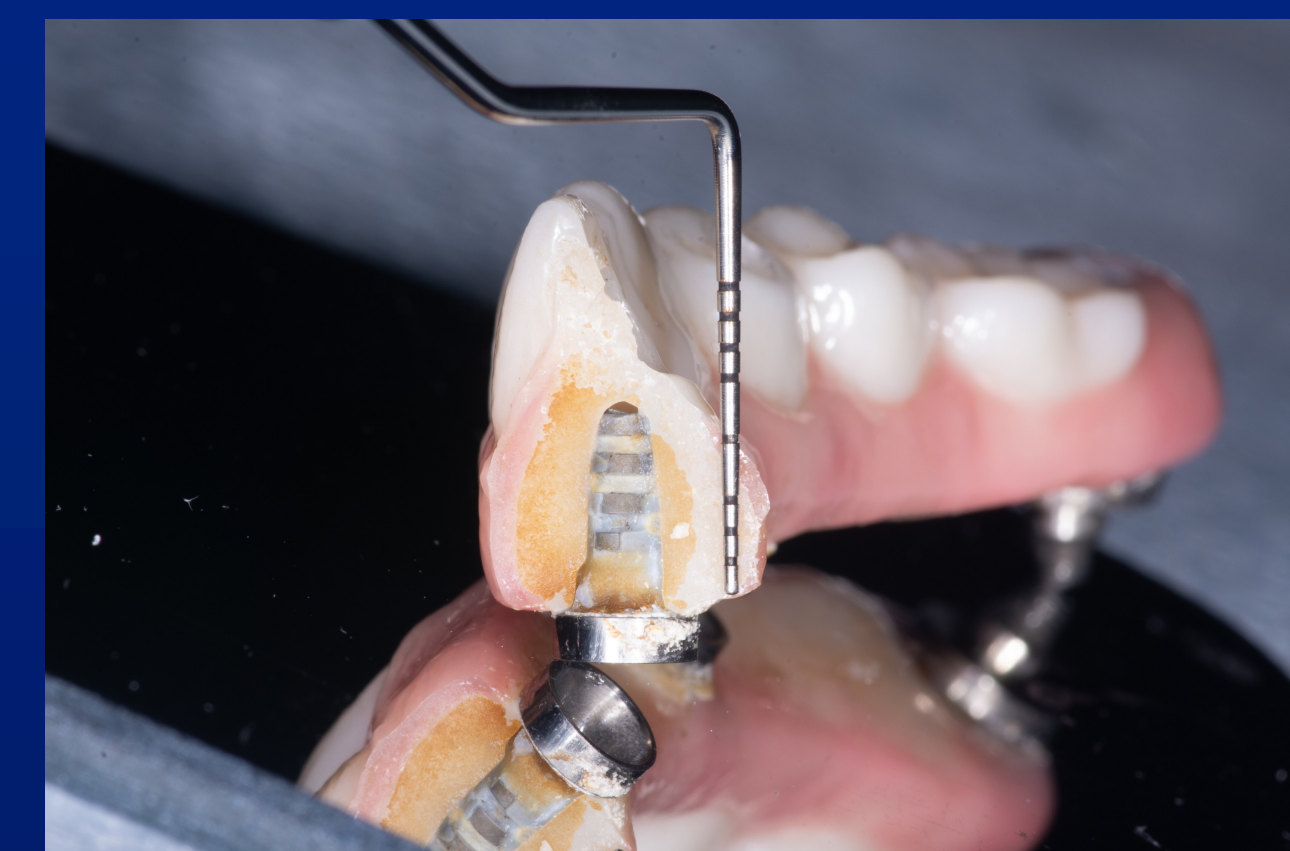
Figure 4. Fractured monolithic zirconia prosthesis at temporary cylinder with adequate prosthetic space present

- Provide adequate thickness to final prosthesis.
- Verify passive fit of prosthesis and address any potential misfit which may be attributed to diverse prosthetic components with different connections.
- Consider eliminating the distal implant in situations with repeated fractures to rule out the potential effect of mandibular flexure.
- Stress the importance of managing parafunctional activity and strict occlusal guard usage.

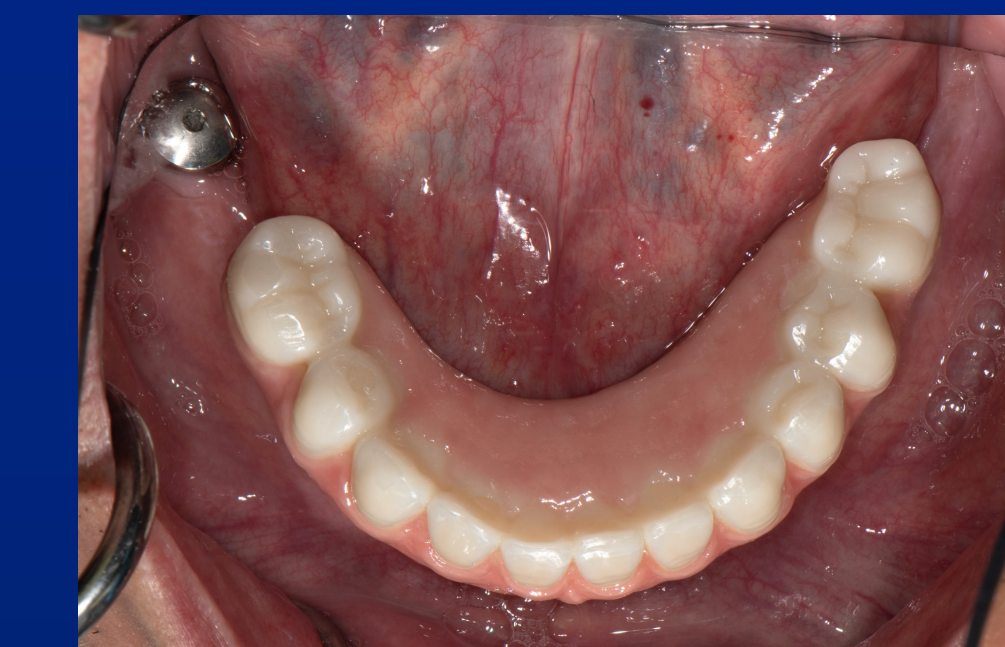
Figure 6. Final monolithic zirconia prosthesis with shortened dental arch

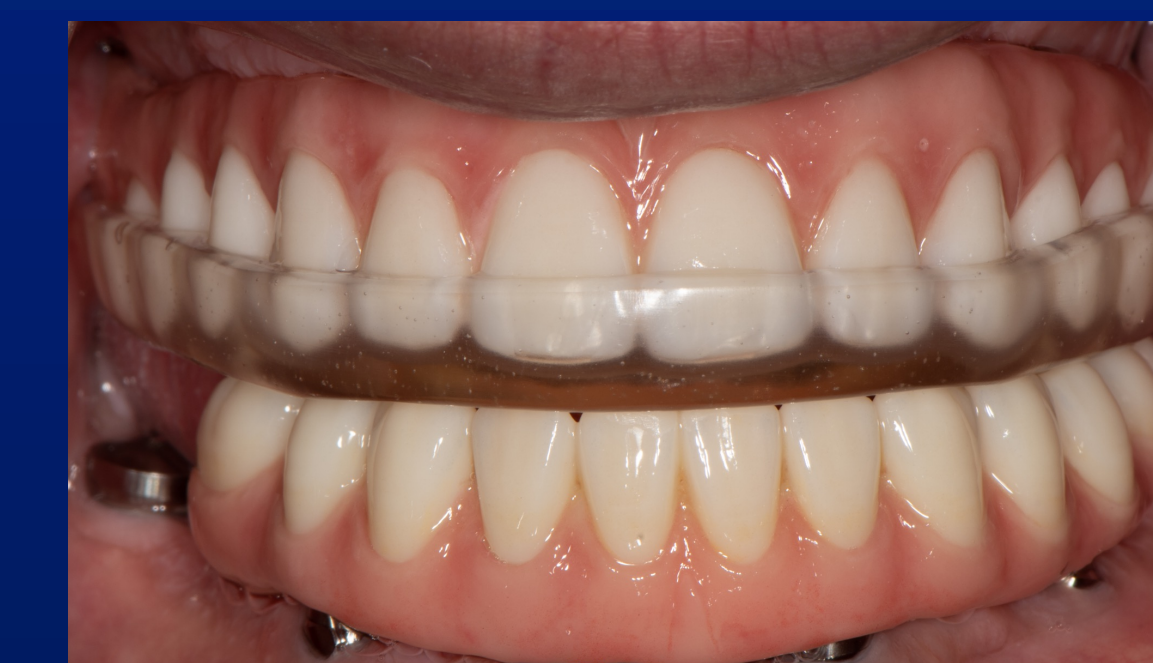
Figure 7. Occlusal guard insertion.
