# Nobel Imperfect: A Case Study Describing Rescue of an Implant with Damaged Internal Threads

**James Clay Sheffield DDS, Rafael Delgado-Ruiz DDS MSc PhD, Kenneth Kurtz DDS FACP, Tanya Somohano-Marquez DMD FACP**

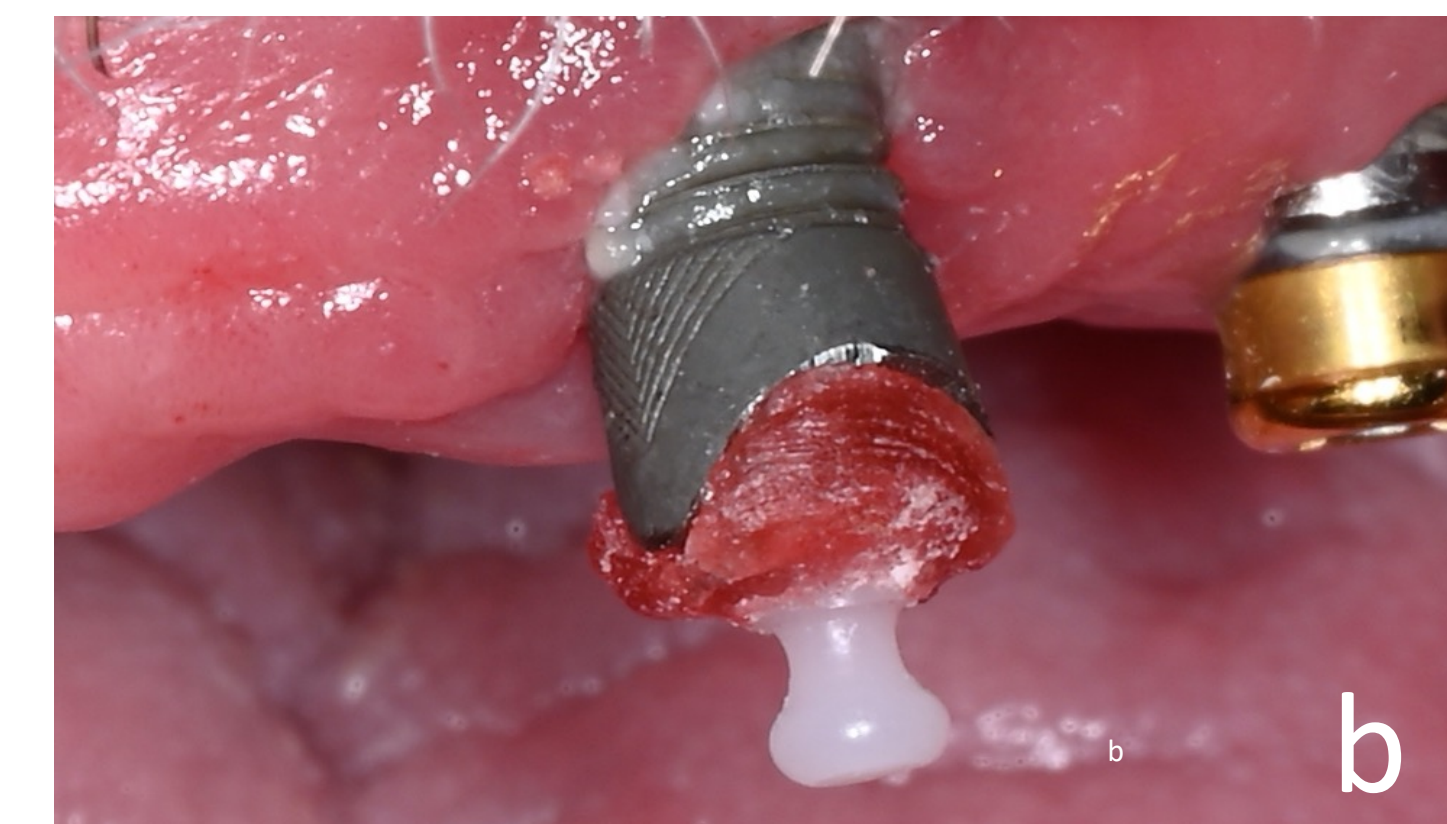
2. A castable ball attachment was waxed onto the pattern extraoral and adjusted intraorally to follow the scalloped implant platform (b).

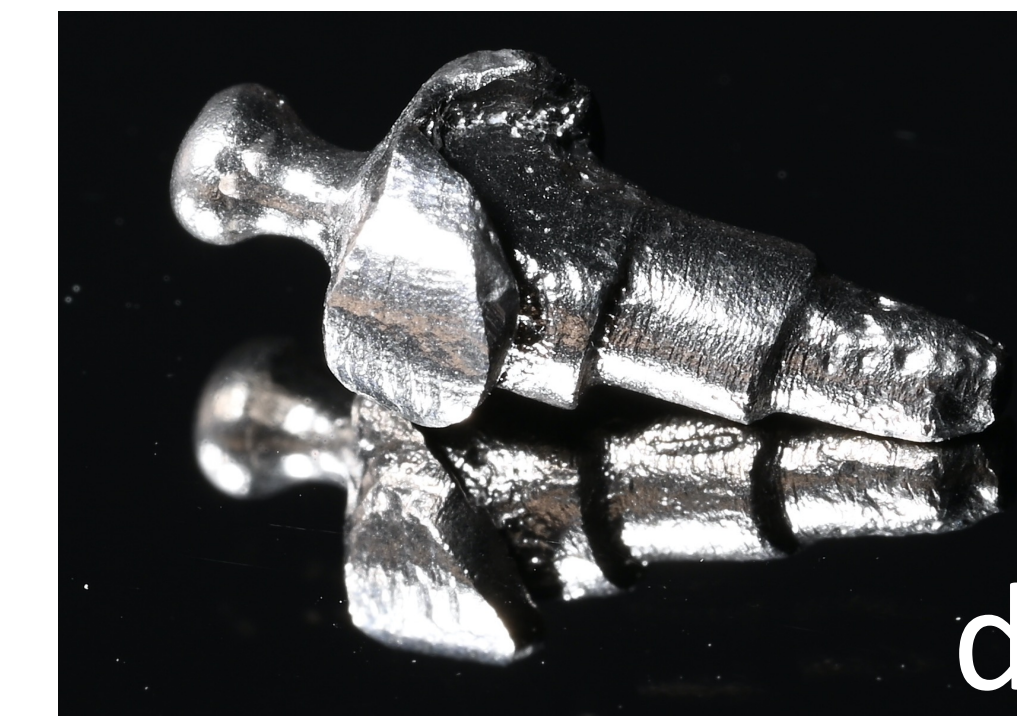
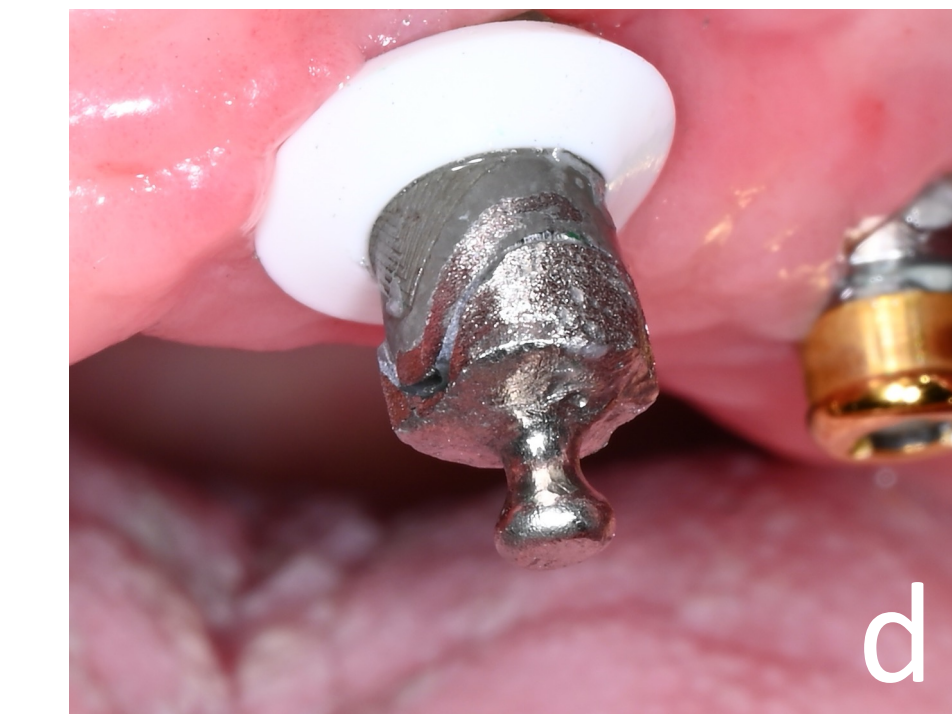
4. The cast post was verified, tried, and cemented with resin cement. After cementation, excess cement was eliminated, and a silicone disk was inserted around the implant neck to prevent the apical displacement of excess material during the housing pick-up (d).

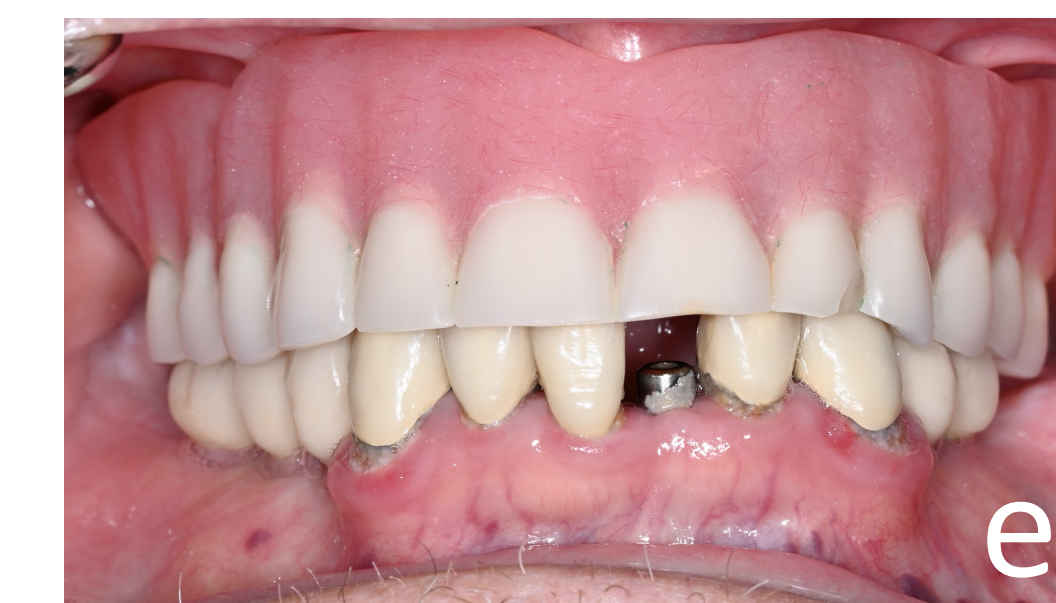
5. The metal housing was positioned over the ball and the denture intaglio was relieved to allow for the insertion of the metal housing. The denture stability was confirmed, and pressure paste was used to determine appropriate seating of the denture base. PMMA repair material was prepared and delivered into the relief space. The patient occluded until the material set (e).

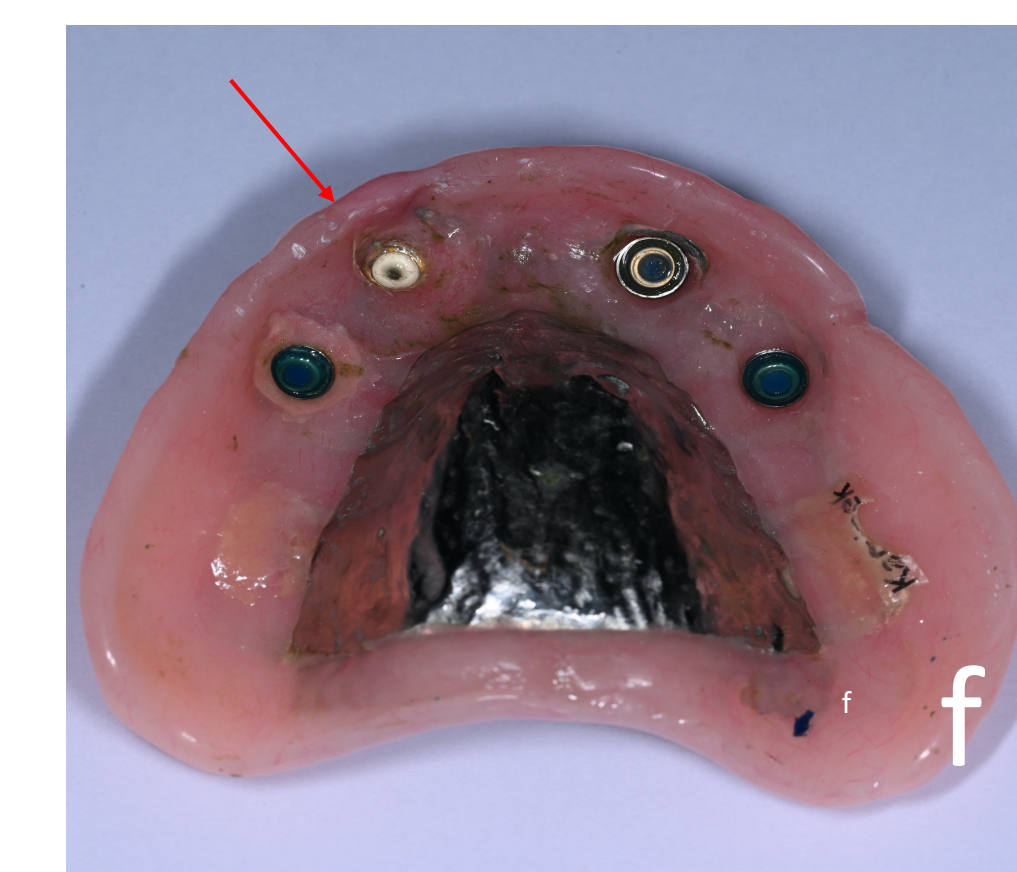
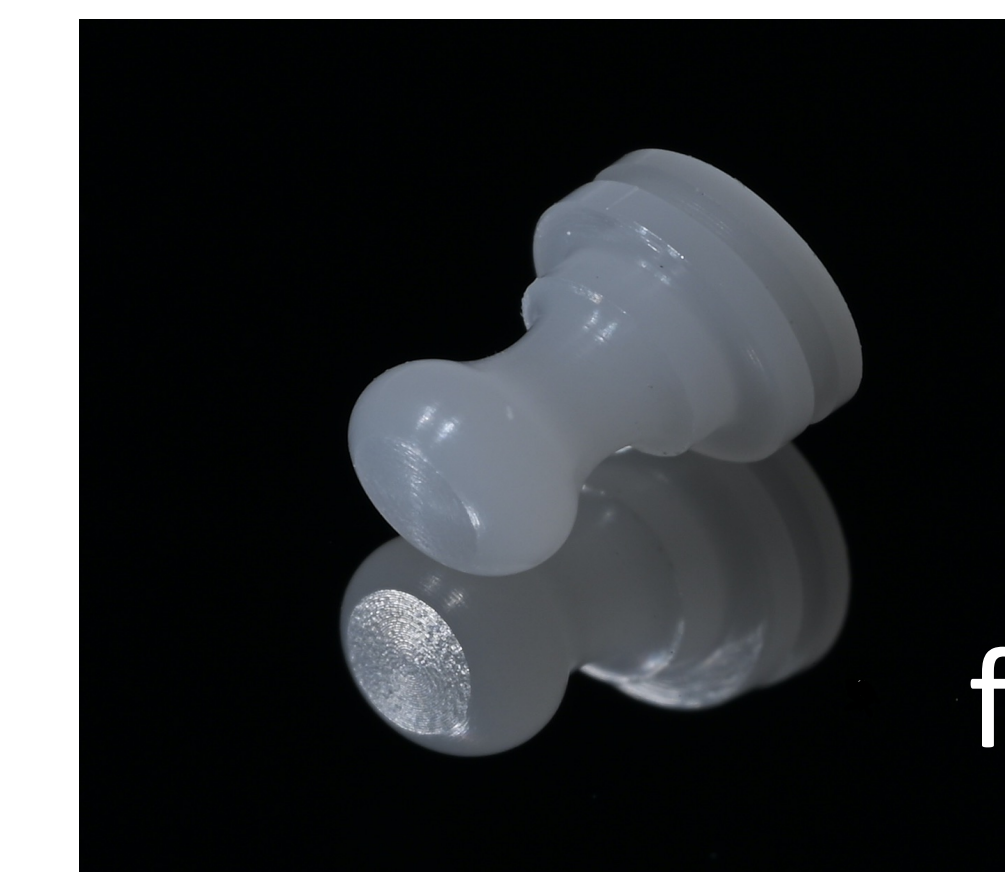
6. The denture was removed, excess of acrylic resin was eliminated, pressure spots were relieved, occlusion was verified, retention was adjusted. The red arrow is pointing the location of the ball housing and three locator housings. At the right is a photo of the castable ball abutment used in this case (f).
