# Decision Making for Identification and Utilization of Existing Implants and Replacement of Unsatisfactory Full-arch Restoration. A Case Report.

**Jose Briceno, BDS ; Niranjan Joshi, MDS, MS, FACP ; Jack Piermatti, DMD, FACP**  
**Nova Southeastern University**

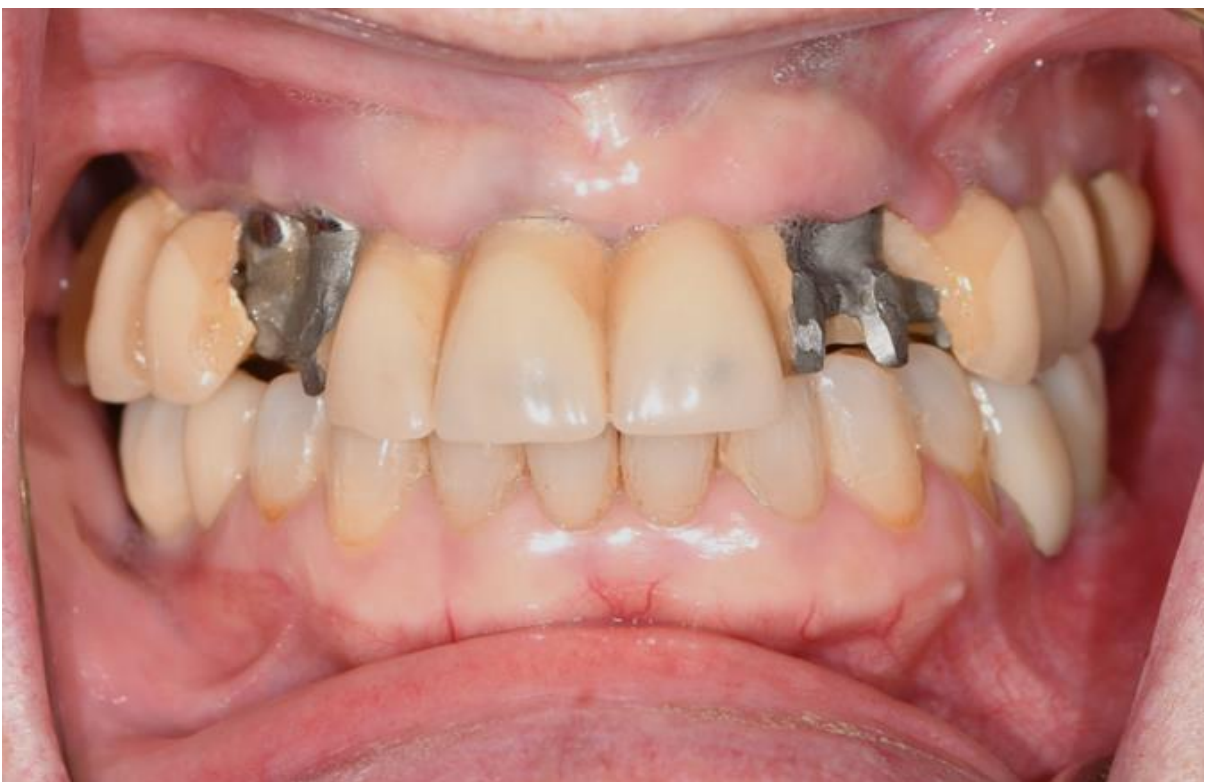
**Fig 1,** Frontal intraoral picture

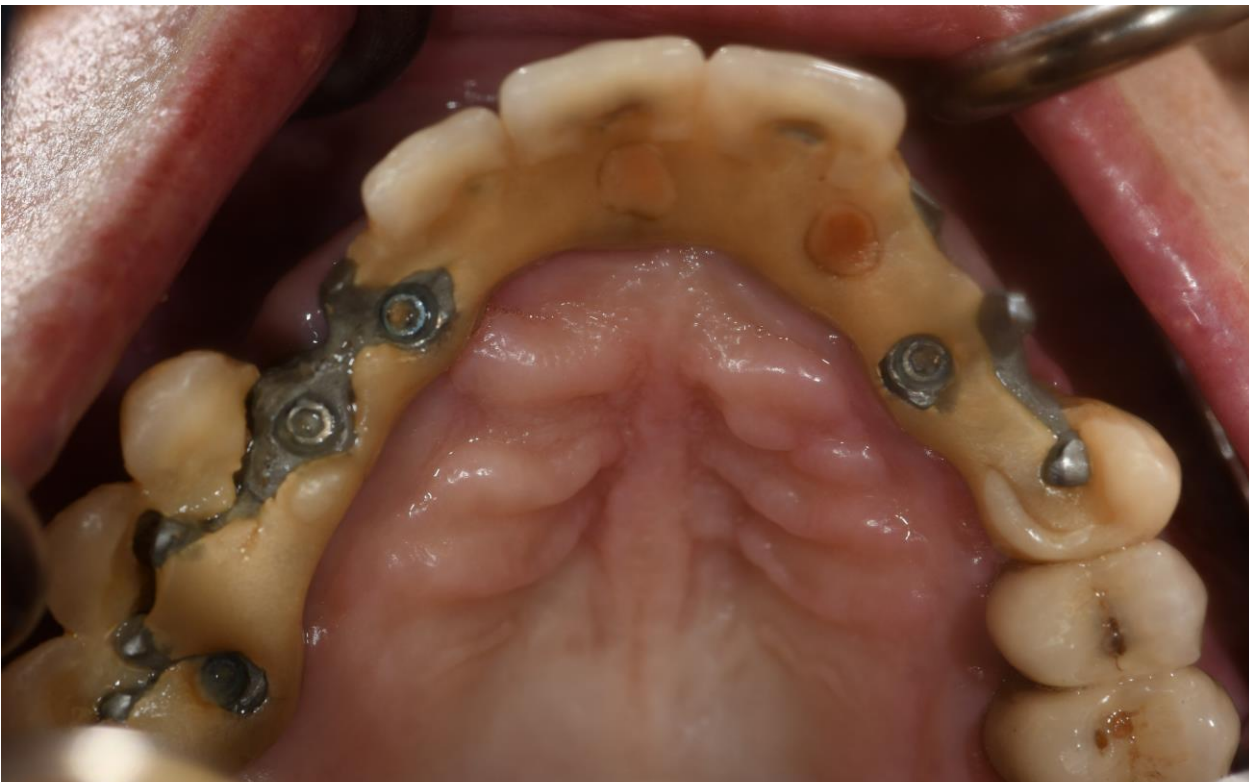
**Fig 2,** Occlusal view of failing FP1

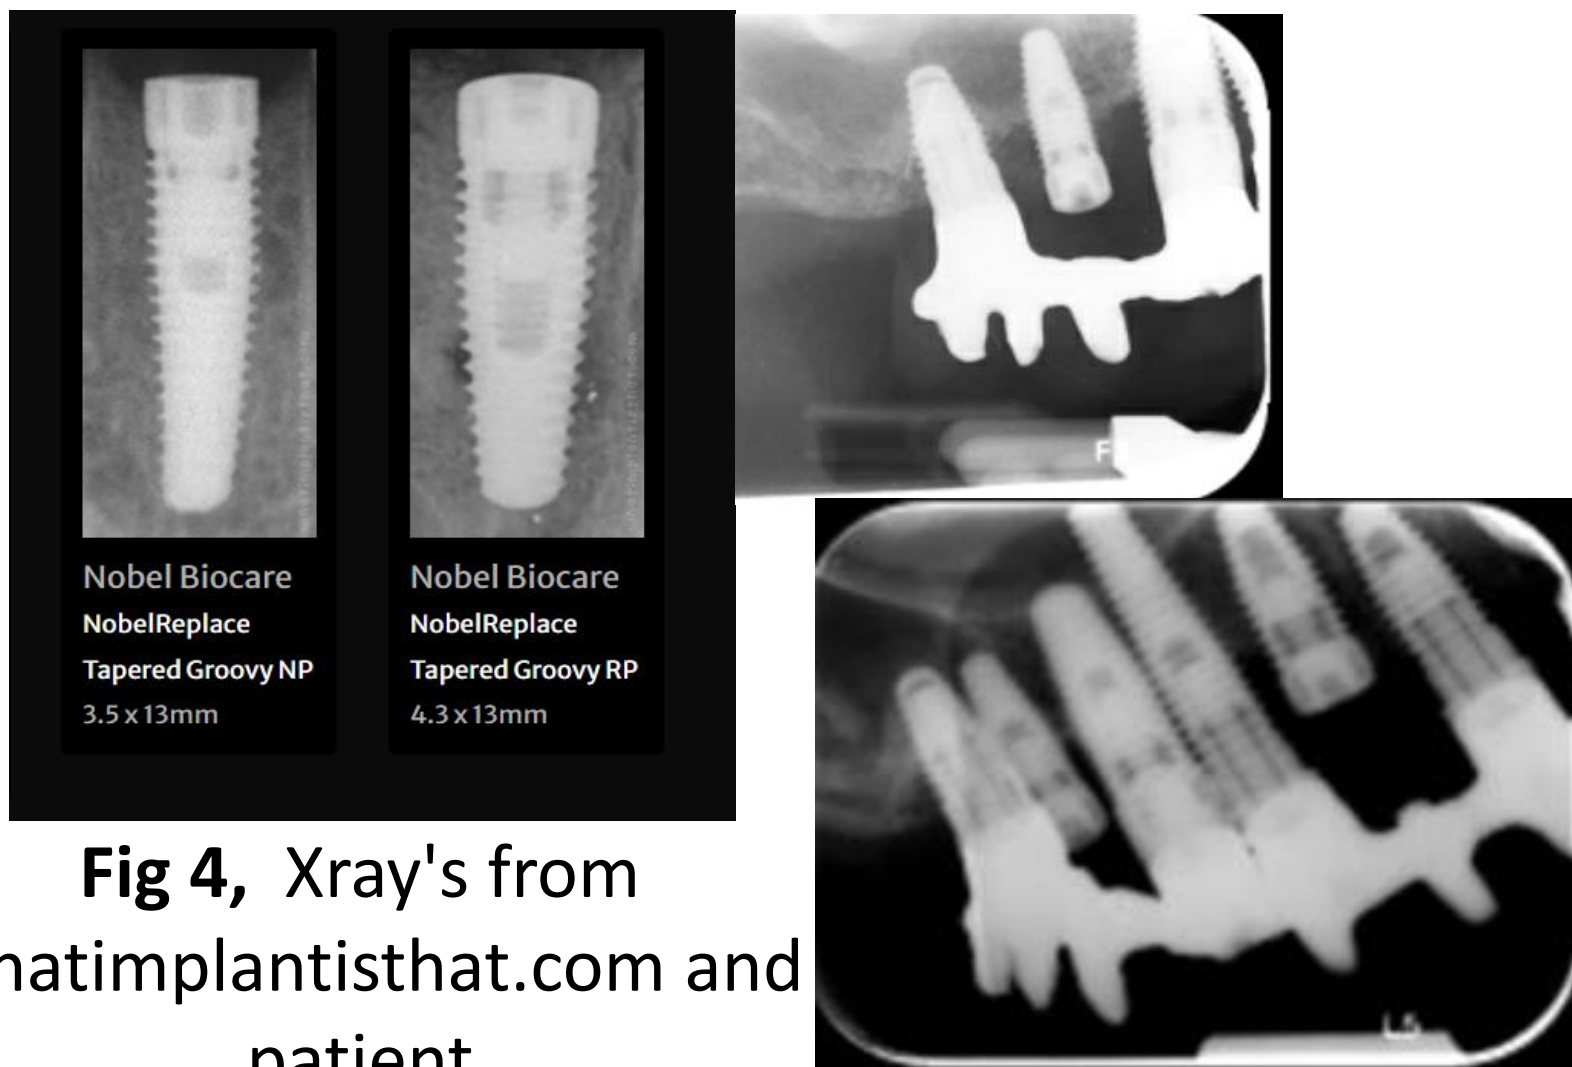
**Fig 4,** Xray's from Whatimplantisthat.com and patient

- 1- Full mouth series radiographs were made and compared with on an online database Whatimplatisthat.com (Fig 3 and 4).
- 2- Implant supported full arch restoration was removed and an abutment level impression was taken (Fig 5 and 6).
- 3- The hybrid was used to articulate the cast in the articulator. All unsupported porcelain was removed, and acrylic was added on the metal structure. Patient left with a functional provisional. Eventually, it lasted for 3 months (Fig 7 and 8).
- 4- Maxillary cast verification (Fig 6).
- 5- Metal structure try in to verify passive fitting (Fig 9).
- 6- Bisque evaluation of the porcelain on the final prosthesis.
- 7- Delivery of final restoration. FP1 (crown and bridge style) (Fig 10, 11 and 12).

Website images specify platform, flanges, mid body characteristics, and type of threads per implant. Images of possible matching implants were compared with the patient's radiographs, until we found the images that were a better match (Fig 3 and 4). This process was completed for each implant. The following step was to try a screwdriver compatible with the selected brand to verify each implant brand. Implants were determined to be compatible with Nobel Biocare.

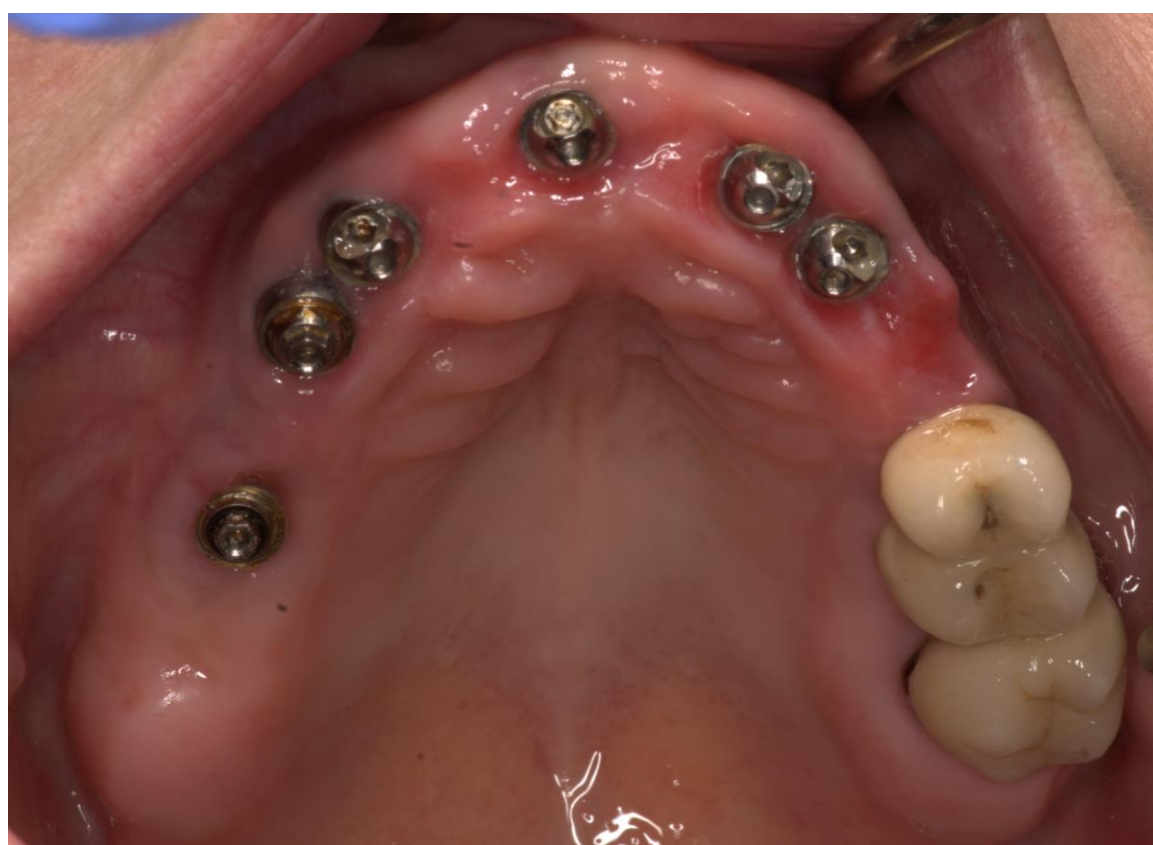
**Fig 5,** Occlusal view without FP1

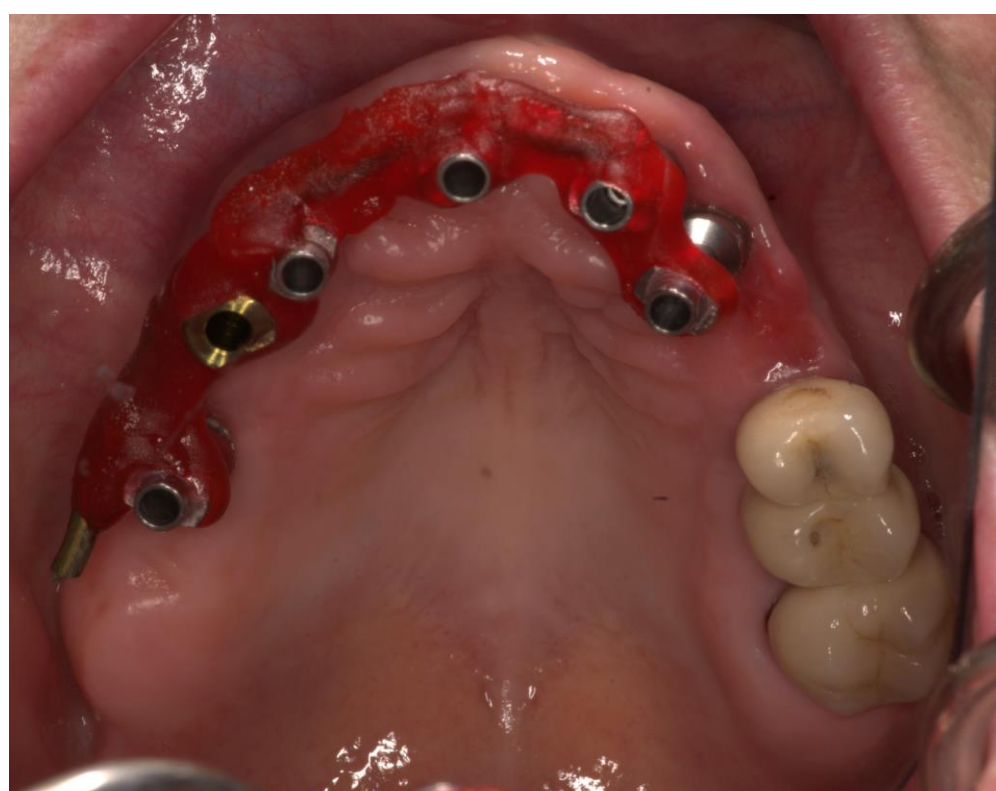
**Fig 6,** Splinted impression post

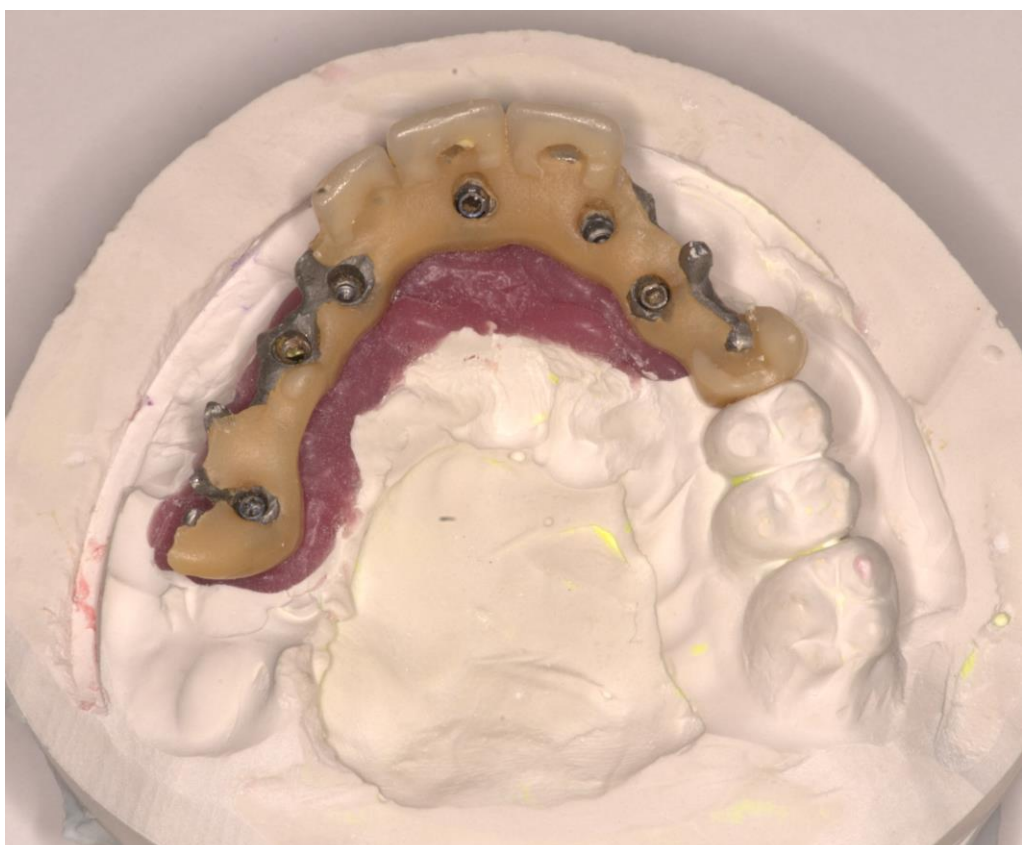
**Fig 7,** Failing FP1 on cast

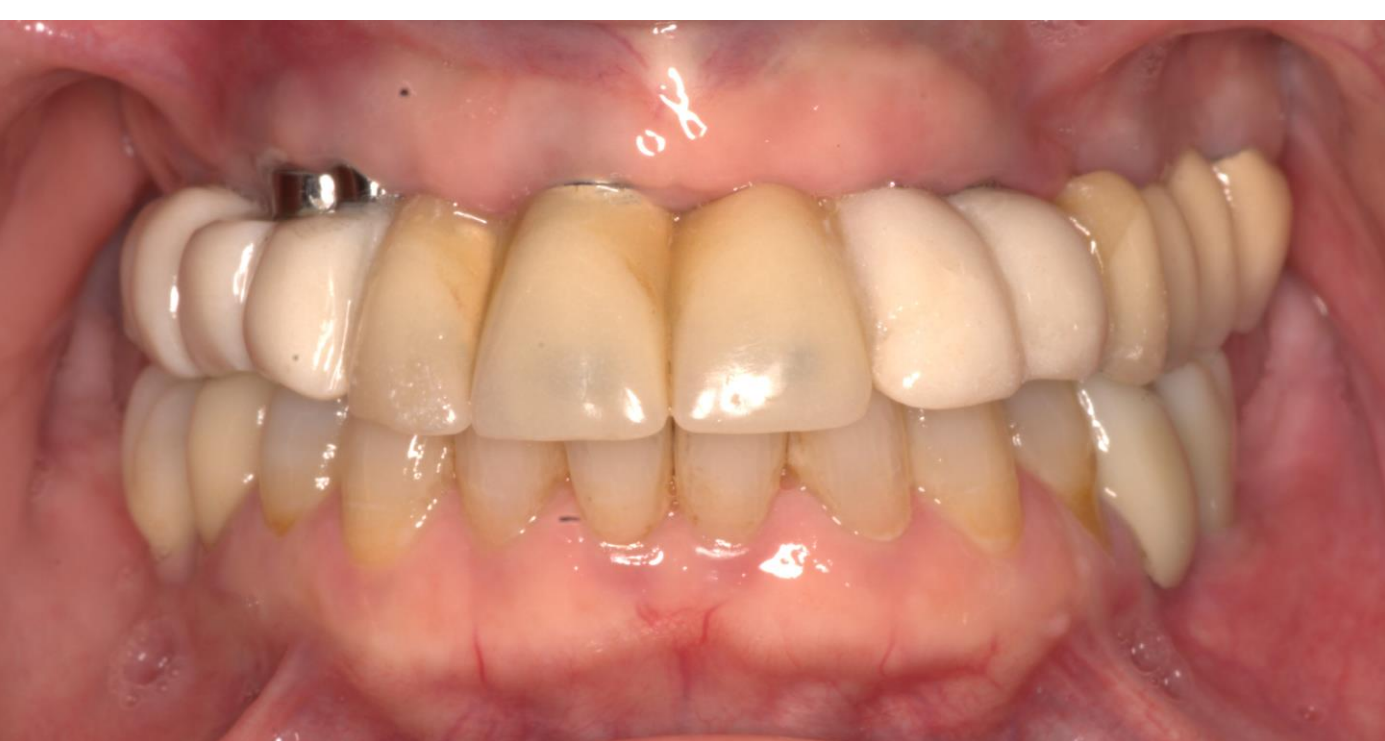
**Fig 8,** Added acrylic to existing Metal framework

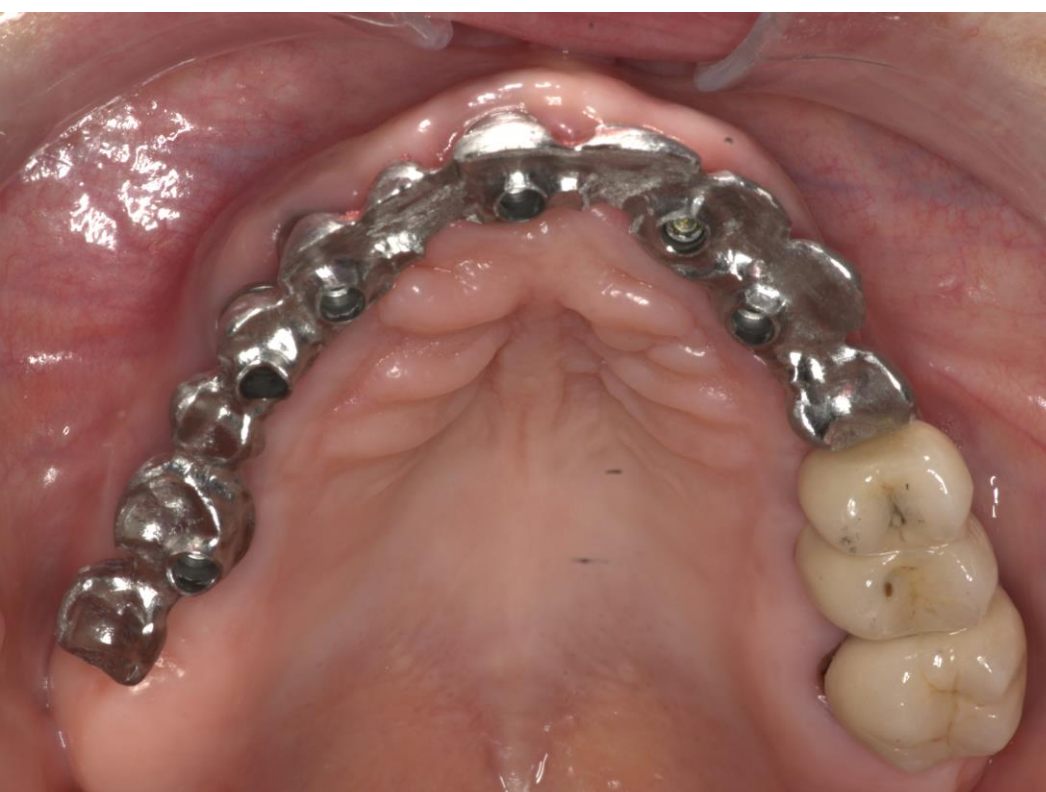
**Fig 9,** Metal framework

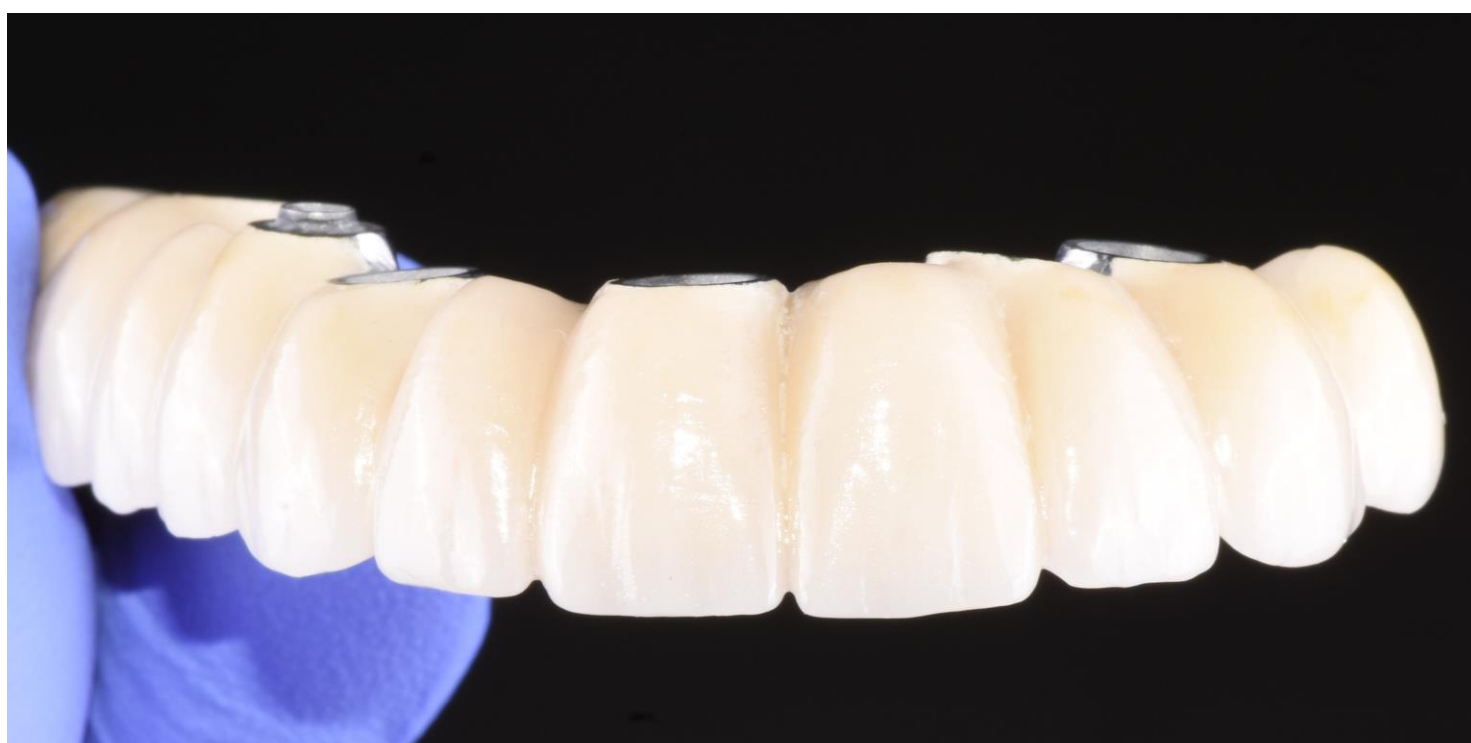
**Fig 10,** Final prosthesis

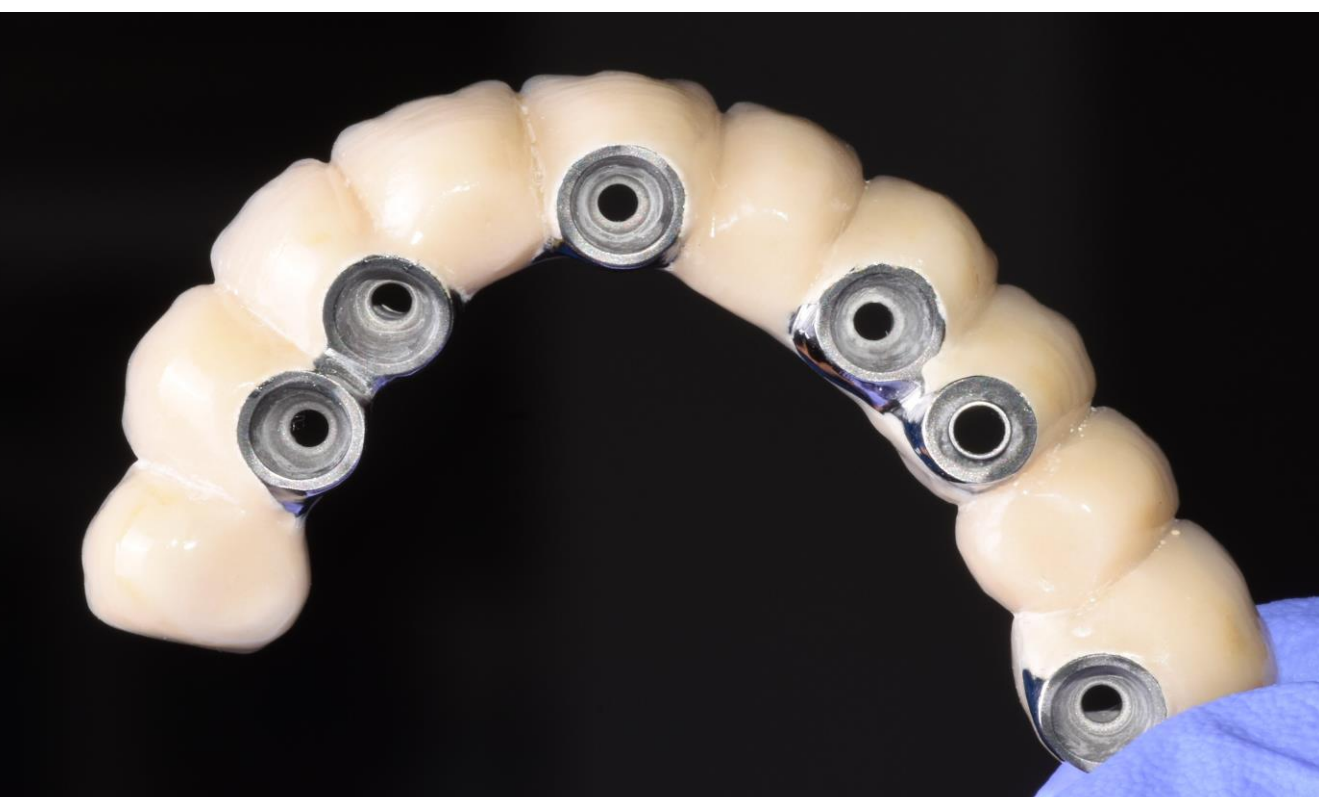
**Fig 11,** Final prosthesis

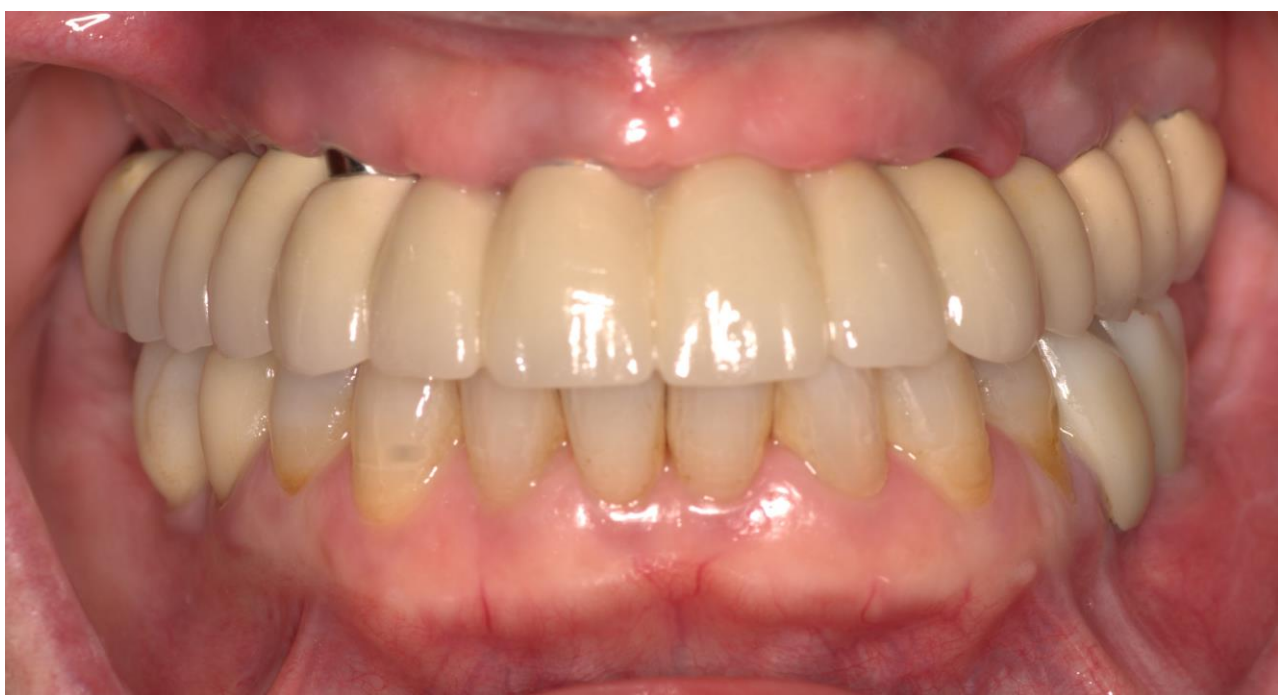
**Fig 12,** PFM full arch prosthesis, intraorally
