To discuss the workflow to fabricate a wear resistance acrylic-titanium implant-supported fixed complete denture (ISFCD) through a digital workflow and using splinted CAD-CAM crowns.

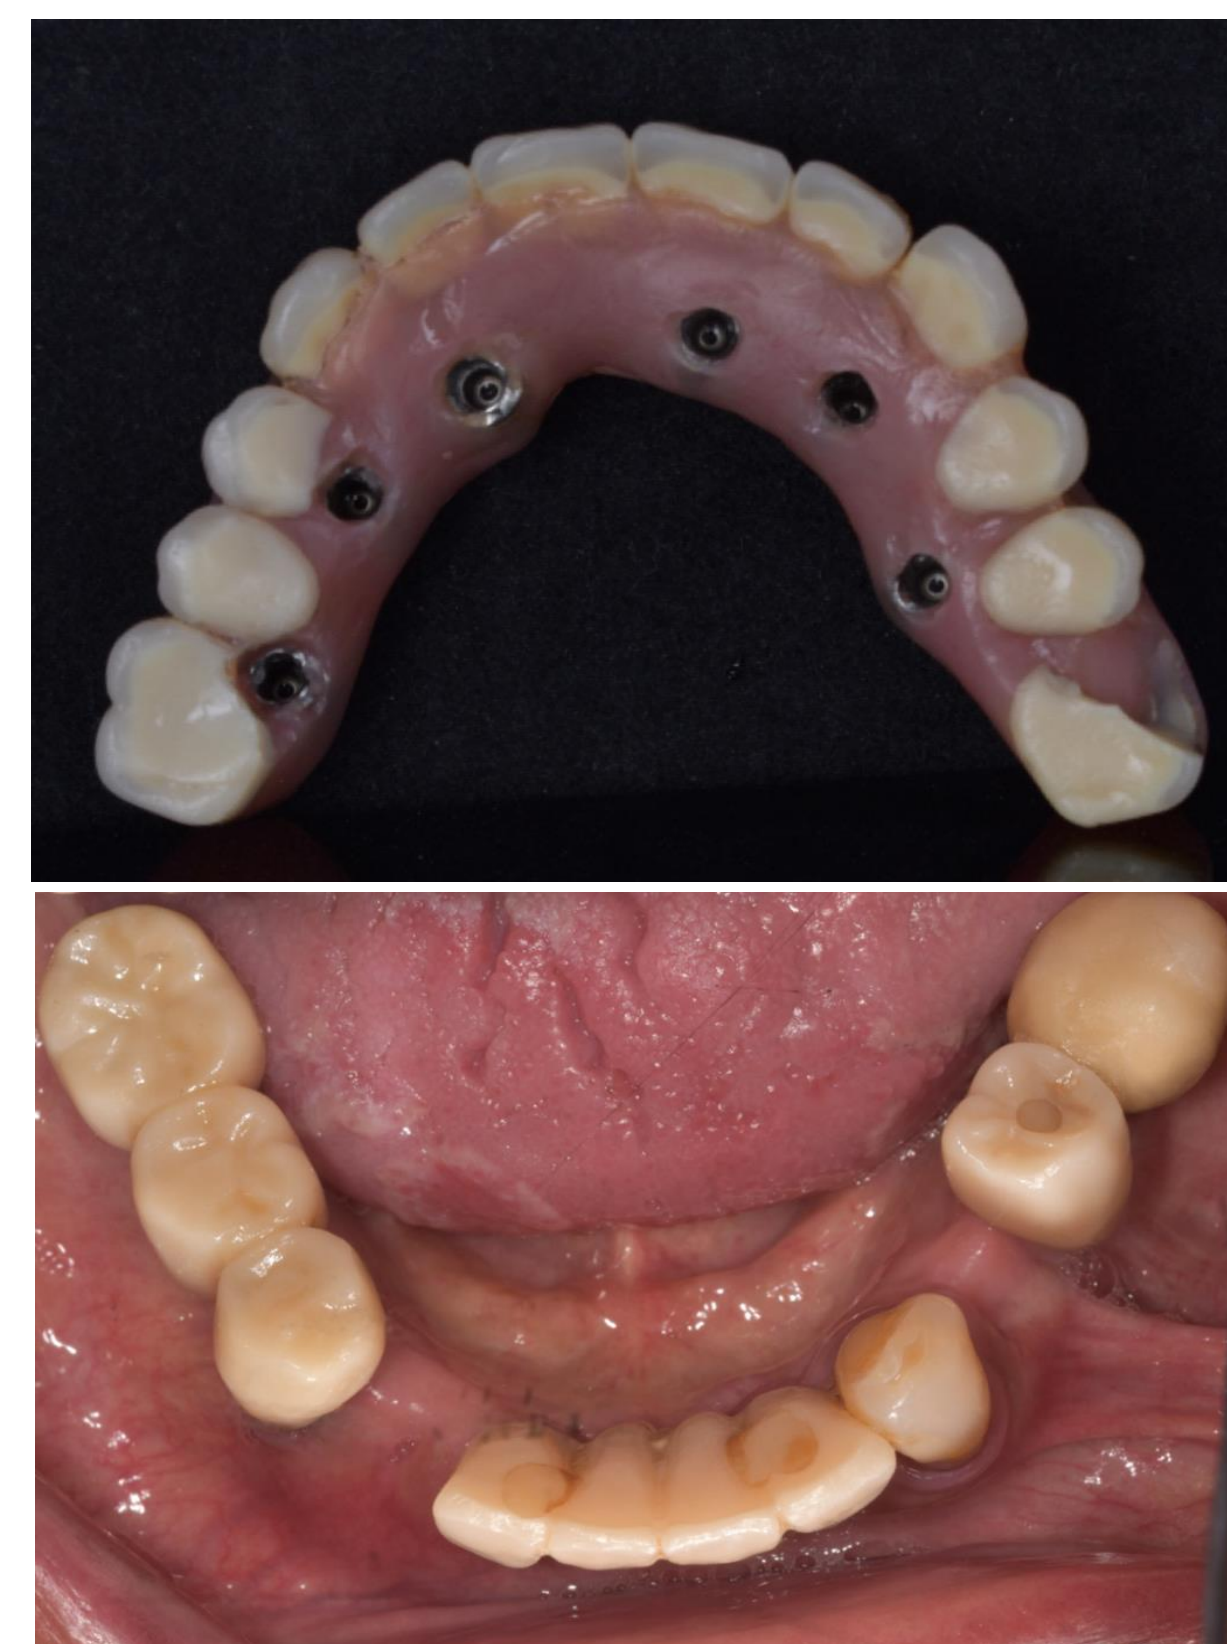
**Fig. 1:** Initial occlusal view of the maxillary and mandibular arches

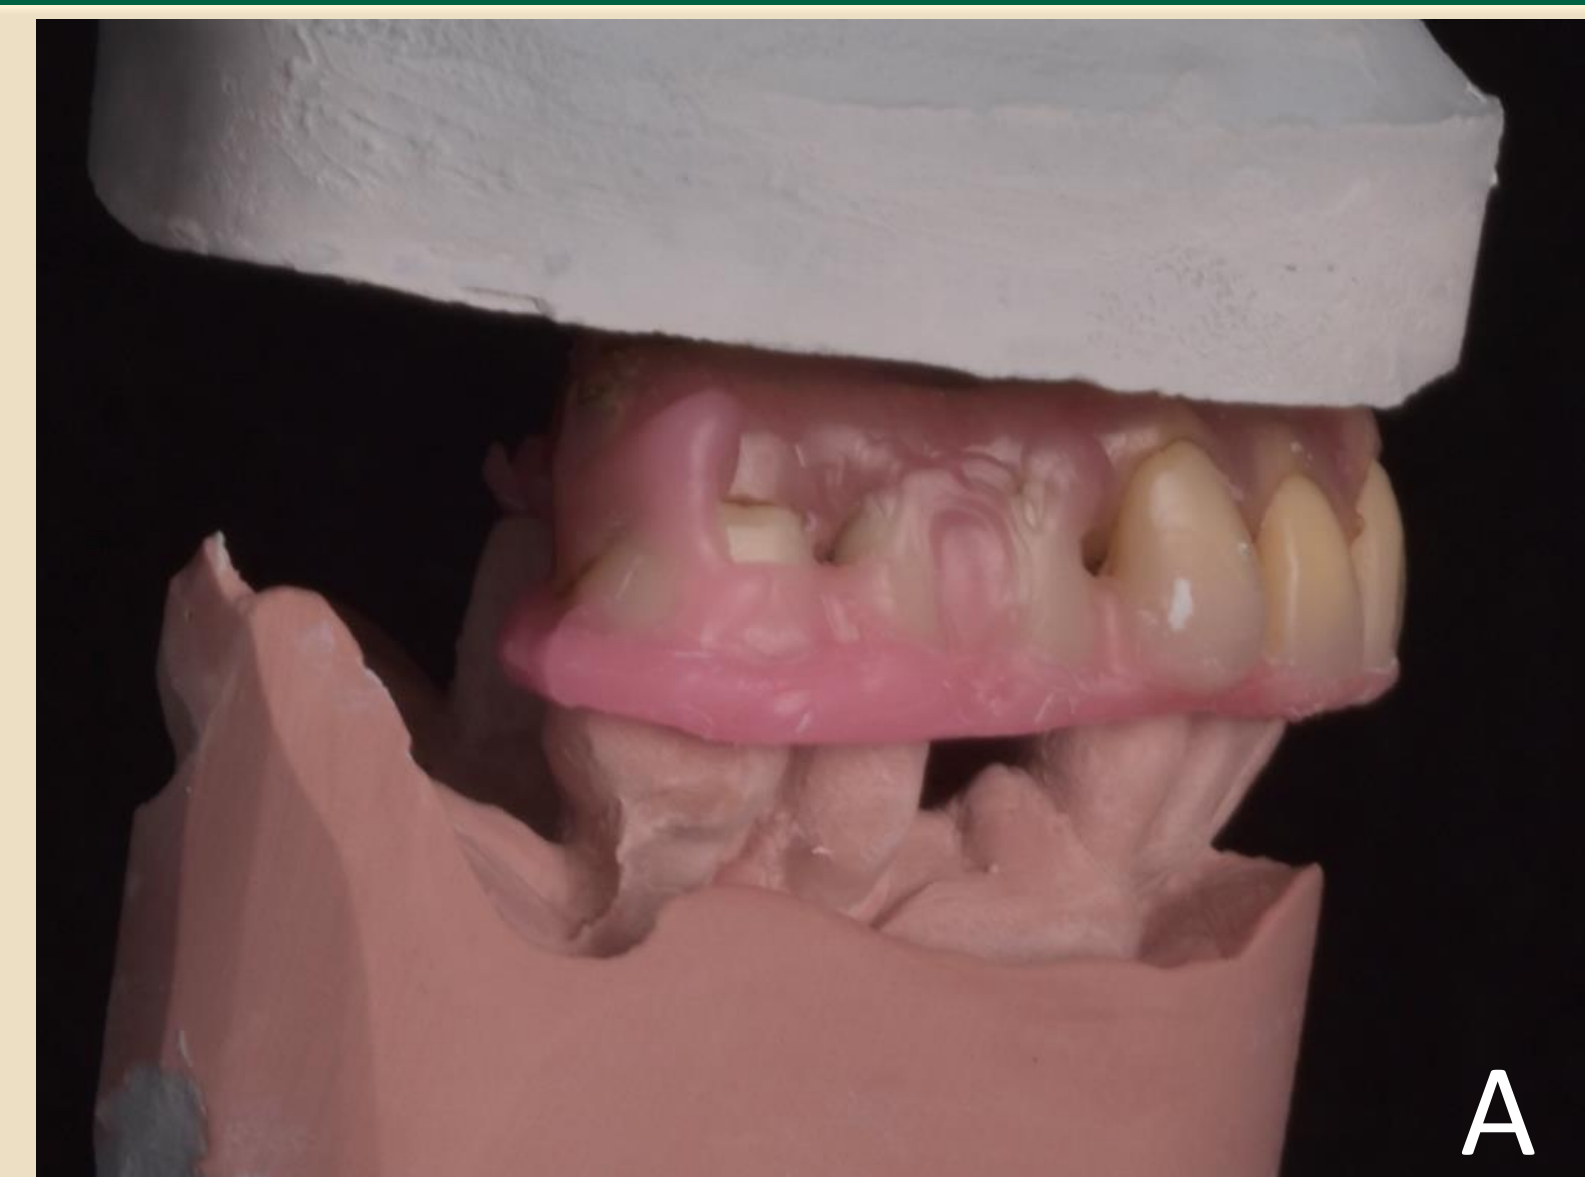
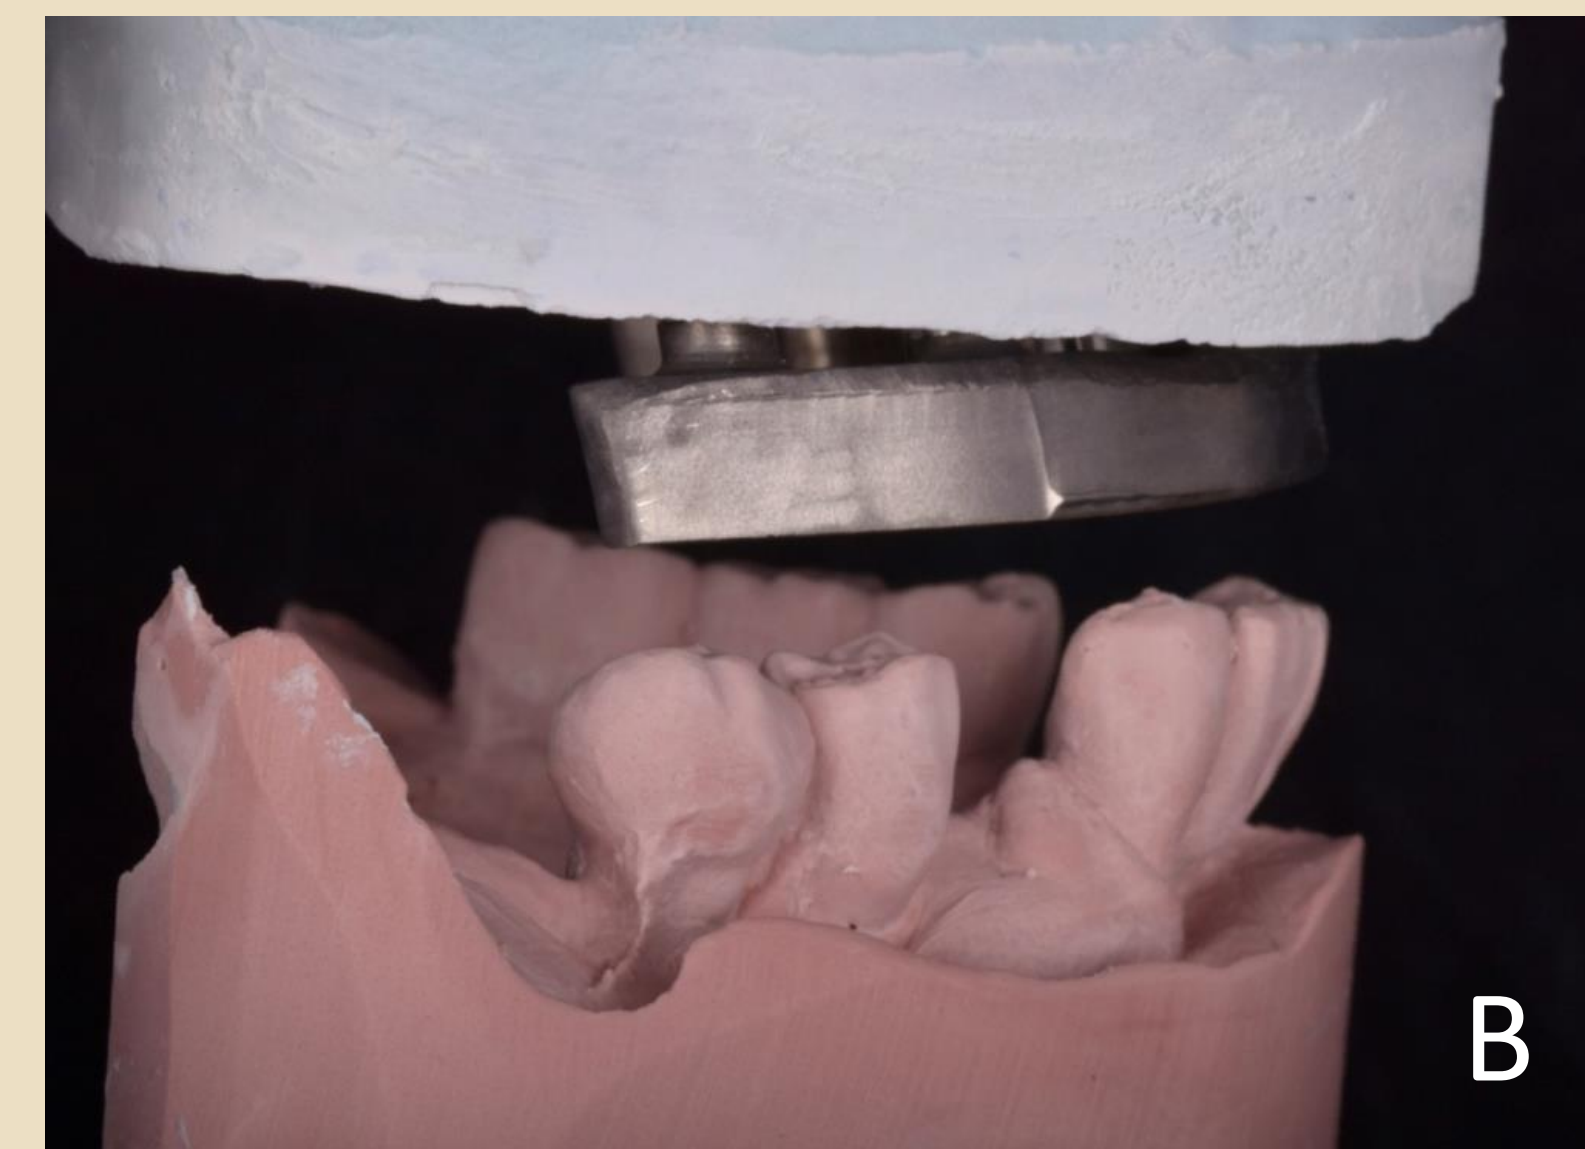
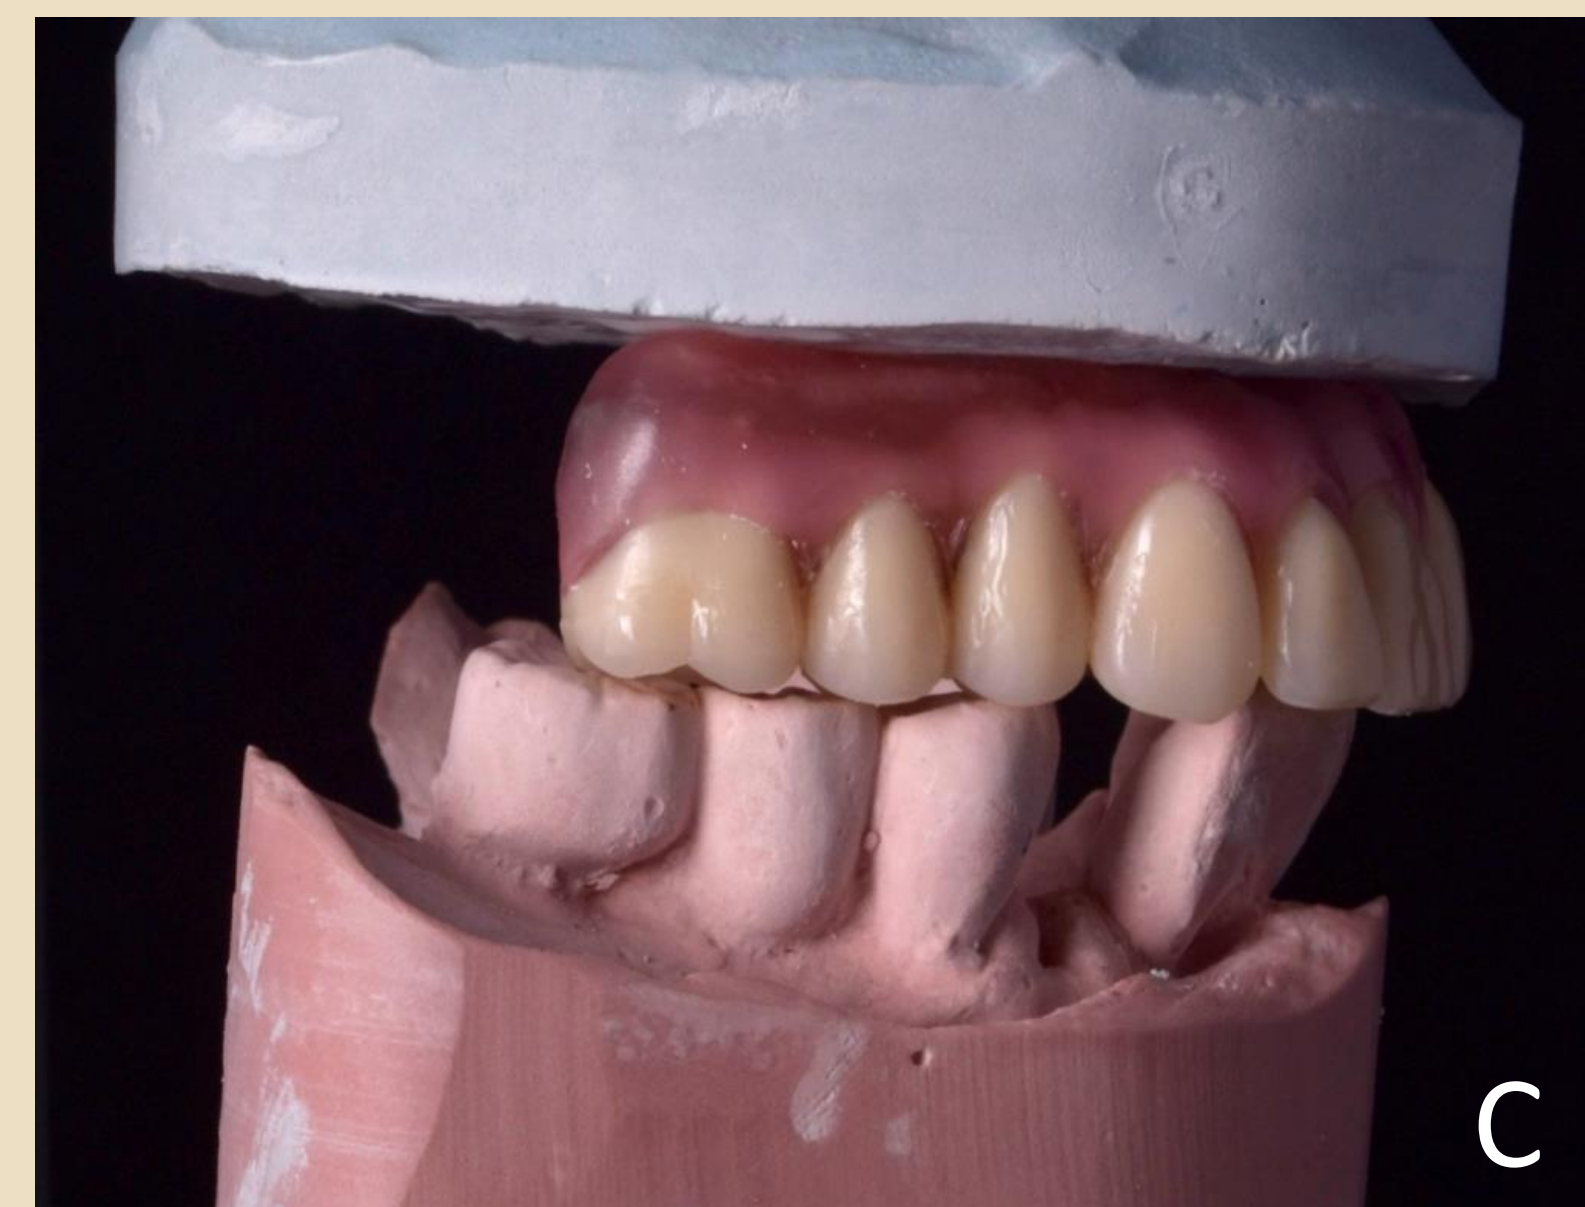
**Fig. 2:** Lateral view of mounted the old hybrid prosthesis at an increased VDO (A); After burning the old prosthesis (B); the new prosthesis at the established OVD (C).

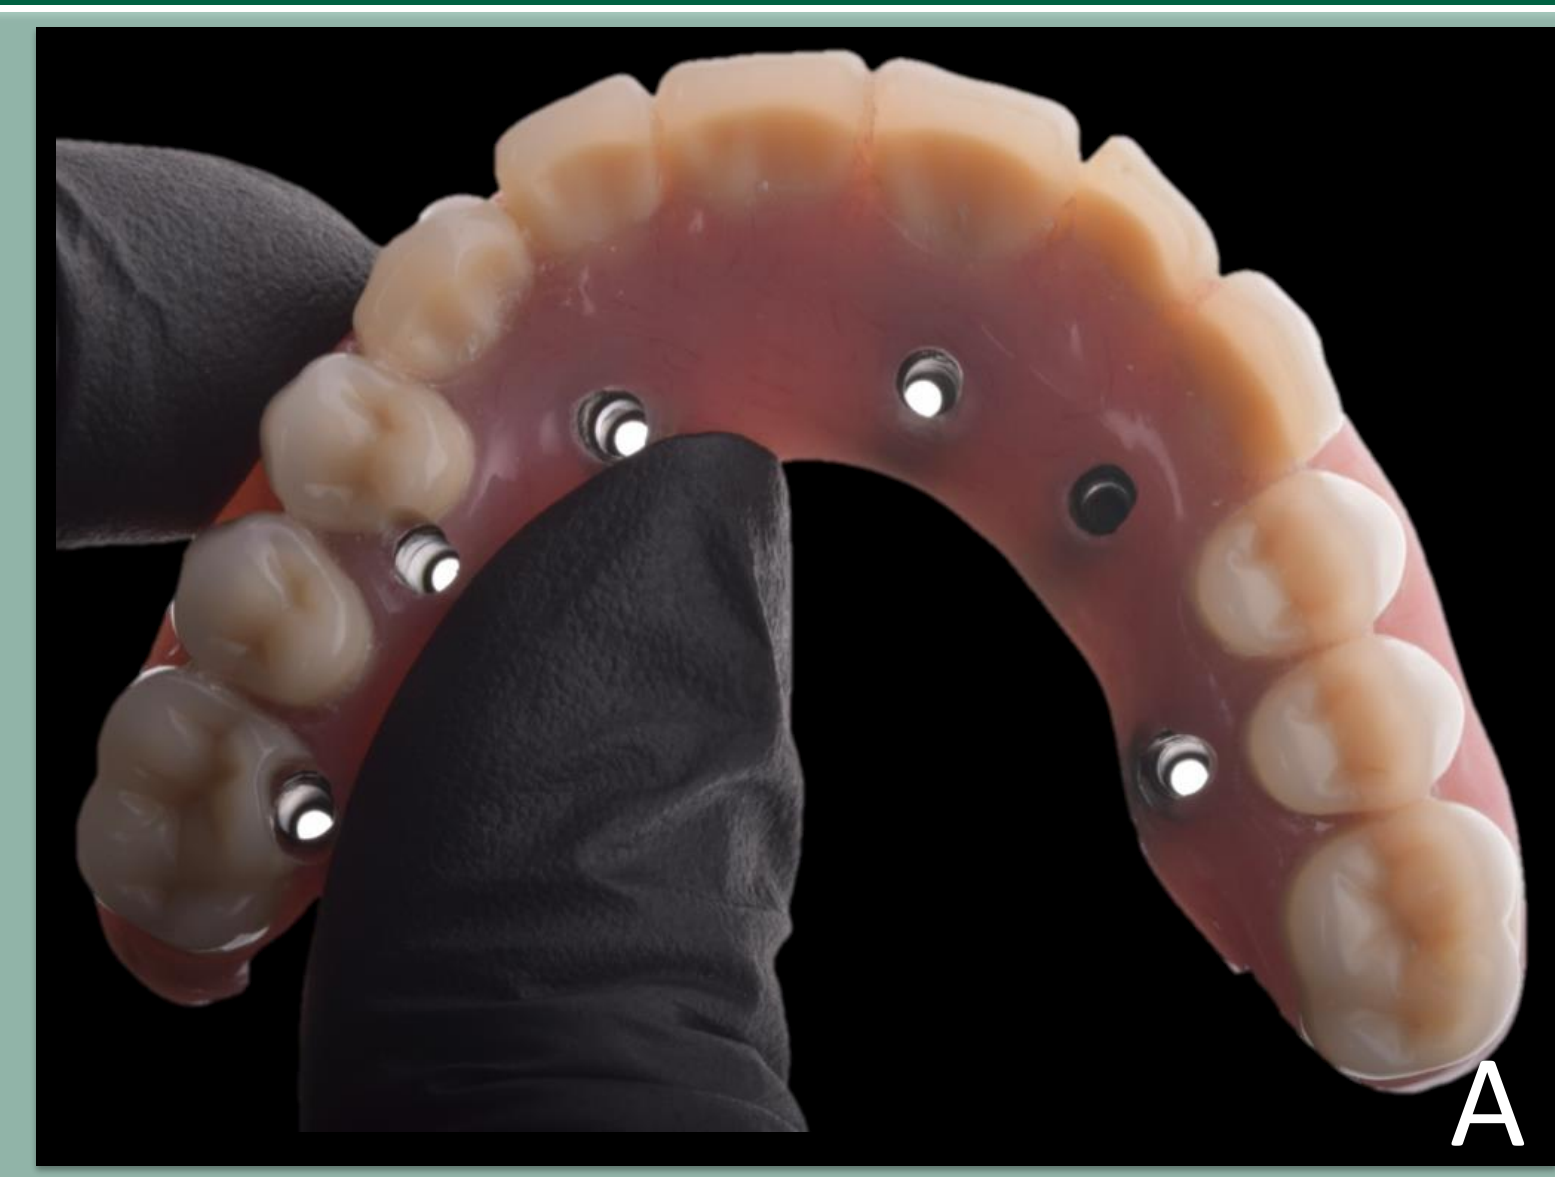
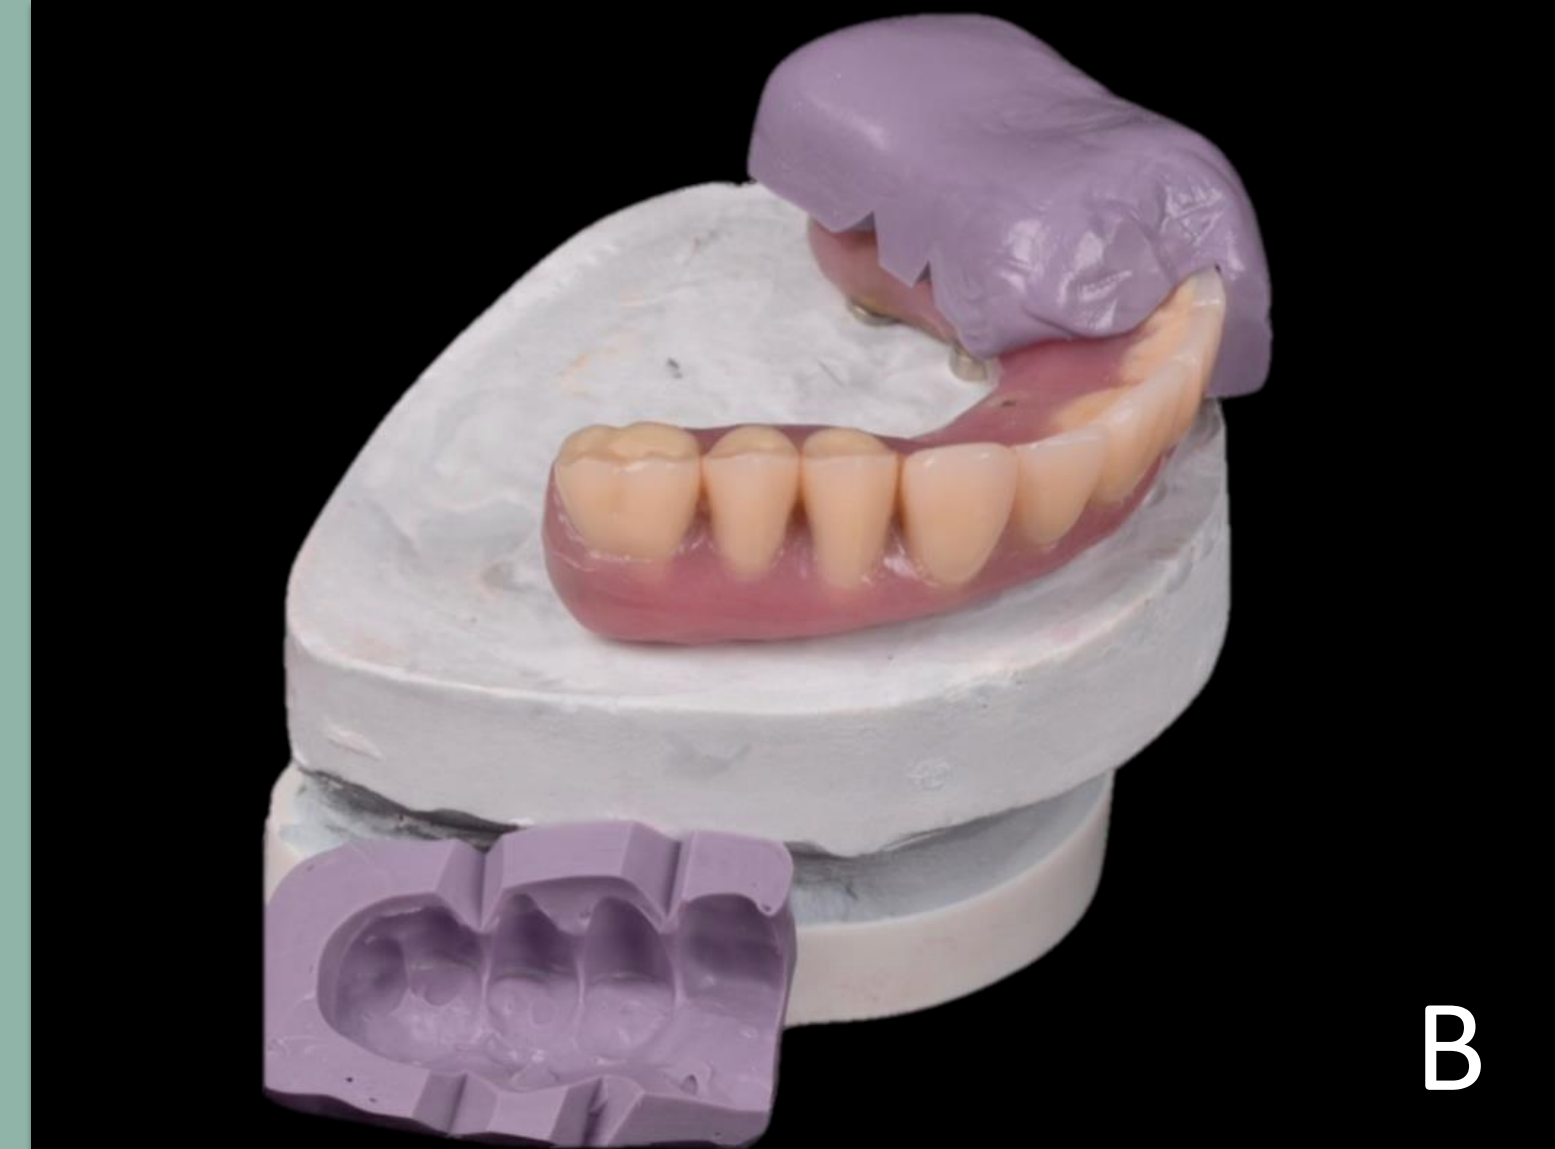
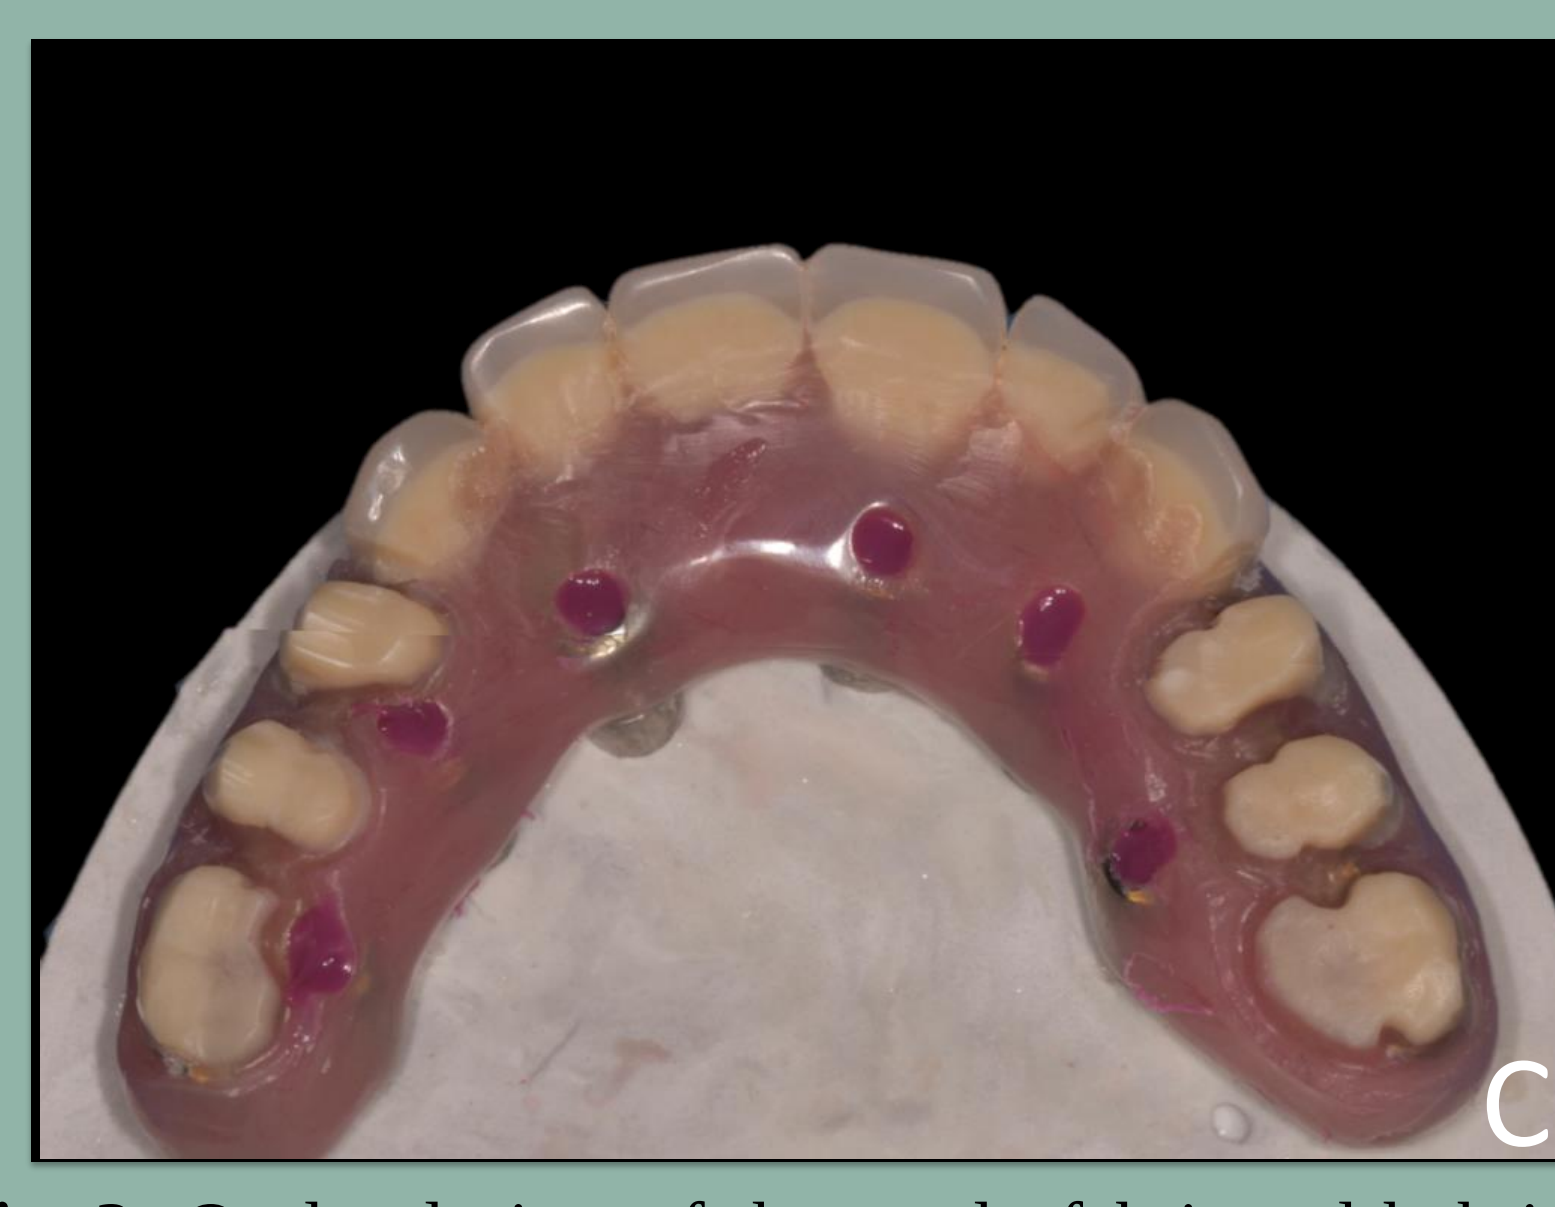
**Fig. 3:** Occlusal view of the newly fabricated hybrid prosthesis (A); Fabrication of external surface form to fabricate interim FDP (B); The prosthesis with prepared posterior teeth with mesial and distal grooves (C).

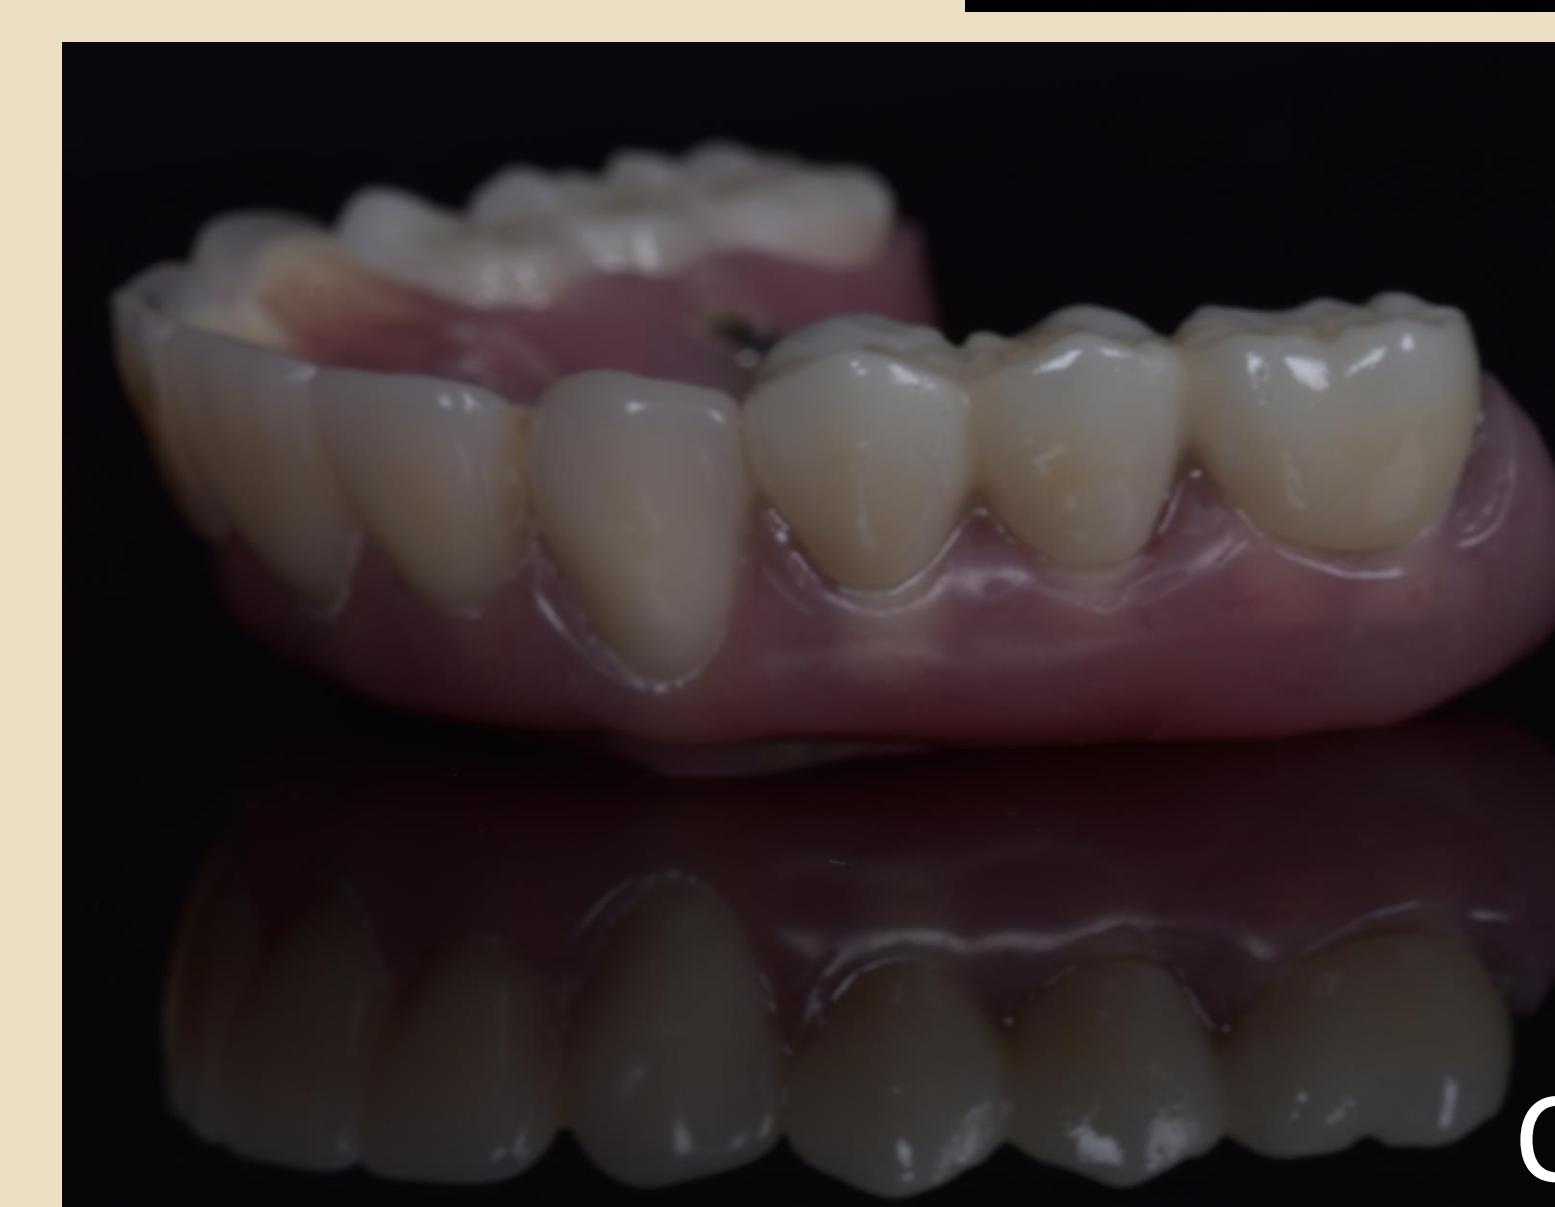
**Fig. 4:** IOS from the prosthesis with prepared teeth assessing the amount of reduction (A); Fabricated splinted zirconia crowns from 3Y-TZP (B); Prosthesis before luting the splinted crowns using a resin cement (C). Prosthesis after luting the splinted crowns The cementation process with Panavia cement post sandblasting of the splinted zirconia crowns.

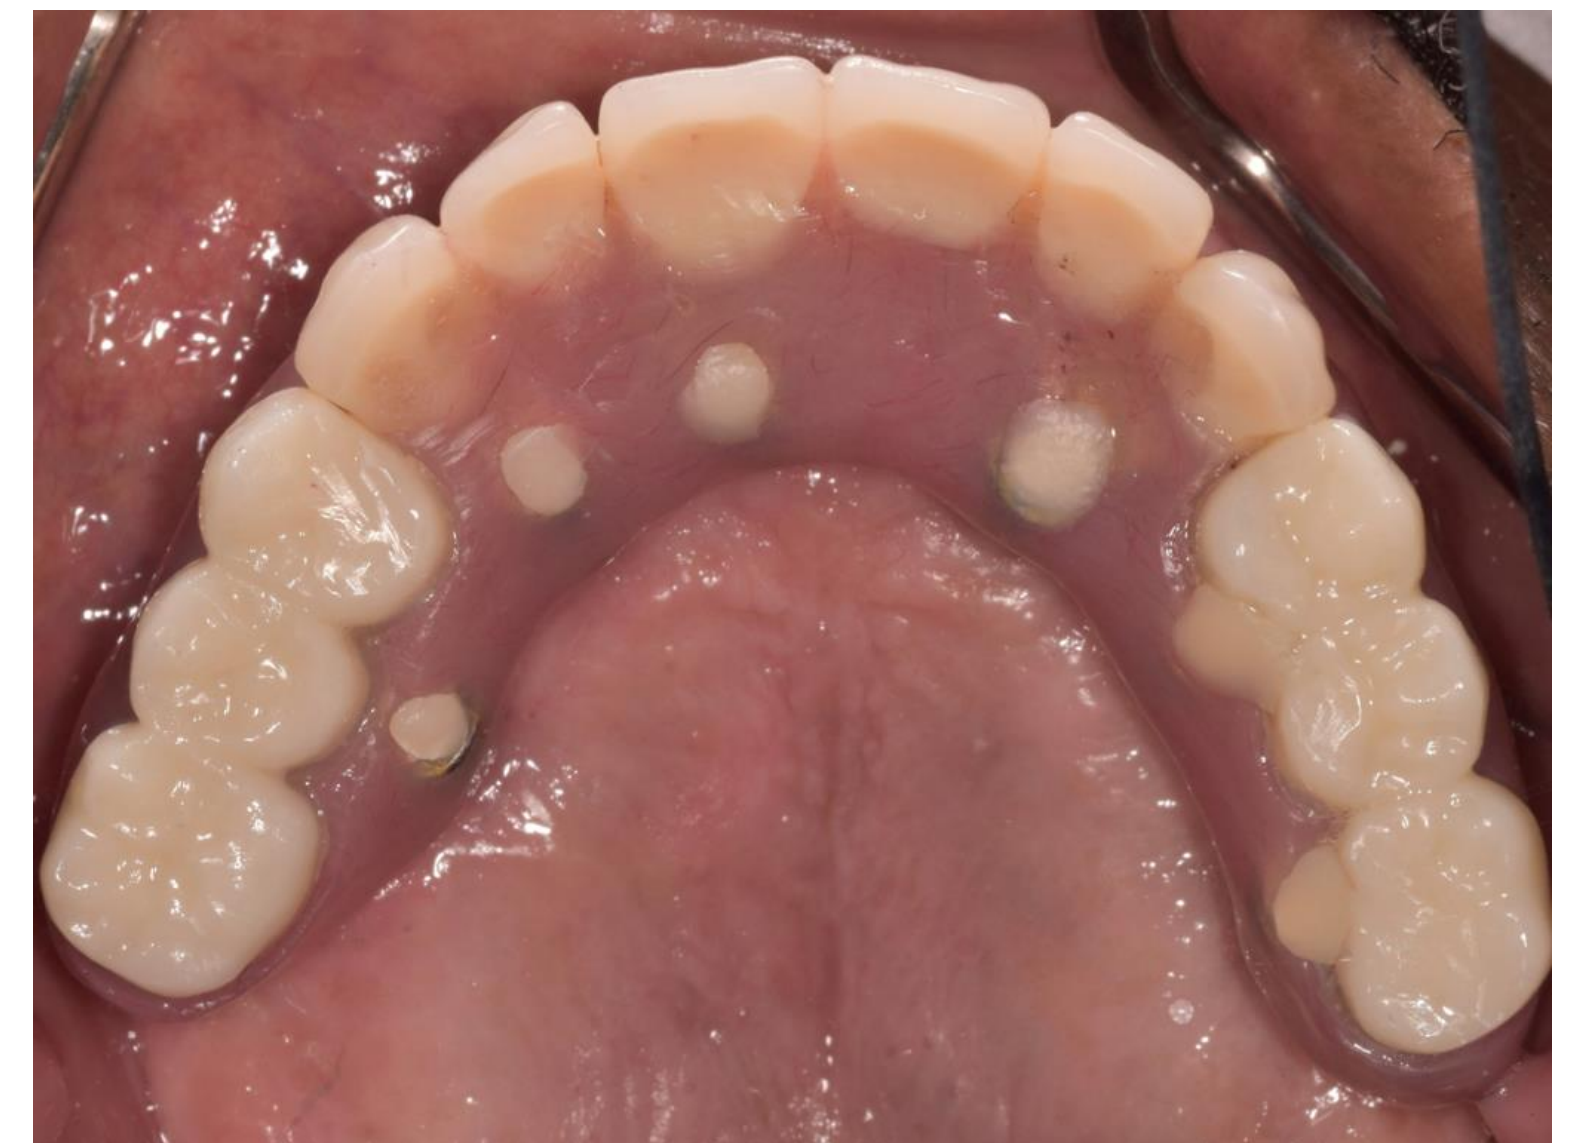
**Fig. 5:** Occlusal and frontal view, 6-month follow up
