# Analysis of Clinically Failed Implant-Supported Complete Arch Zirconia Prostheses

Kanisa Chantarothorn DDS, Cheryl Park DDS FACP  
Advanced Prosthodontics, Herman Ostrow School of Dentistry of USC

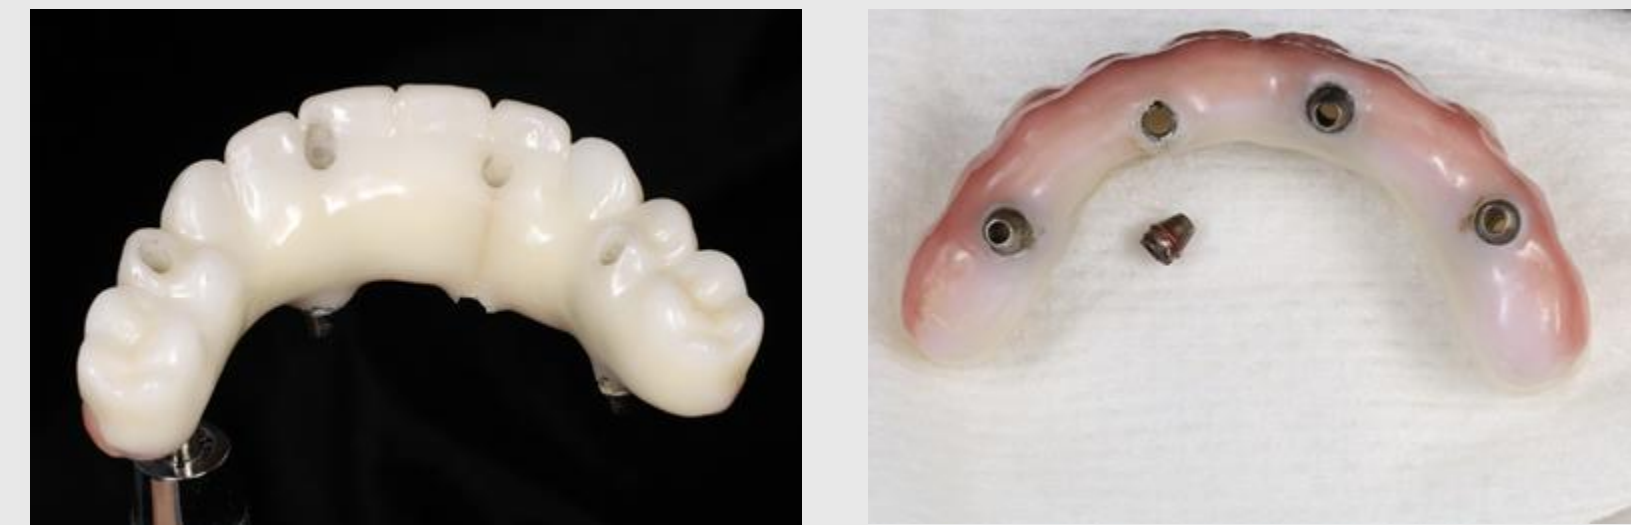
**Sample 1** exhibited a visible crack line on the lingual side and a fractured temporary cylinder, with unclear fracture initiation after 5 years in function.

Fig. 1A - Lingual view of sample 1 with crack line at abutment site #10  
Fig. 1B - Gingival view of sample 1 with fracture titanium abutment at site #10

Visual inspection revealed Sample 1's failure with vertical fracture line of zirconia surrounding the titanium abutment (Fig. 1A and 1B) and a partial absence of cement between the zirconia and the abutment (Fig. 3B), while sample 2 showed complete fracture at a non-abutment site (Fig. 2A and 2B).

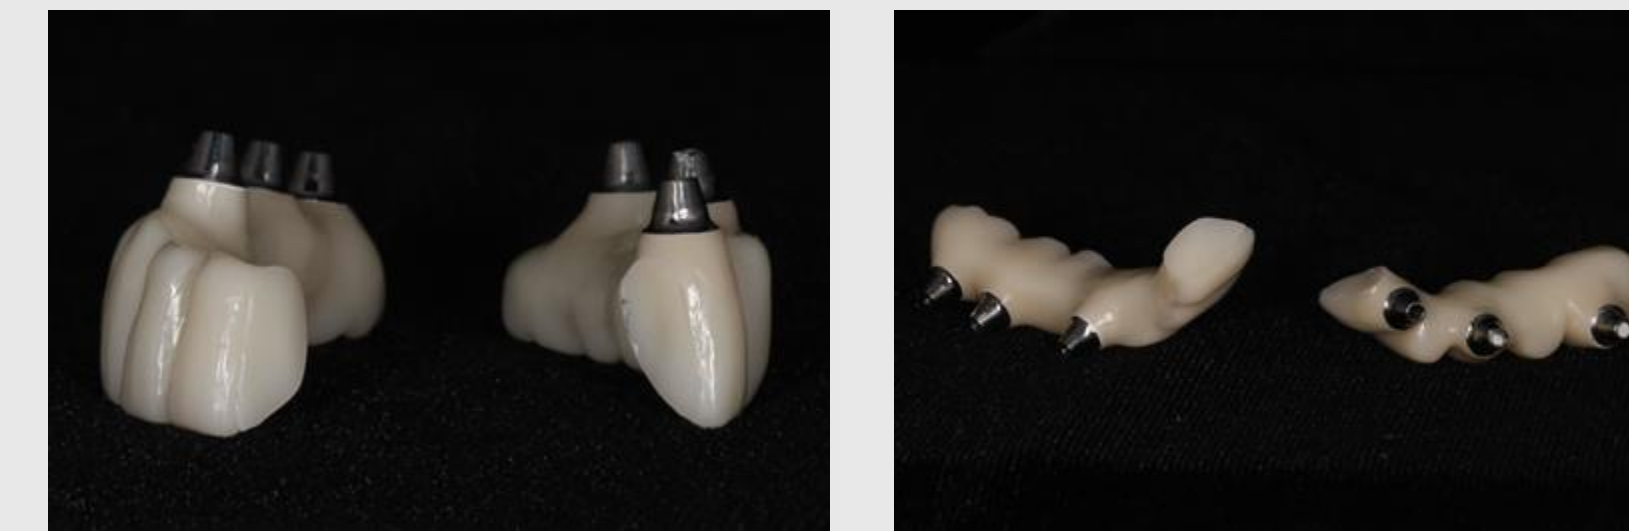
**Sample 2** exhibited a complete fracture separating the prosthesis into two parts after 5 months in function.

Fig. 2A and 2B show fracture site of sample 2 at the connector of pontic sites #24, 25

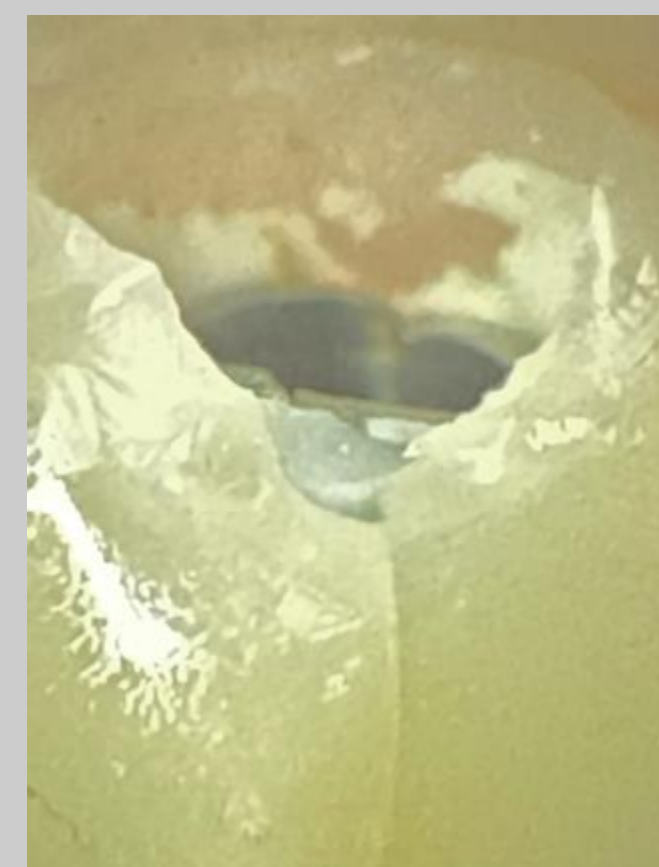
Fig. 3A - Fracture site with crack line along the zirconia

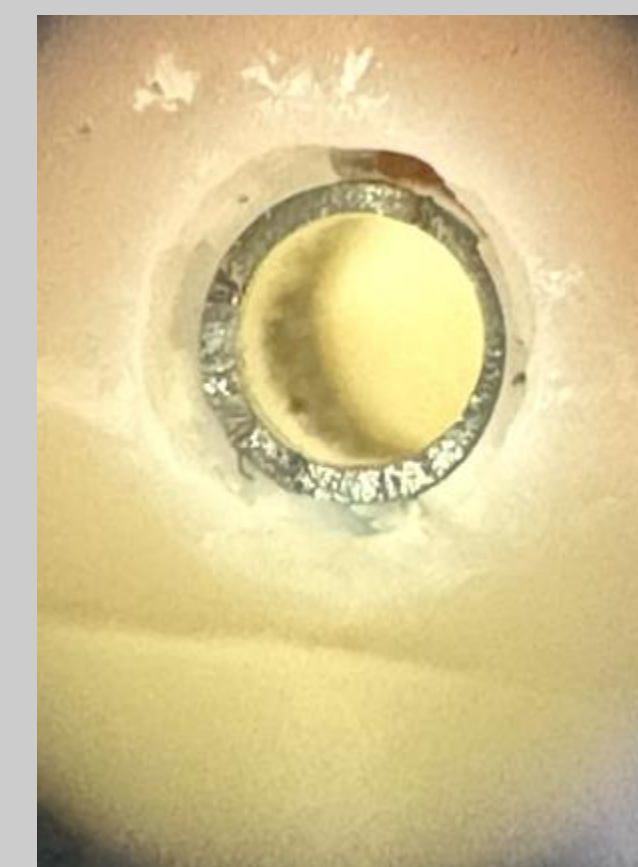
Fig. 3B - Partial absence of cement between zirconia and titanium abutment

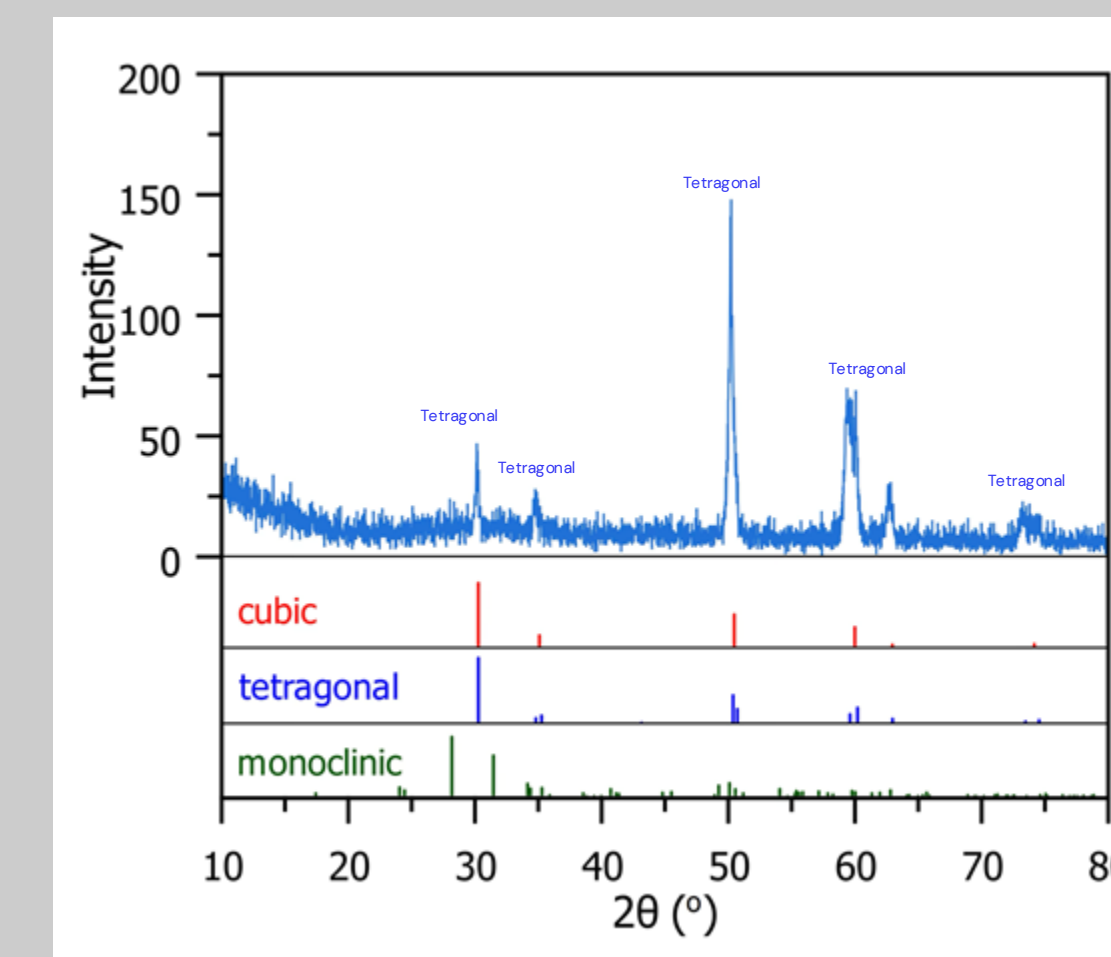
**Sample 1** revealed predominantly tetragonal phase (Table 1), while **Sample 2** exhibited both tetragonal and monoclinic phases (Table 2)

Table 1  
X-ray diffraction profiles presenting the phase configurations on the crack line of sample 1

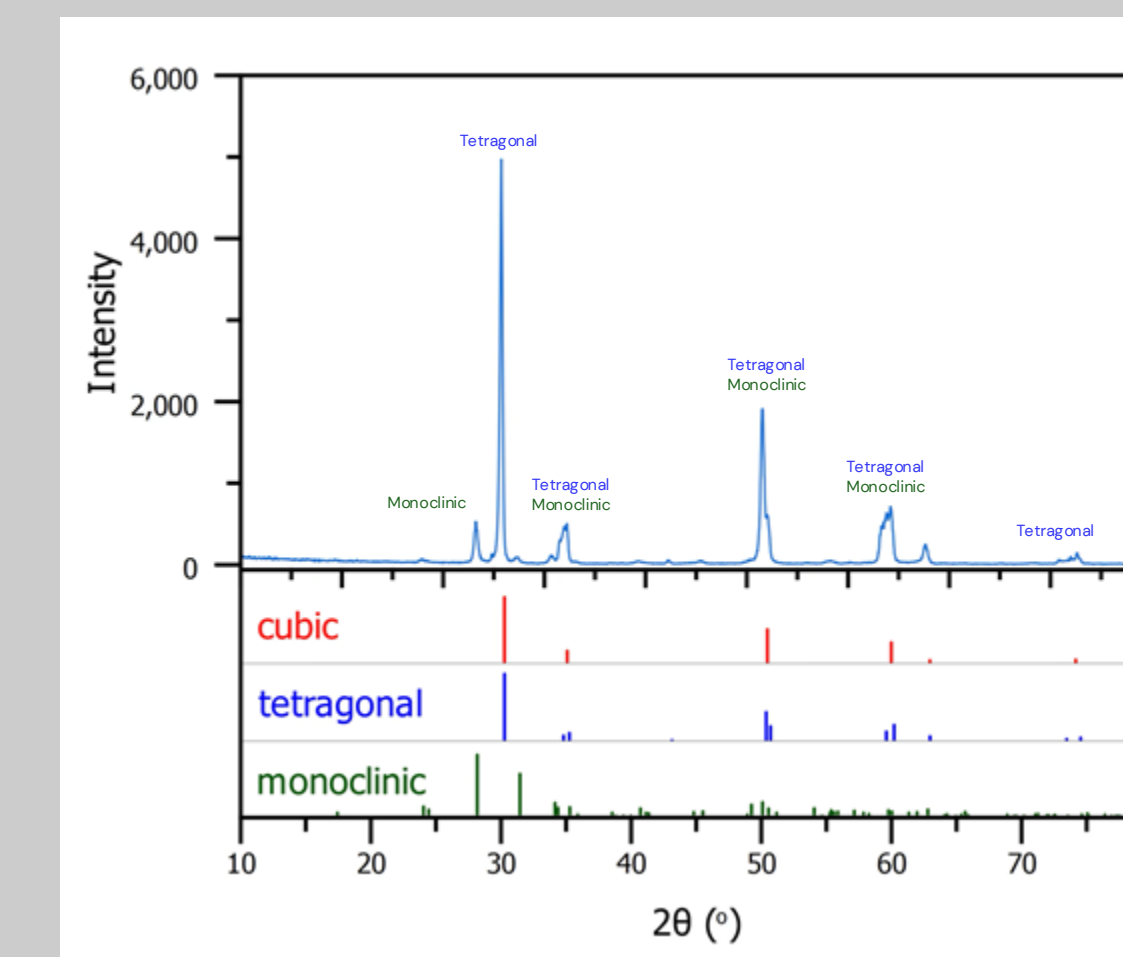
Table 2  
X-ray diffraction profiles presenting the phase configurations on the crack line of sample 2

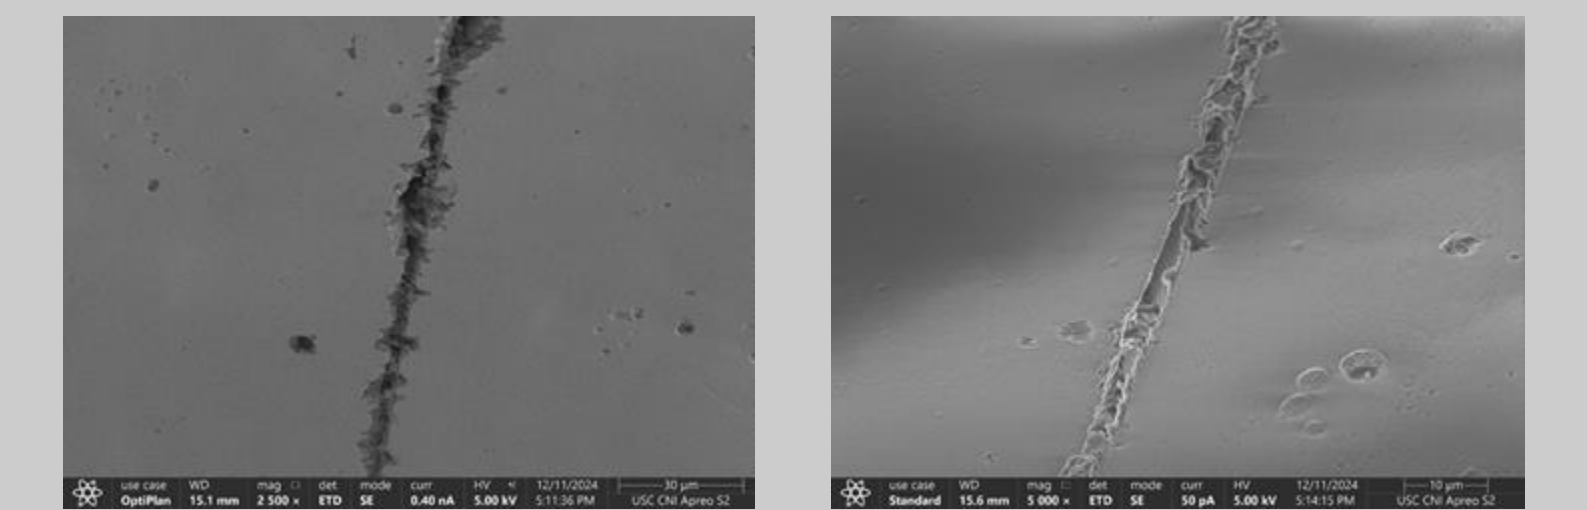
**Sample 1** demonstrated mixed transgranular-intergranular fracture

Fig. 4A and 4B - SEM images at 2500x and 5000x of crack line in sample 1 respectively

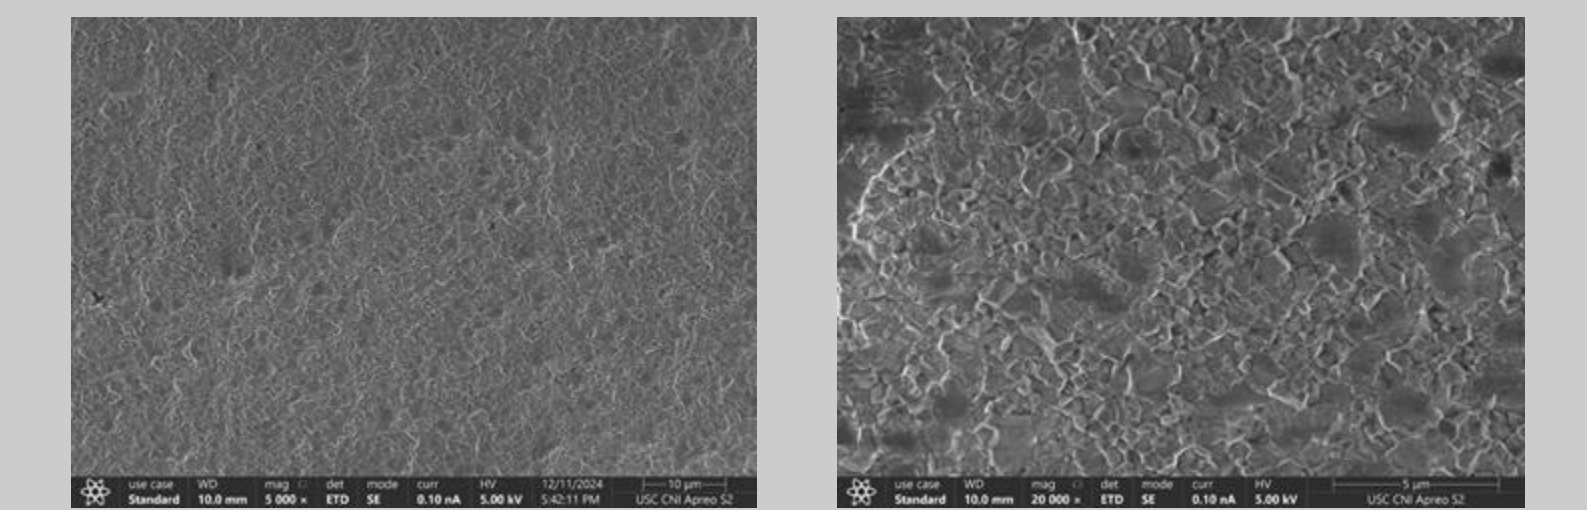
**Sample 2** exhibited predominantly intergranular fracture, grain pull-out, and interconnected cracks

Fig. 5A and 5B - SEM images at 5000x and 20000x of crack line in sample 2 respectively
