# INTRODUCTION

The purpose of this study is to determine the effect of the resin repair protocols on the fracture strength of endodontically accessed 0.6mm thick zirconia crowns (3Y-TZP).

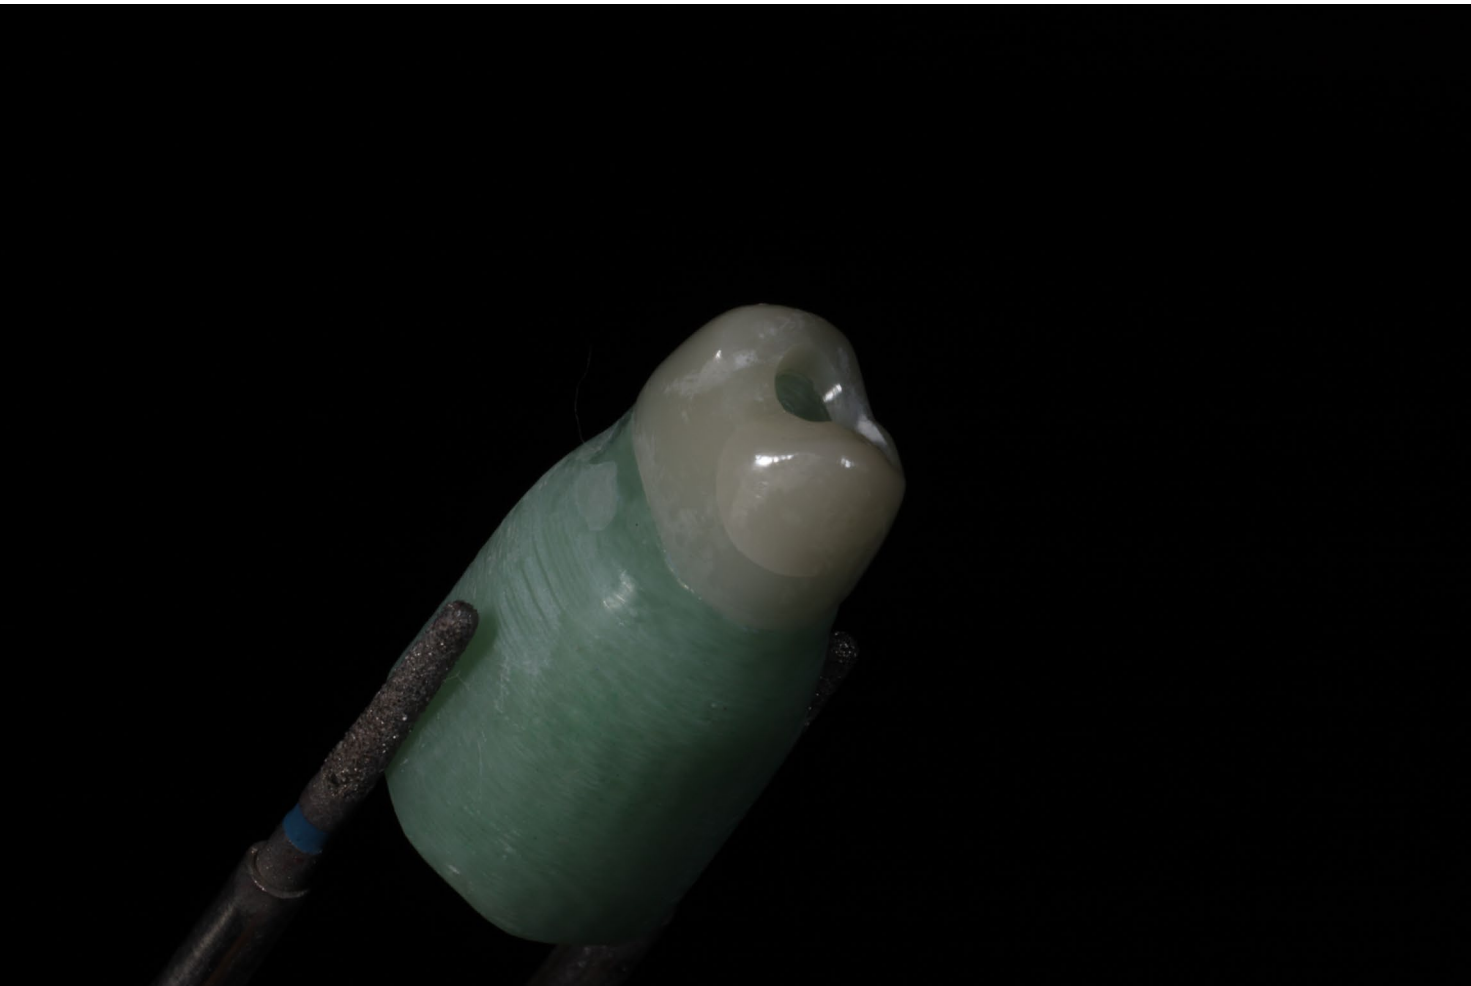
Fracture strength analysis

The mean load to fracture of the intact control group was 2789 +/- 473 (N). The samples with a repaired endodontic access had a mean load to fracture of 2507 +/- 659 (N) for Group A, and 2419 +/- 553 (N) for Group B. The one-way ANOVA indicated no significant difference in the load to failure among any of the sample groups (p=0.32). The post-hoc Tukey test revealed statistically similar fracture strengths of the intact control group when compared to repaired samples in Group A (p=0.52), and the repaired samples in Group B (p=0.33). The method of repairing an endodontic access did not significantly affect the fracture strength (p=0.94) (Figure 3).
