# From Fracture to Functional: Reimagining Prosthetic Design Through Diagnostic Reversal in Complete Arch Fixed Implant-Supported Prostheses

Dina Mesmar, BDS , Yu-Chun Lin, DDS, MS, DMSc; Nupur Patel, BDS, DMD MS, FACP, Leslie Stone Hirsh, DDS

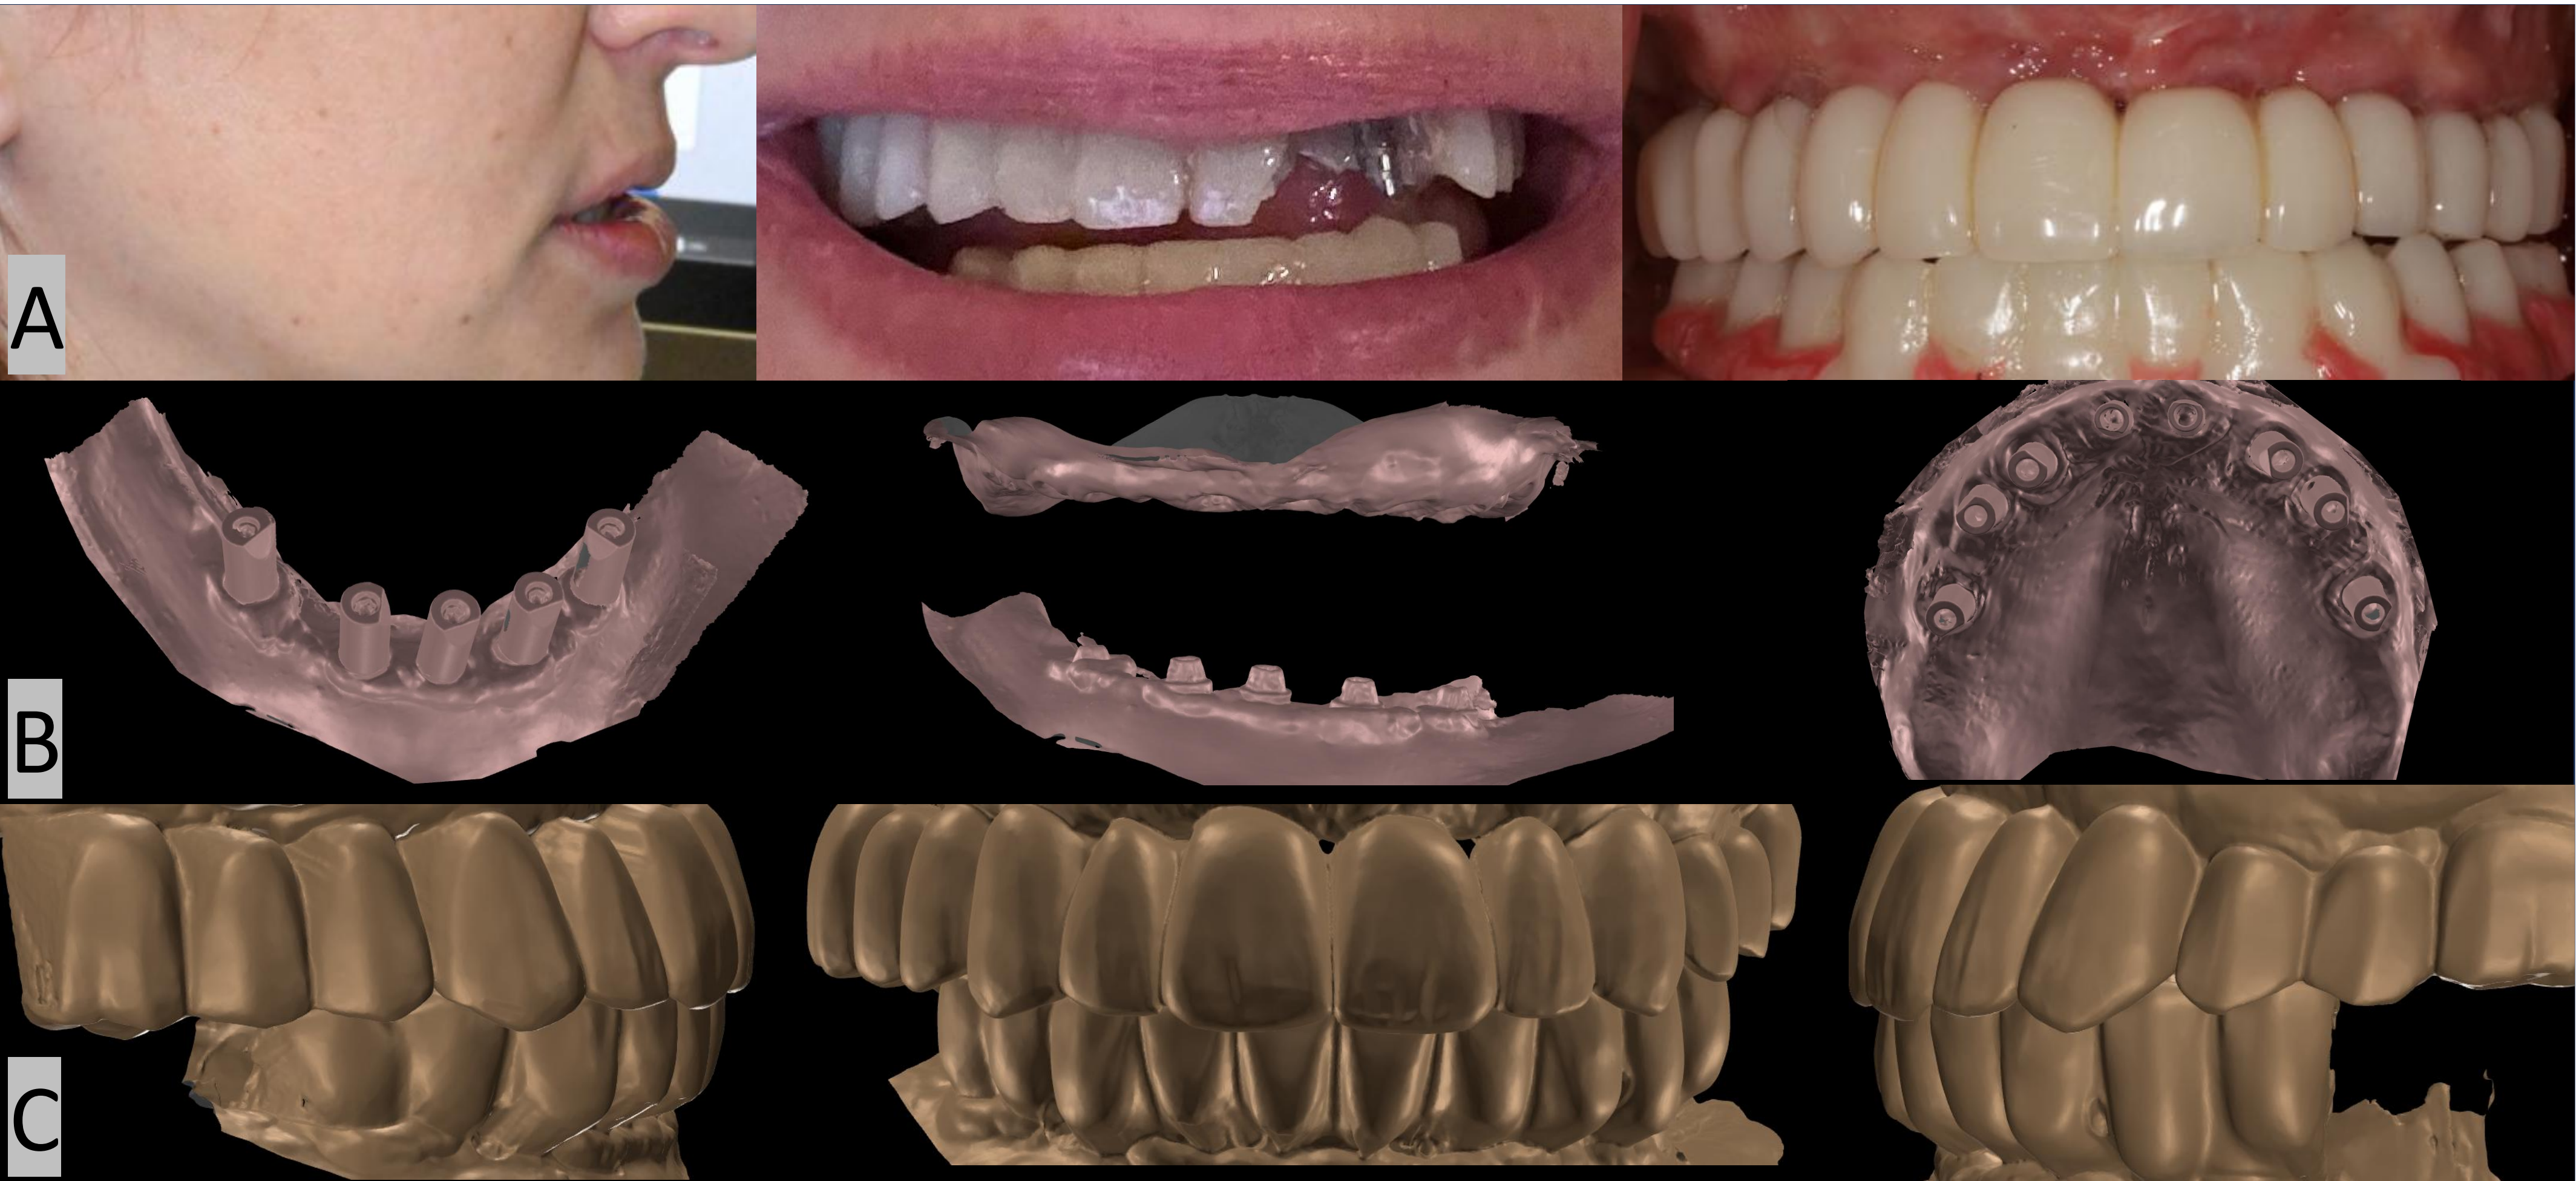
A 49 year-old patient presented with fractured milled PMMA prototypes, supported by 8 maxillary and 5 mandibular implants. The prototypes, designed as FP1, had a deficiency of 7 mm from the ideal OVD, inadequate interocclusal restorative space, and lack of harmonious occlusion. Additionally, it was determined that the master cast obtained from a scan-body–based digital impression was inaccurate, with lack of passive fit. Through prosthodontic diagnostic reversal, OVD was reestablished using phonetics, esthetics, and functional methods and a repeatable centric relation record was made. A splinted, abutment-level open-tray impression produced an accurate master cast which was then verified. The prosthesis was redesigned from segmented implant level FP1 to a splinted MUA- level monolithic zirconia FP3 with cross-arch stabilization and passive fit.

Figure A: Initial presentation with fractured PMMA prototypes and a 7-mm deficiency in OVD; Figure B: Inaccurate full-arch digital impression using scan bodies with an incorrect MMR; Figure C: STL 's of the patient's OVD at intial PMMA prototype phase .

Monolithic zirconia prostheses show high survival, but failures rise when OVD and restorative space are inadequate. For Zirconia Implant Supported Complete Dental Prosthesis 11–14 mm of interocclusal restorative space is recommended from the edentulous ridge to the opposing occlusal table [1]; in this case, OVD deficiency by 7 mm and limited interocclusal restorative space contributed to fracture of PMMA prototypes. Moreover, digital scan-body impressions can accumulate error over complete arches and jeopardize passive fit, whereas splinted conventional open-tray impressions remain more predictable [2], though novel scan-body designs, such as arcuate or extended forms, have shown improved precision comparable to conventional methods [3]. By applying diagnostic reversal, these issues were corrected and successfully tested in the new PMMA prototypes [5]. Redesigning from FP1 to FP3, with verified casts and functional records, restored harmony, stability, and passivity, supported by literature that stresses verification and prototype fabrication to ensure long-term success [1,4].

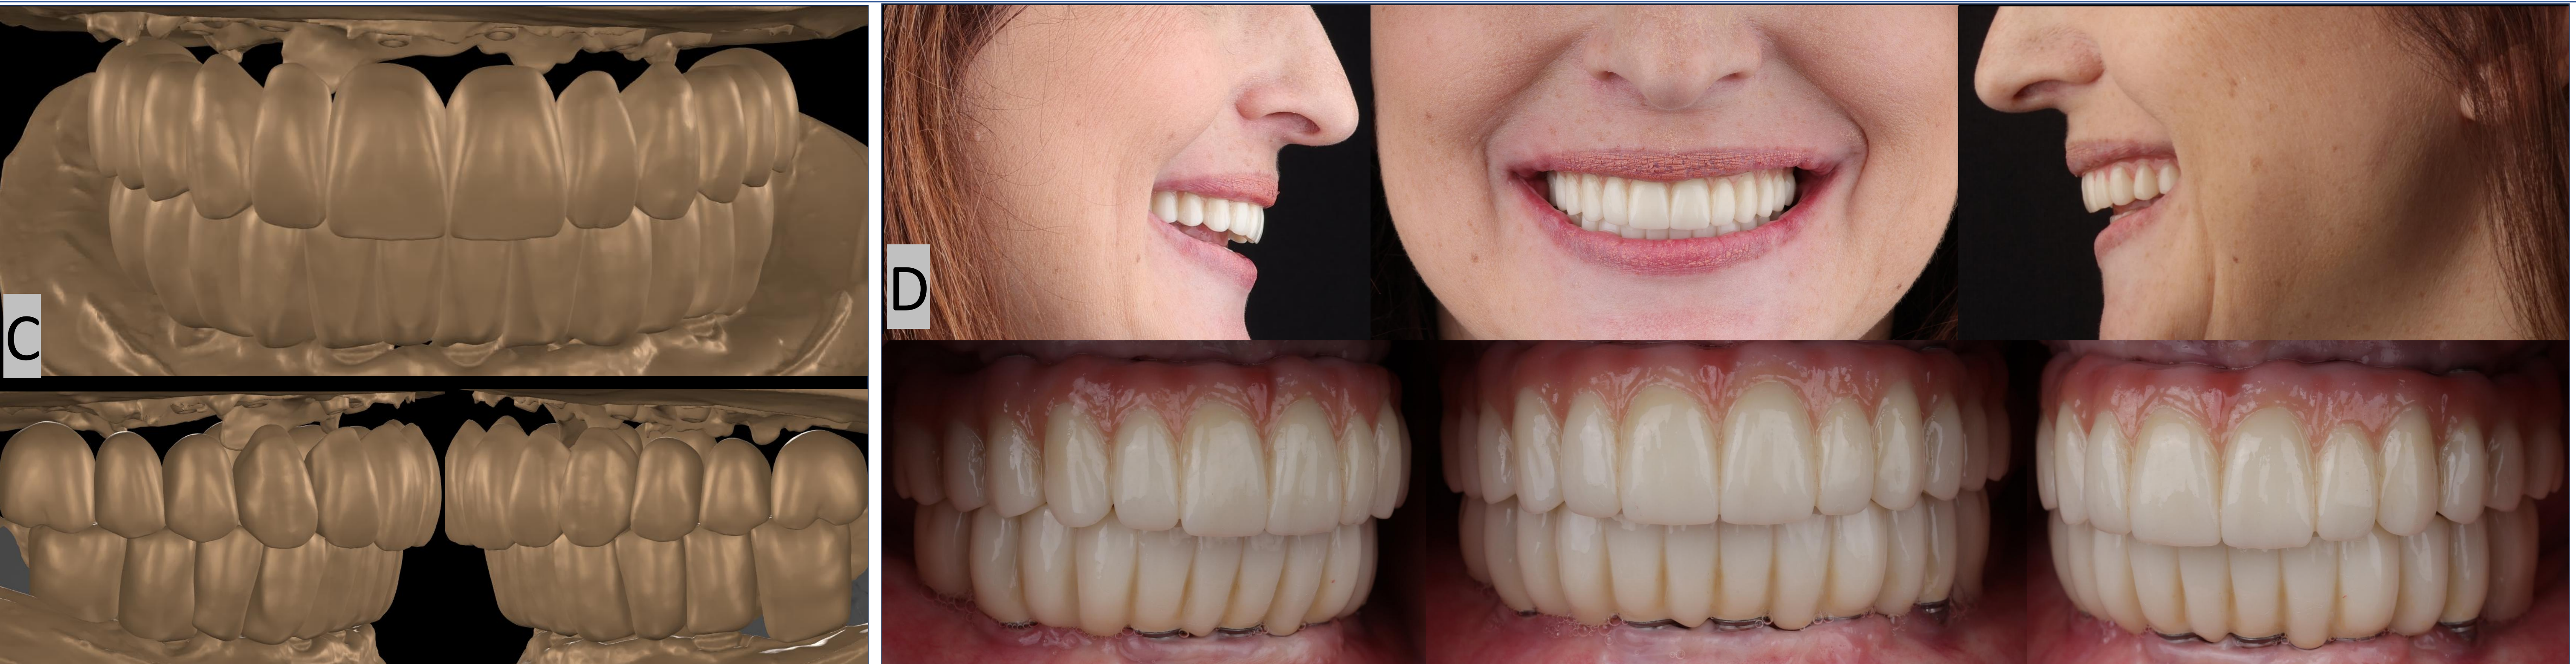
The redesigned FP3 prosthesis restored OVD, occlusal harmony, and structural stability. Passive fit was verified, and the patient reported improved comfort, speech, and esthetics. Follow-up confirmed durability without complications.

Figure C: Diagnostic wax-up after a 7 mm increase in OVD

Figure D : Final implant-supported fixed complete dental prosthesis at increased OVD
