Objectives

Patients today often present with existing dental implants. When there is a need to incorporate existing implants into patient’s treatment plan, this poses a clinical challenge especially for implants that are unserviceable due to unfavorable position or implant systems that do not have readily available components.

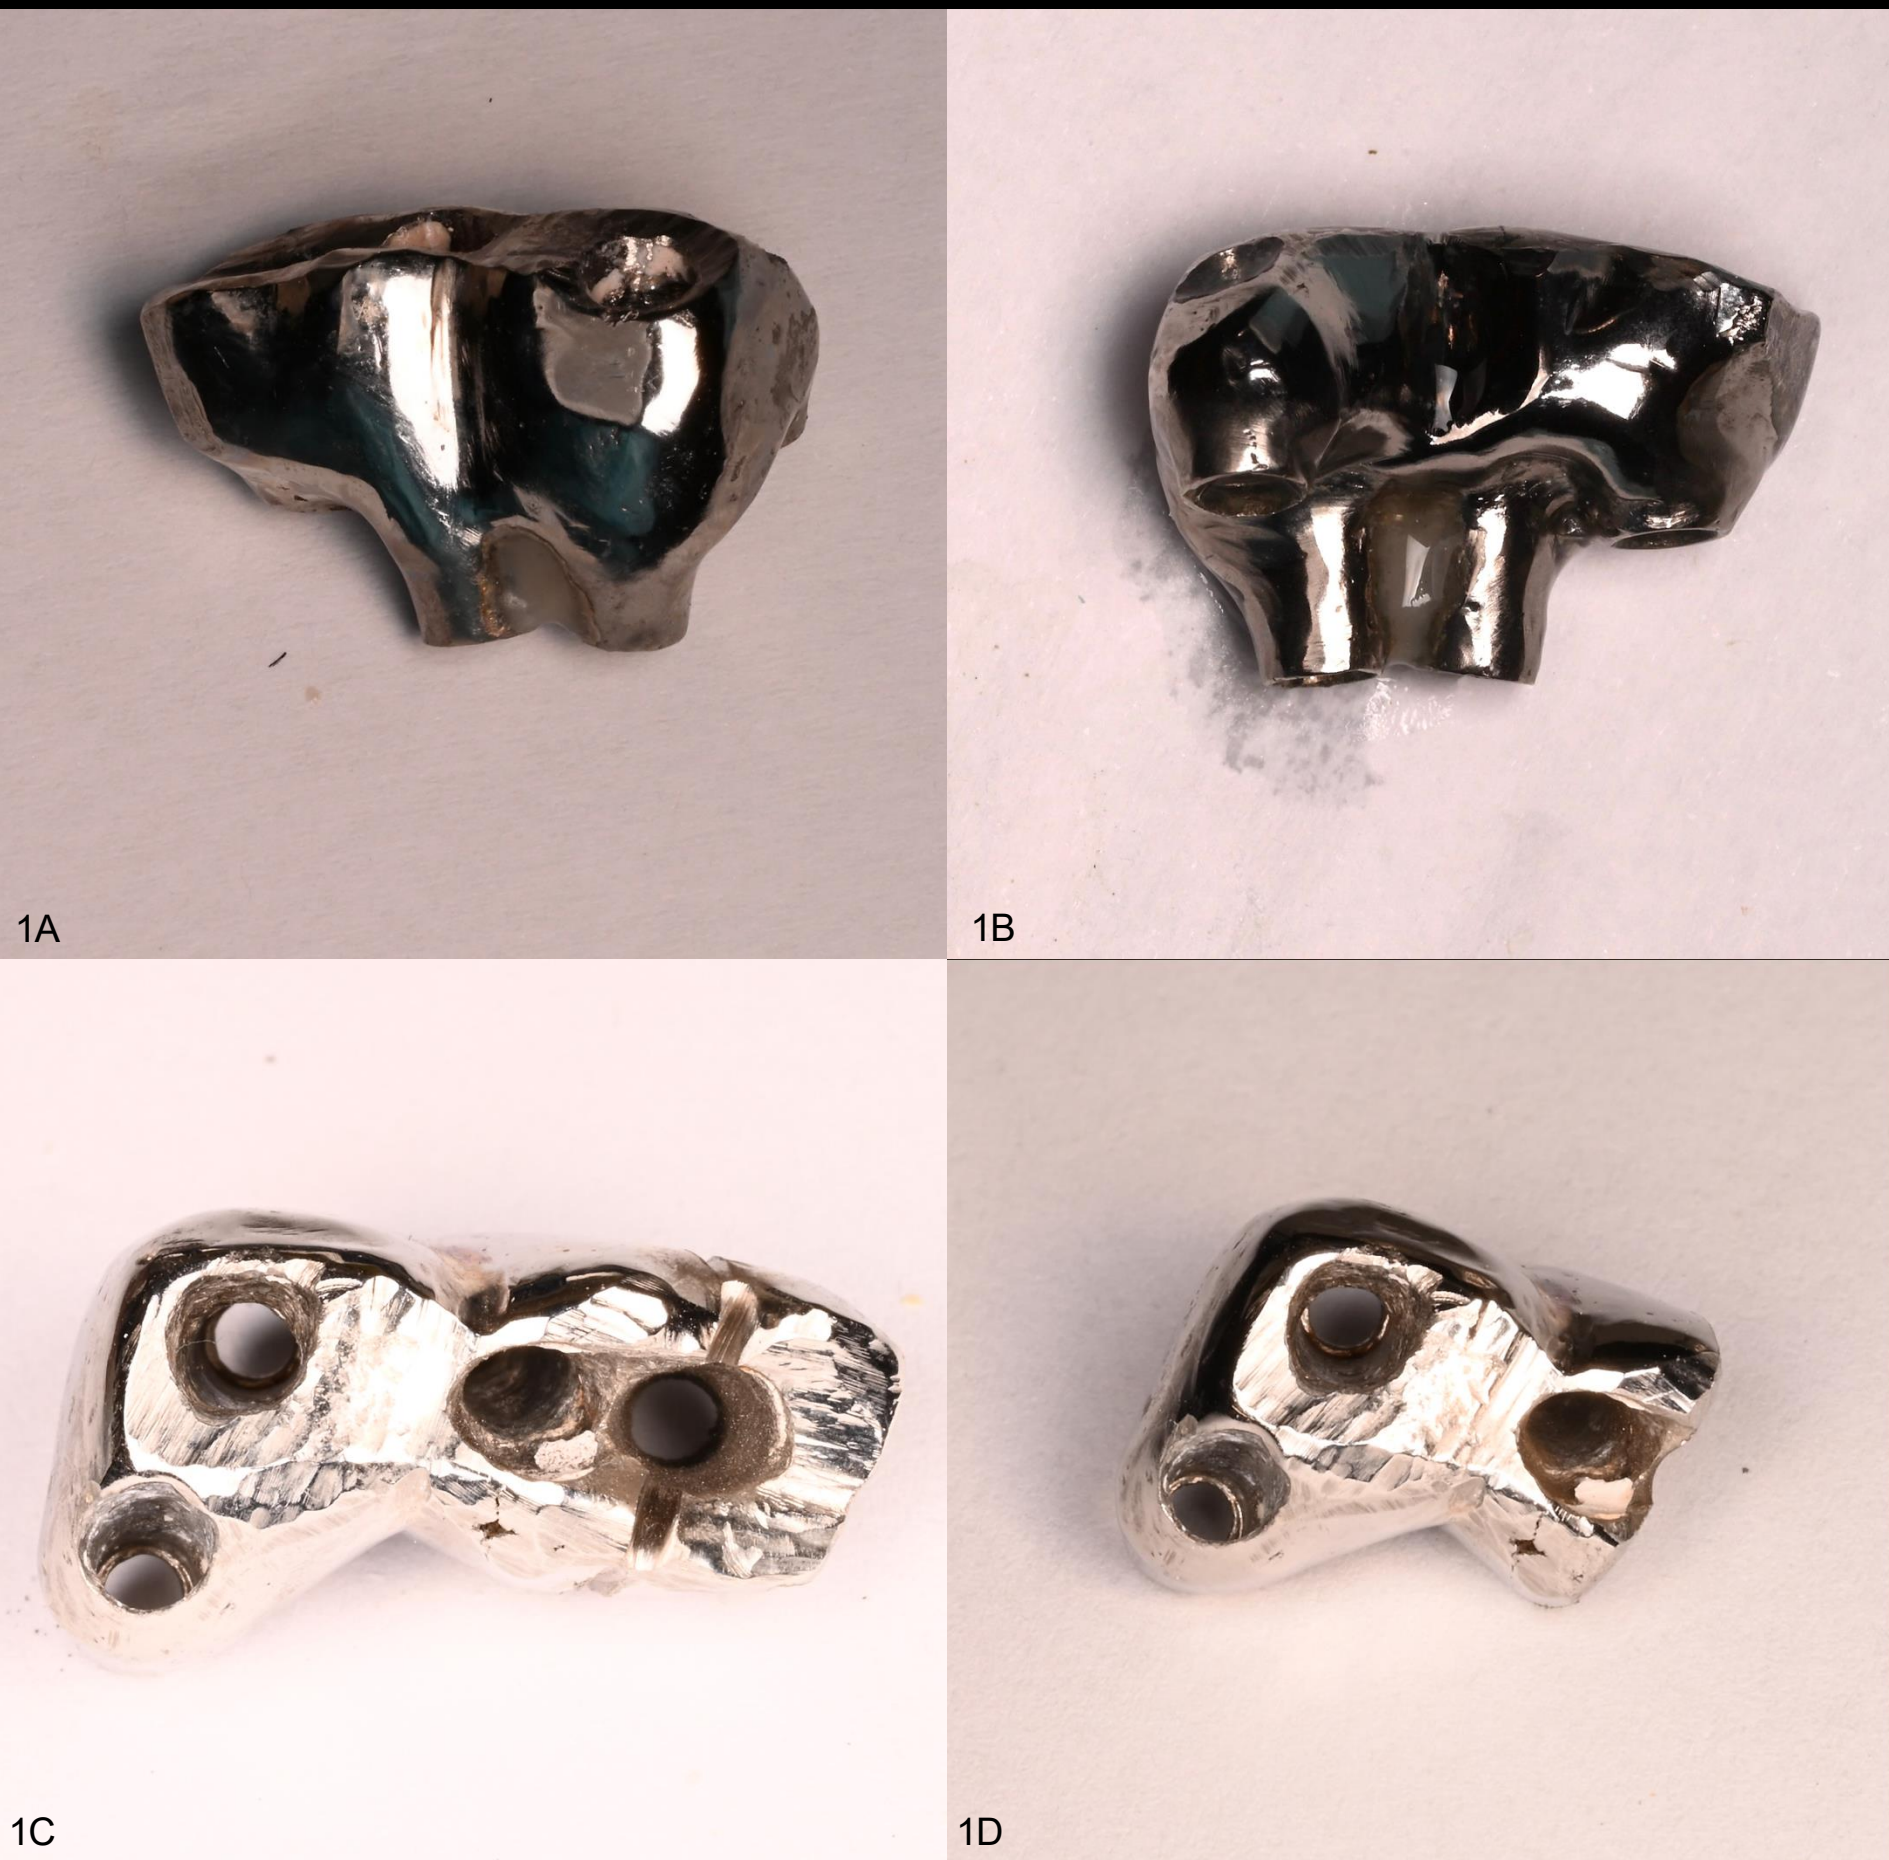
Fig.1A (Buccal) and 1B (Palatal) side of Implant FPD  
Fig.1C and 1D: Before and after sectioning of #3i engaging component
