## INTRODUCTION

## CASE

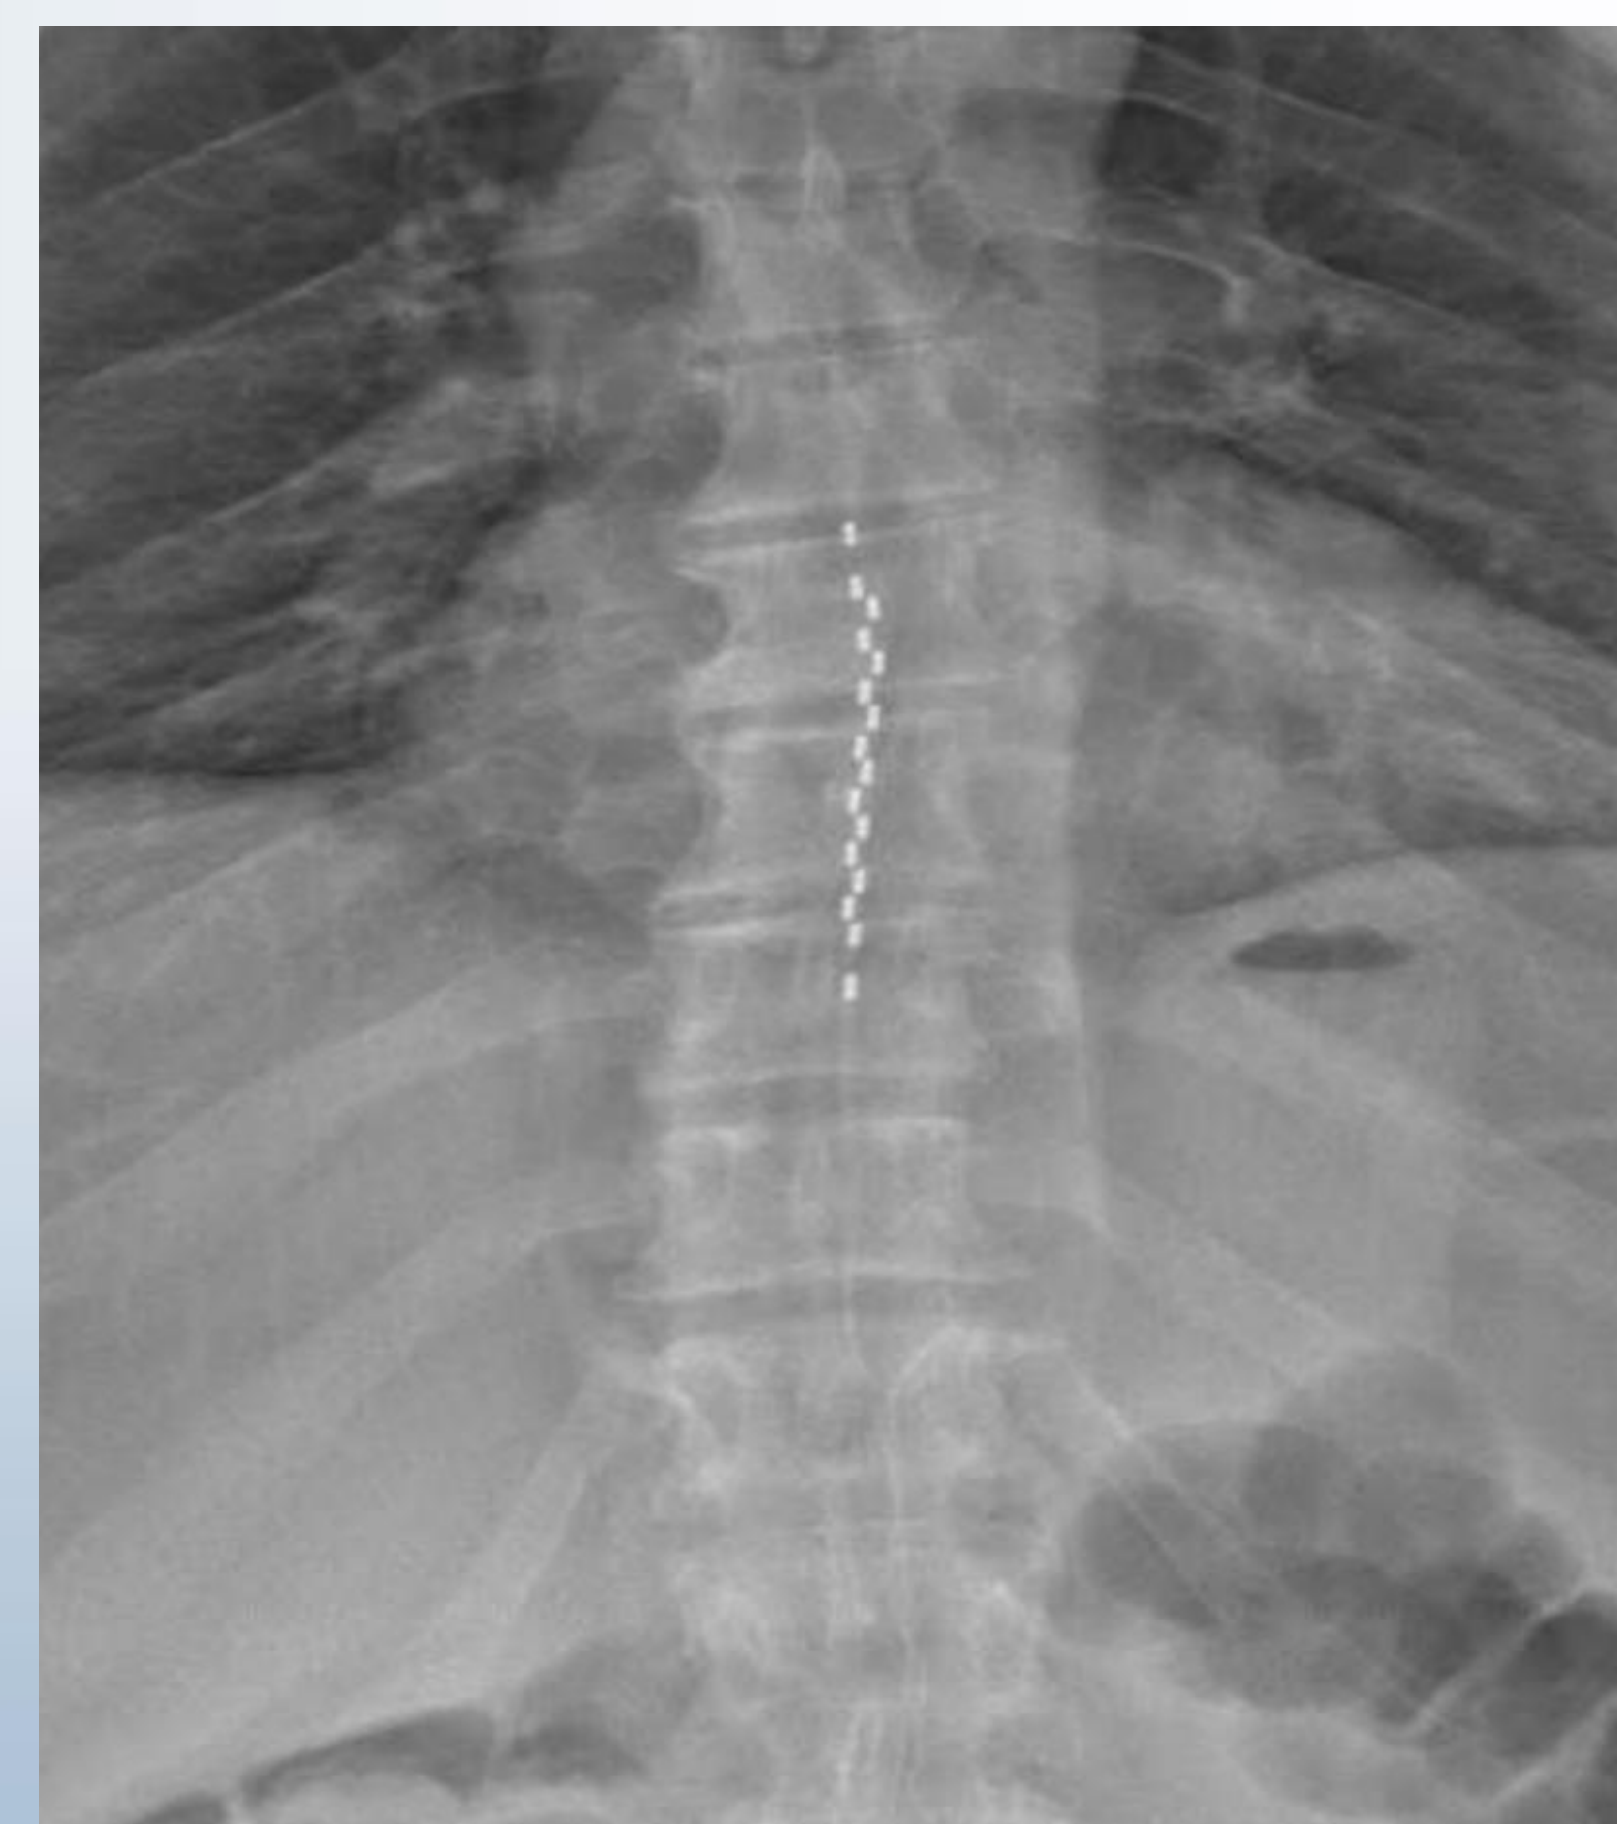
Fig 1: X-Ray of Thoracolumbar Spine, AP view

- The SCS was unable to be reprogrammed secondary to a high impedance, and lead fracture was suspected. Only three contacts of 16 total were functional

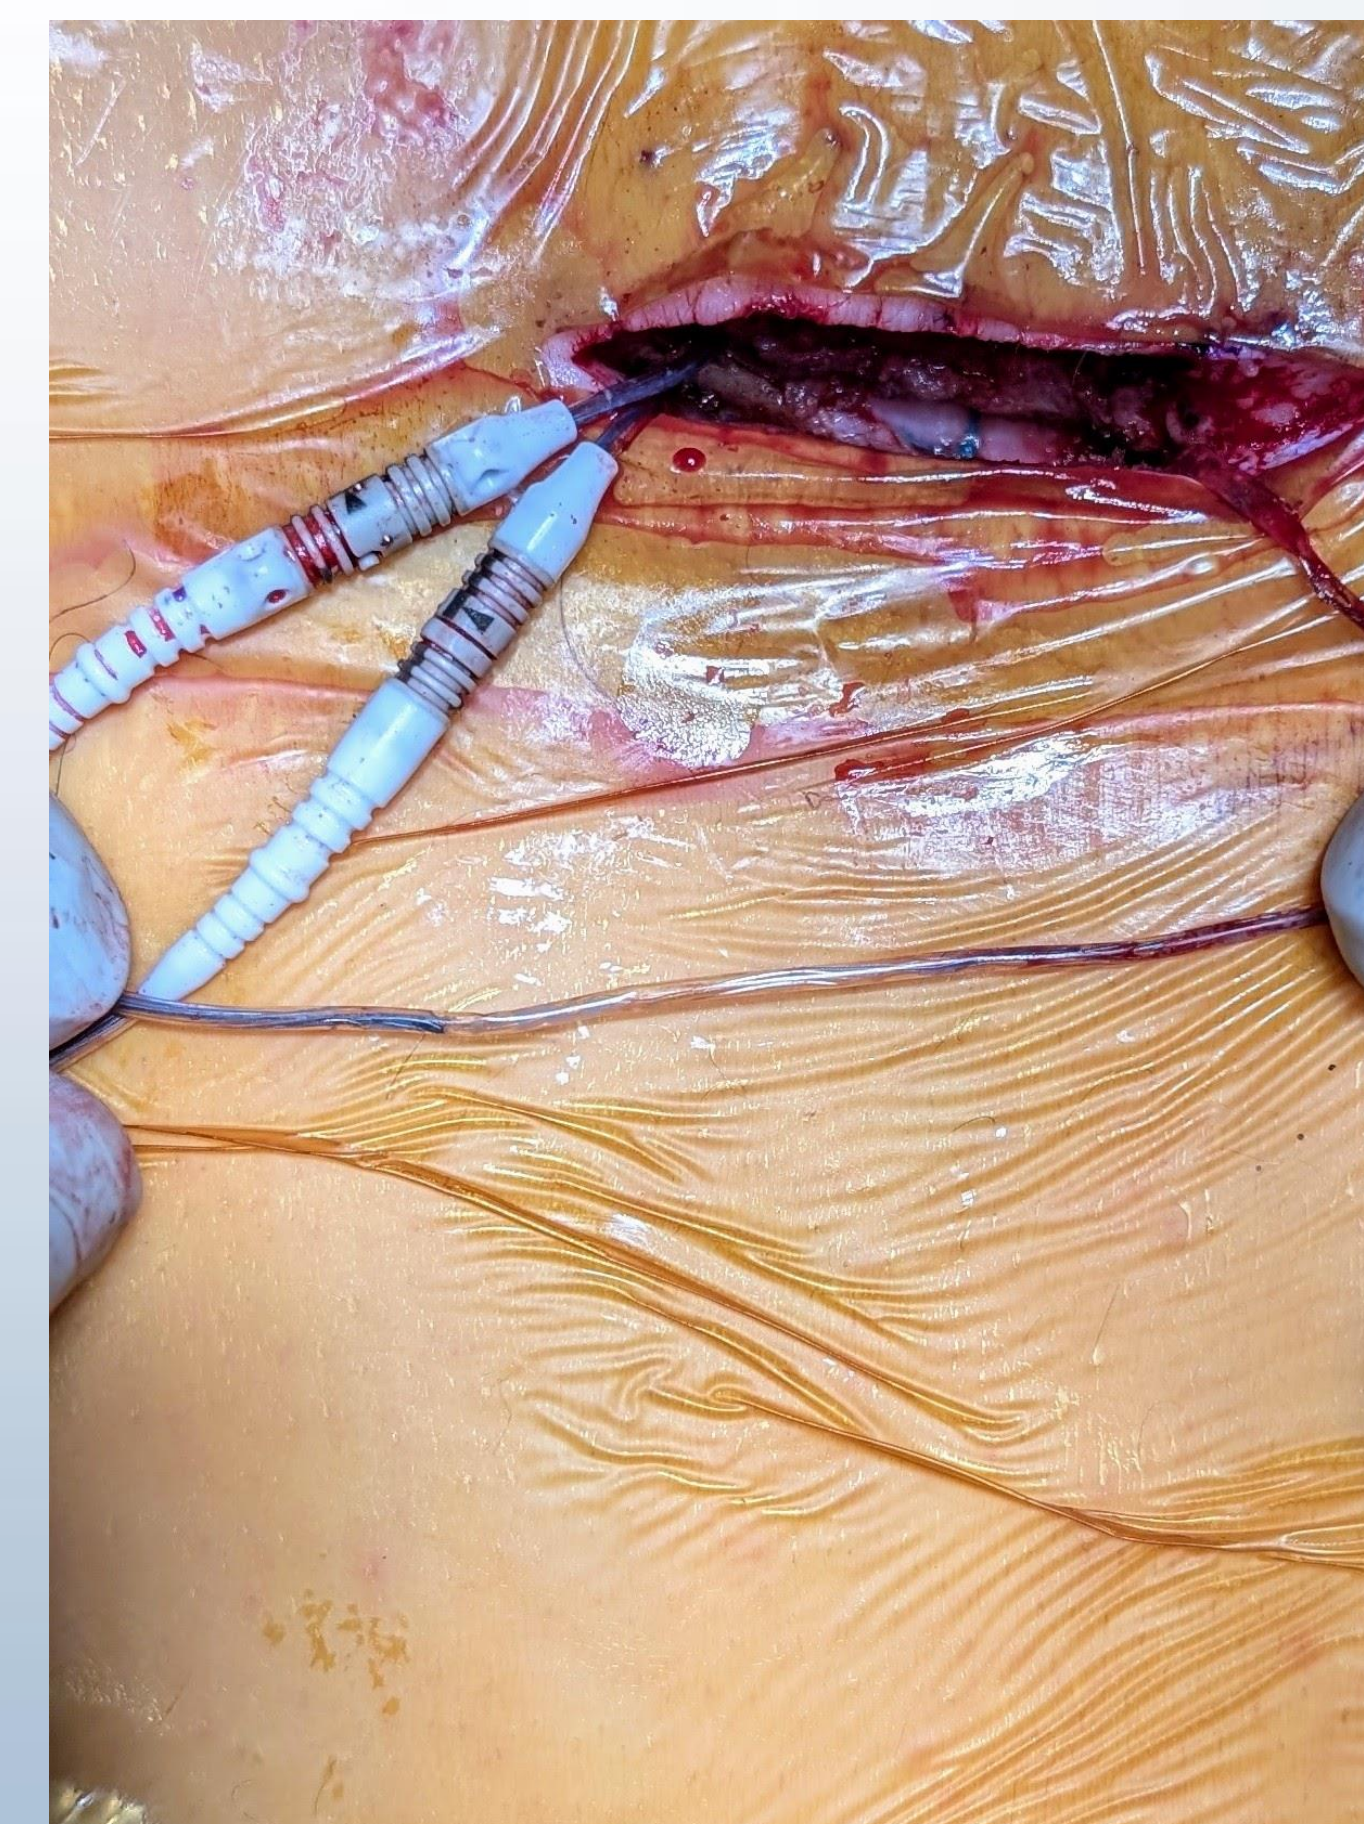
Fig 2: Discontinuous metallic lead the with clear sheath extended

- The decision was made for a lead revision
- A left paramedian incision was made, multiple lead fractures within each lead were noted. One lead was easily removed, and two fractures were visualized within the lead
- The other lead was gently pulled back and examination revealed the metallic lead in the lumen was discontinuous and the clear sheath extended several centimeters into the fascia making intact removal unlikely
- The incision was therefore extended cephalad and once the portion of the lead with metallic material within it was visible, this was grasped with a DeBakey and gently pulled out with the lead intact
- Approximately 5 different lead fractures were noted on the lead
