BACKGROUND

CASE DESCRIPTION

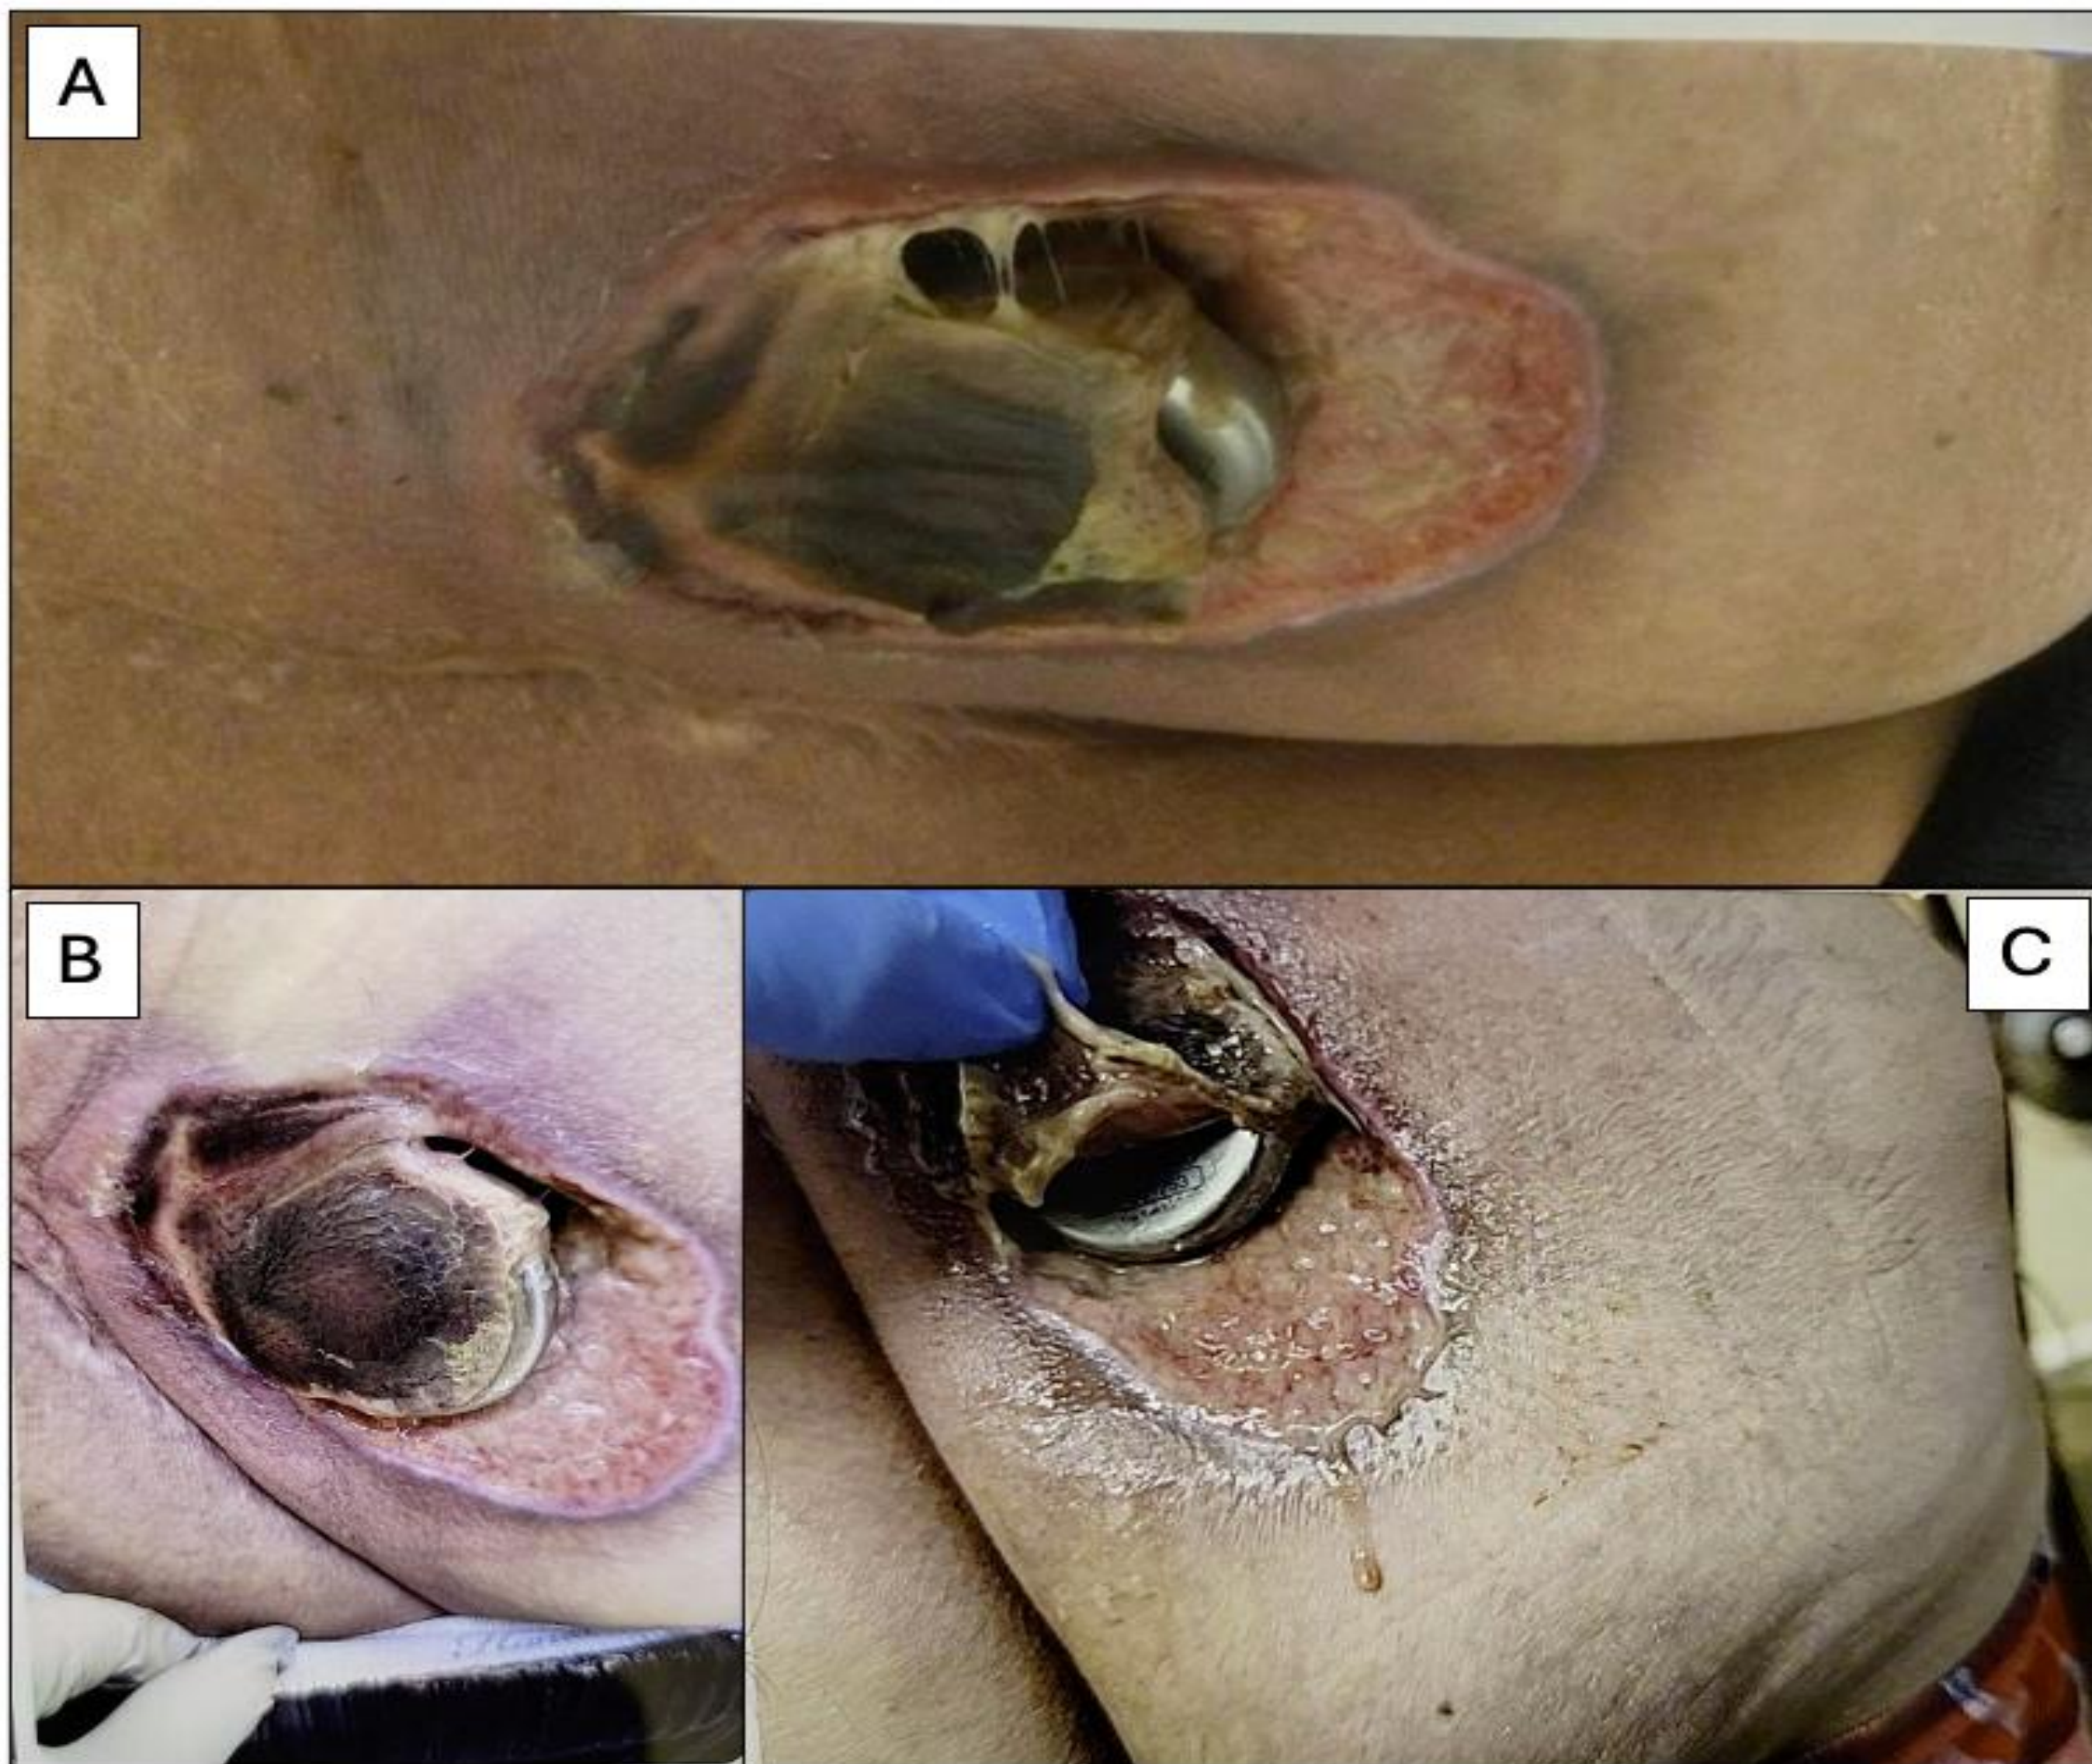
Figure 1: IPG extrusion depicted (A) on initial presentation, (B) after initial cleansing and debridement, and (C) with residual capsule reflected to reveal IPG.

- Late extrusion in our case was multifactorial with pressure necrosis and suspected skin and soft tissue infection from prolonged sitting, constant vibration on the IPG location from wheelchair use, age-related skin frailty, and IPG migration.
- Given the increasing popularity SCS, pain physicians should educate patients on avoiding prolonged pressure and schedule frequent follow up visits with skin inspection, particularly for patients with risk factors for limited immobility (i.e. wheelchair bound)or skin frailty (i.e. age, prolonged steroid use) [5]
- IPG extrusion may potentially be prevented by using a smaller rechargeable pulse generator and changing the location of the implantation from the gluteal region to a location that is more pressure avoidant such as the abdomen subcutaneous tissues [3]

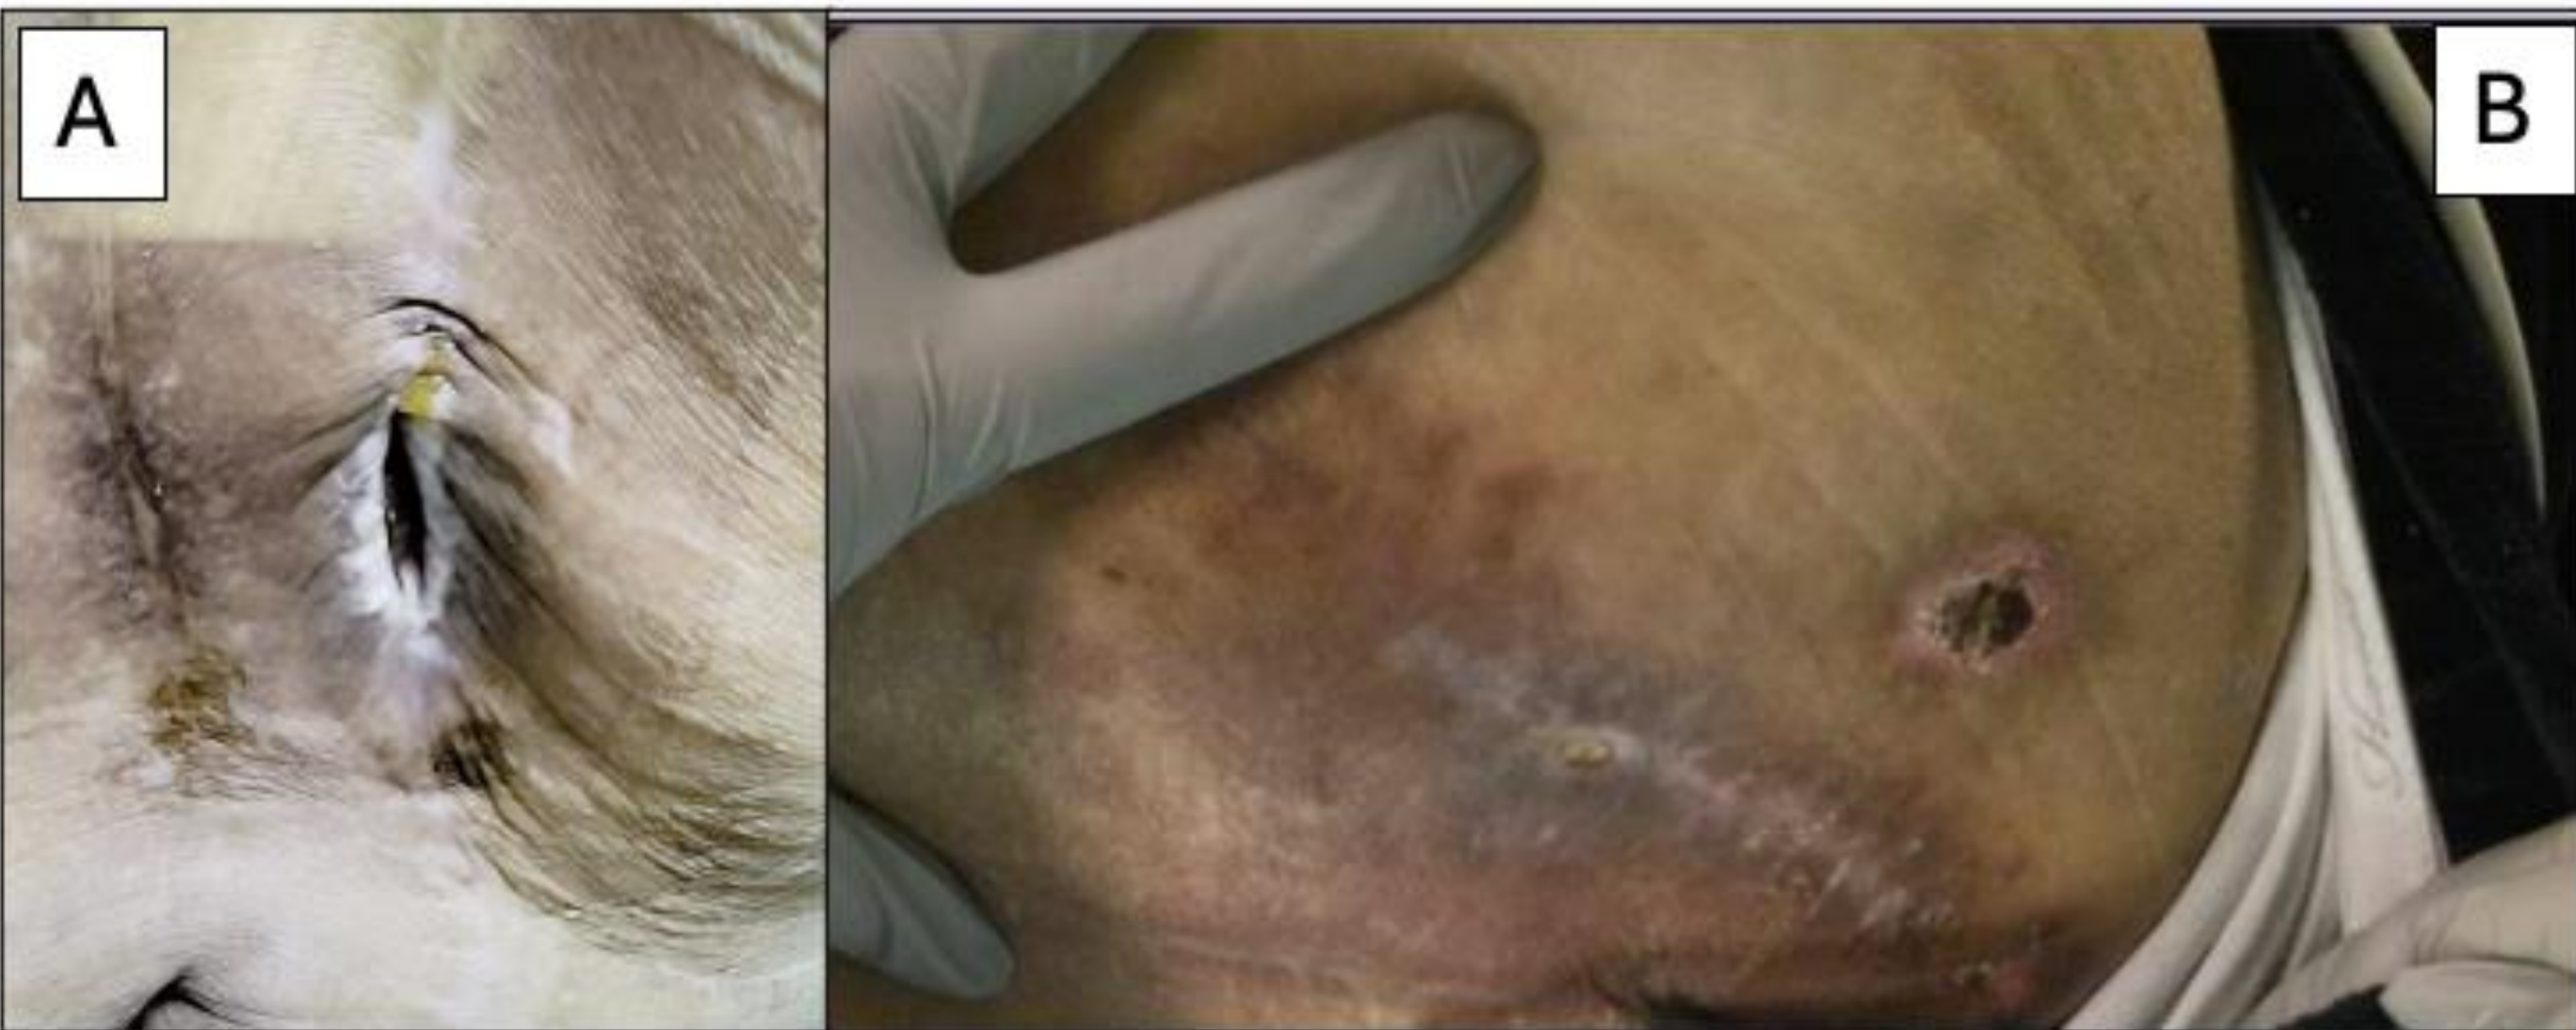
Figure 2: Post extrusion healing photos taken during (A) initial stages of healing process and (B) final stages of healing process

- History:** 67-year-old female wheelchair bound patient with history of multiple failed back surgeries, left foot drop, and CRPS of the left lower extremity refractory to pharmacologic and interventional modalities including opioids and lumbar sympathetic nerve blocks had two-lead SCS system placement with IPG implantation in the right lumbar region between the iliac crest and lower rib margin.
- Prior Response:** excellent pain relief with no complications or concern for IPG migration until six years later
- Complication:** severe pain over the IPG site with evidence of extrusion (Figure 1).
- Intervention:** surgical removal of the SCS system, washout, and intravenous antimicrobial therapy.
- Result:** Delayed wound healing was successfully managed with oral antibiotics and outpatient wound care, until final healing (Figure 2).
