# A Complex Case of fungal Periprosthetic Joint Infection of the Knee with *Aspergillus niger* aetiology

**Author: MD Jakub Banasiewicz**  
Czerniakowski Hospital, Department of  
Trauma and Orthopedic Surgery,  
Warsaw, Poland

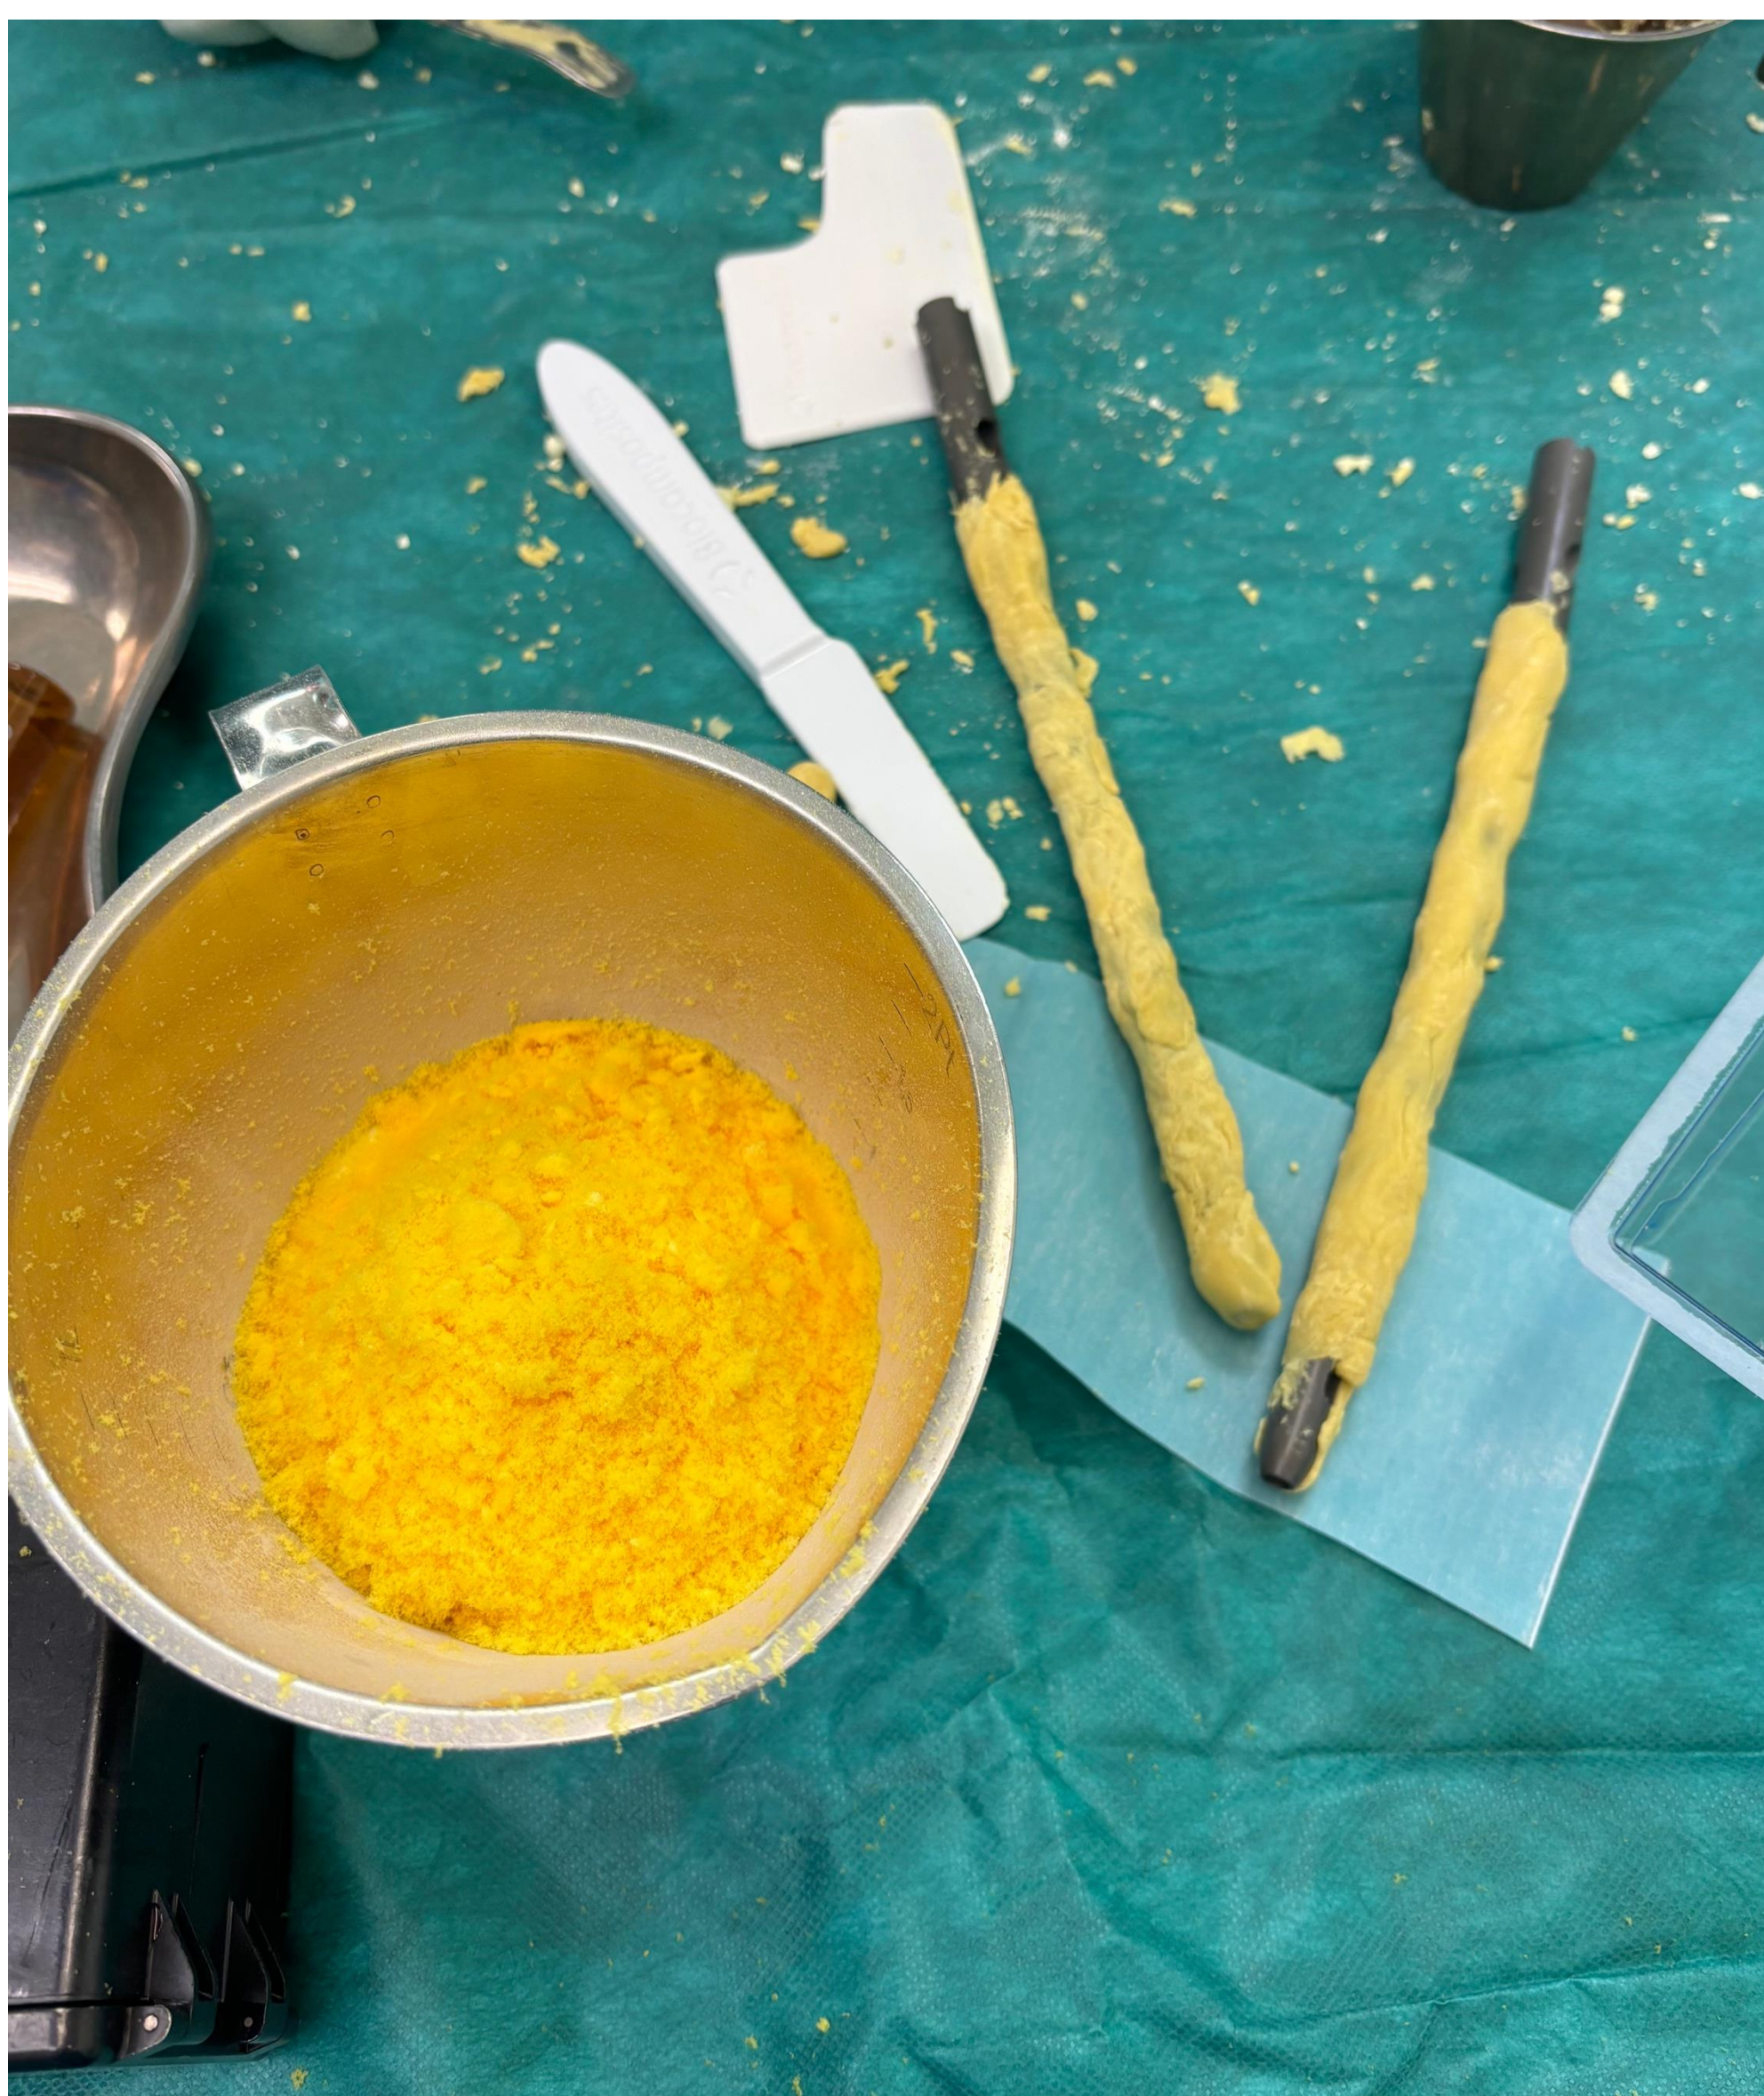
(Fig.1): Two Gamma 3 (Stryker) intramedullary nails covered with PMMA with addition of amphotericin B and vancomycin, on the left amphotericin B powder before adding PMMA to prepare static knee spacer

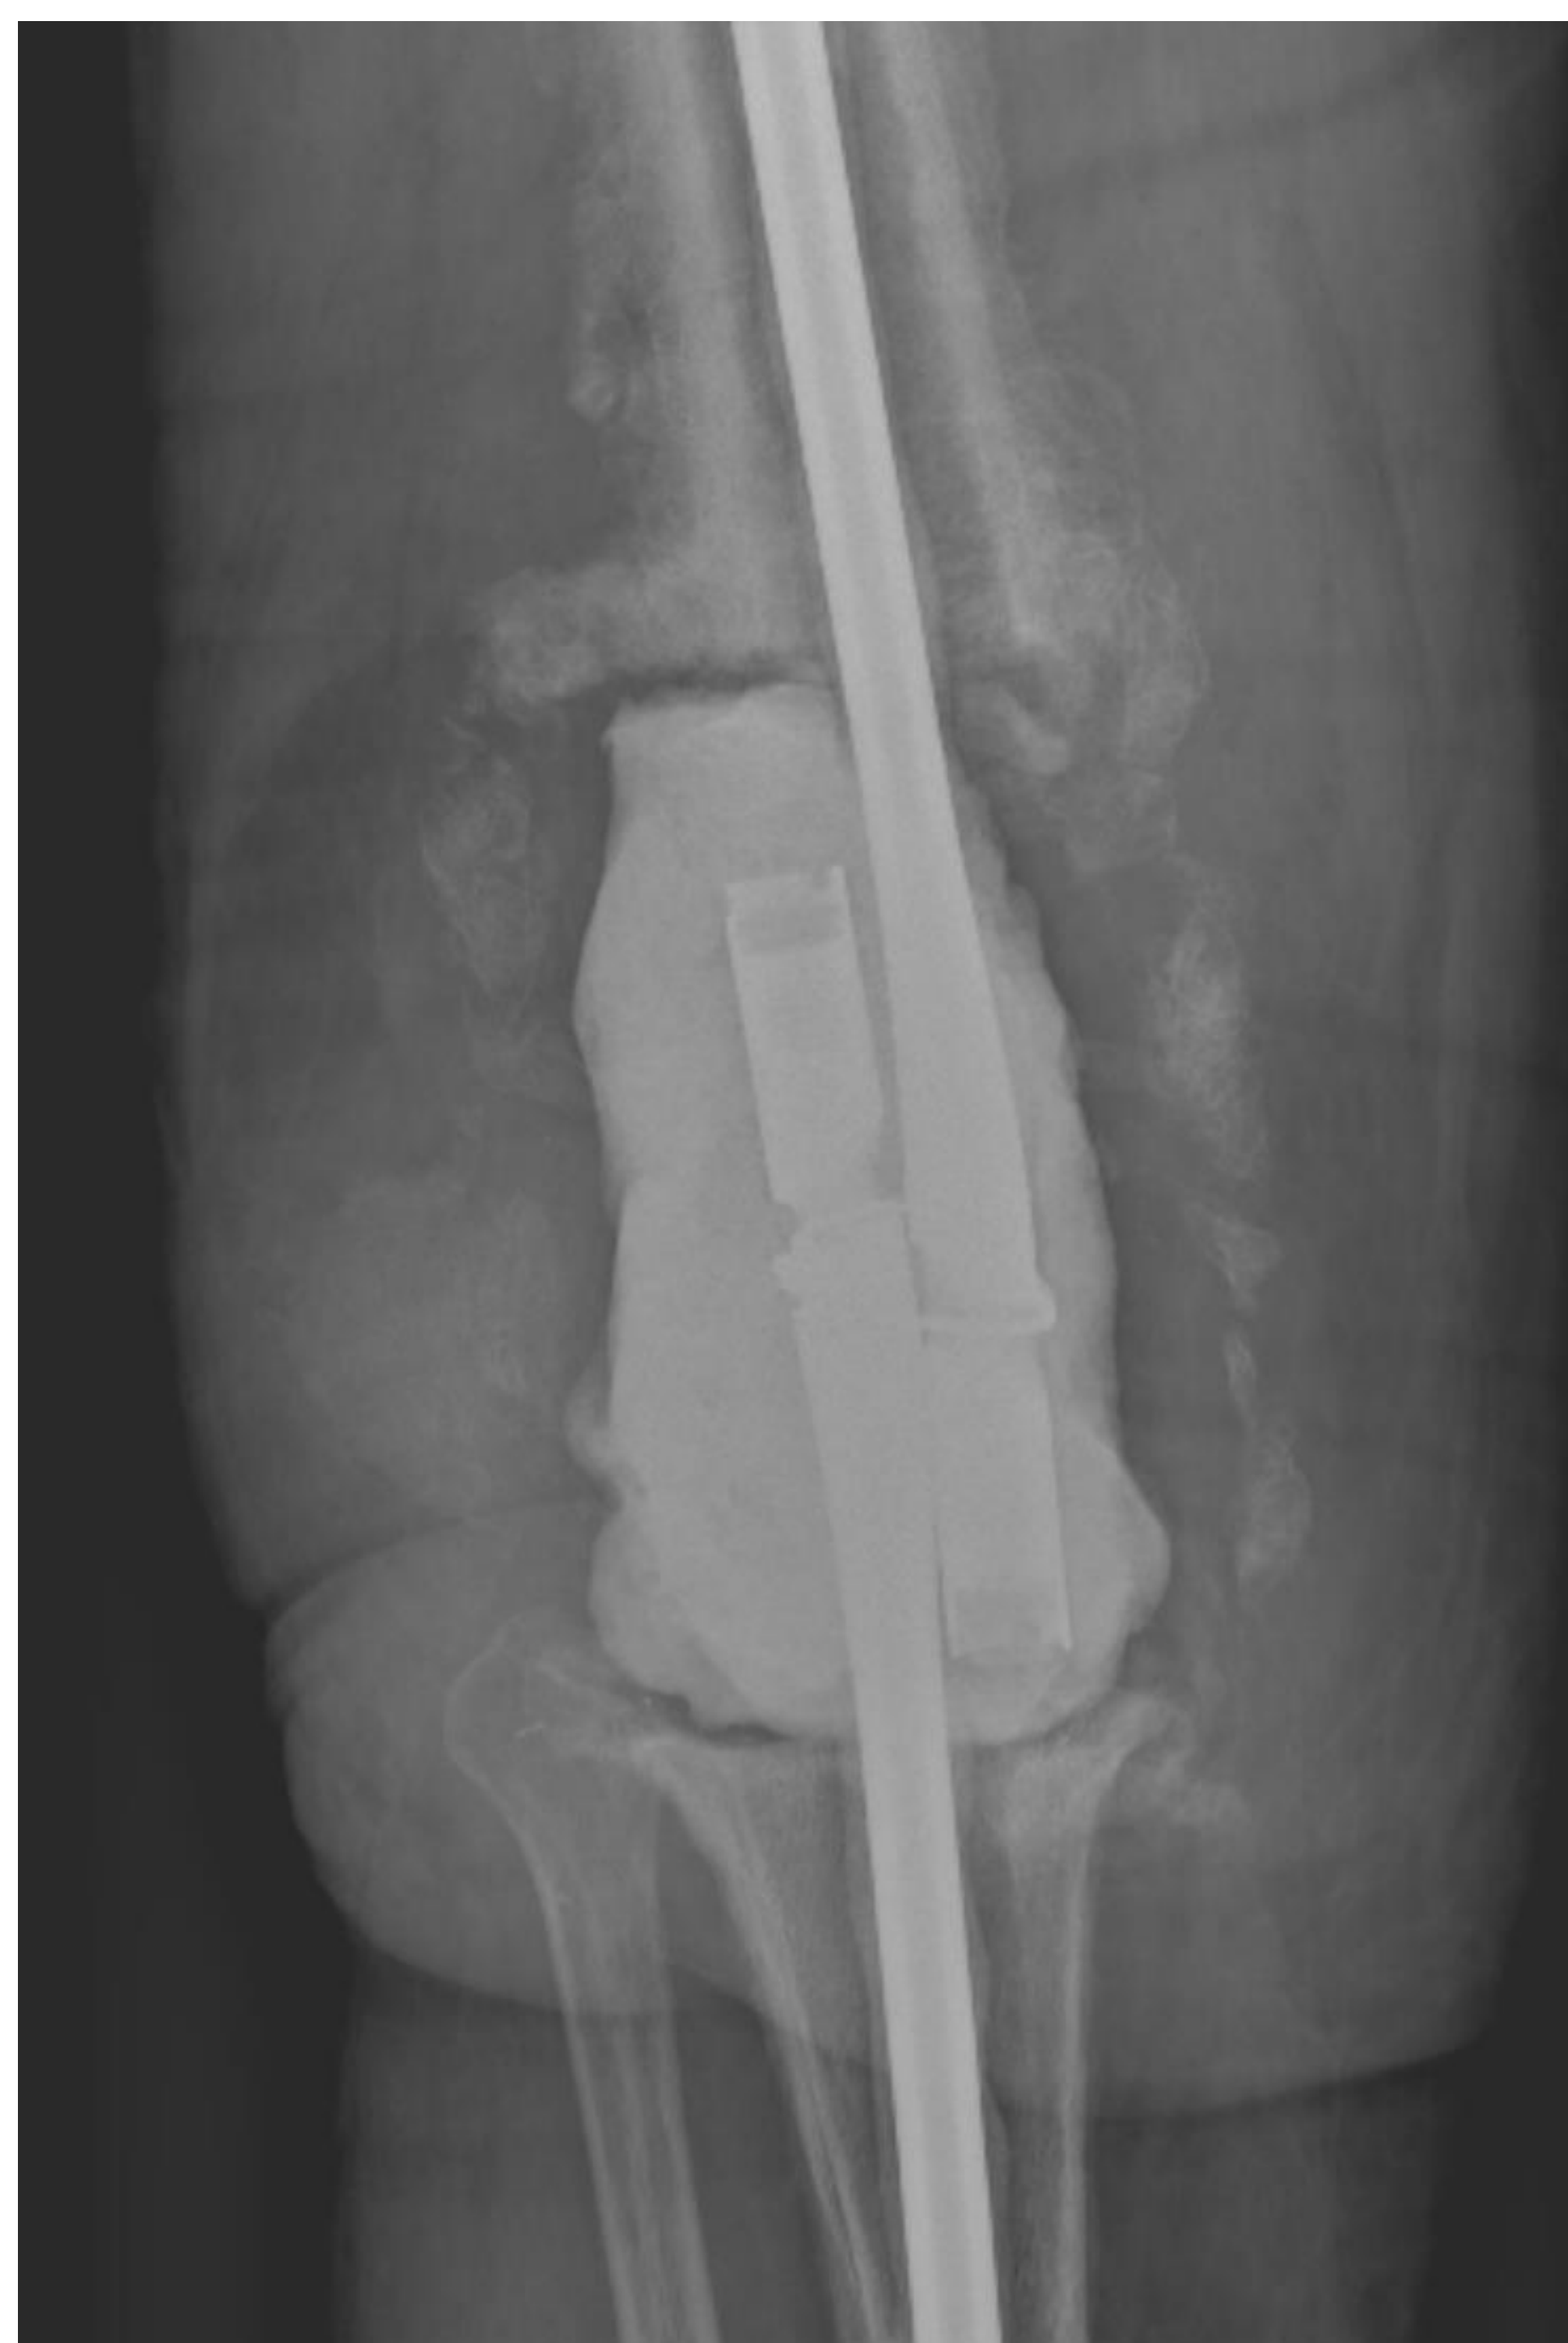
(Fig.2): AP view of static spacer in situ. Two nails connected with steel cables surrounded by PMMA block with addition of amphotericin B and vancomycin
