## MULTIPLE IMPLANT PLACEMENT ATTEMPT FAILURE DUE TO CANNABIS SMOKE INHALATION. A CASE STUDY

SOGOL H BIROON, DMD; MOHAMAD TAREK OMRAN, BDS, MSC; ROBERT L. BLACKWELL,  
DDS; KATHERINE HANSER, DMD

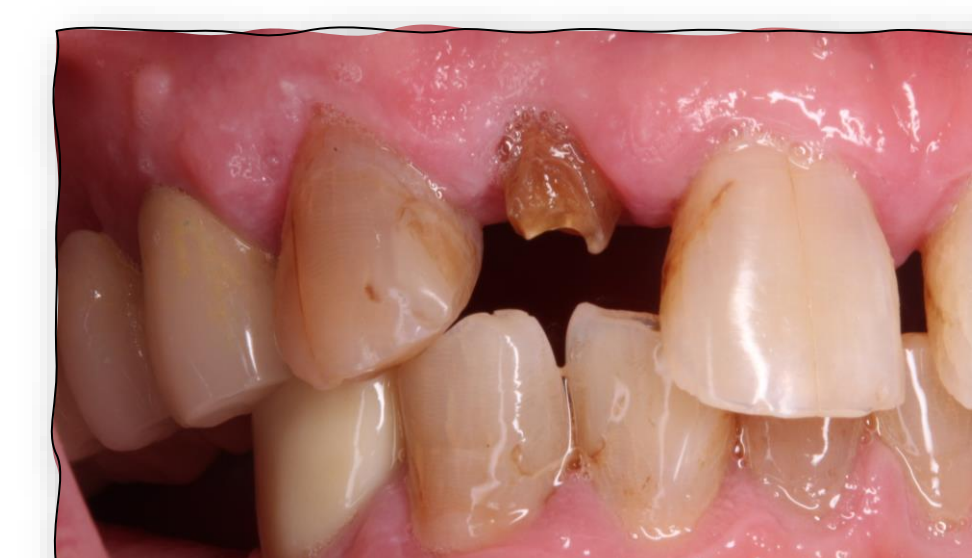
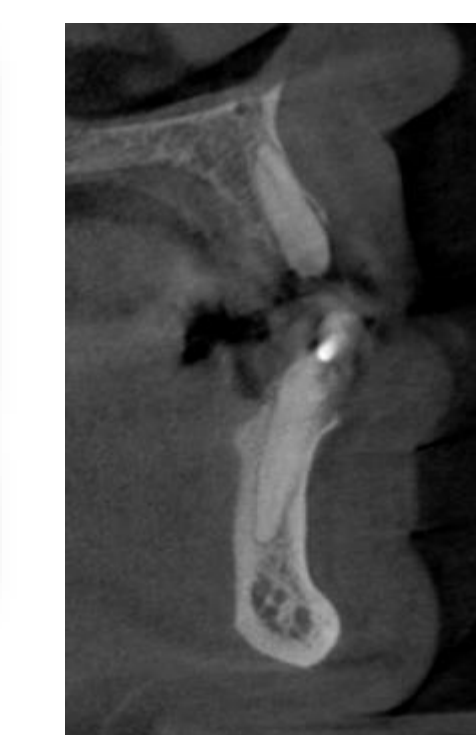
Pic 1

- **Case review:** A 64-year-old healthy male with a history of **smoking marijuana for the past 48 years** presented to clinic with the chief concern of non-restorable #7. (Pic 1,2). Patient did not inform the practitioner about his smoking habits.

- It was determined **that the extraction, immediate implant placement with immediate temporization** can be performed. Simple extraction of tooth #7 was done. Surgical protocol for the implant system followed and a 4.0/5.0 x 13 mm 12-degree Co-Axis implant was placed. A screw-retained temporary crown was fabricated and was placed out of occlusion. The patient was instructed to avoid pressure on the implant. ( Pic 3,4,5)

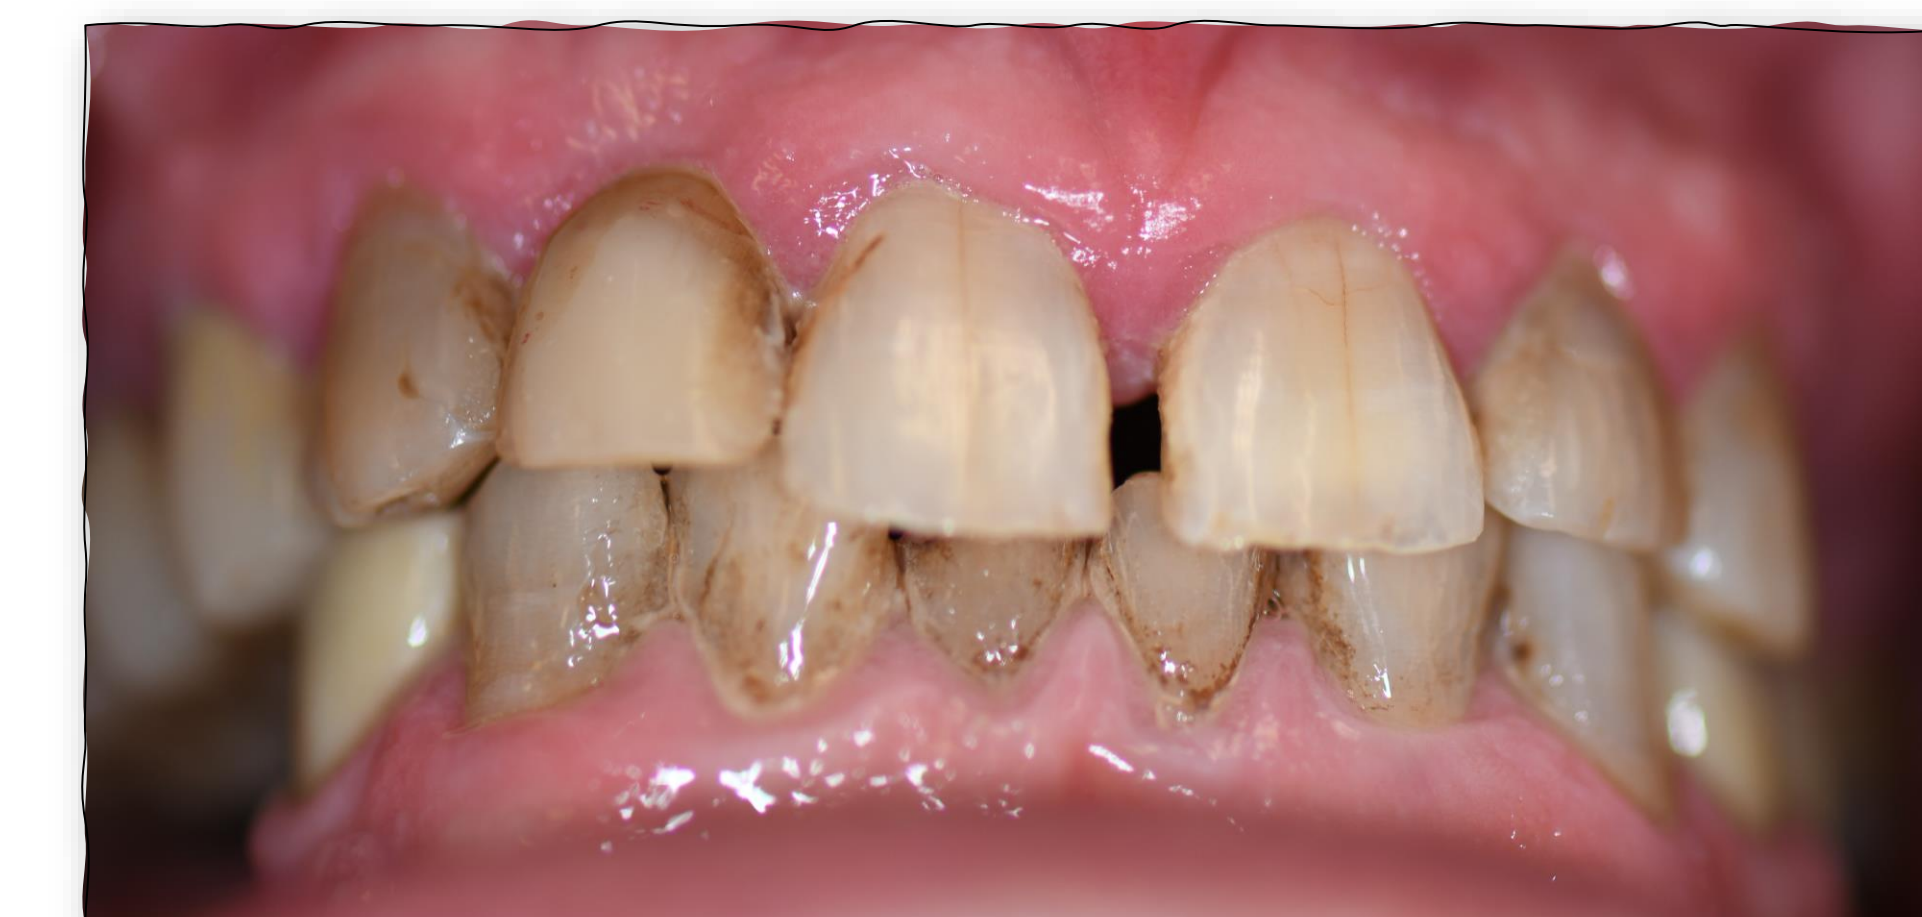
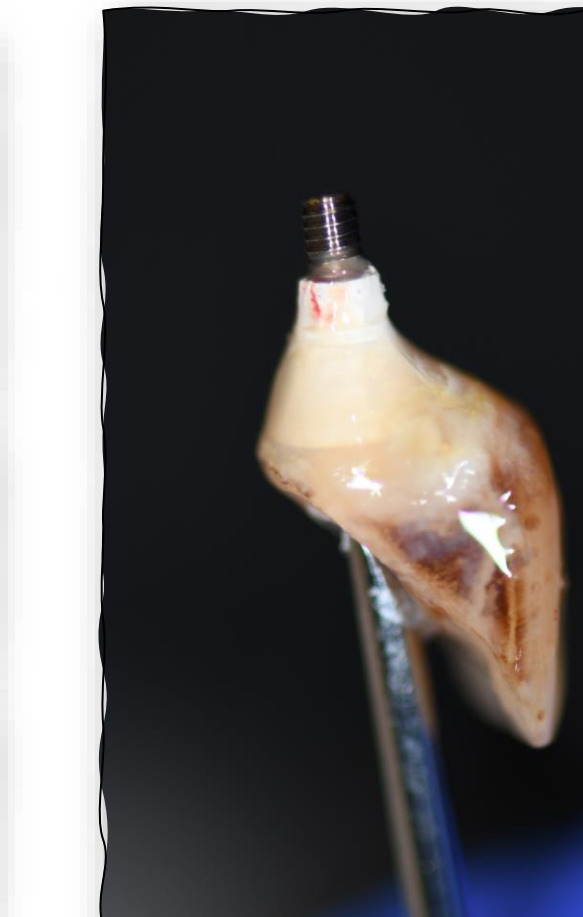
Pic 6

- **Five months later**, the patient presented with a loose temporary crown. Upon examination, it was noticed that the soft tissue around the implant is healthy, but the implant is rotating and has not integrated. CBCT showed no bone loss around the implant. Implant had failed and not integrated. ( Pic 6,7,8)

- ▶ The failed implant was removed. Socket curetted and irrigated. A 3.5/4.5 x 15 mm 12-degree Co-Axis implant was placed and more than 40 Ncm torque was achieved. (Pic 9). No temporary crown was delivered, and the implant was buried.

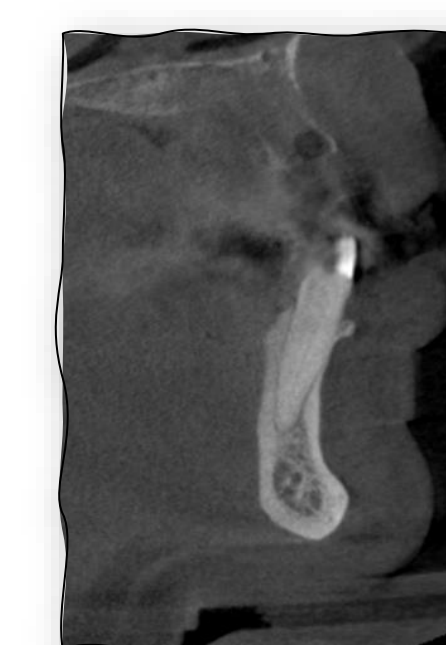
Pic 12

- ▶ The implant was removed, socket debrided, and filled with 1.0 cc of freeze-dried bone allograft and Enamel matrix derivative (Emdogain) and covered with collaplug. (Pic 12)
- ▶ A week later patient developed swelling in the site preservation area and was prescribed amoxicillin for the infection. (Pic 13)

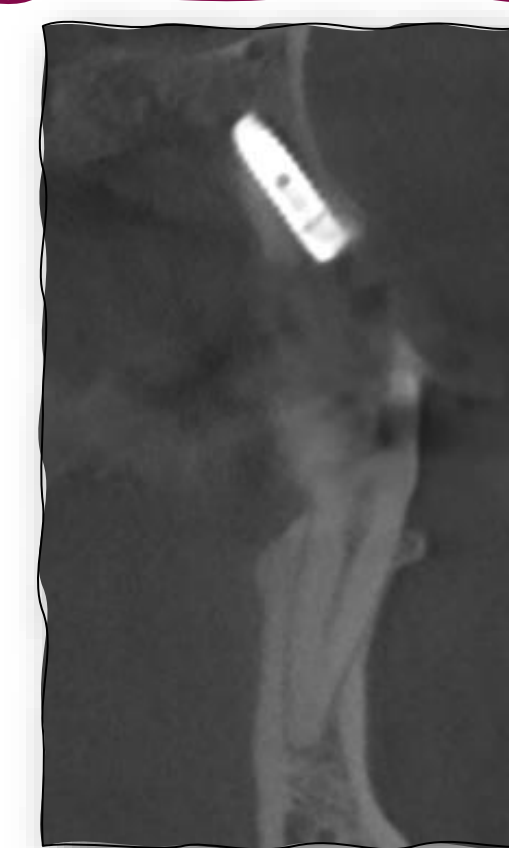
Pic 14

- **Seven months later**, a new 3.3 mm x 12mm implant from another system was placed and buried. (Pic 14,15) Uncovery was done 5 months later. 3<sup>rd</sup> implant was fully integrated with bone to implant level (Pic 16). The implant was temporized again to contour the gingival tissue around the implant.

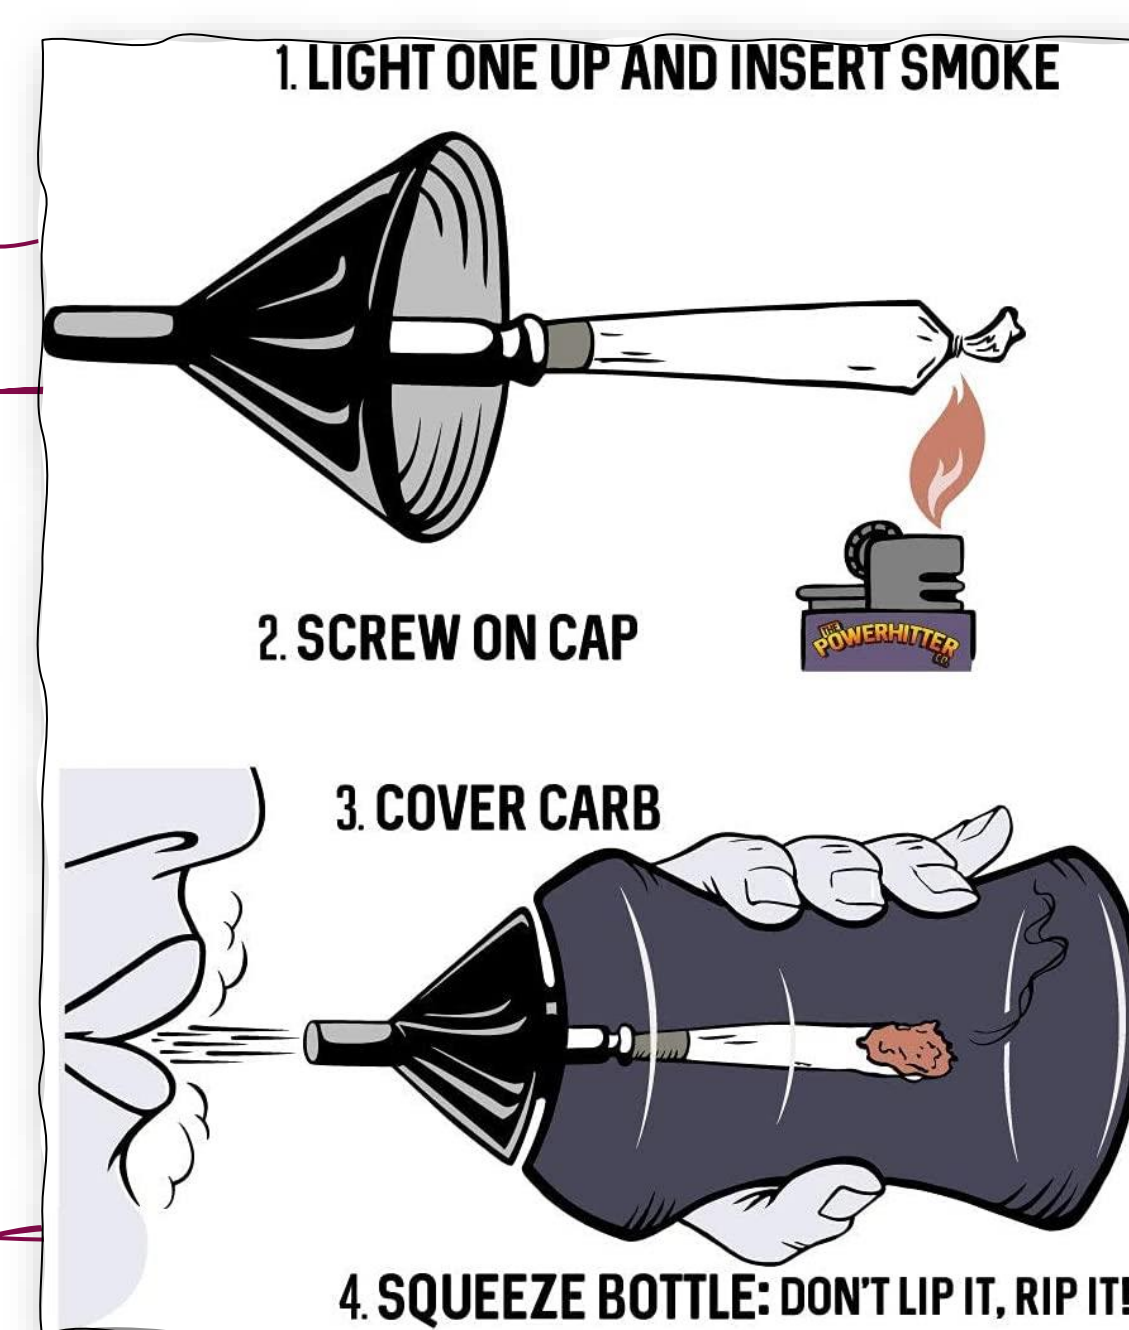
Pic 22

Patient reported that he is using a device (pic 22) to lead the smoke to his throat to avoid the direct smoke and heat touching the implant site which has seemed to help with initial integration of the implant.

- ▶ **Conclusion:** Vaping cannabis can be easily missed by dentists and patients in medical history questionnaire but still can have detrimental effects on implant osseointegration and healing.
- ▶ Two- stage implant placement is recommended when a patient has history of cannabis smoking.
- ▶ Long term prognosis of smoking cannabis is not widely studied, but potential negative effect of smoking on healing and the outcome of implant treatment has been well documented in research. (1)
