# National Autonomous University of Mexico

## Periodontics and Implantology Department

### A Complication and its Follow-up of a Maxillary Sinus Lift Procedure and Simultaneous Placement of an Implant. A Case Report.

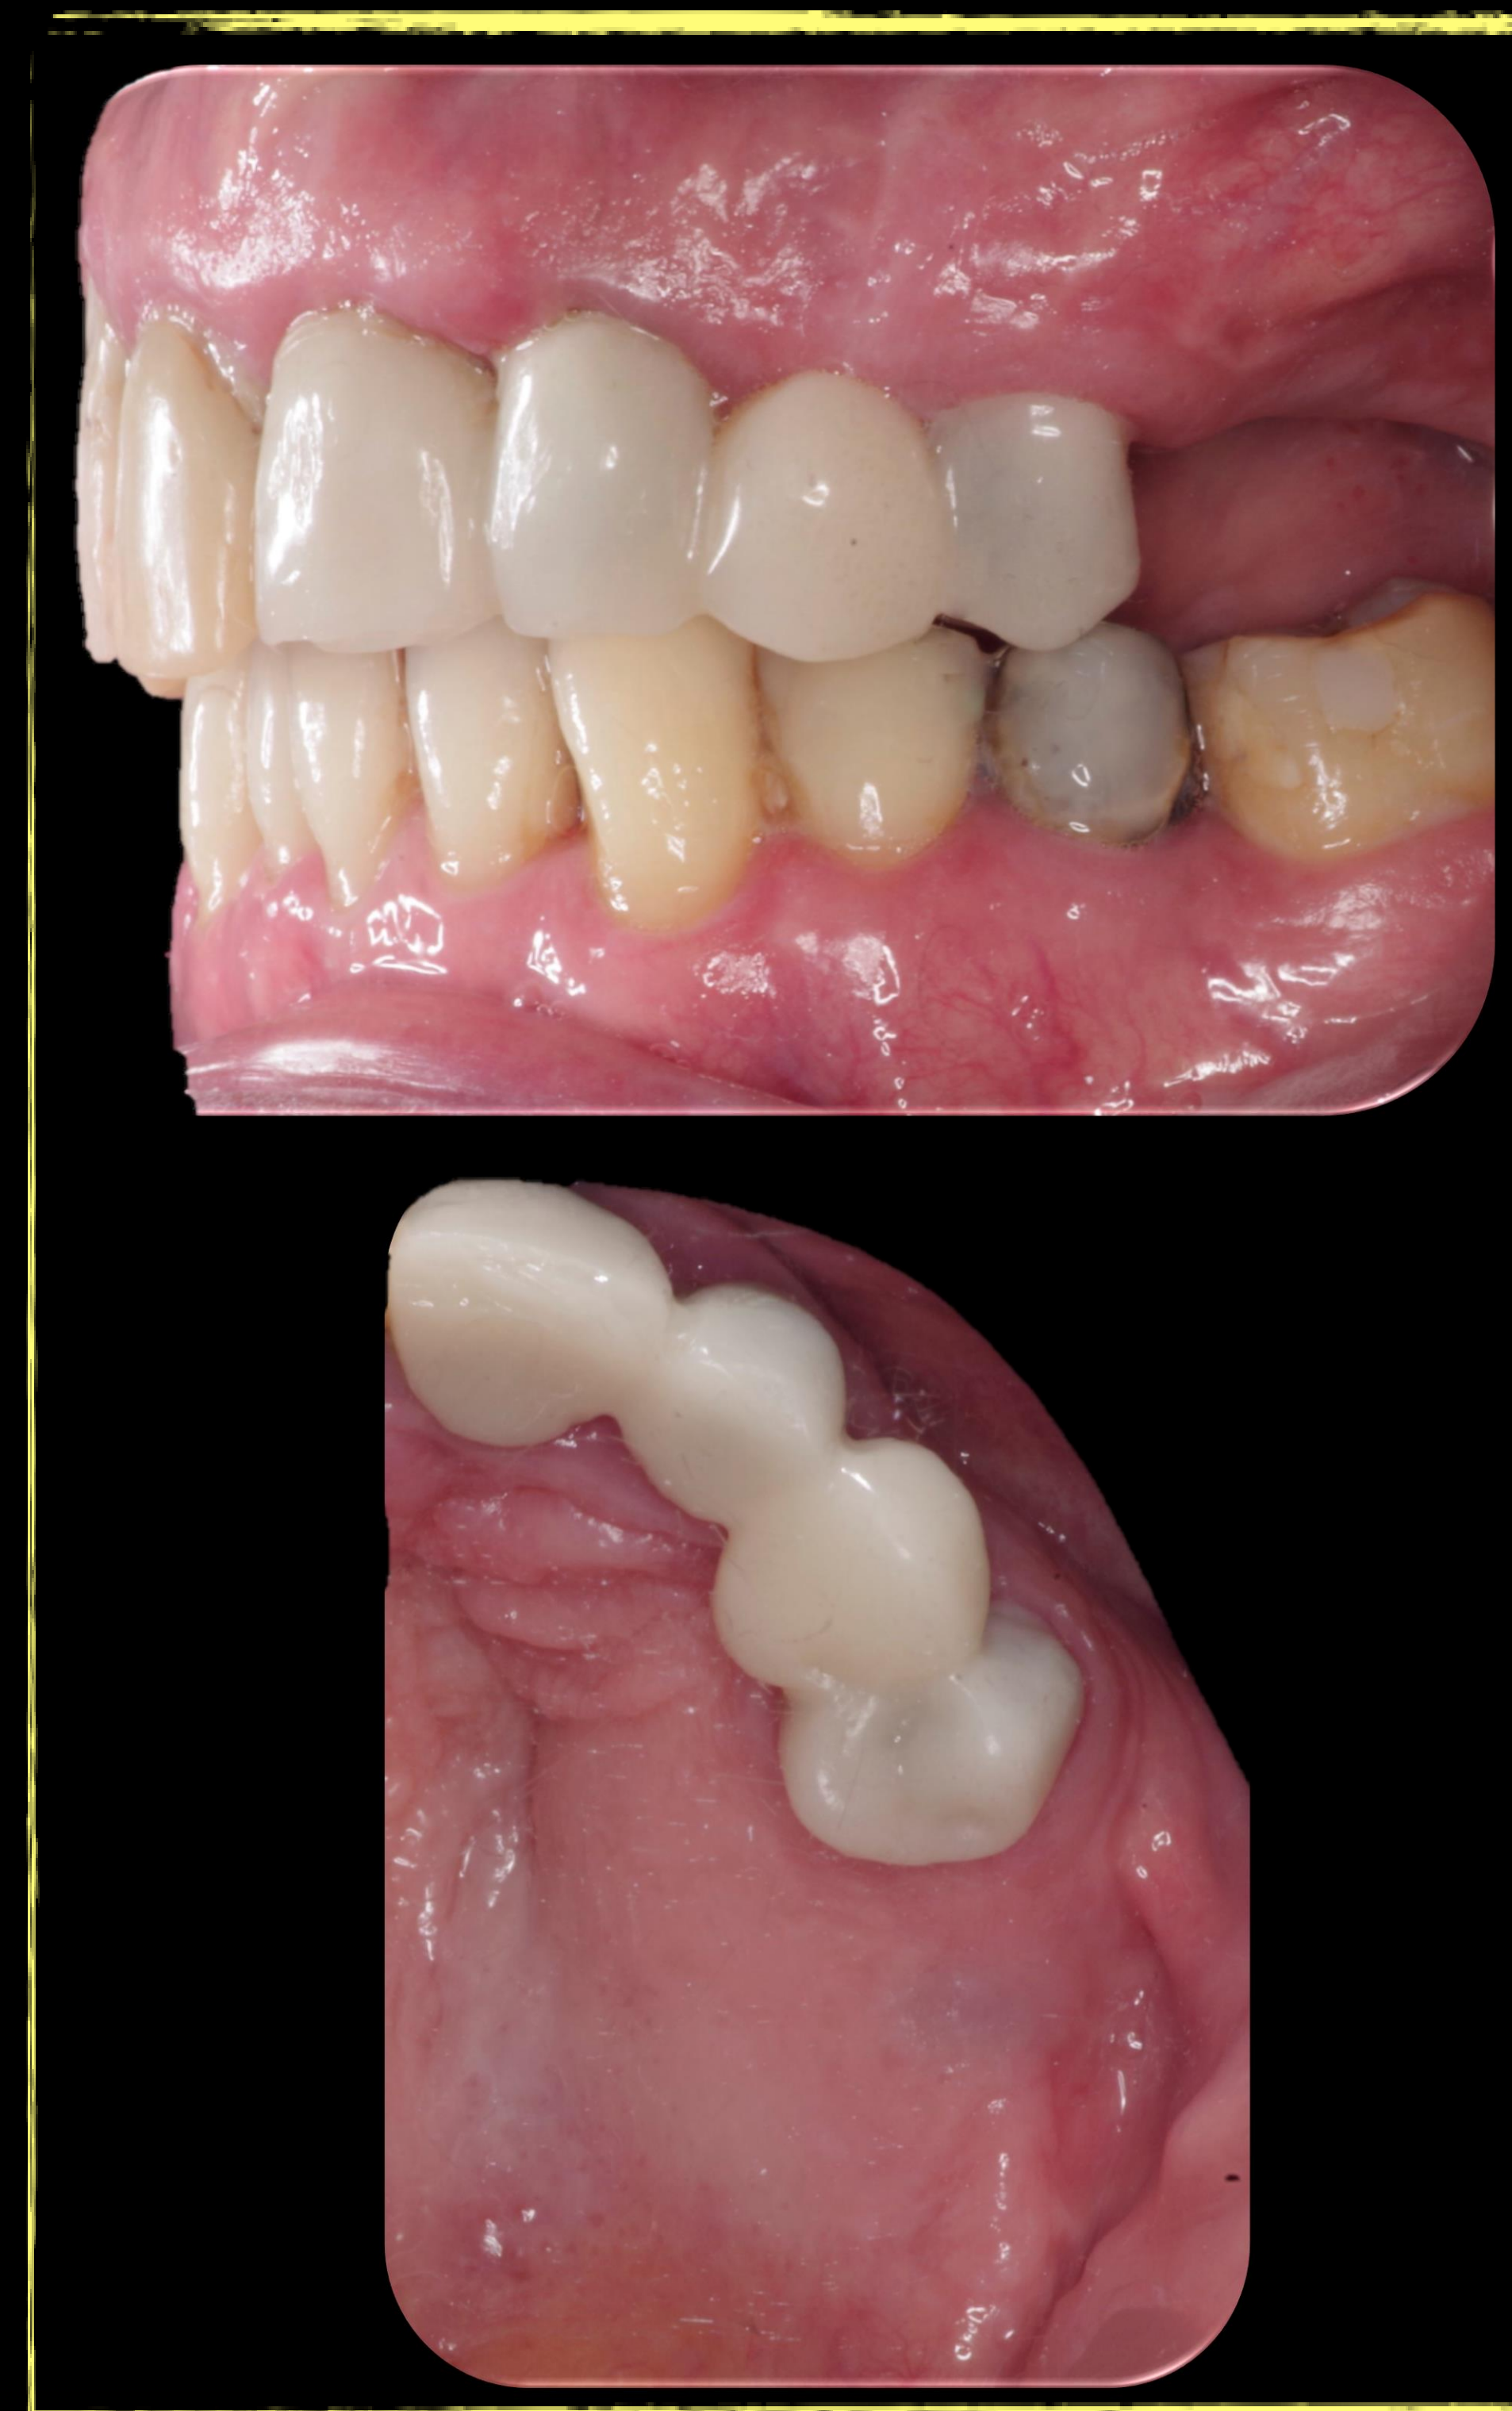
Fig 3. Initial clinical presentation.

A 65-year-old female patient applied to the periodontics clinic with a chief concern of dental absences.

**Oral examination** Unilateral edentulism of left maxillary molars.

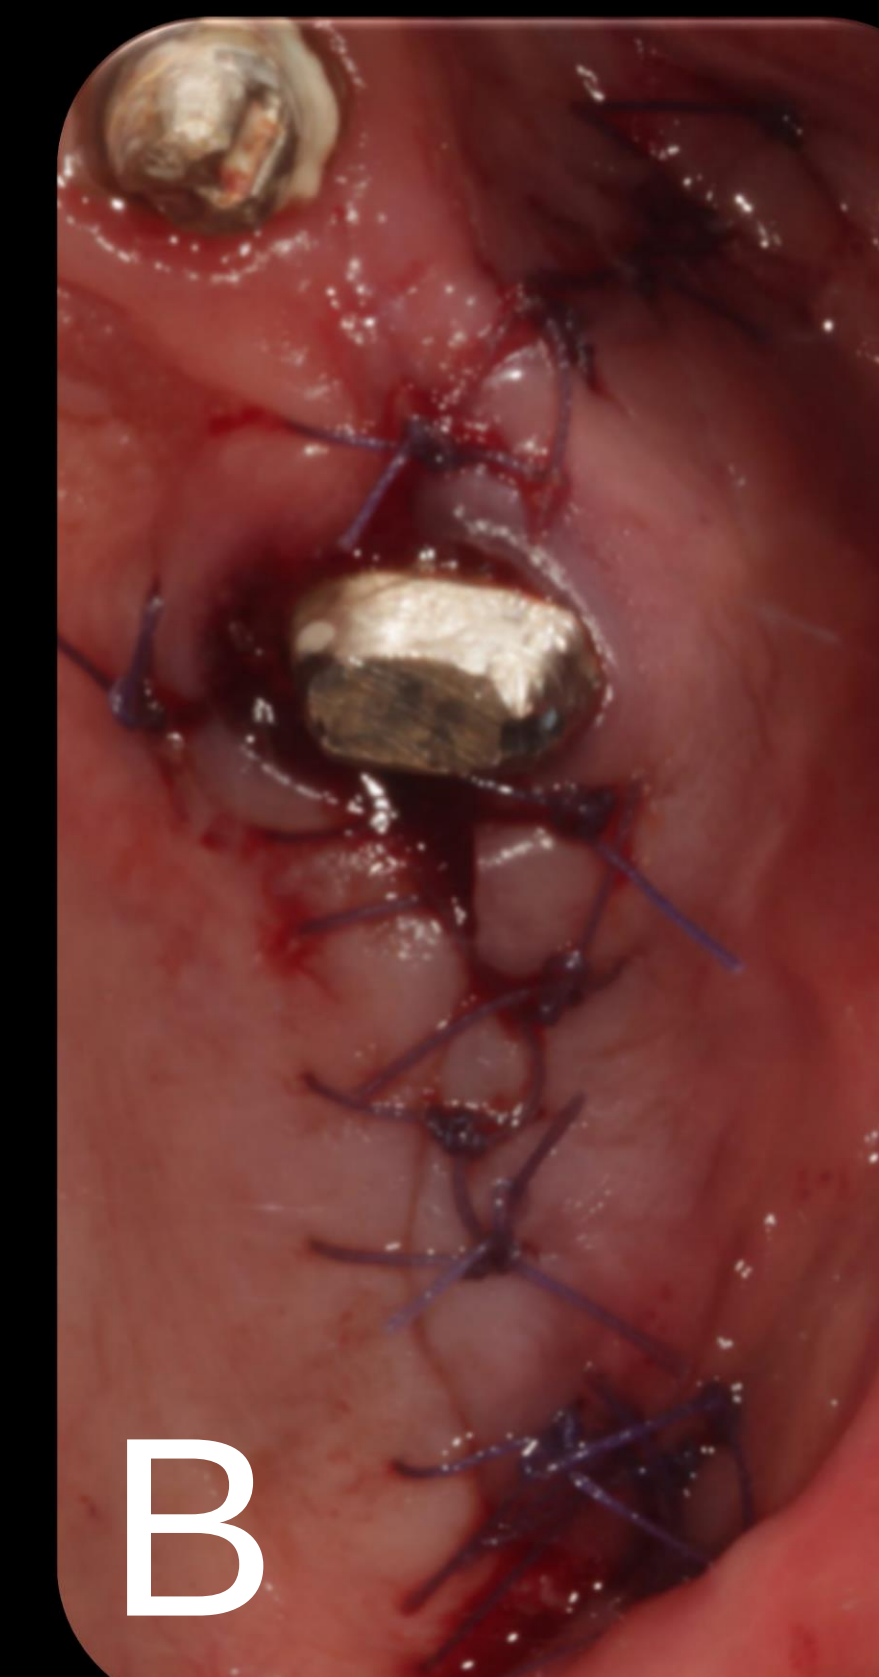
**Figure 6.** A, Surgical guide; B, Immediate post-operative.

A Straumann 4.1\* 12 mm implant was placed with a insertion torque of 25 Ncm, 1.5 g of allograft was grafted. A collagen membrane was placed and the flap was sutured with interrupted sutures.

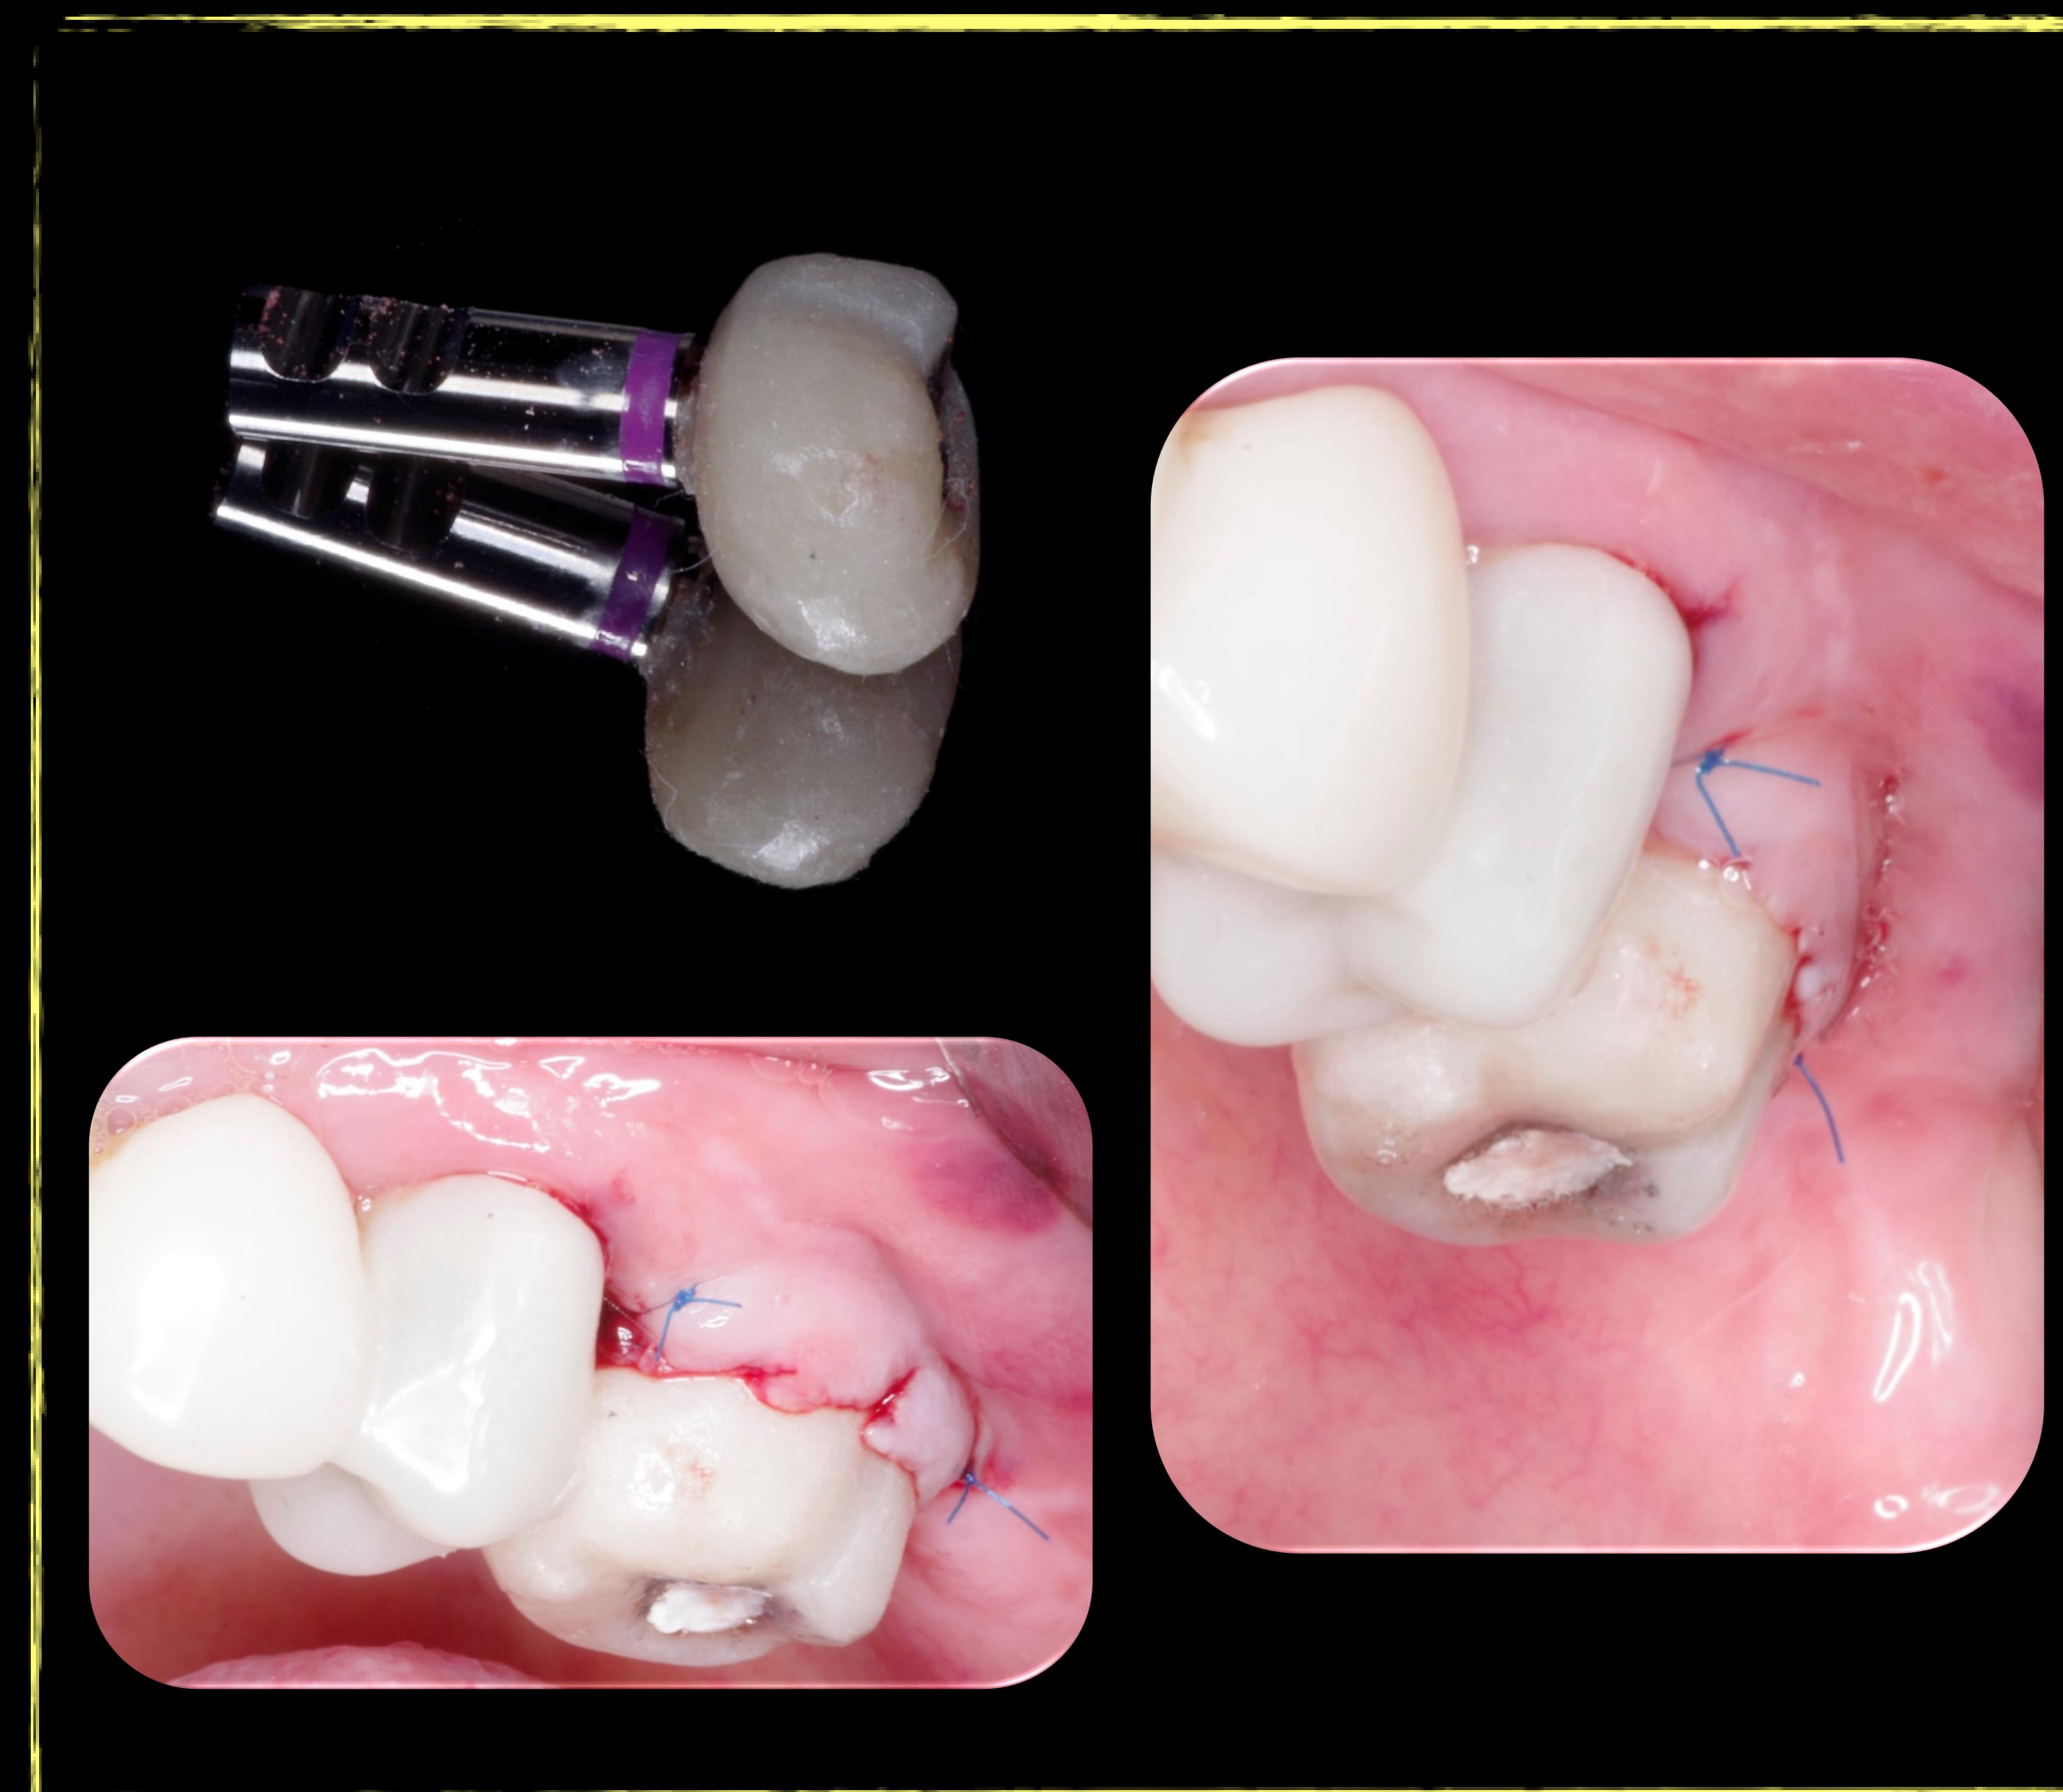
Fig 10. Immediate interim restoration

**Clinical findings** There is no presence of any symptoms such as pain, infection or supuration.
