# Re-tapping the Internal Threads of Dental Implants After Fractured Screw Removal: A Case Report

Hui Ling Cheah, Mohamed R. Mahmoud, Mohammed K. Baig, Hans Malmström  
*Department of General Dentistry, Eastman Institute for Oral Health, University of Rochester, NY*

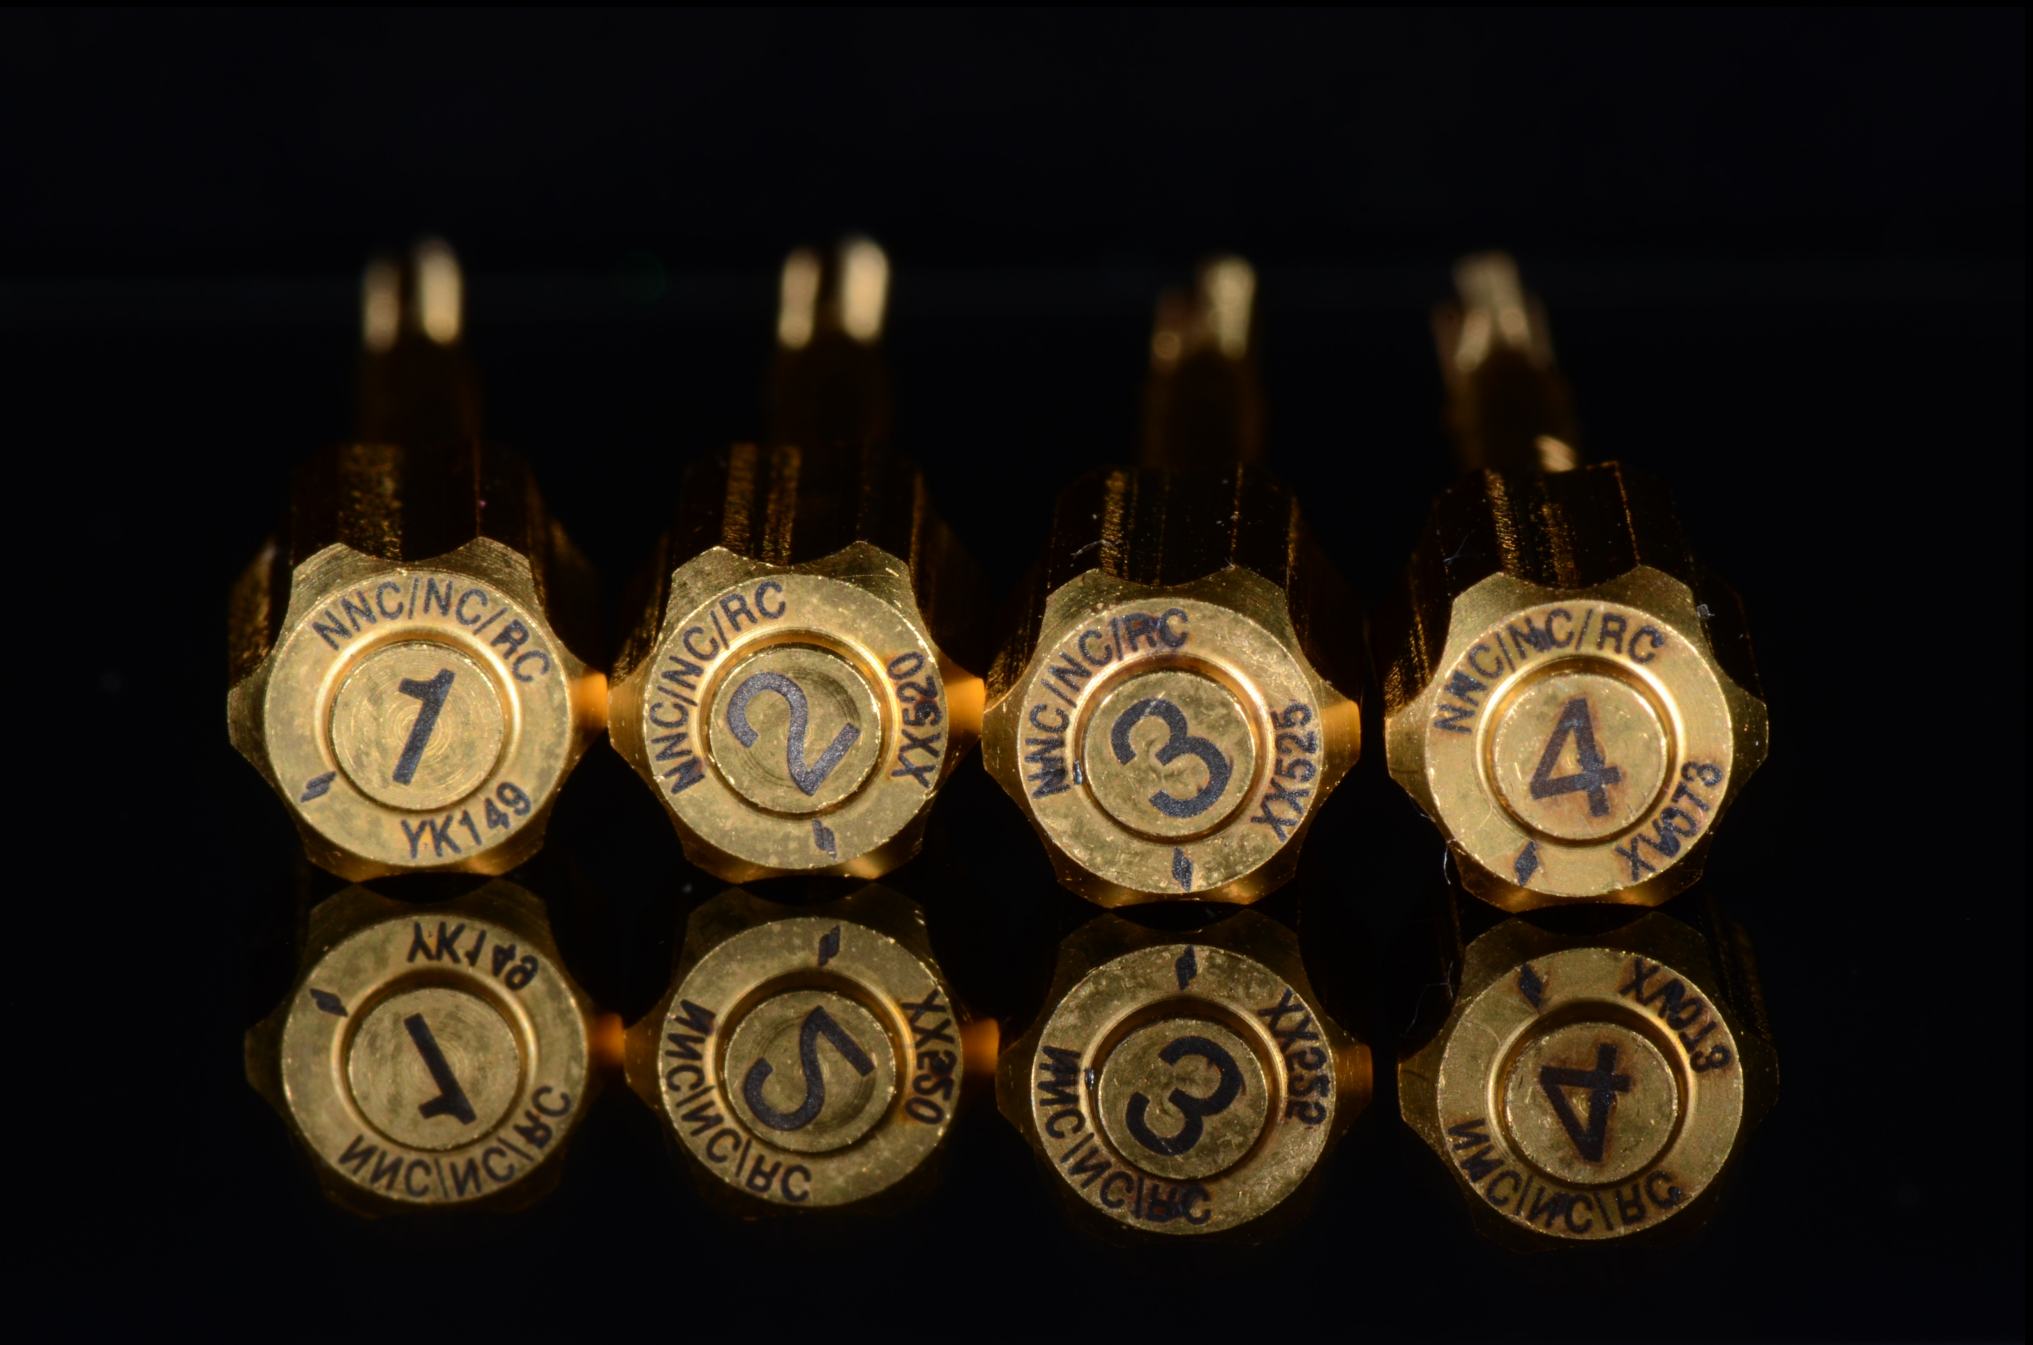
Figure 3: Dental implant tapping tools.

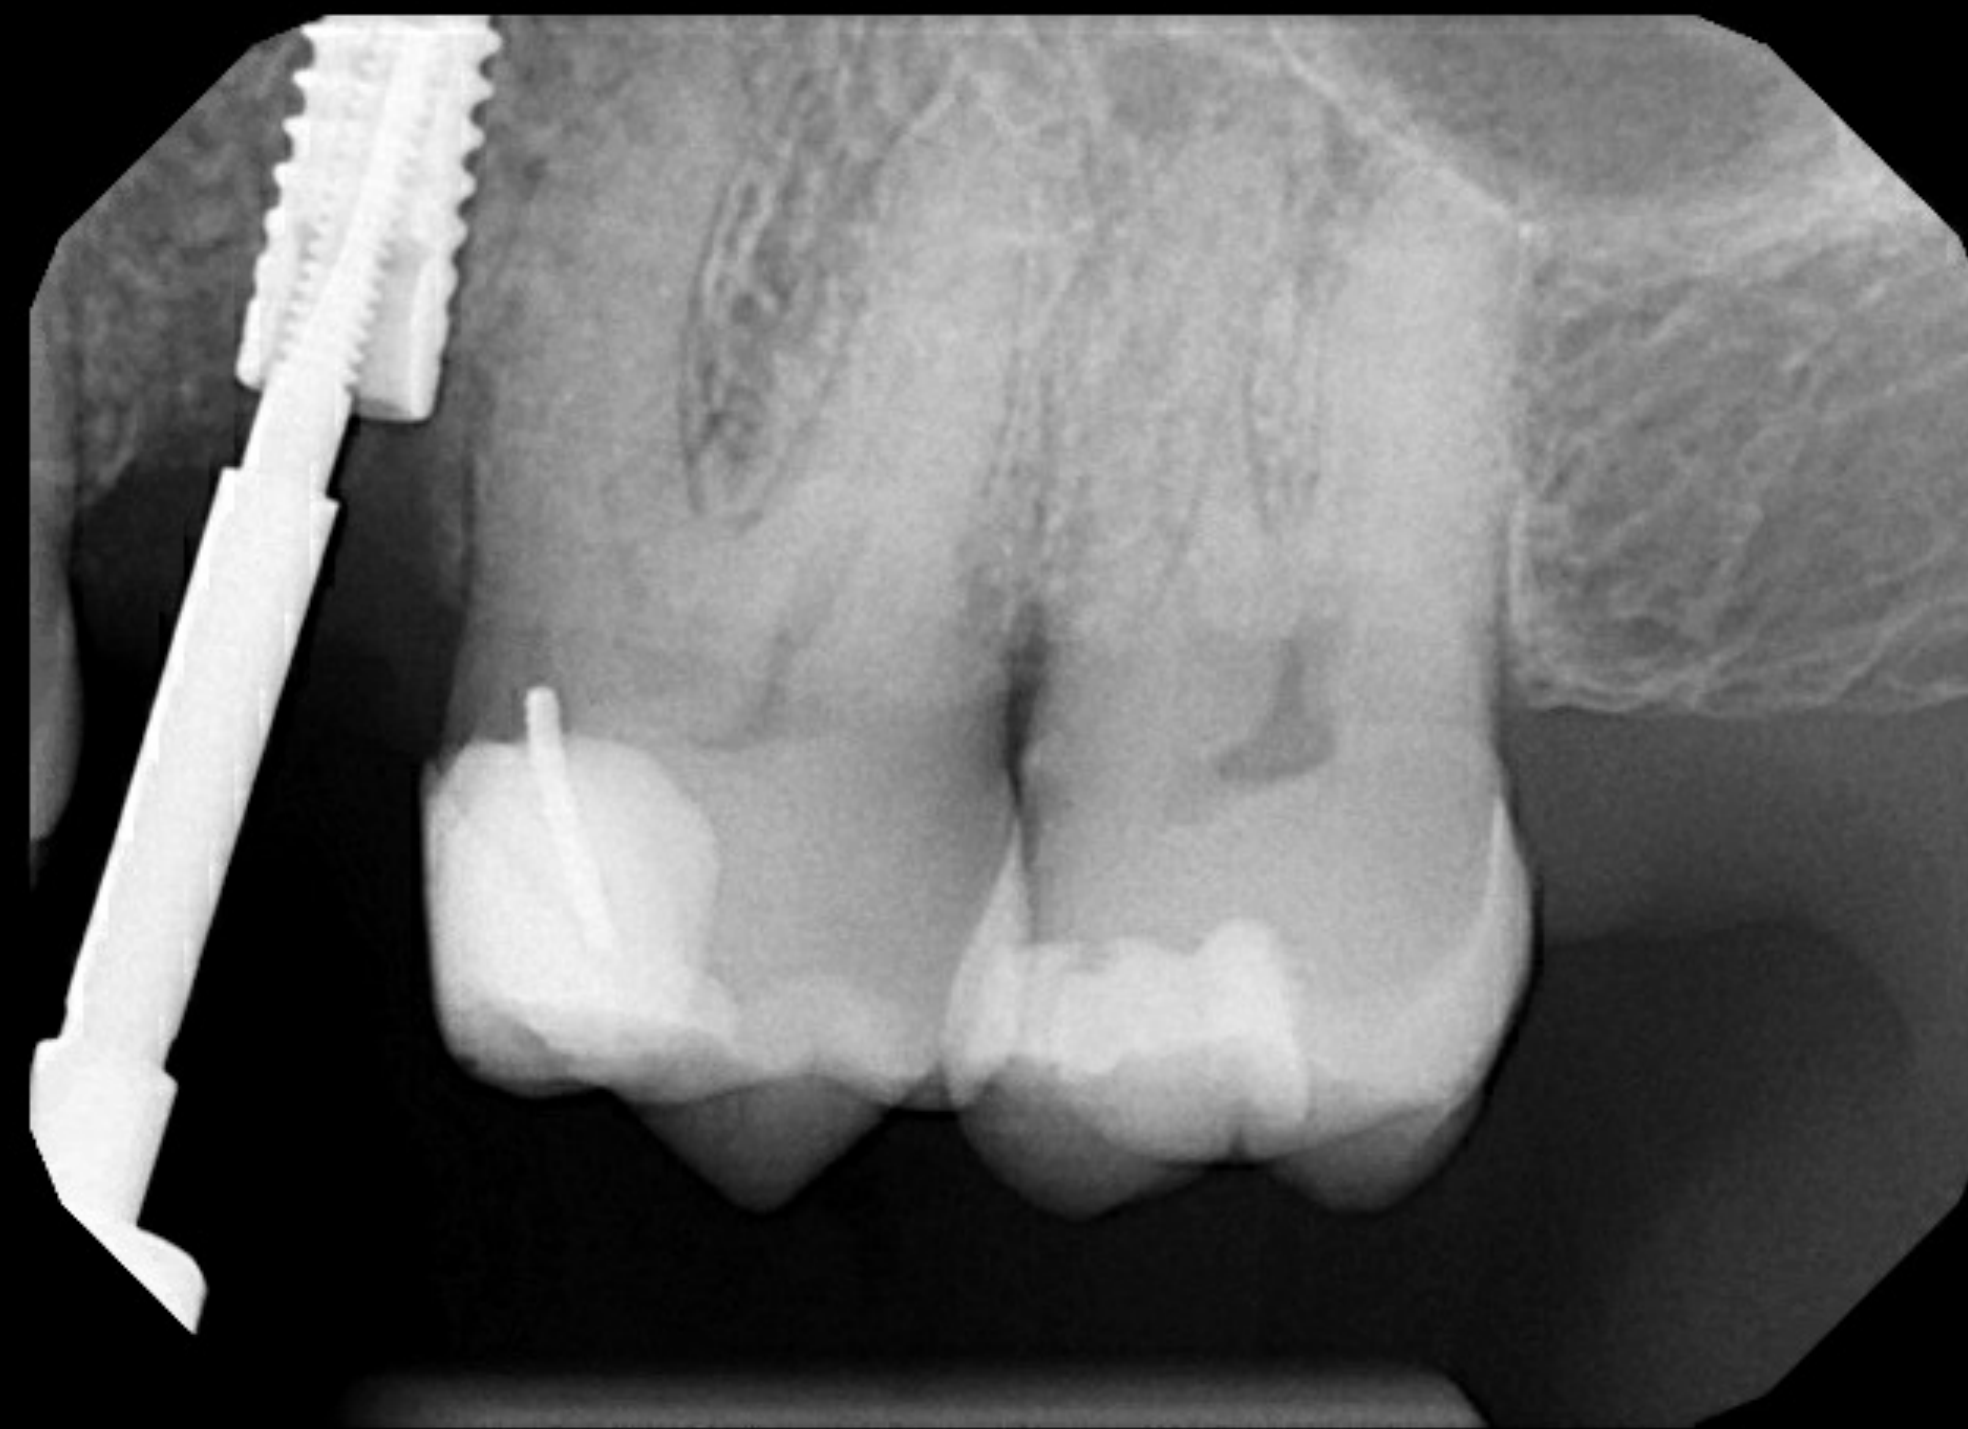
- This action was continued until the tap reach the resistance (*Figure 5*).
- The residues were irrigated with saline in the internal connection of the implant after every tap was used .
- The internal implant threads were checked by fitting a temporary abutment (*Figure 6*).
- Digital impression was taken by using a scan body and the intraoral scanner (*Figure 7*). STL file was sent to the laboratory for screw-retained zirconia crown fabrication (*Figure 8*).
- The final implant crown was made with a broad contact area to prevent any rotation force and occlusion was checked and adjusted.

Figure 5: Re-tapping the internal threads of dental implants .

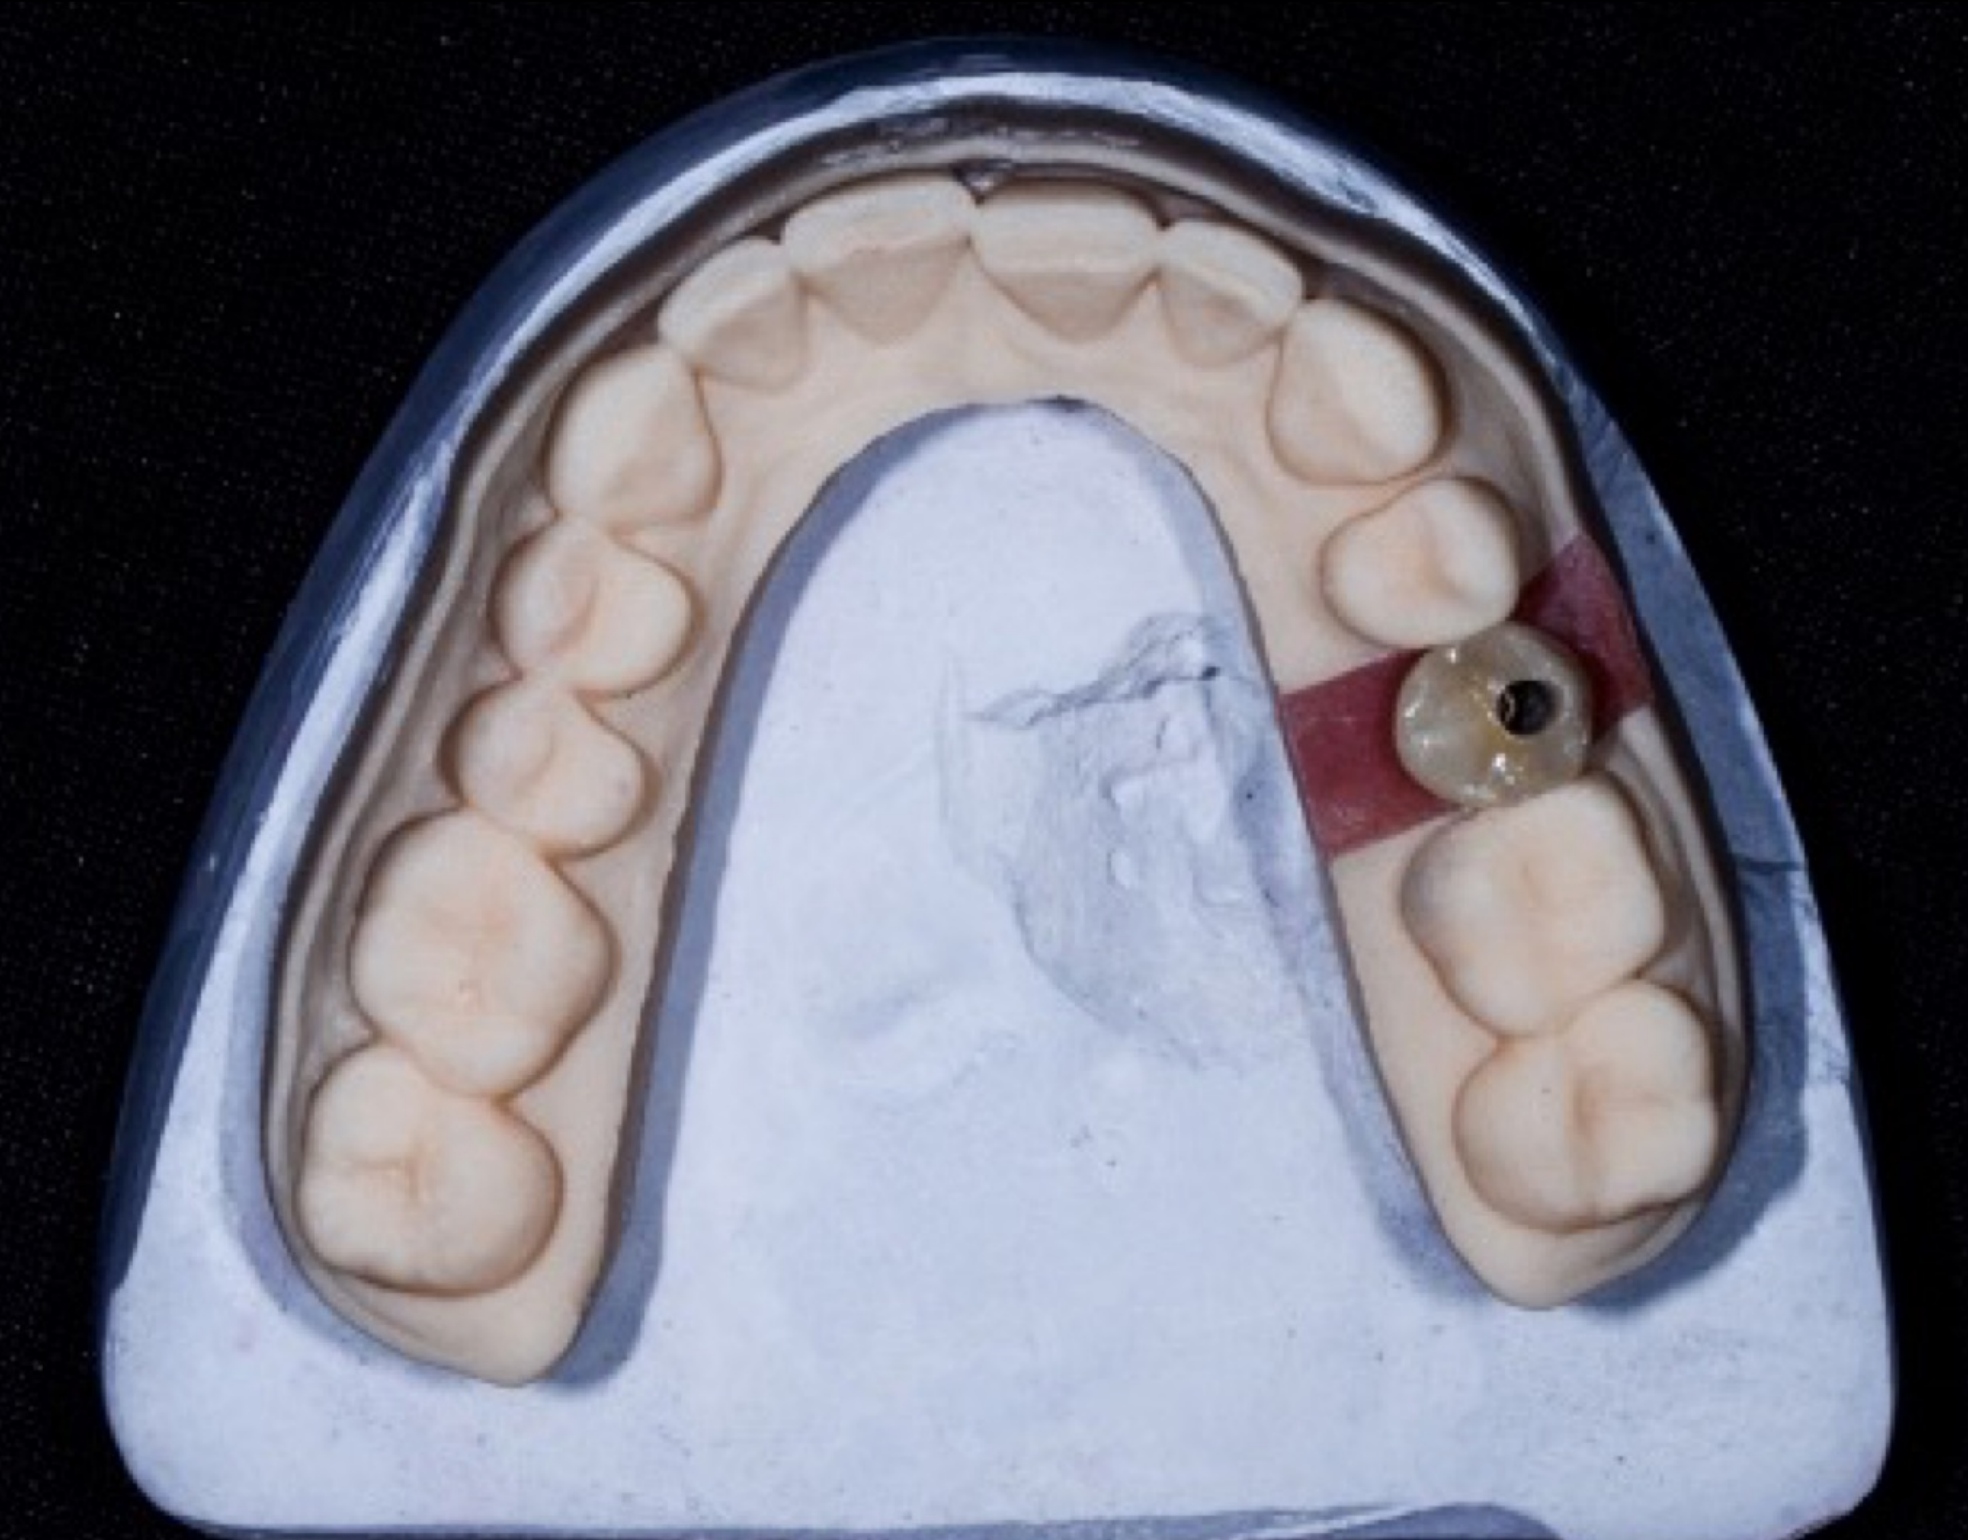
Figure 8: Screw-retained zirconia crown

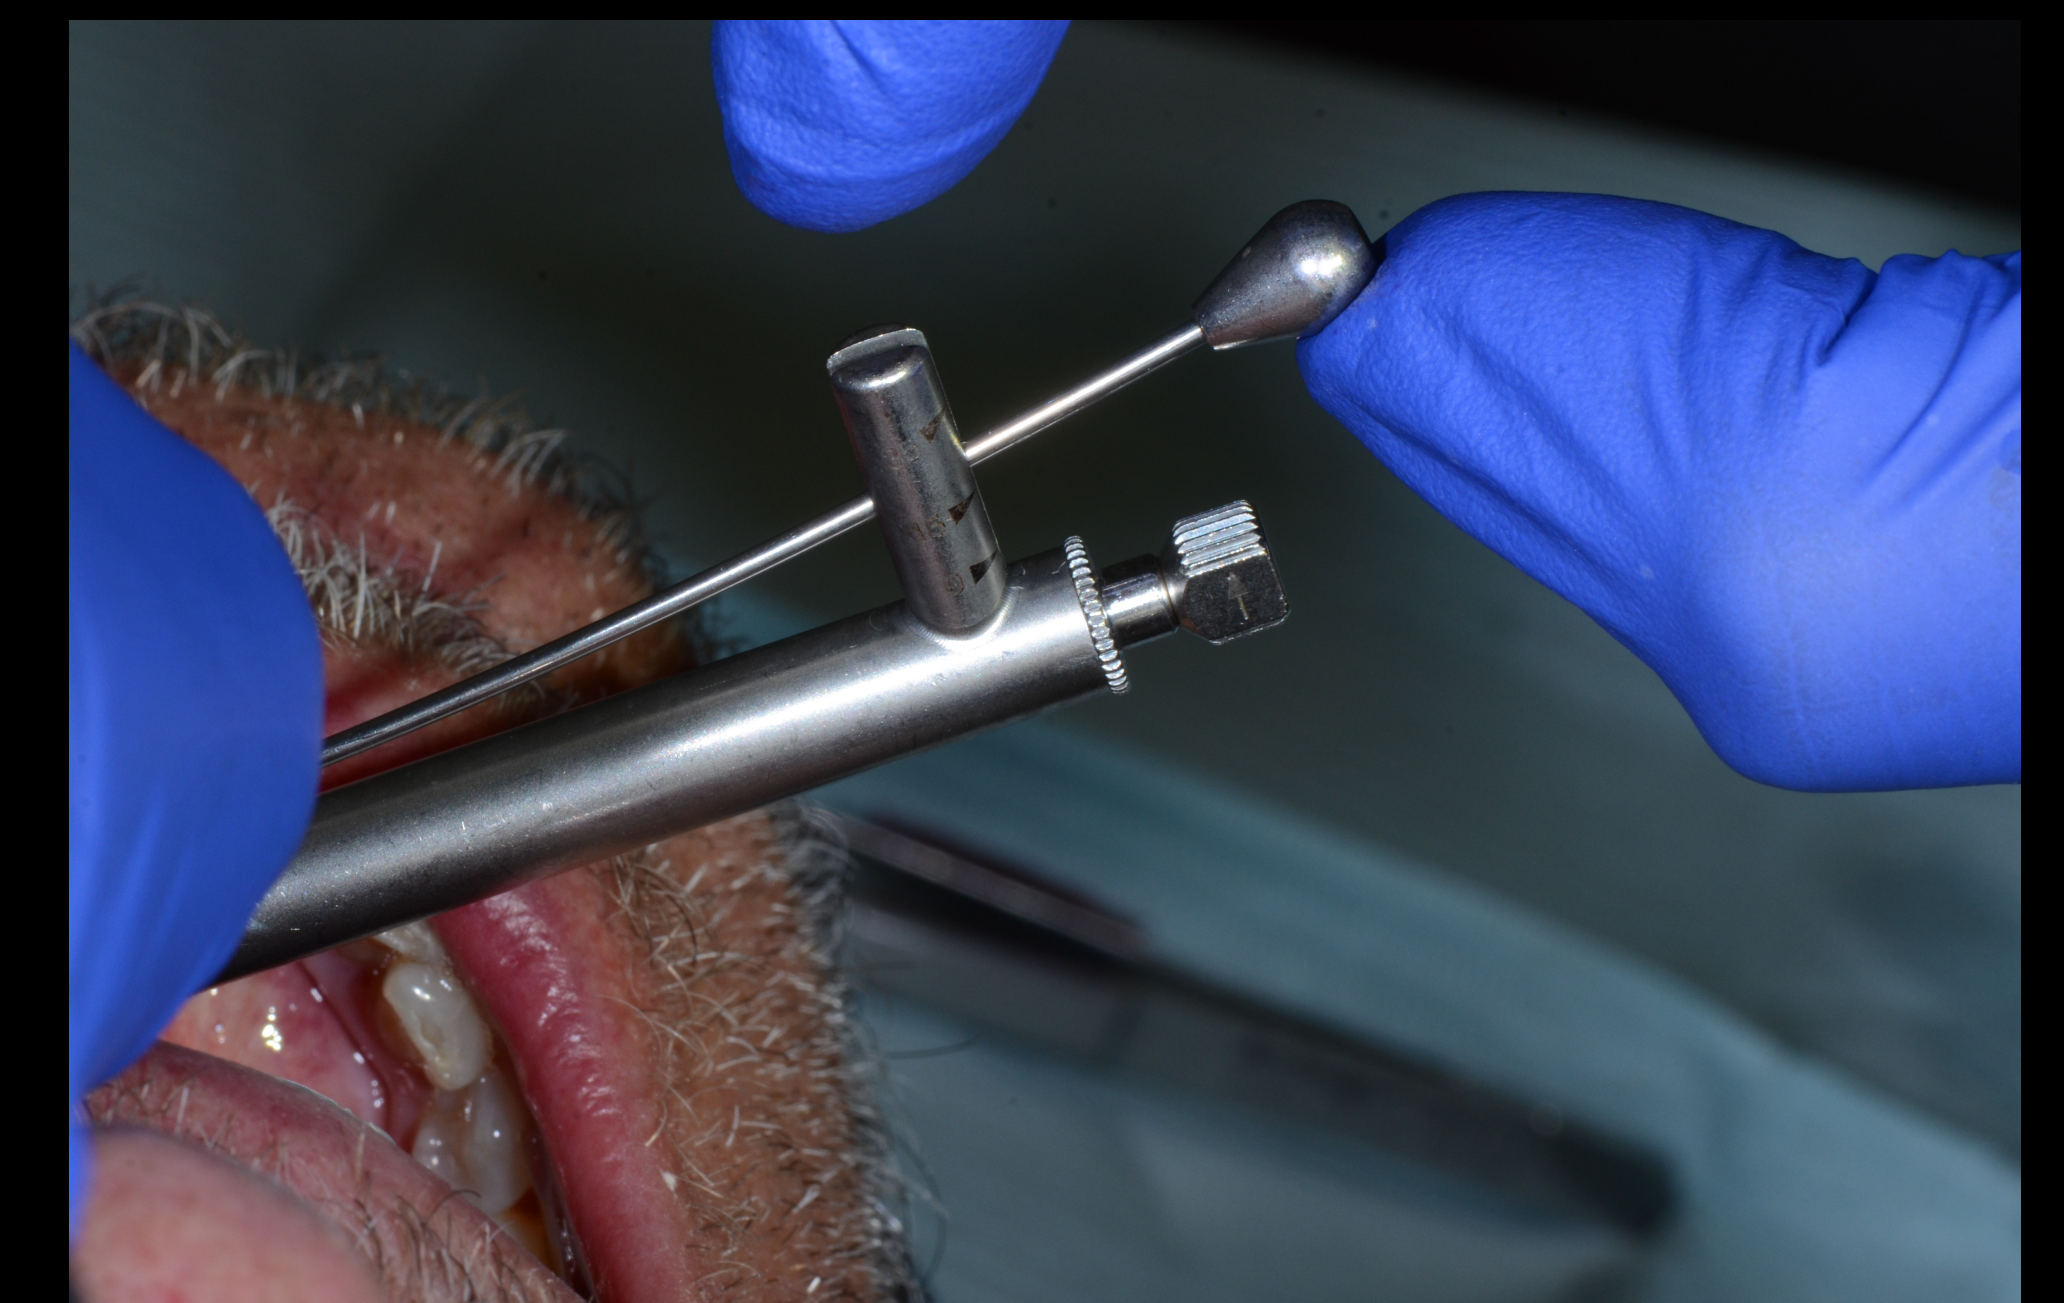
Figure 9: The prosthetic screw was torqued with torque wrench

The temporary abutment was seated fully without any marginal gap. The final implant crown was torqued to 25Ncm with no marginal gap detected both clinically and radiographically at the time of crown delivery (*Figure 9 and 10*). After 3 months of follow up, no marginal gap, bone loss, or prosthetic complications were detected clinically and radiographically (*Figure 11*).

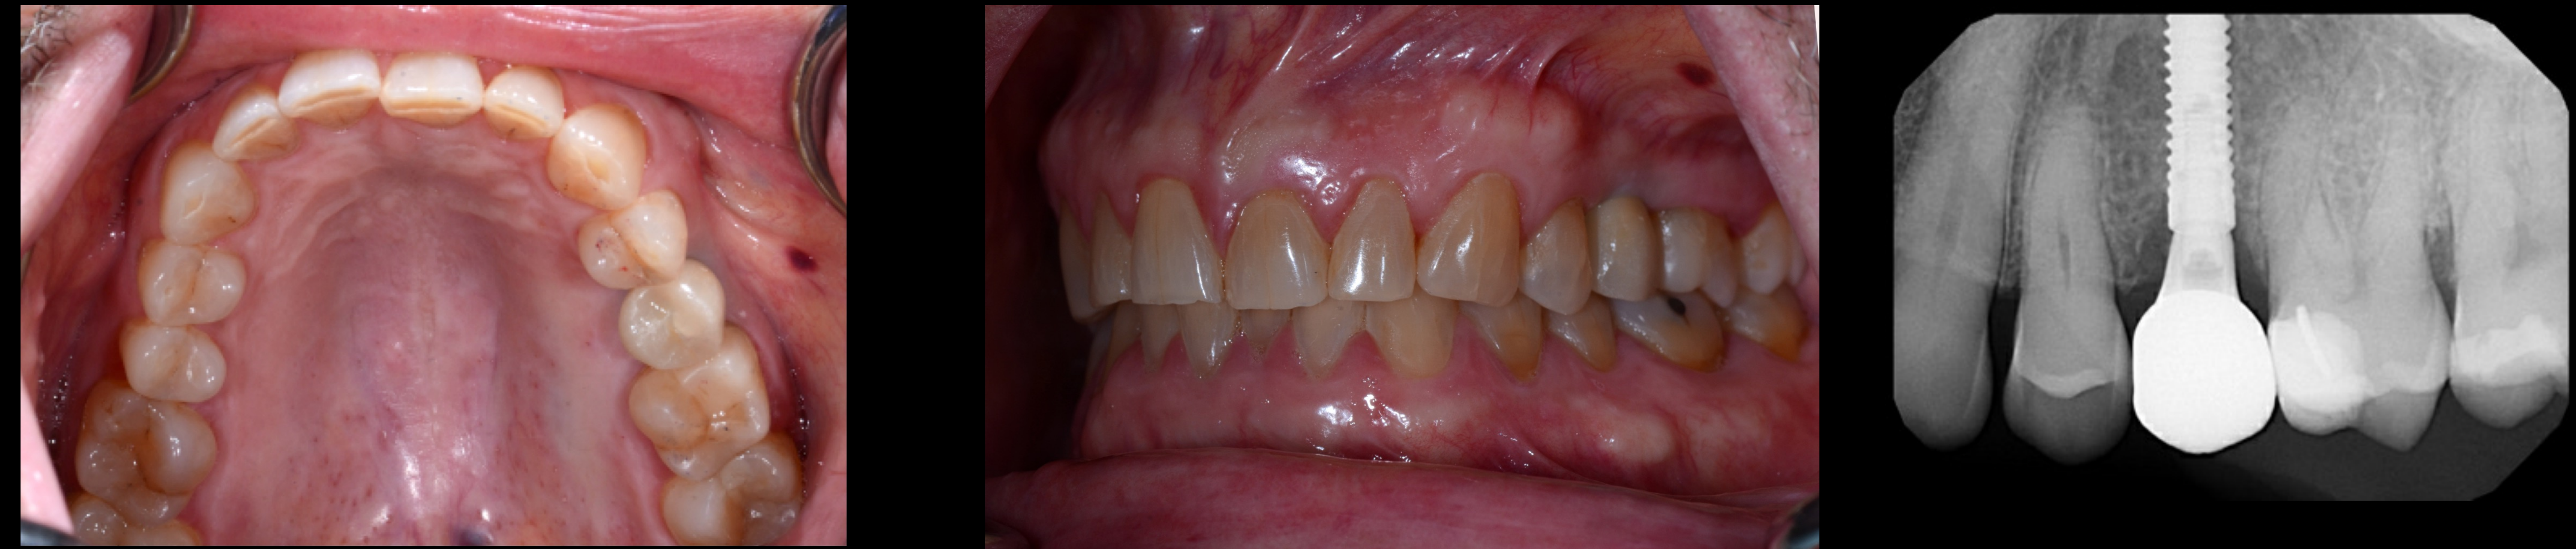
Figure 10: Clinical photos and radiograph after implant crown delivery.
