# Managing Broken Implant Supported Metal-Acrylic Full Arch Hybrid Prosthesis: A Case Report

Department of General Dentistry, Eastman Institute for Oral Health, University of Rochester, NY

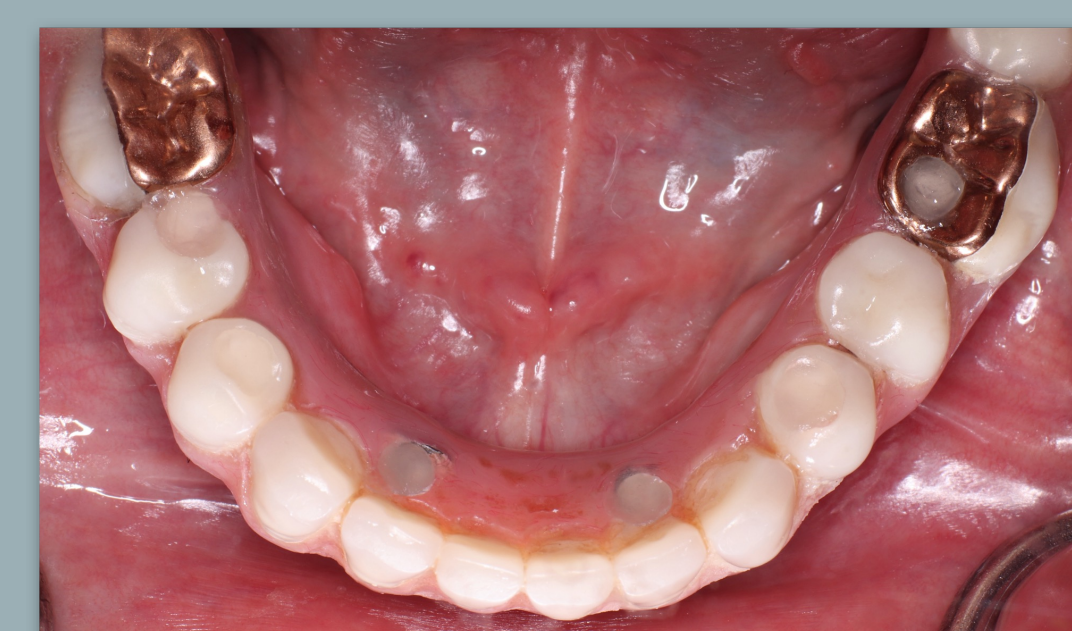
Figure 1

- All the first molars including both maxillary overdenture and mandibular implant supported fixed-prosthesis were changed to acrylic teeth with gold occlusal surfaces. (Figure 1).

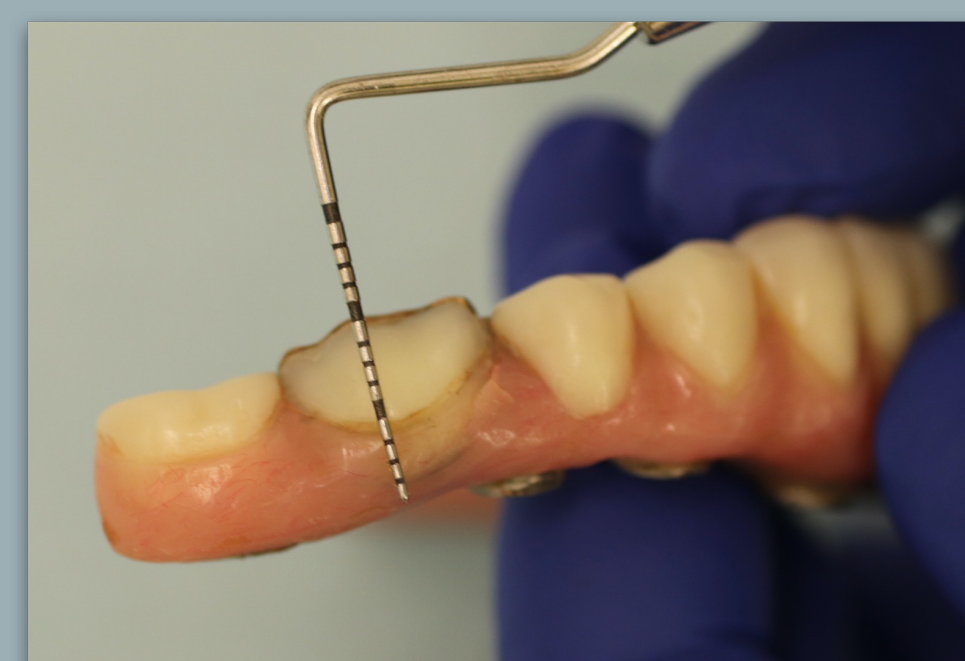
Figure 2 (a) Right

- The height of prosthetic space was about 9-10mm (Figure 2a, 2b).
- Monolithic zirconia was selected as the material of choice in this case to manage this type of complication.

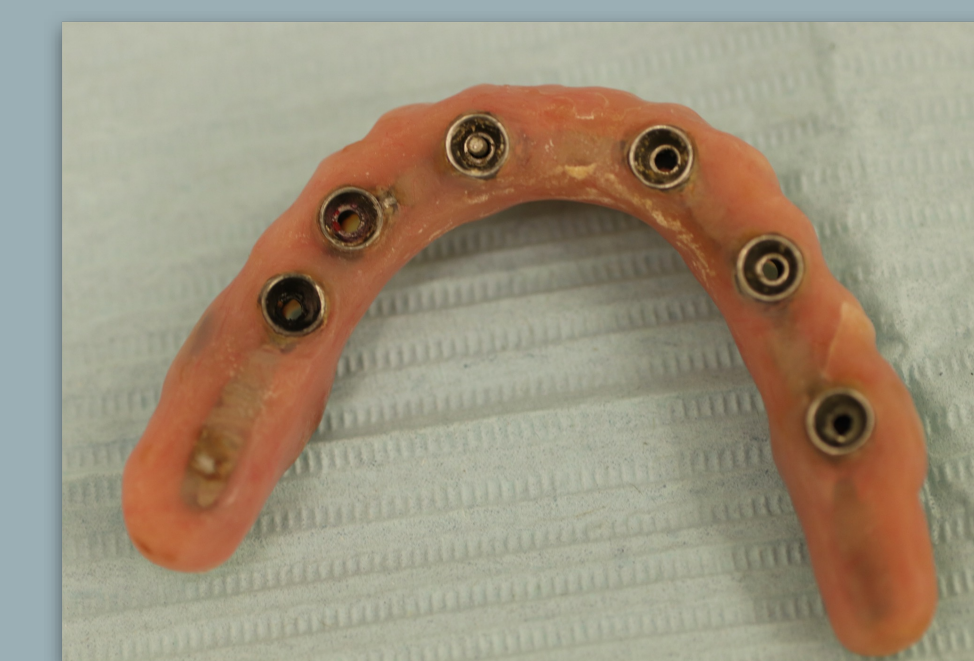
Figure 3

- 8 months later, the new hybrid prosthesis was fractured again at the acrylic part close to acrylic teeth #19 and #20 (Figure 3).
- All the prosthetic screws loosening was detected.

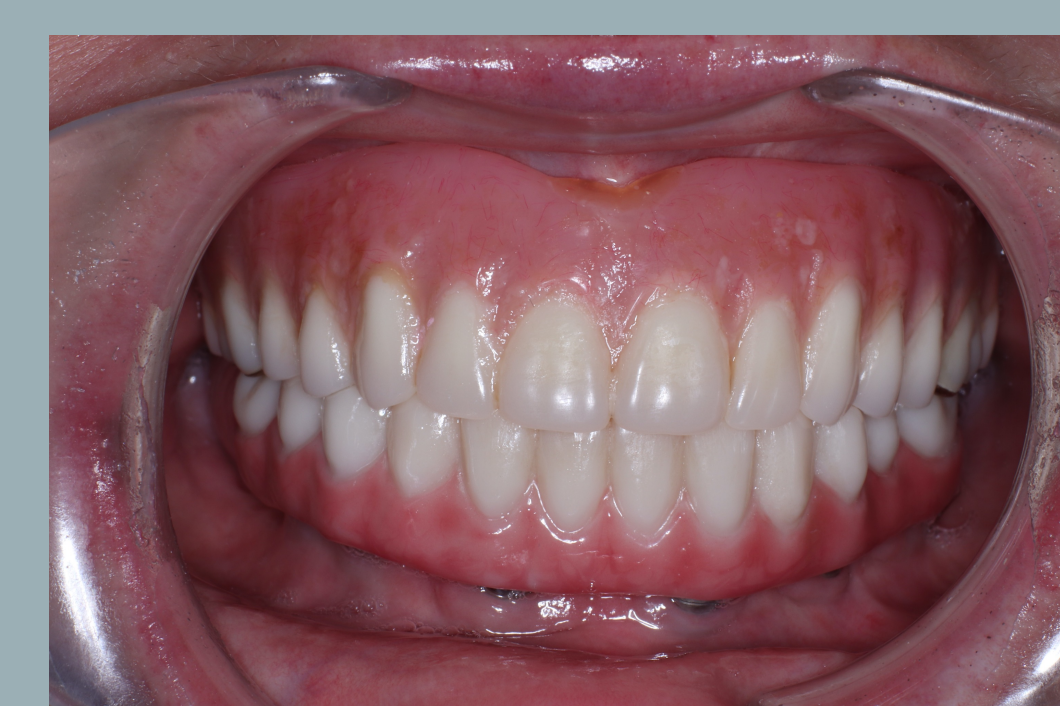
Figure 10(a)

- Mandibular monolithic zirconia prosthesis delivery (Figure 10a, 10b)
- Maxillary occlusal guard was delivered (Figure 11).

All the prosthetic screws were torqued to 15Ncm. Occlusion was checked. Follow up was made after 6 months and no prosthetic complication was encountered both clinically and radiographically. (Figure 12a, 12b, 13)
