# Assessing the cleanliness of dental implants using scanning electron microscope (SEM) and Energy-dispersive X-ray spectroscopy analysis (EDS)

Department of Oral Rehabilitation, The Maurice and Gabriela Goldschleger School of Dental Medicine, Tel Aviv University, Israel

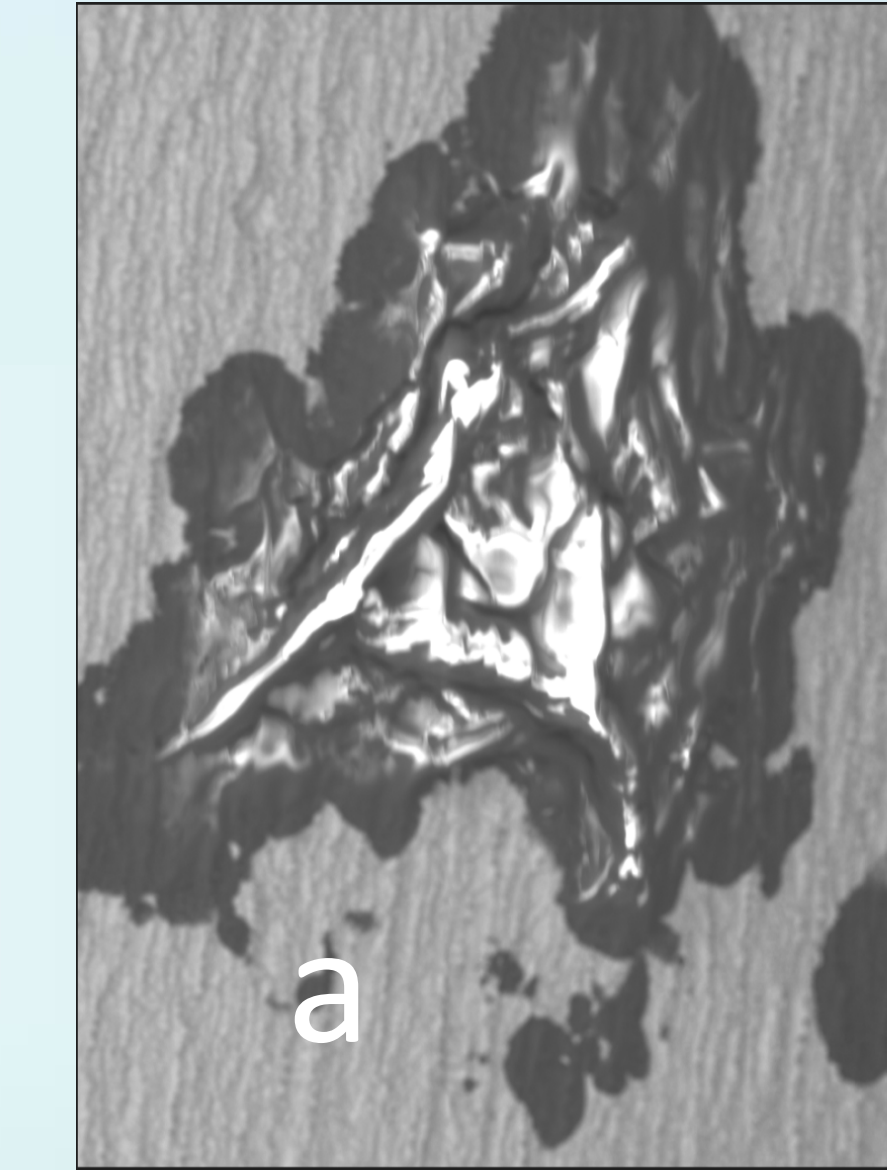
## Zimmer

SEM images Zimmer Biomet dental implants. Very large irregular particle(a). a "touch-like" contamination at the apex(b). Several particles on the outer surface area(c). A large particle with two adjacent flat particles (d).
