# Technical Complications Due to Incorrect Positioning in Dental Implant Placement ,and How to Change a Technical Failure into a Success

Mohseni Salehimonfared, Seyedhossein<sup>1</sup>; Pesteei, Seyede Ozra<sup>1</sup>

Department of Periodontology, Tehran University of Medical Sciences, Tehran, Iran Email:salehimo@tums.ac.ir

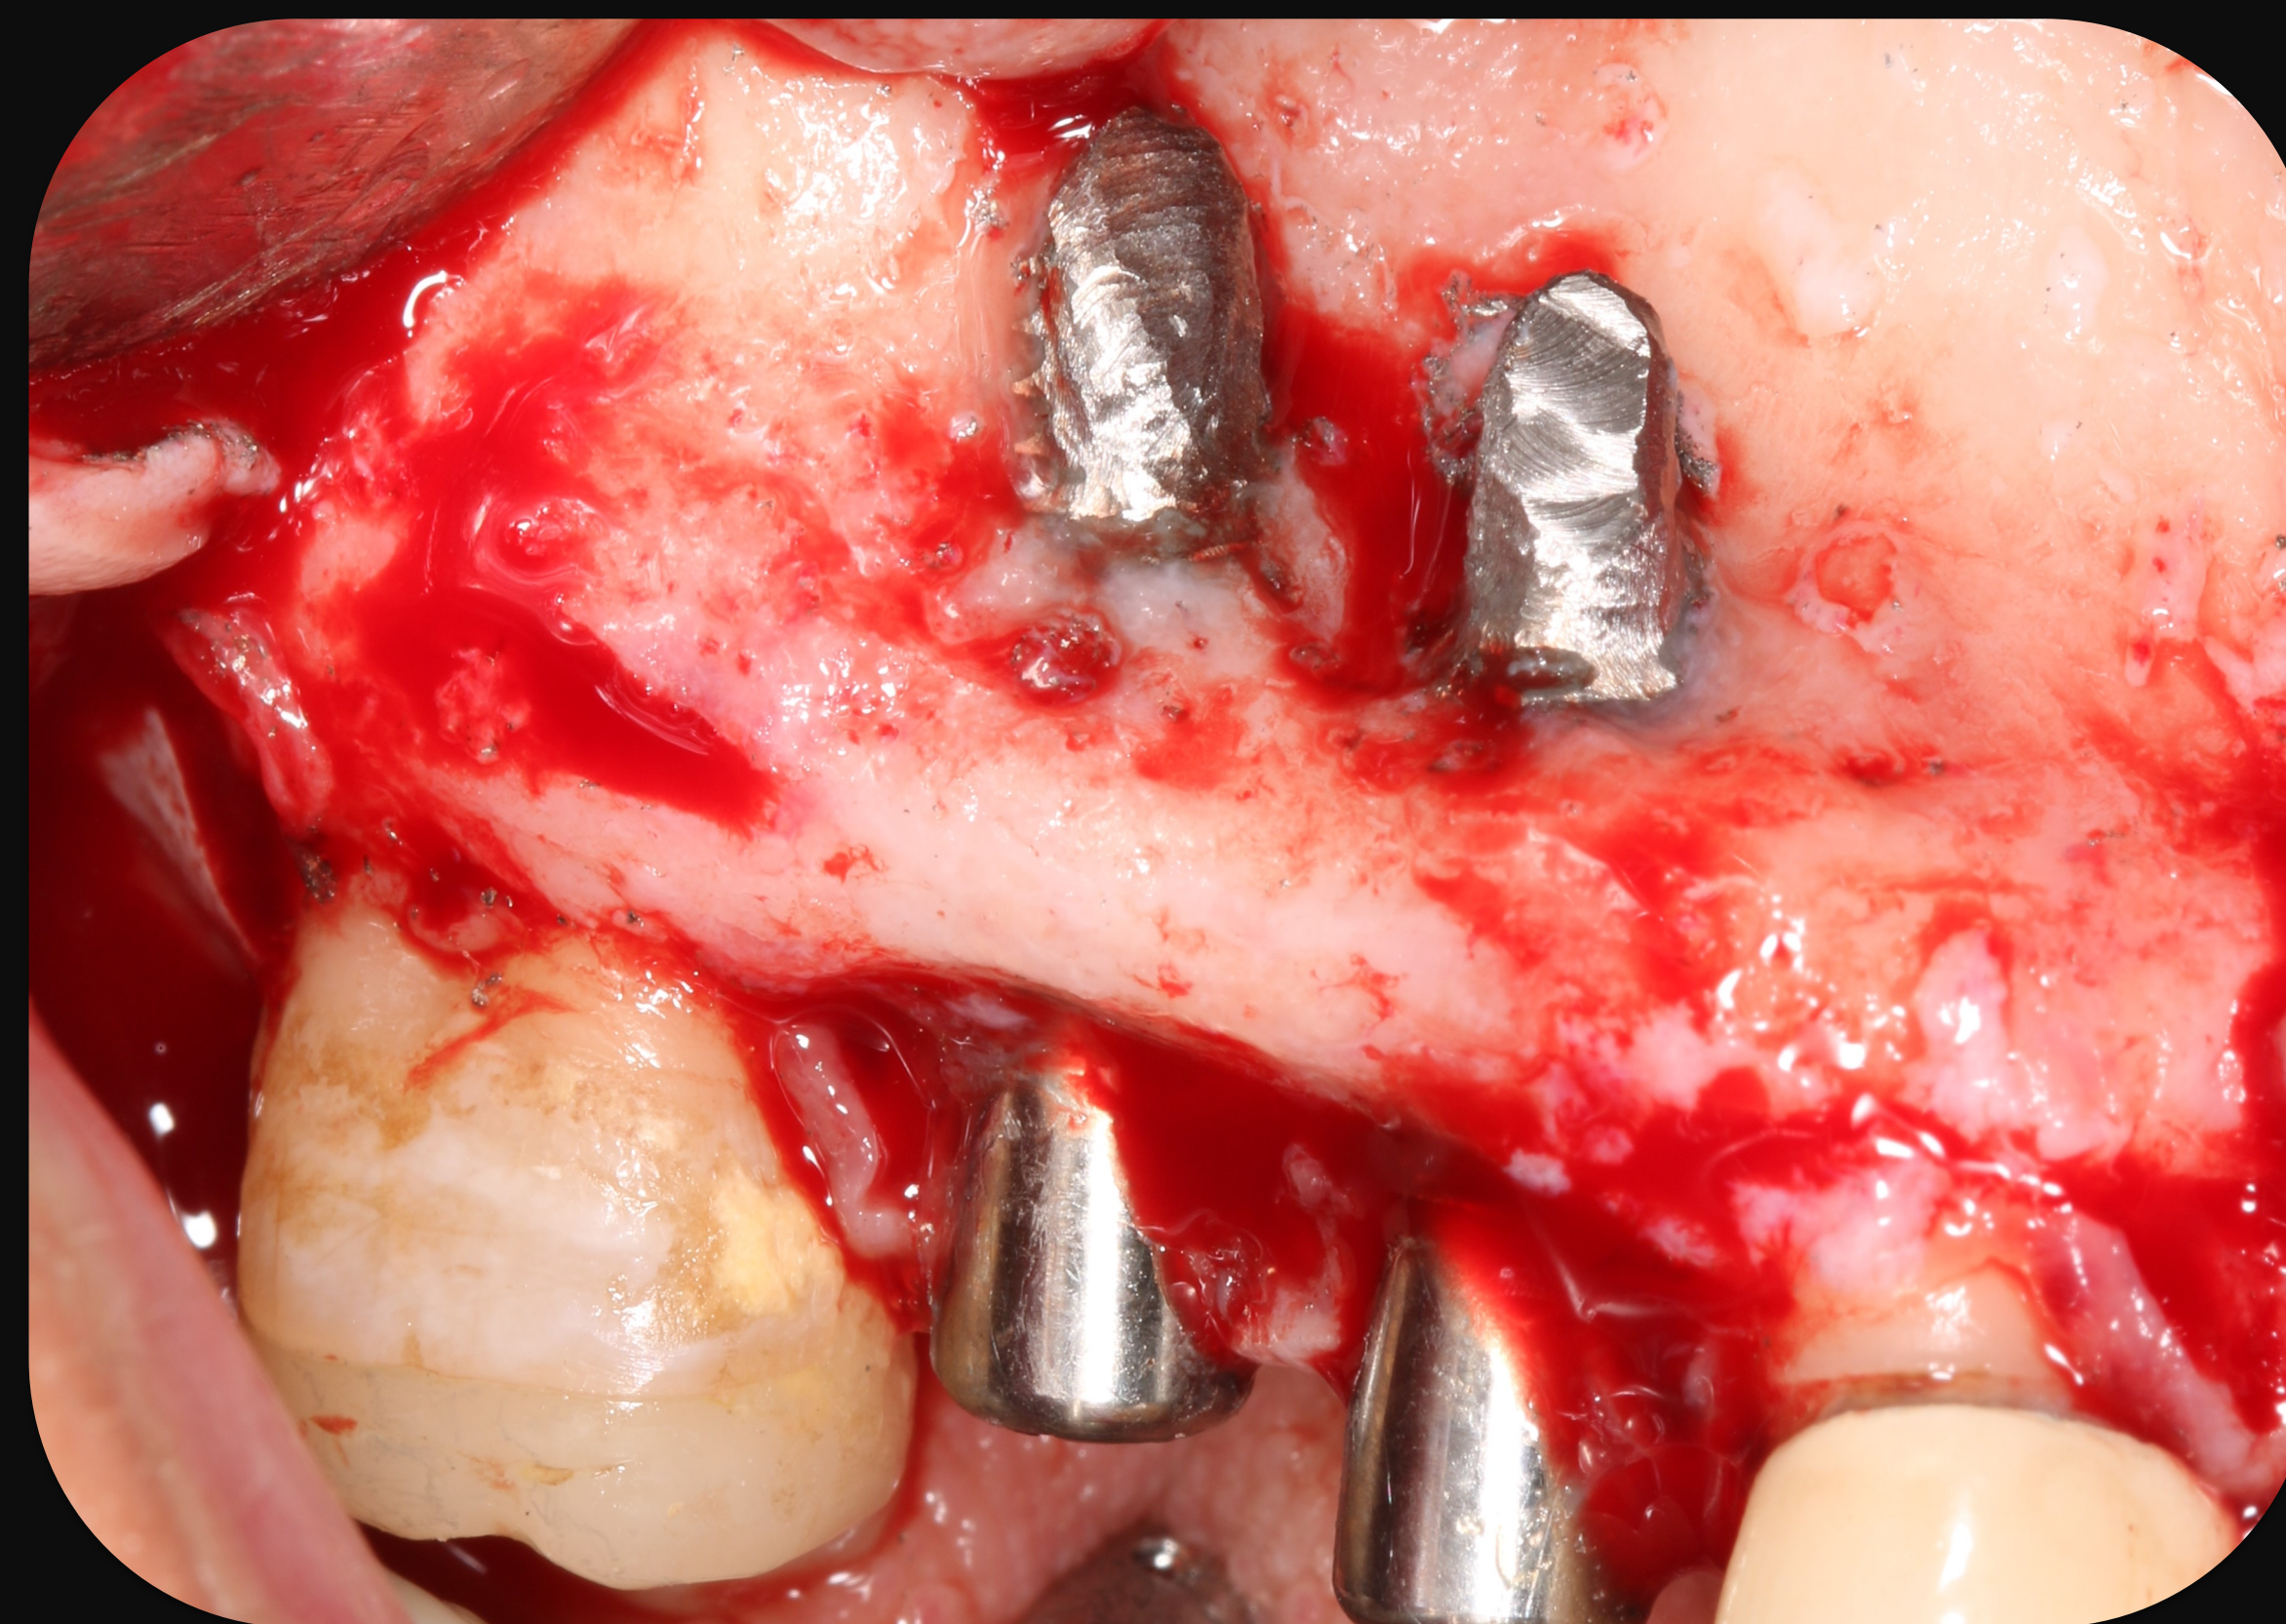
implantoplasty

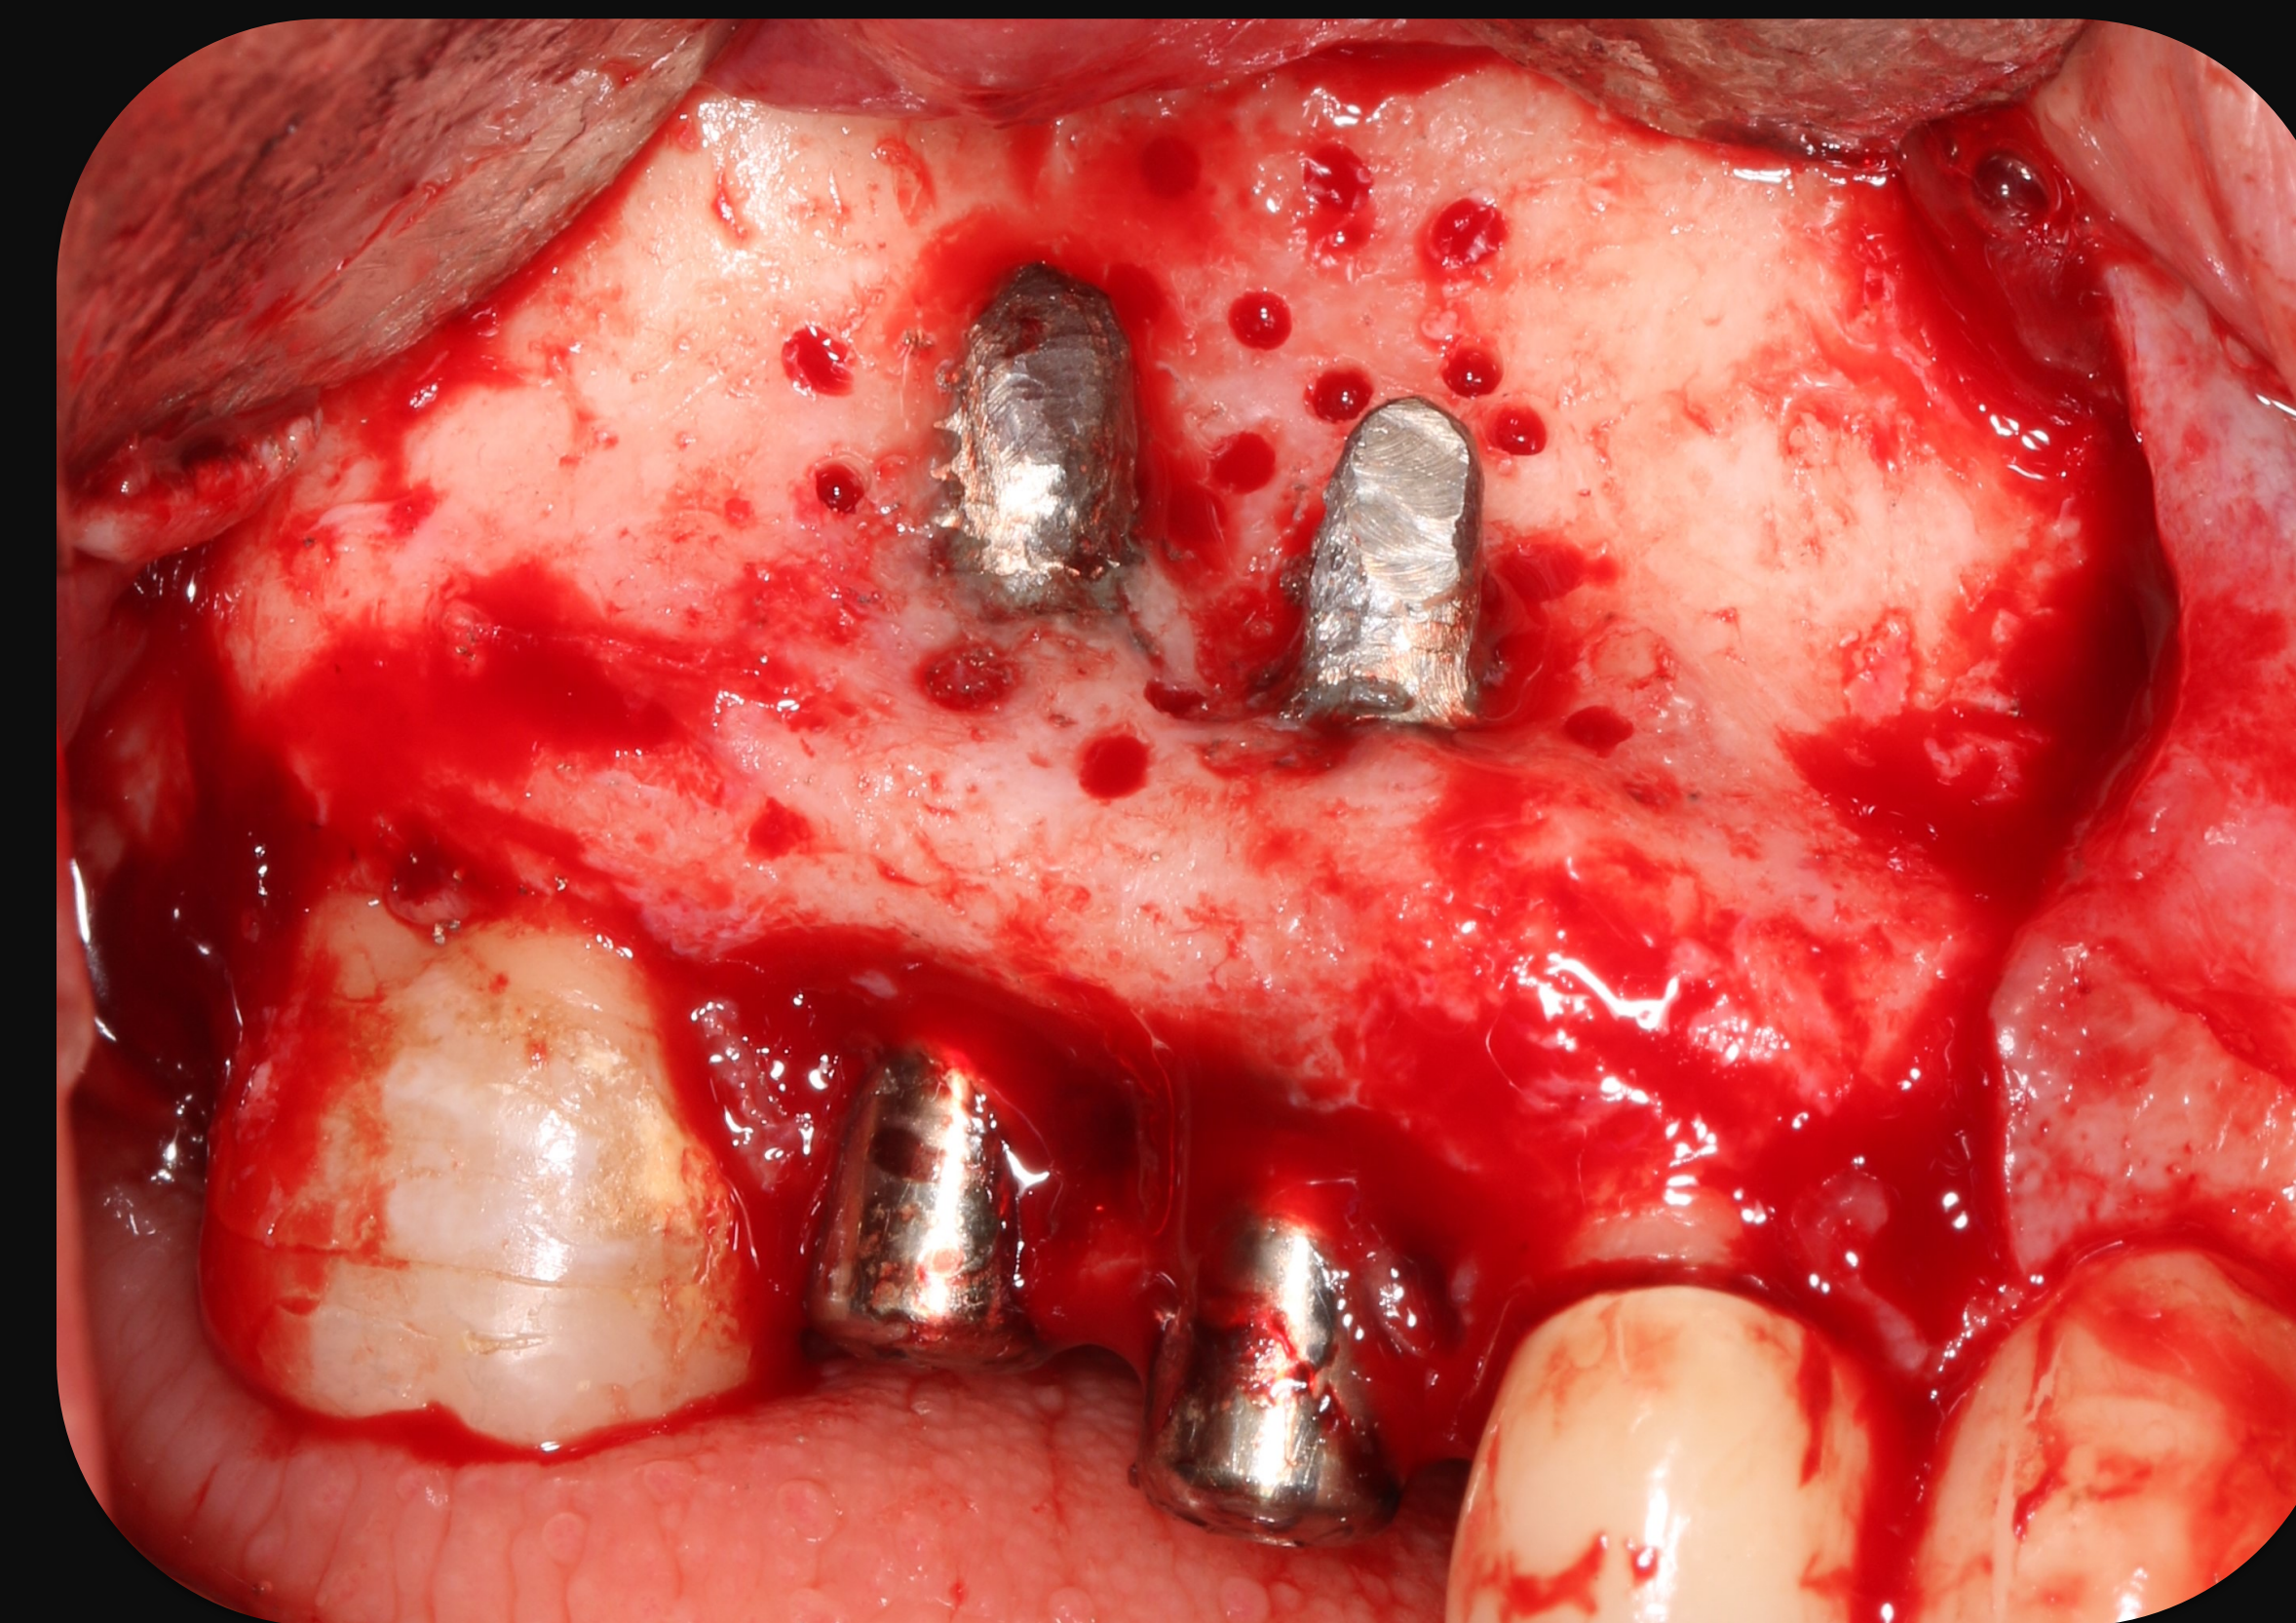
cortical bone penetration

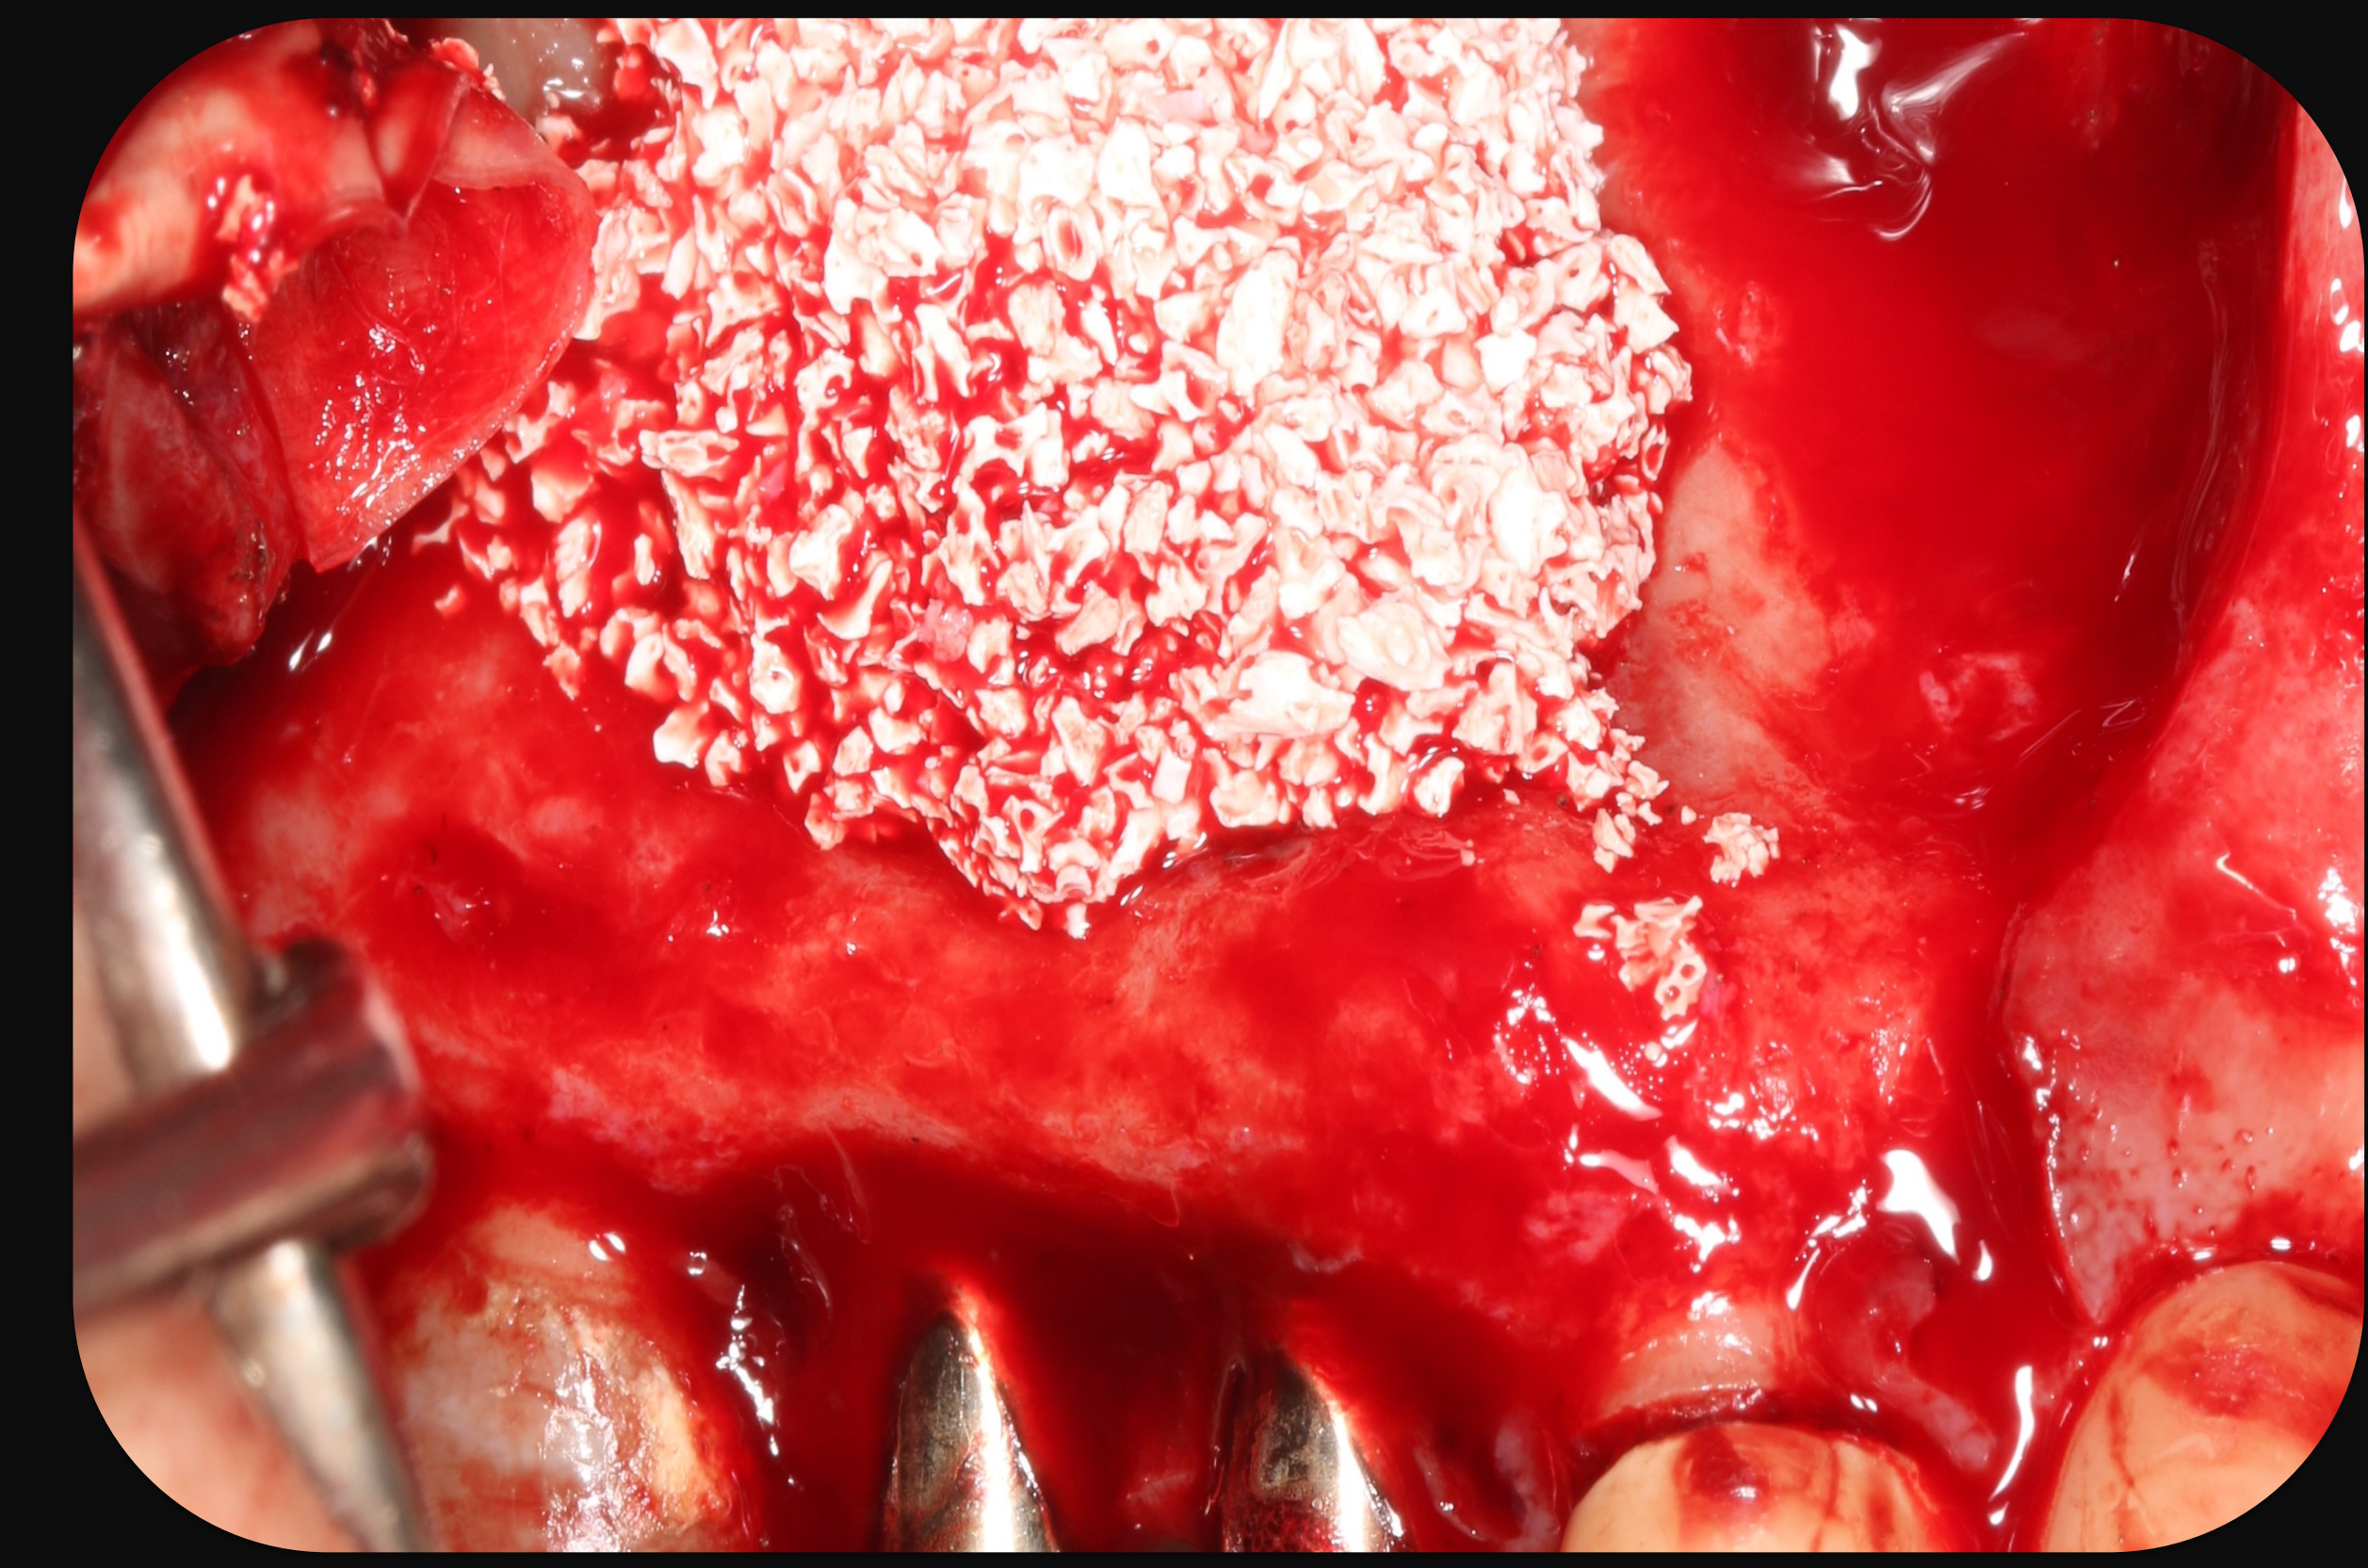
GBR(xenograft)

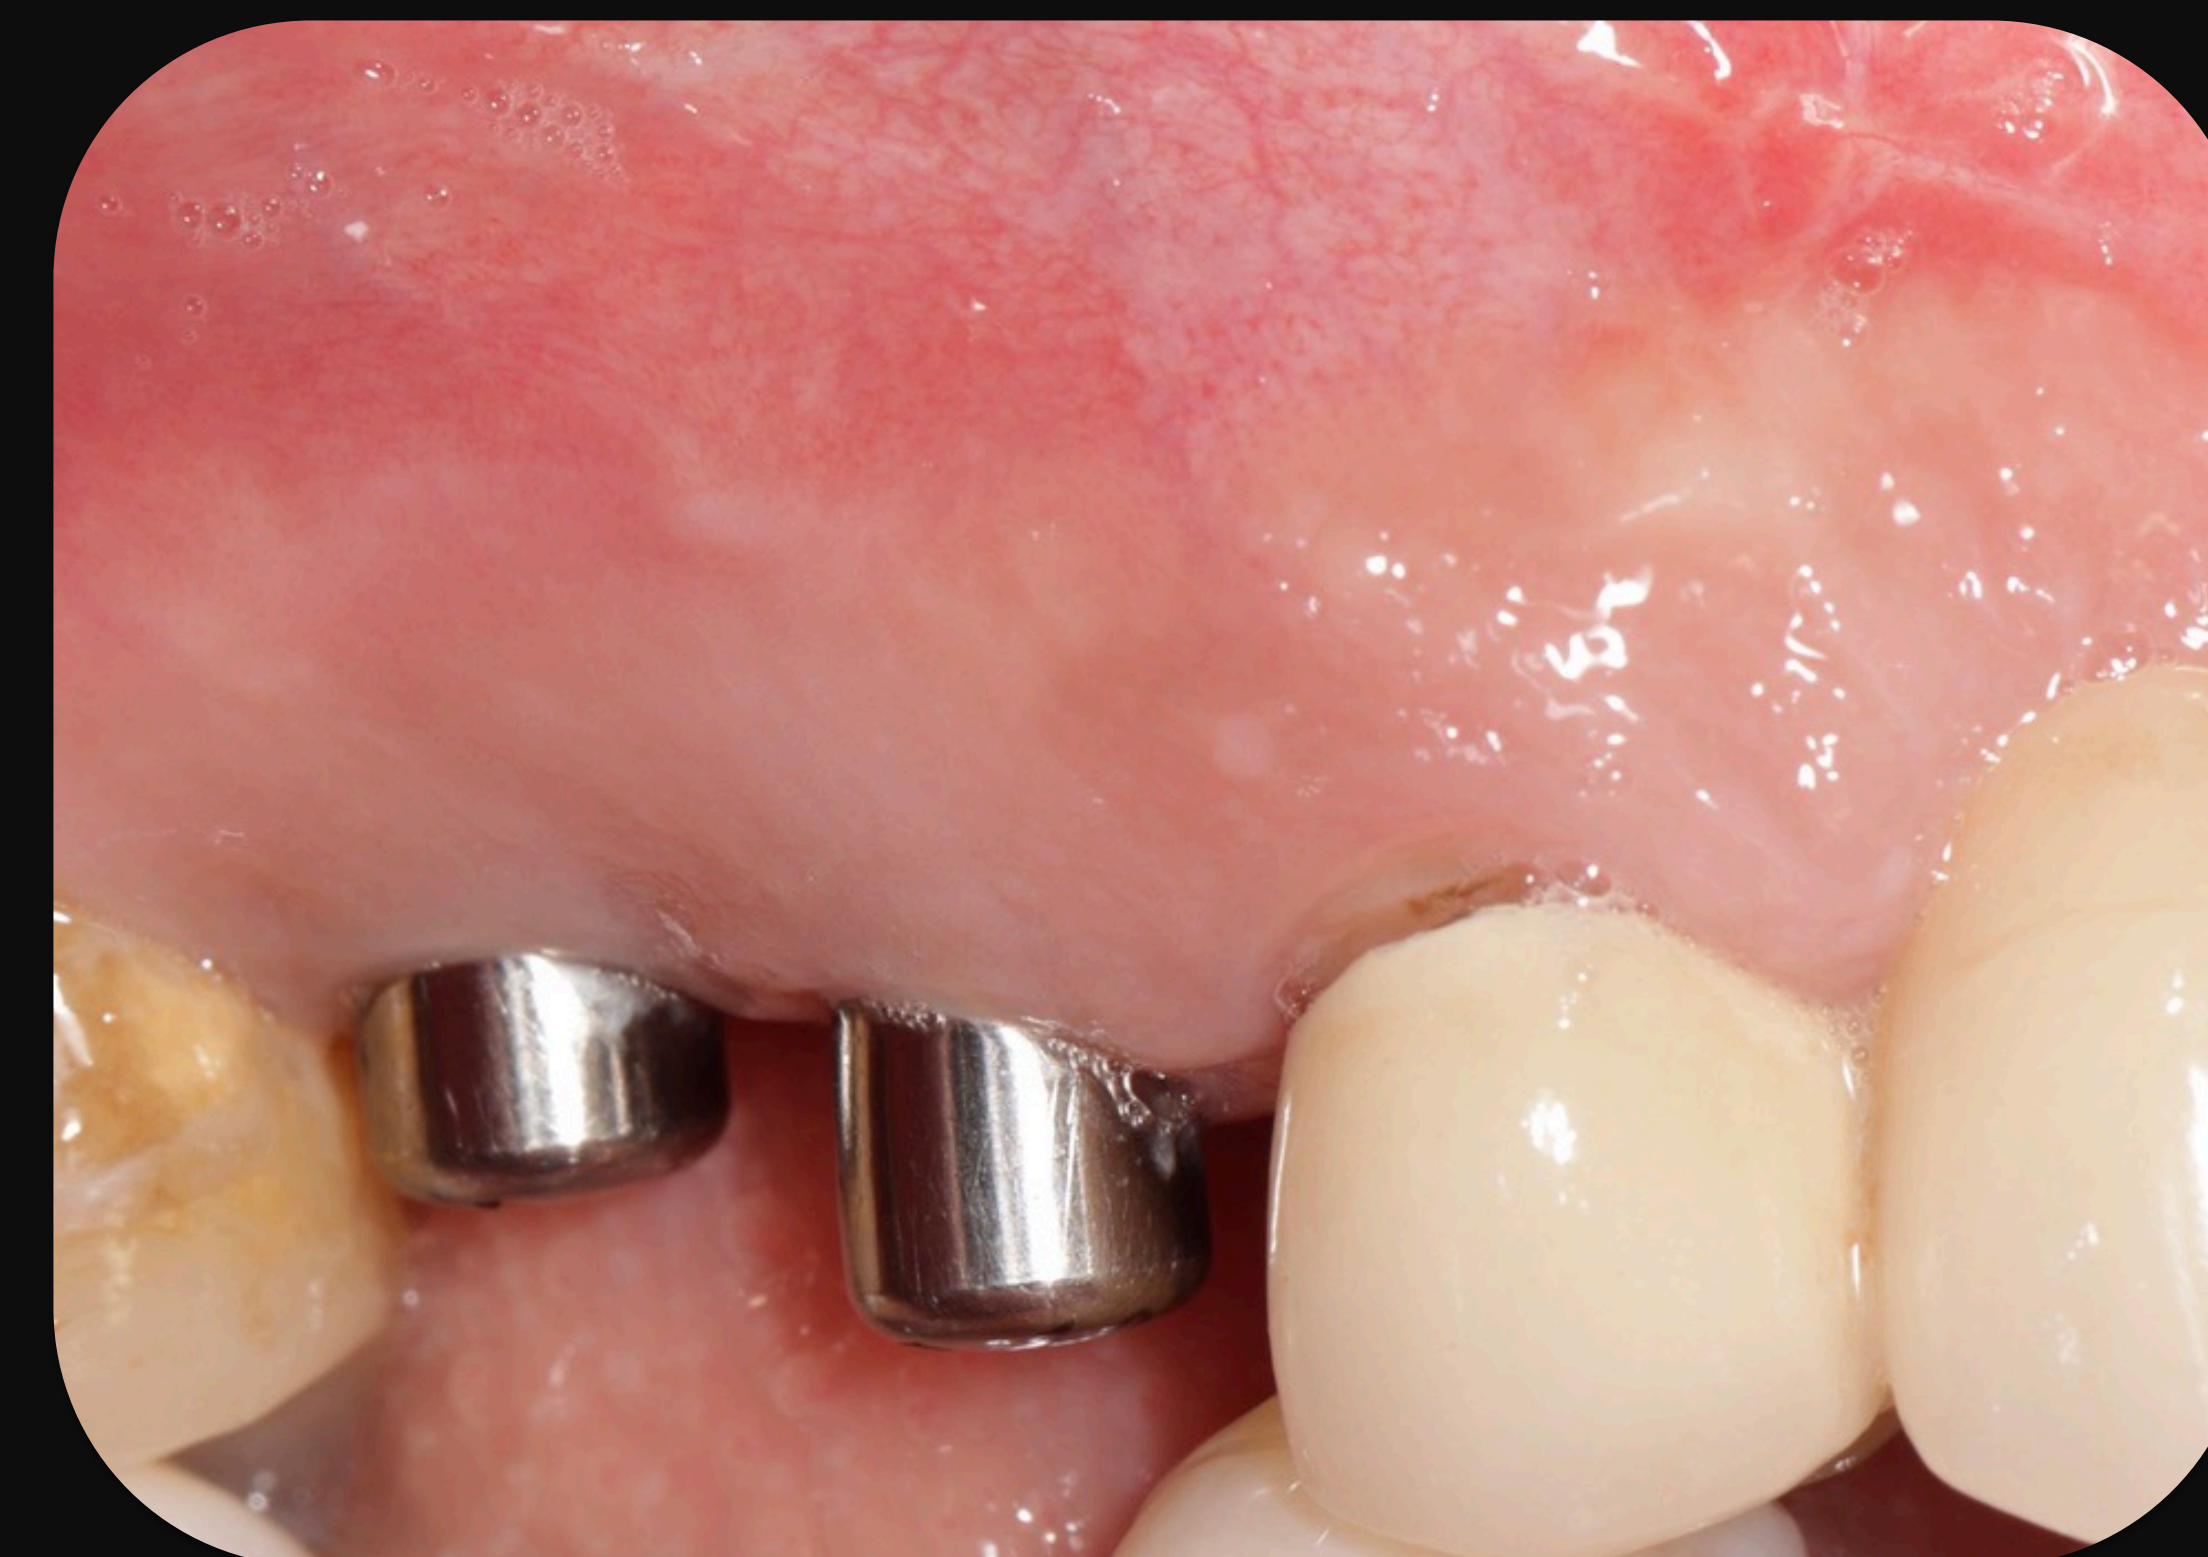
6-months follow-up

The 6-months follow-up of these patients using CBCT images shows the success of the treatment. Also, no clinical signs of inflammation were observed and the soft tissue were healthy and stable. In the clinical examination of the patients, there was no metal showing within the soft tissue.

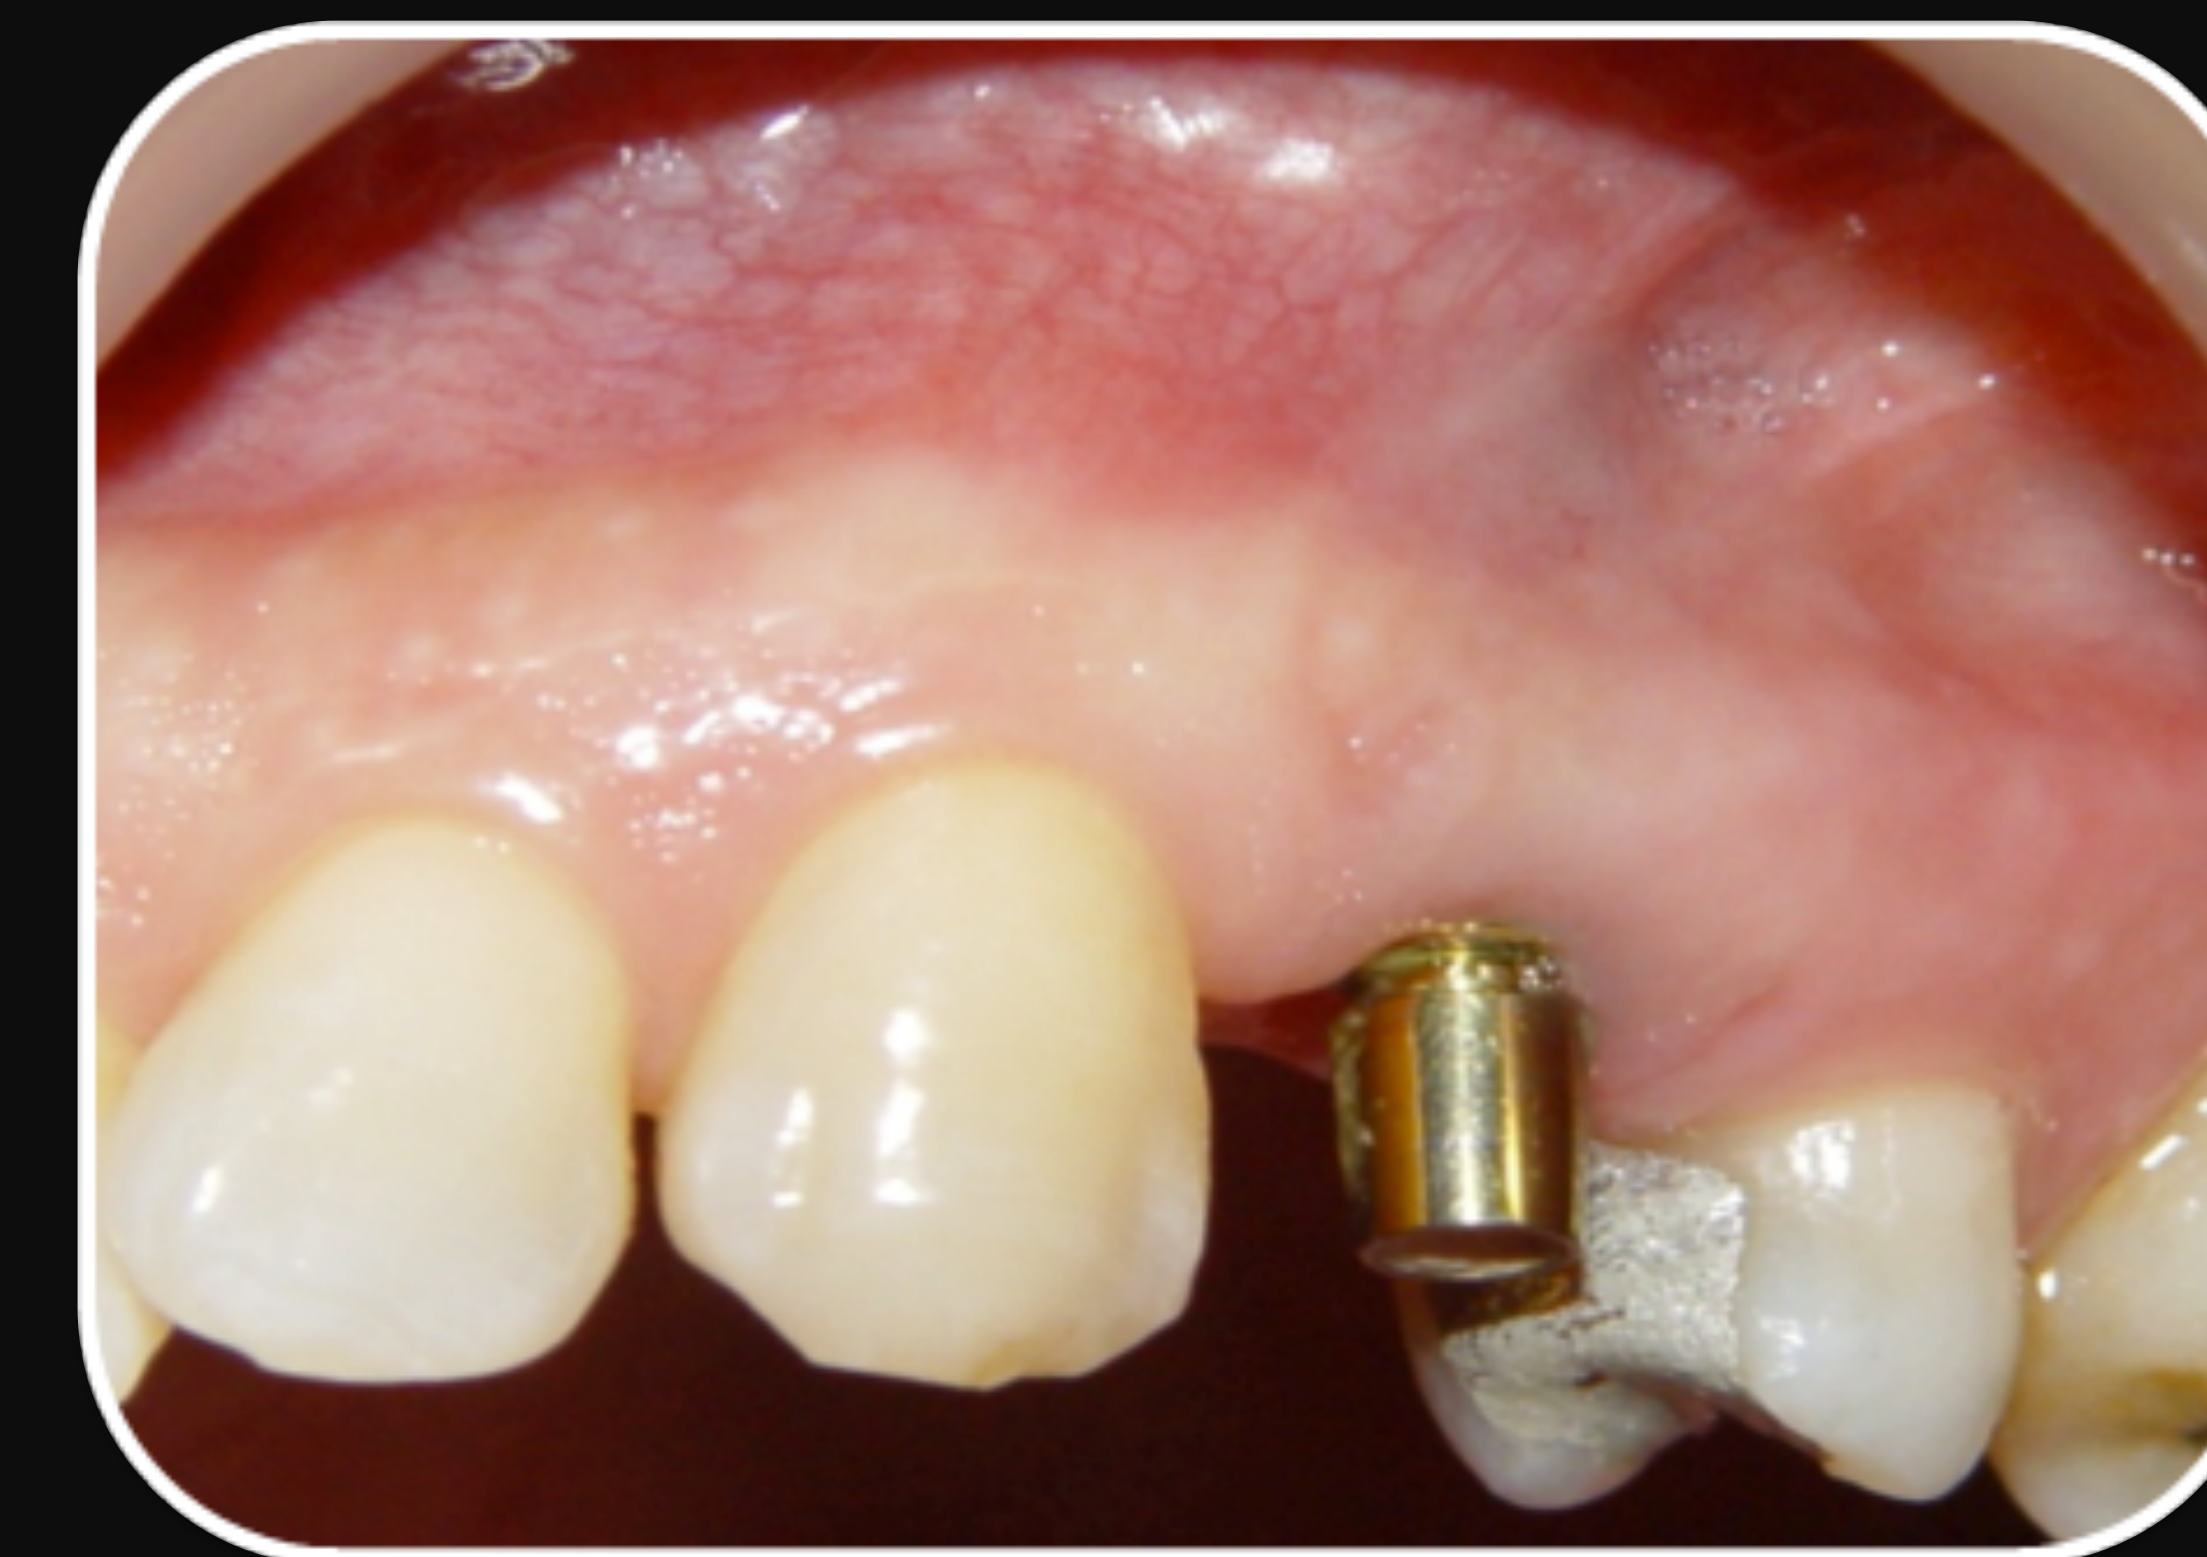
Pre-surgical view

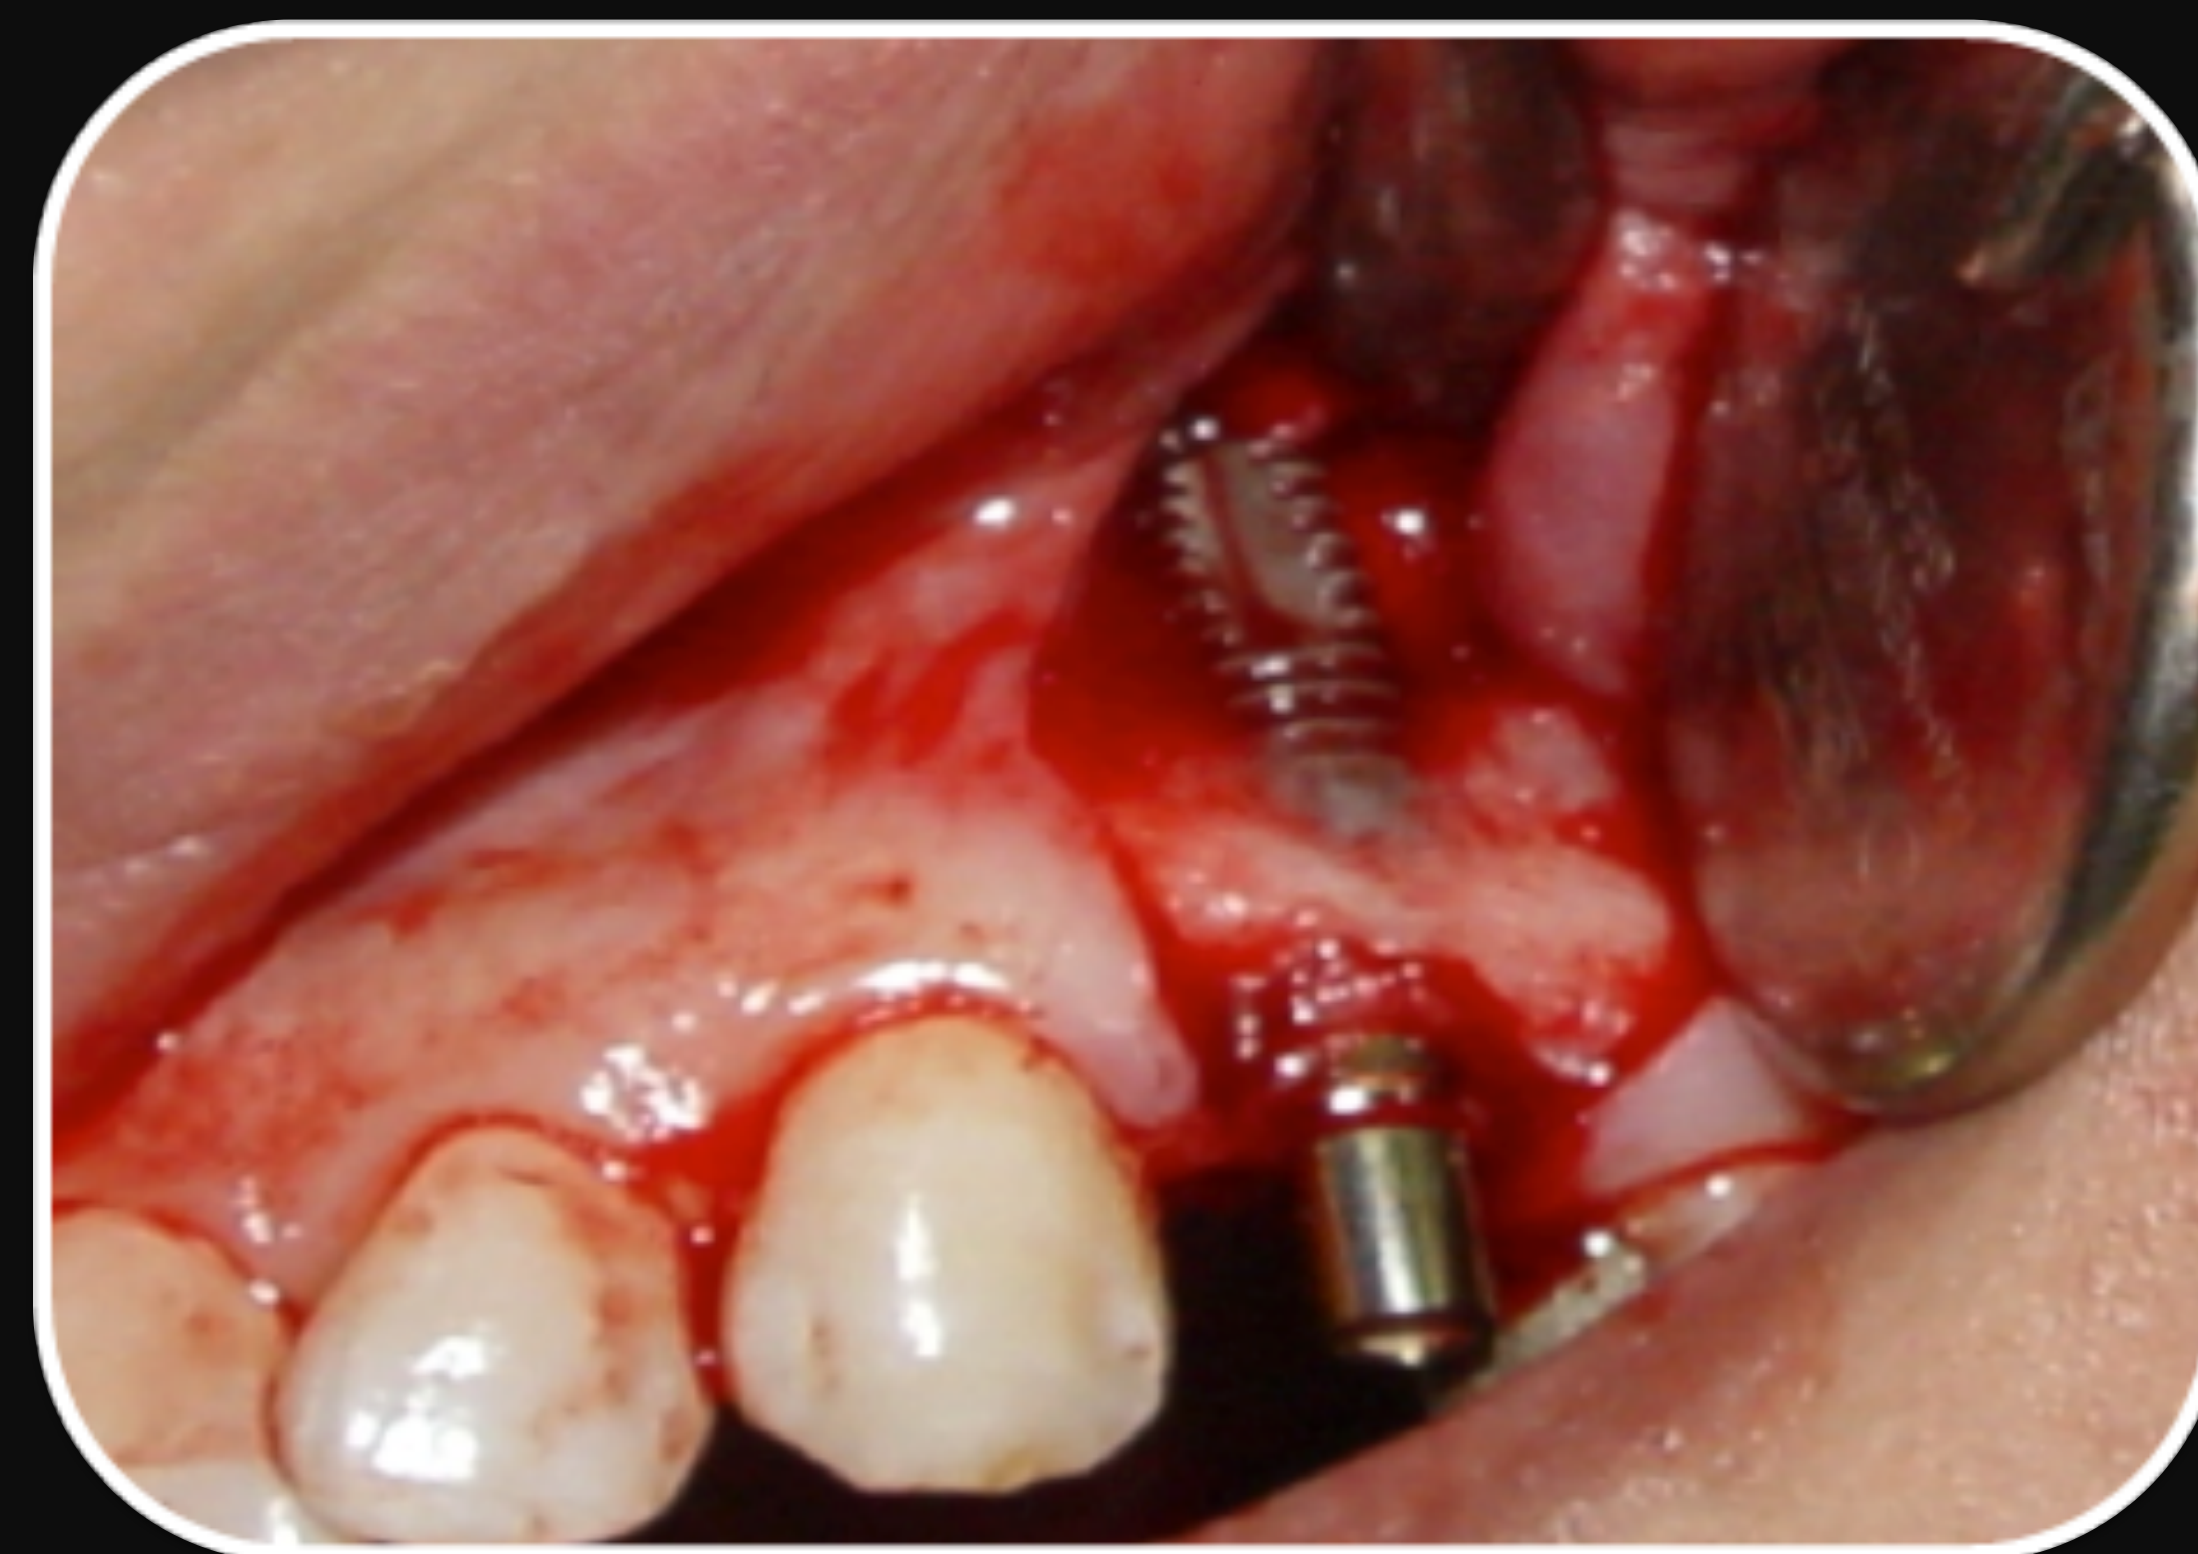
full thickness flap
