# Technical Complications Due to Incorrect Positioning in Dental Implant Placement ,and How to Change a Technical Failure into a Success

Mohseni Salehimonfared, Seyedhossein<sup>1</sup>; Pesteei, Seyede Ozra<sup>1</sup>

Department of Periodontology, Tehran University of Medical Sciences, Tehran, Iran Email:salehimo@tums.ac.ir

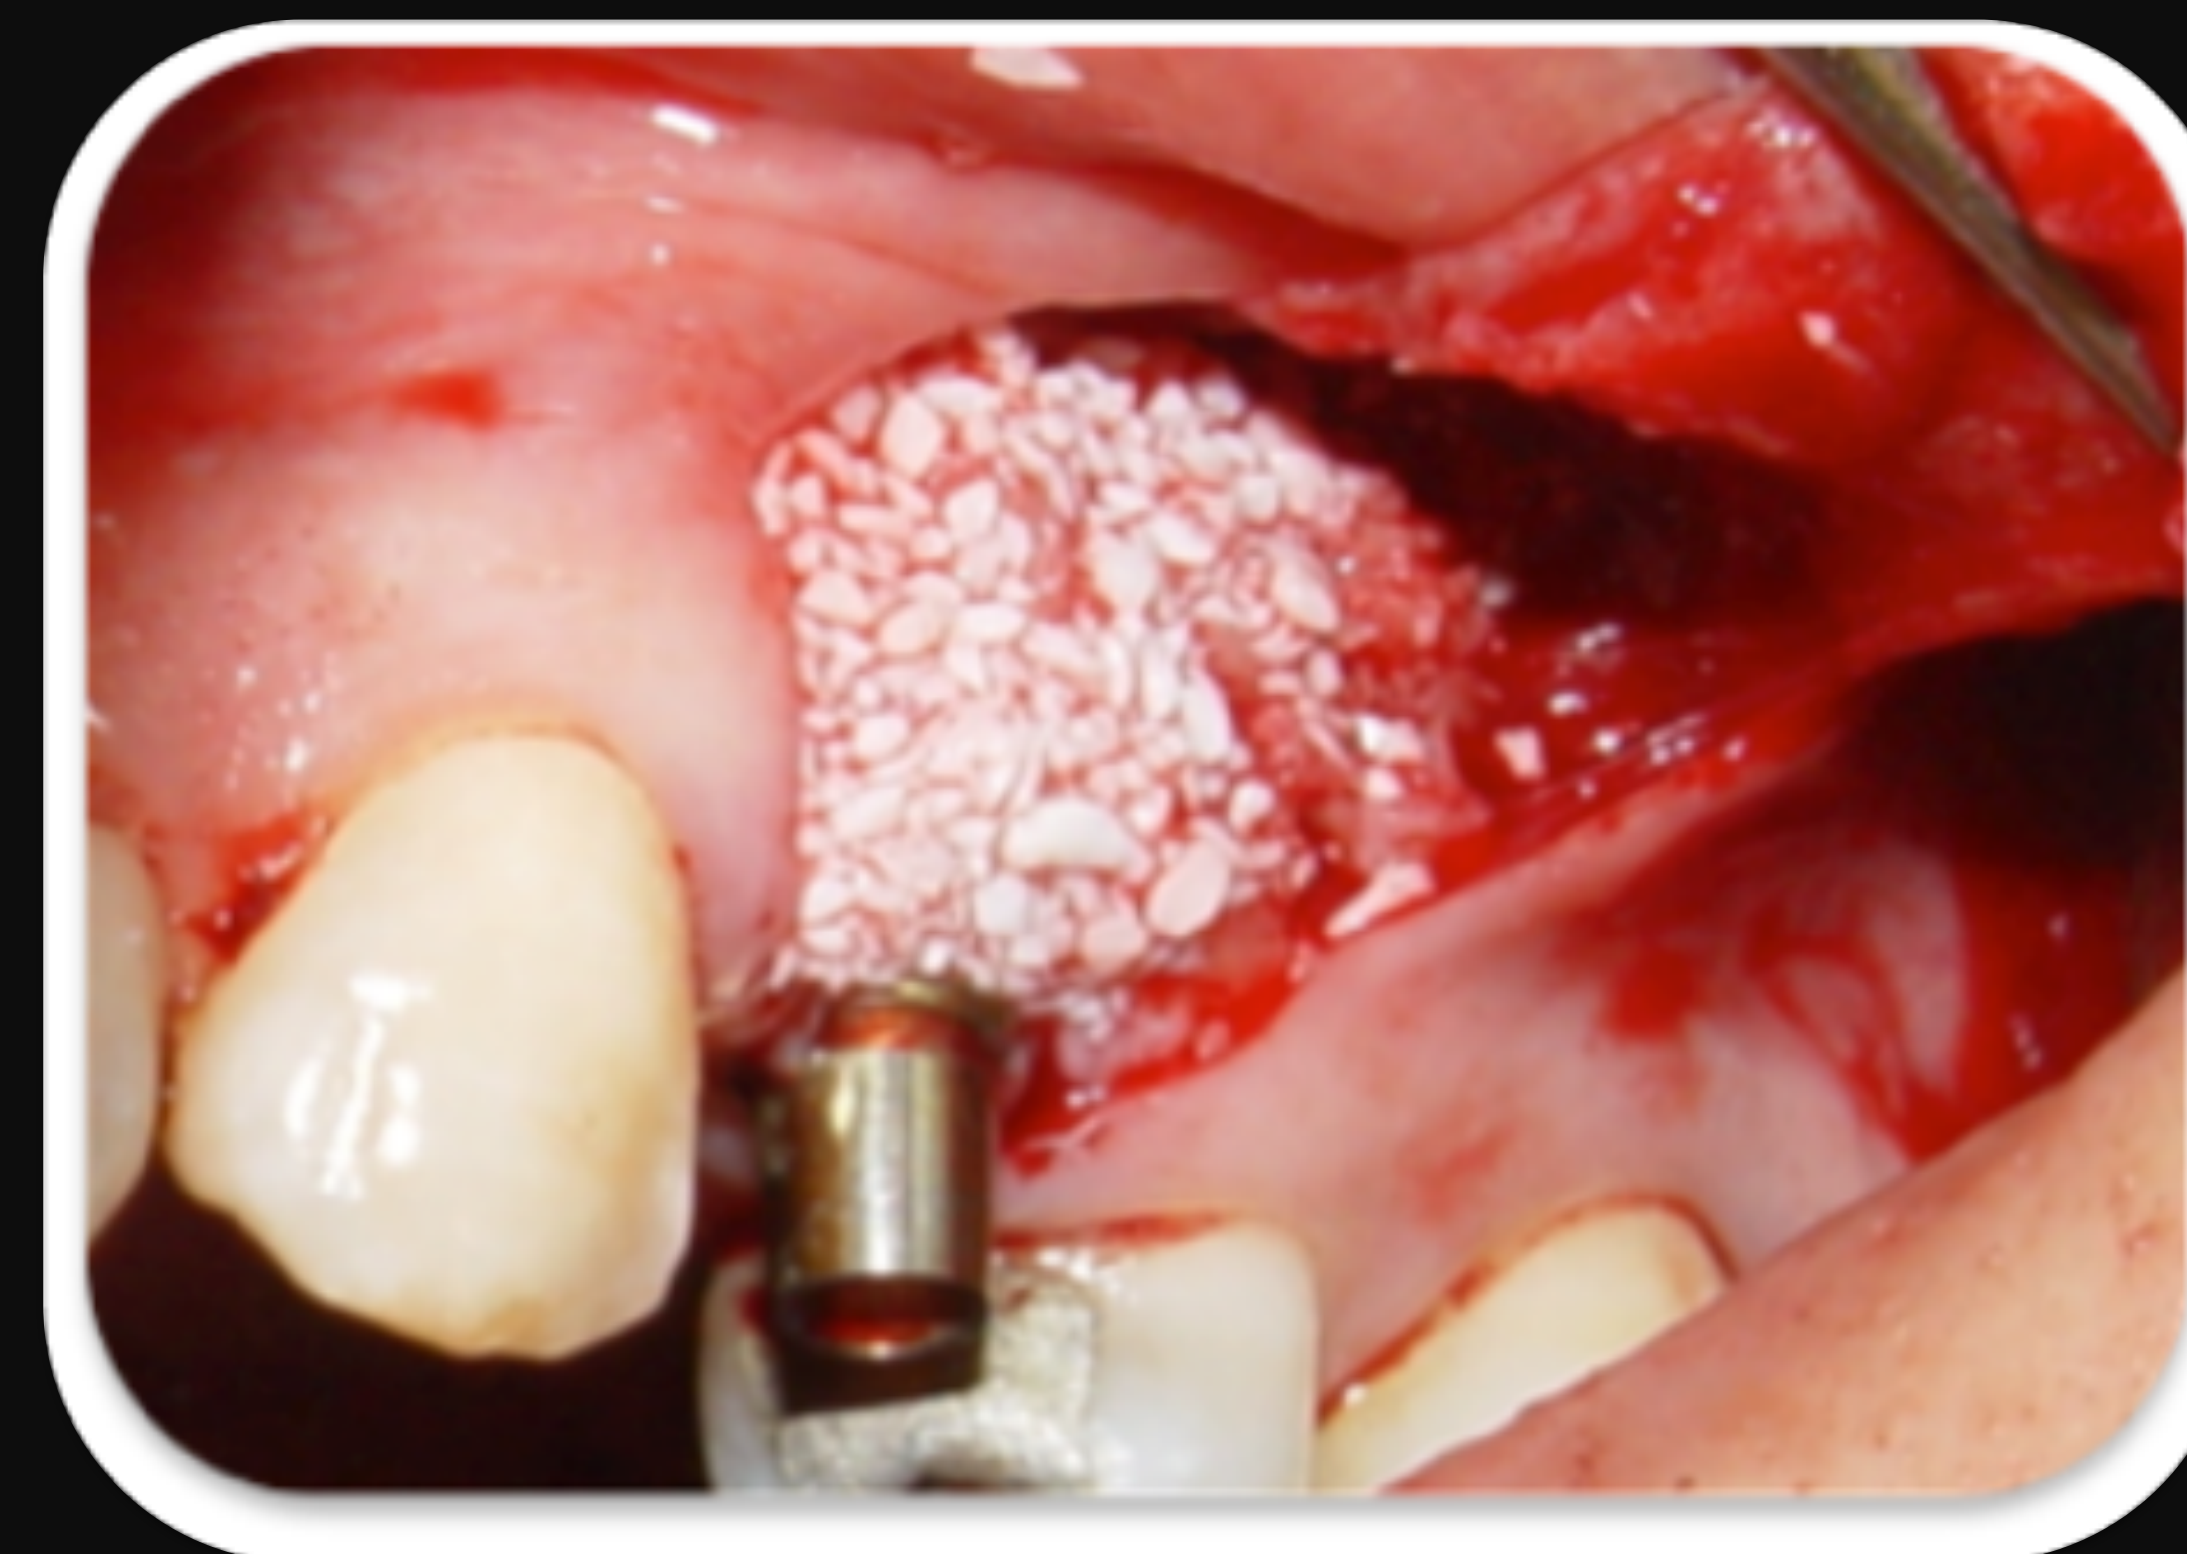
GBR(xenograft+ collagen resorbable membrane)

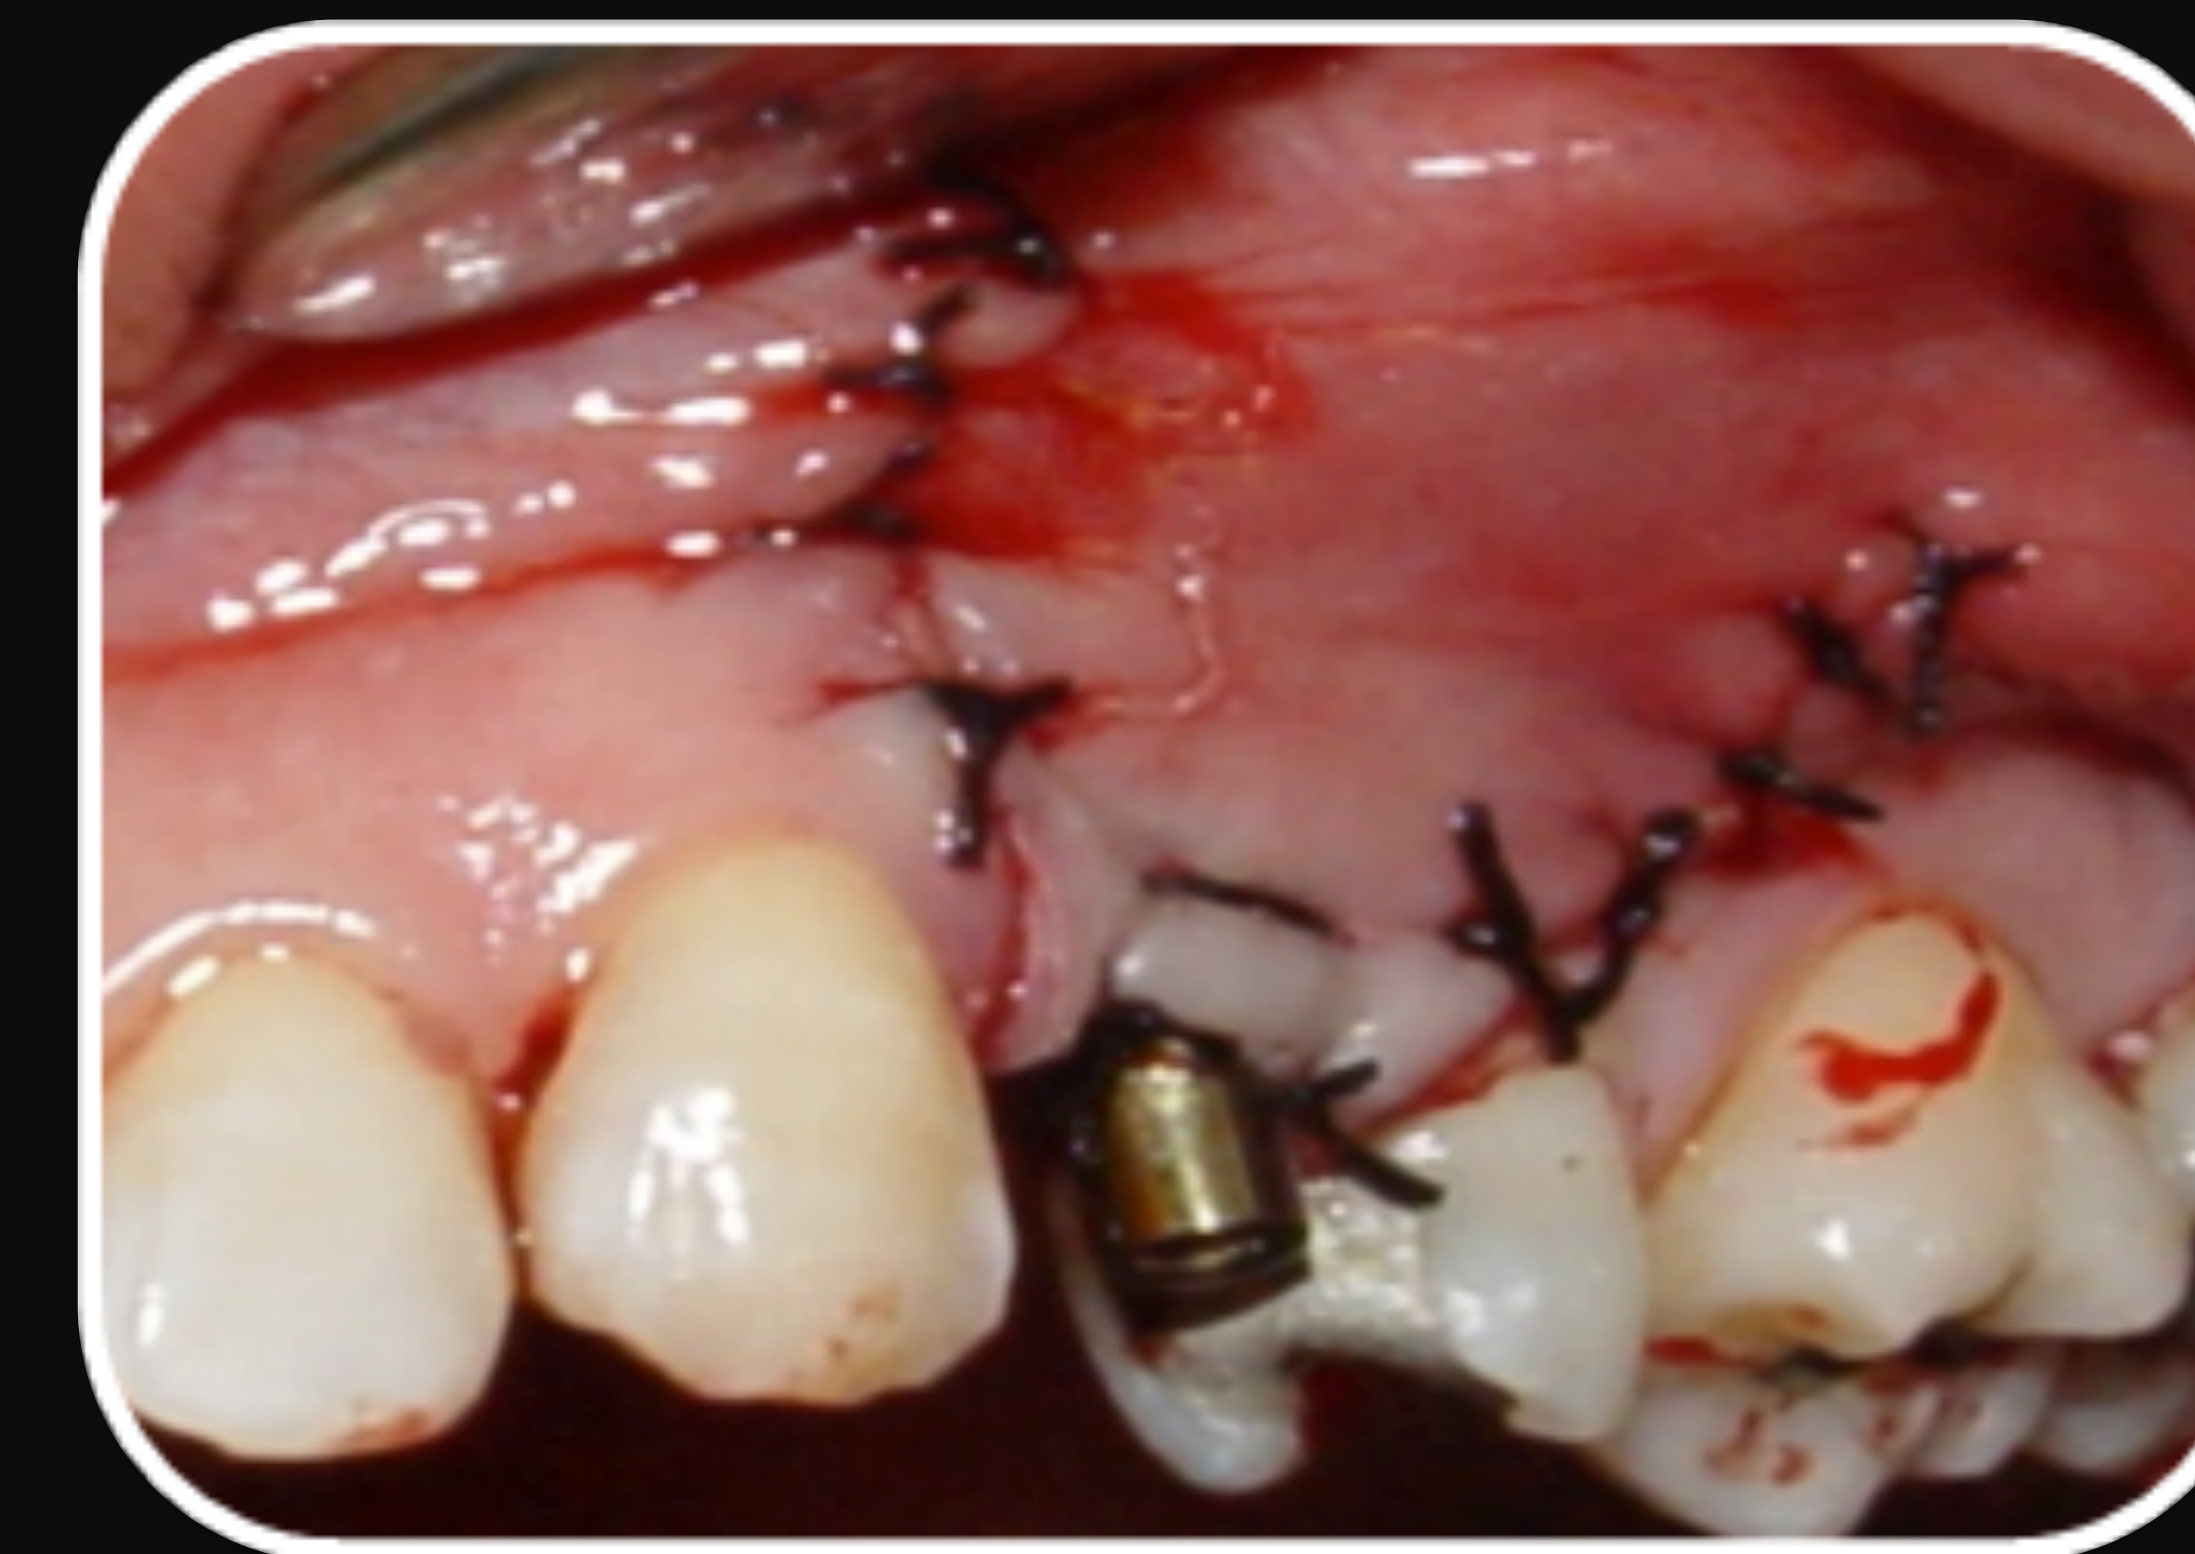
Tension free suturing

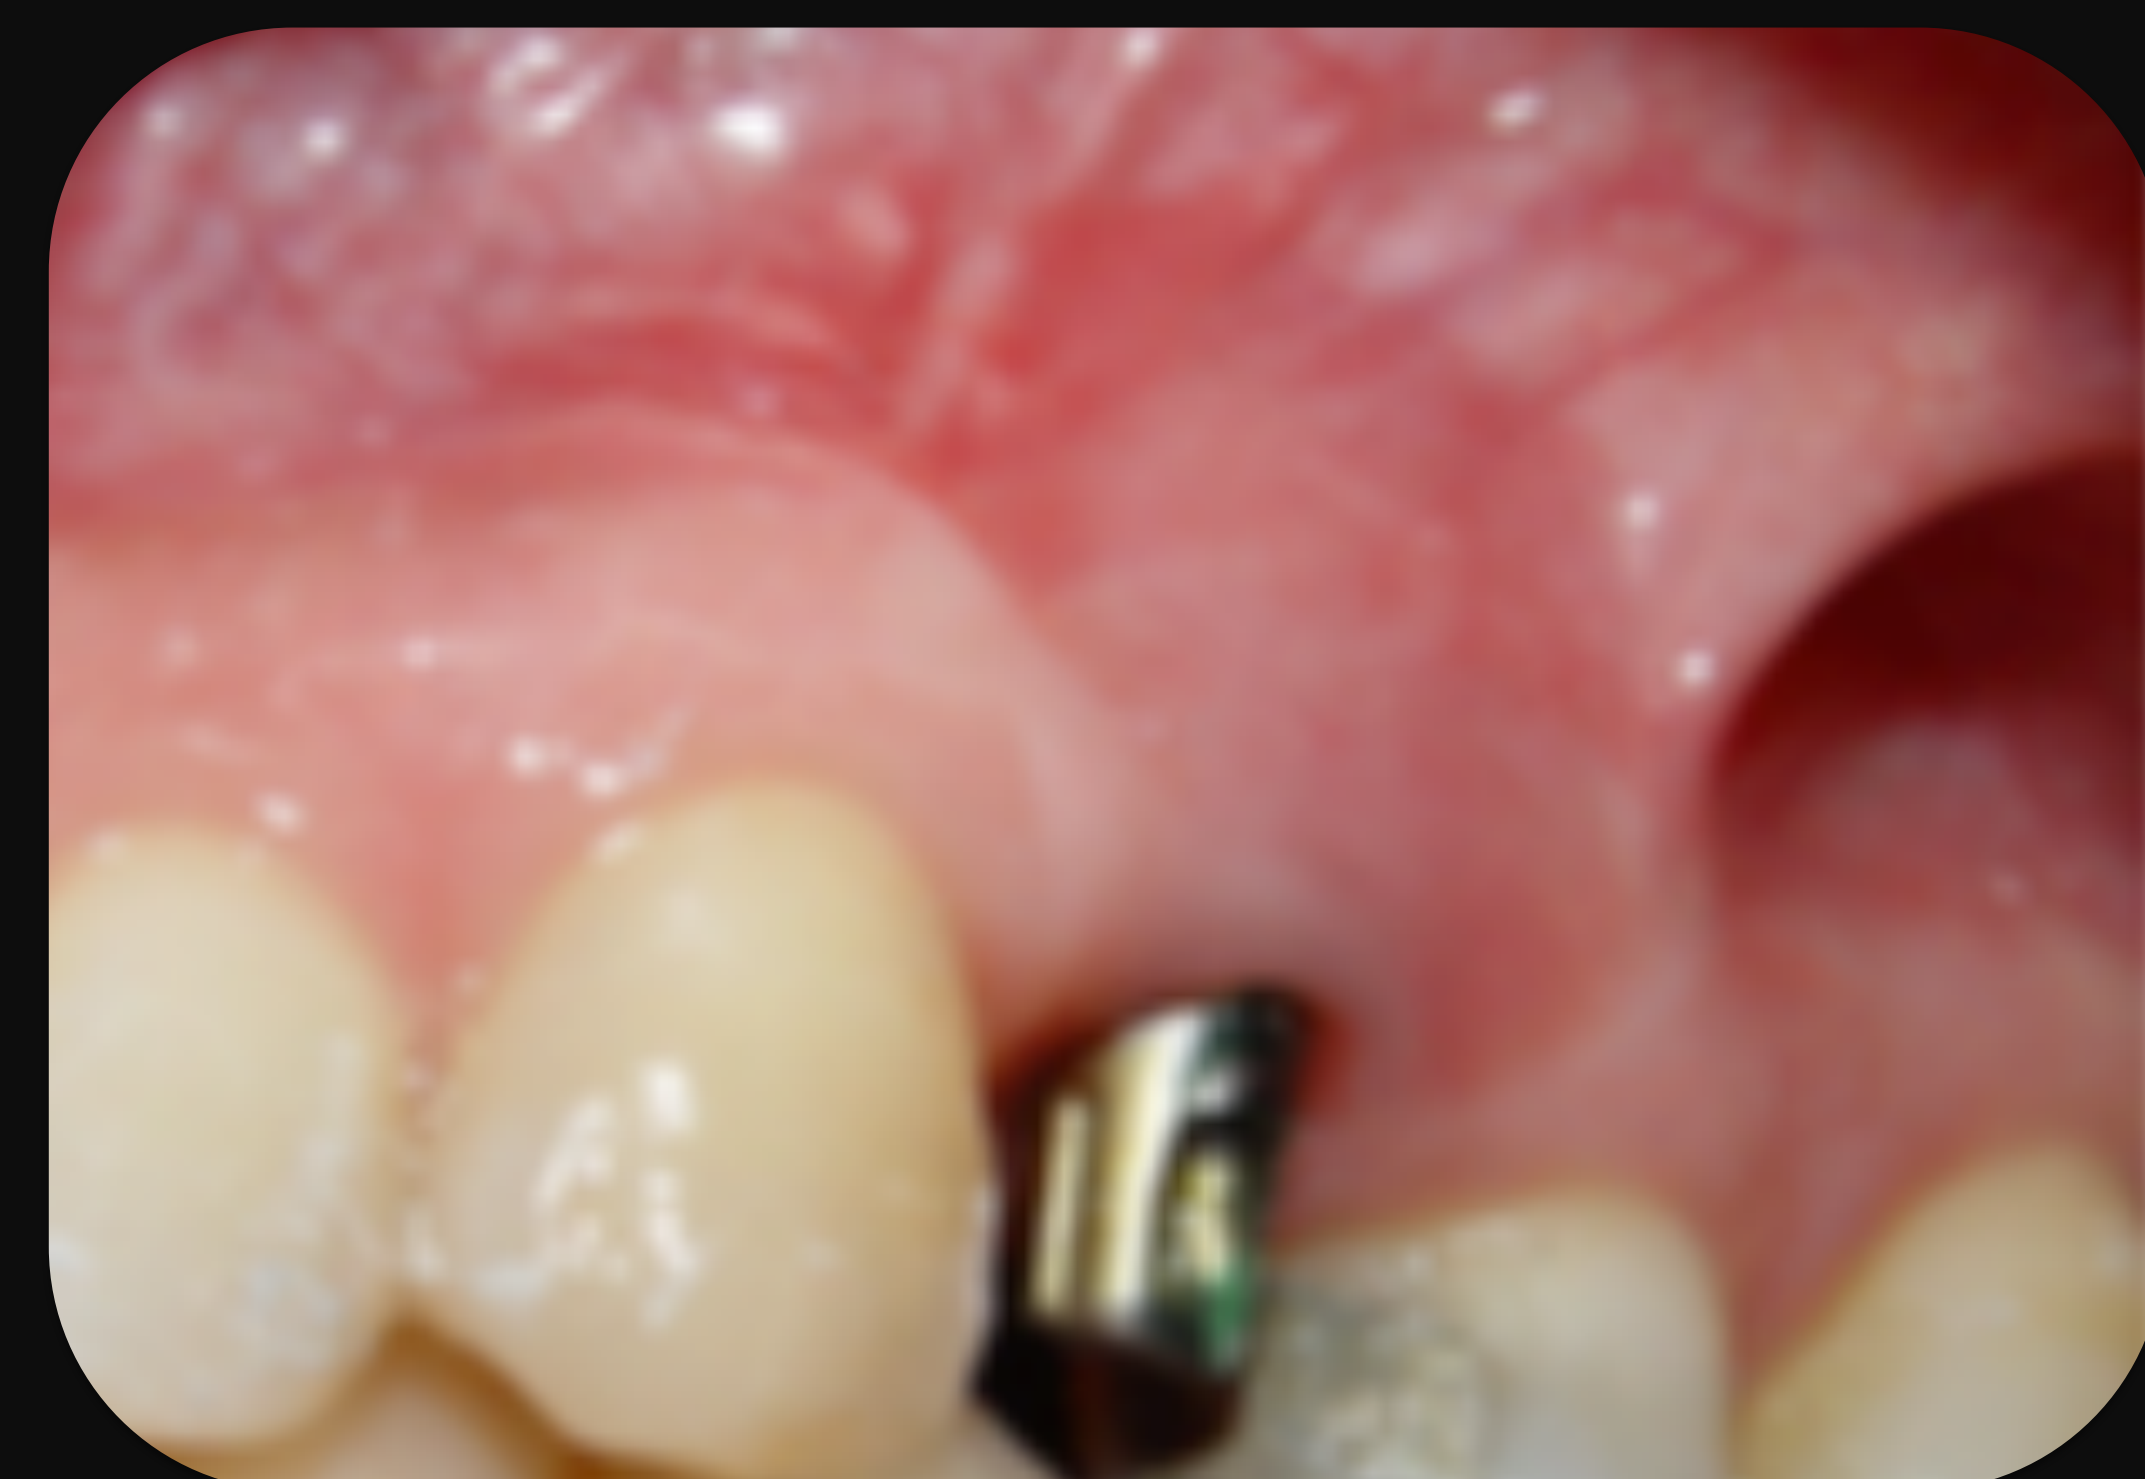
6-months follow-up

The 6-months follow-up of these patients using CBCT images shows the success of the treatment. Also, no clinical signs of inflammation were observed and the soft tissue were healthy and stable. In the clinical examination of the patients, there was no metal showing within the soft tissue.

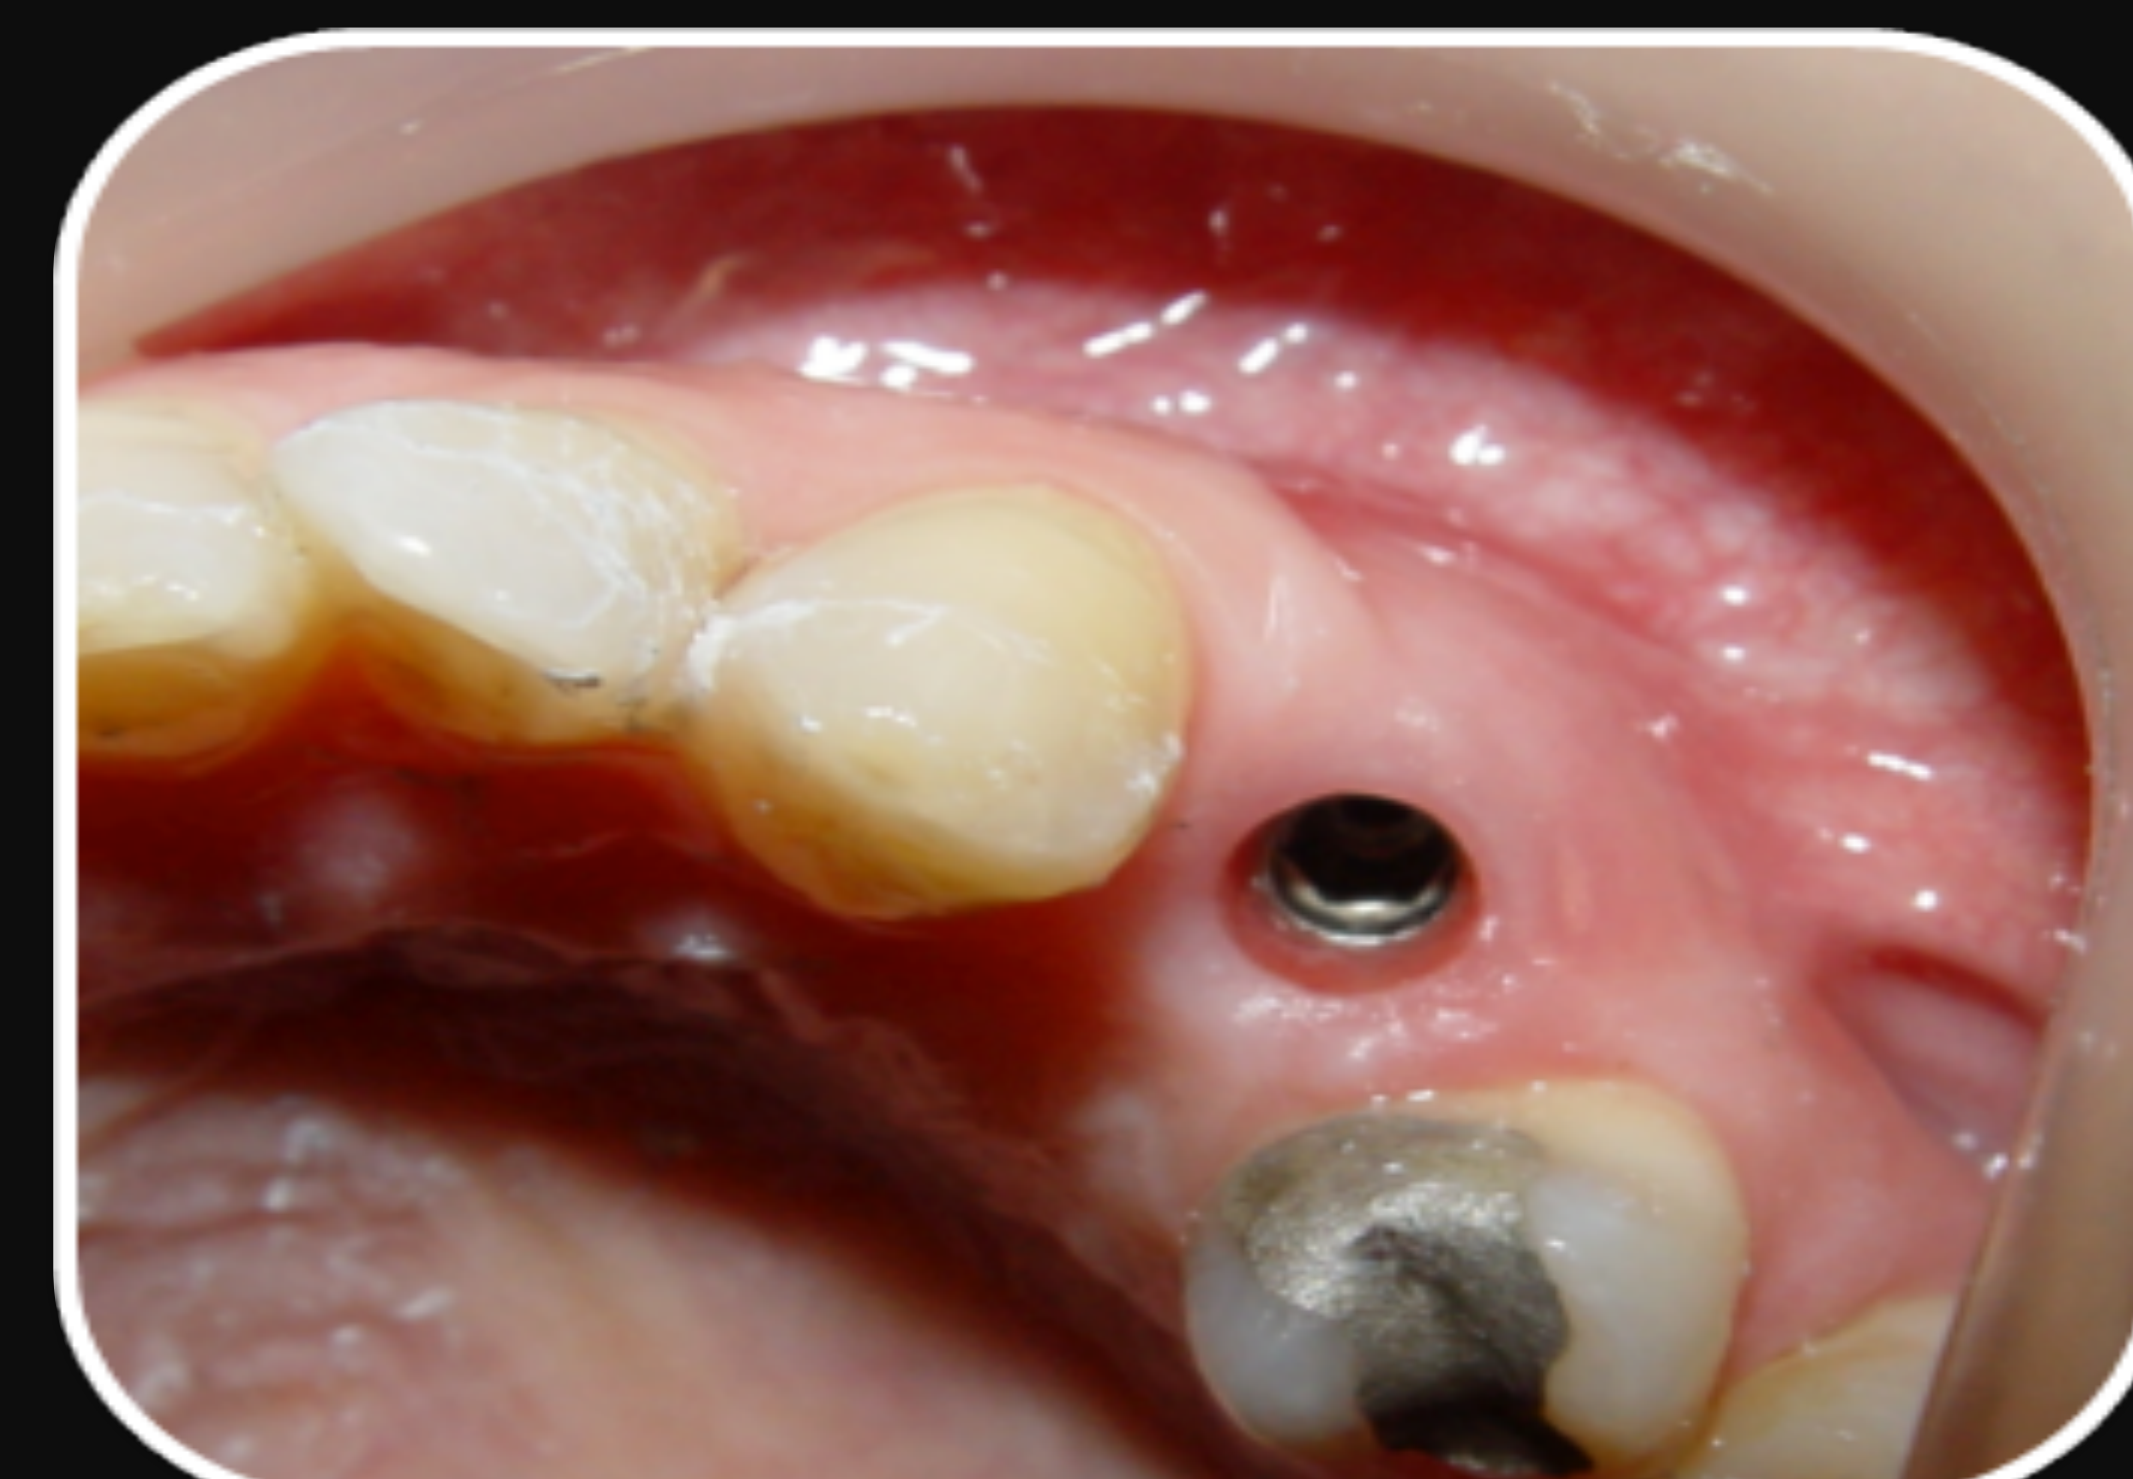
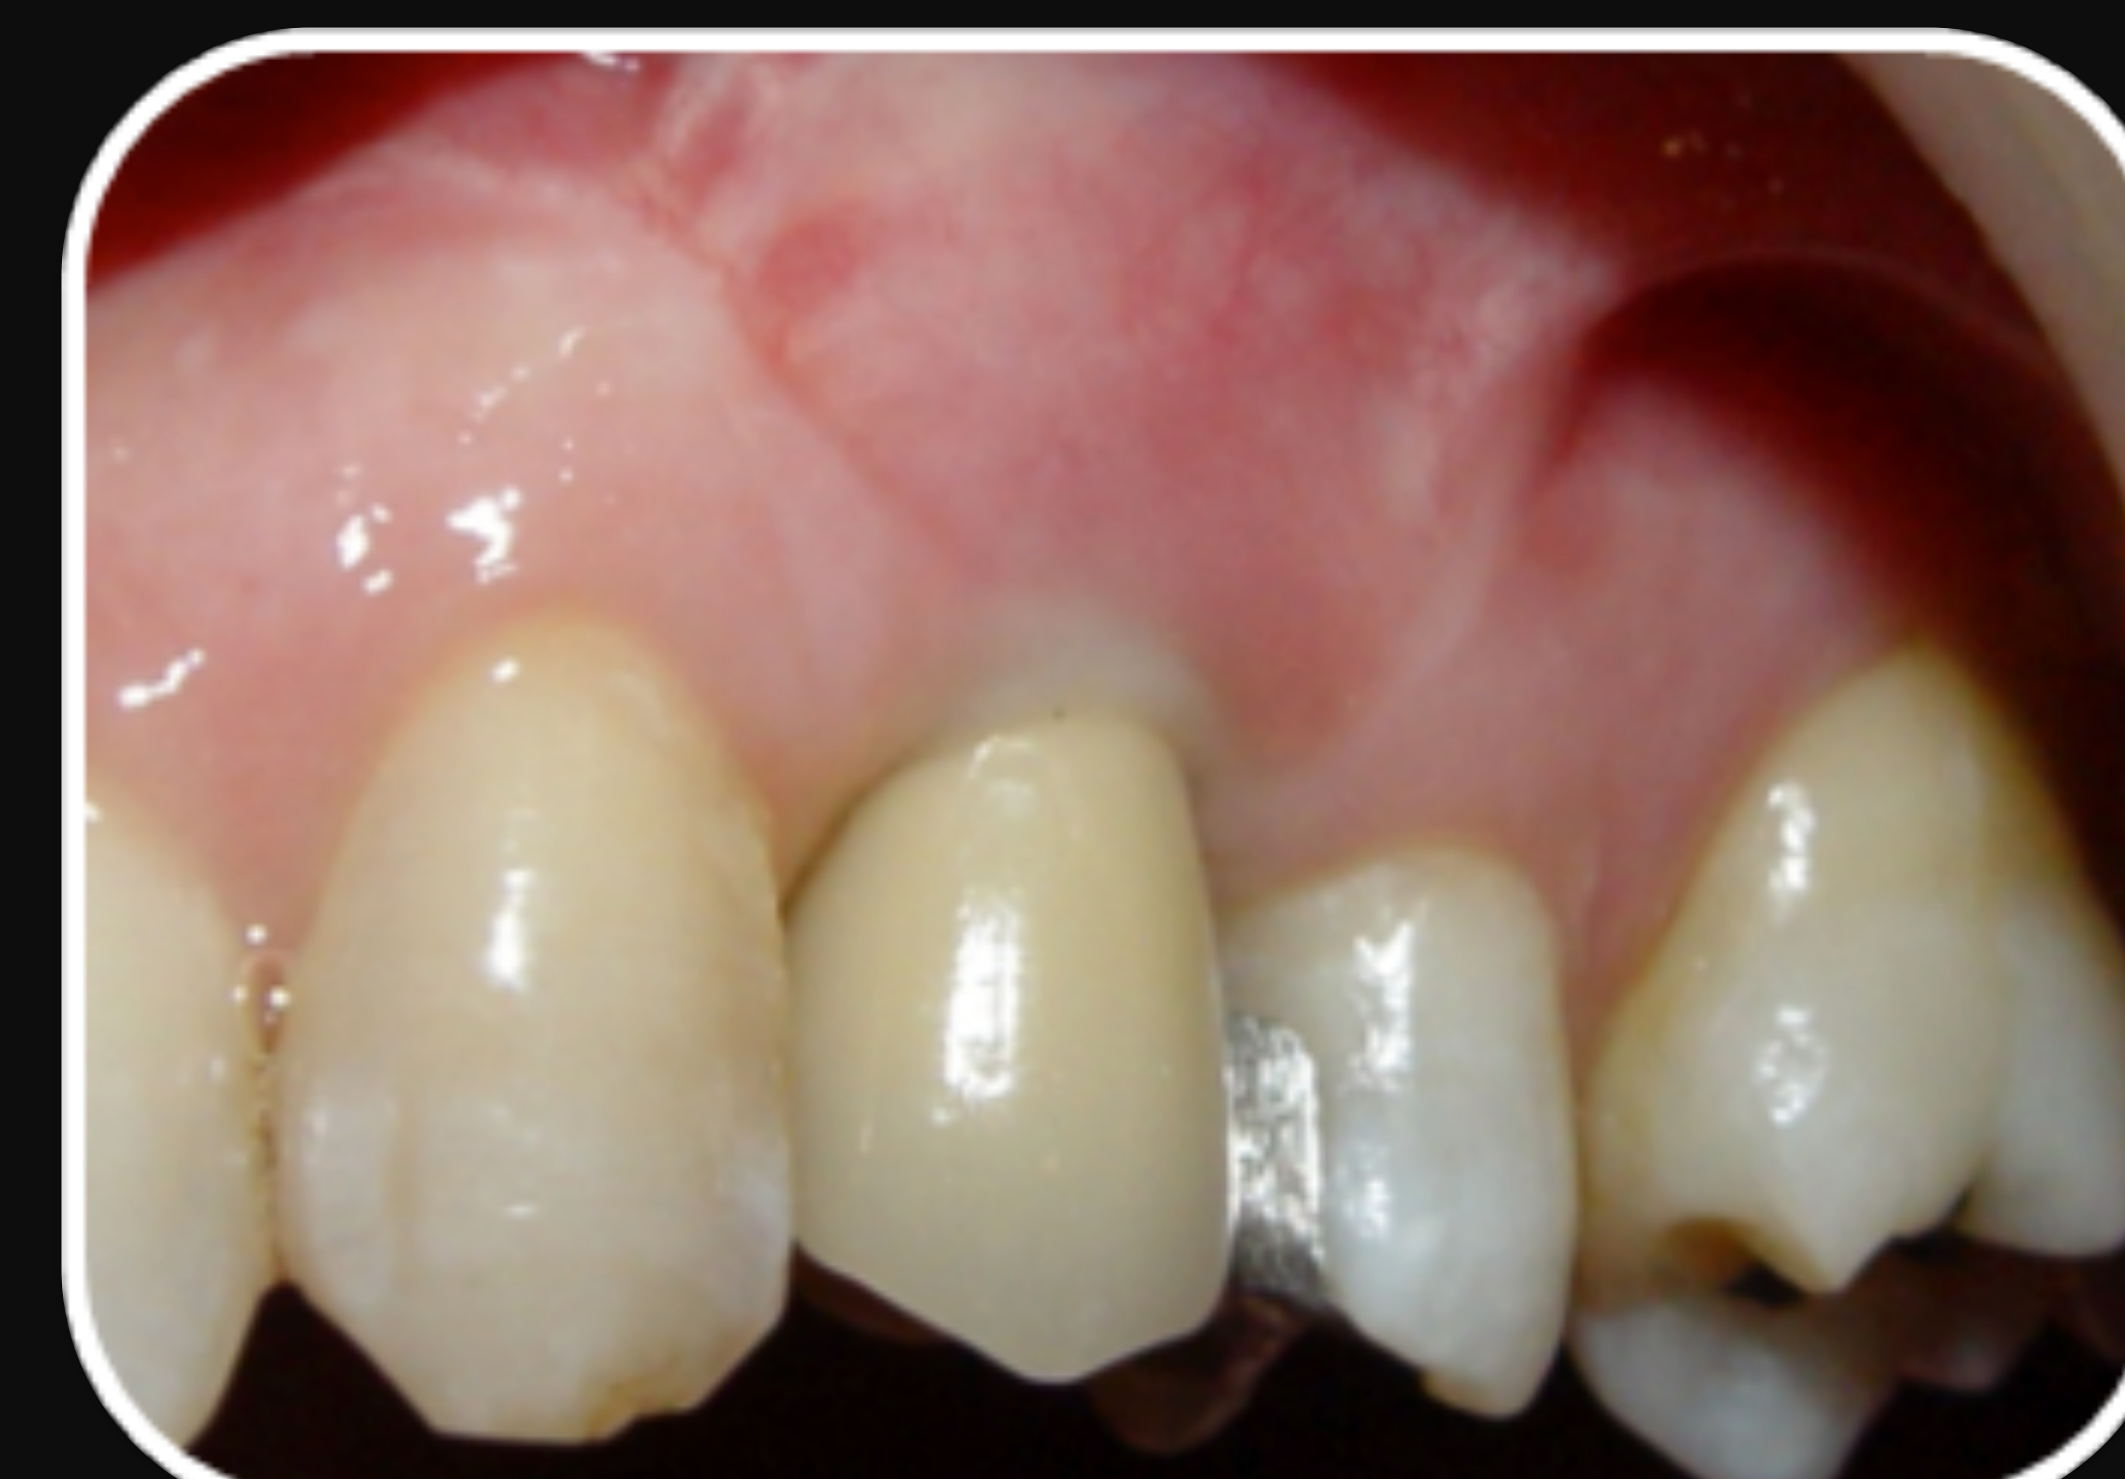
Final prosthesis
