# **A Novel Technique of Placing Immediate Implants in Poor Bone Sockets: The Hanged Implant Concept**

DR LAITH GLISSA, DDS

PR LATIFA BERREZOUGA, DDS, PHD

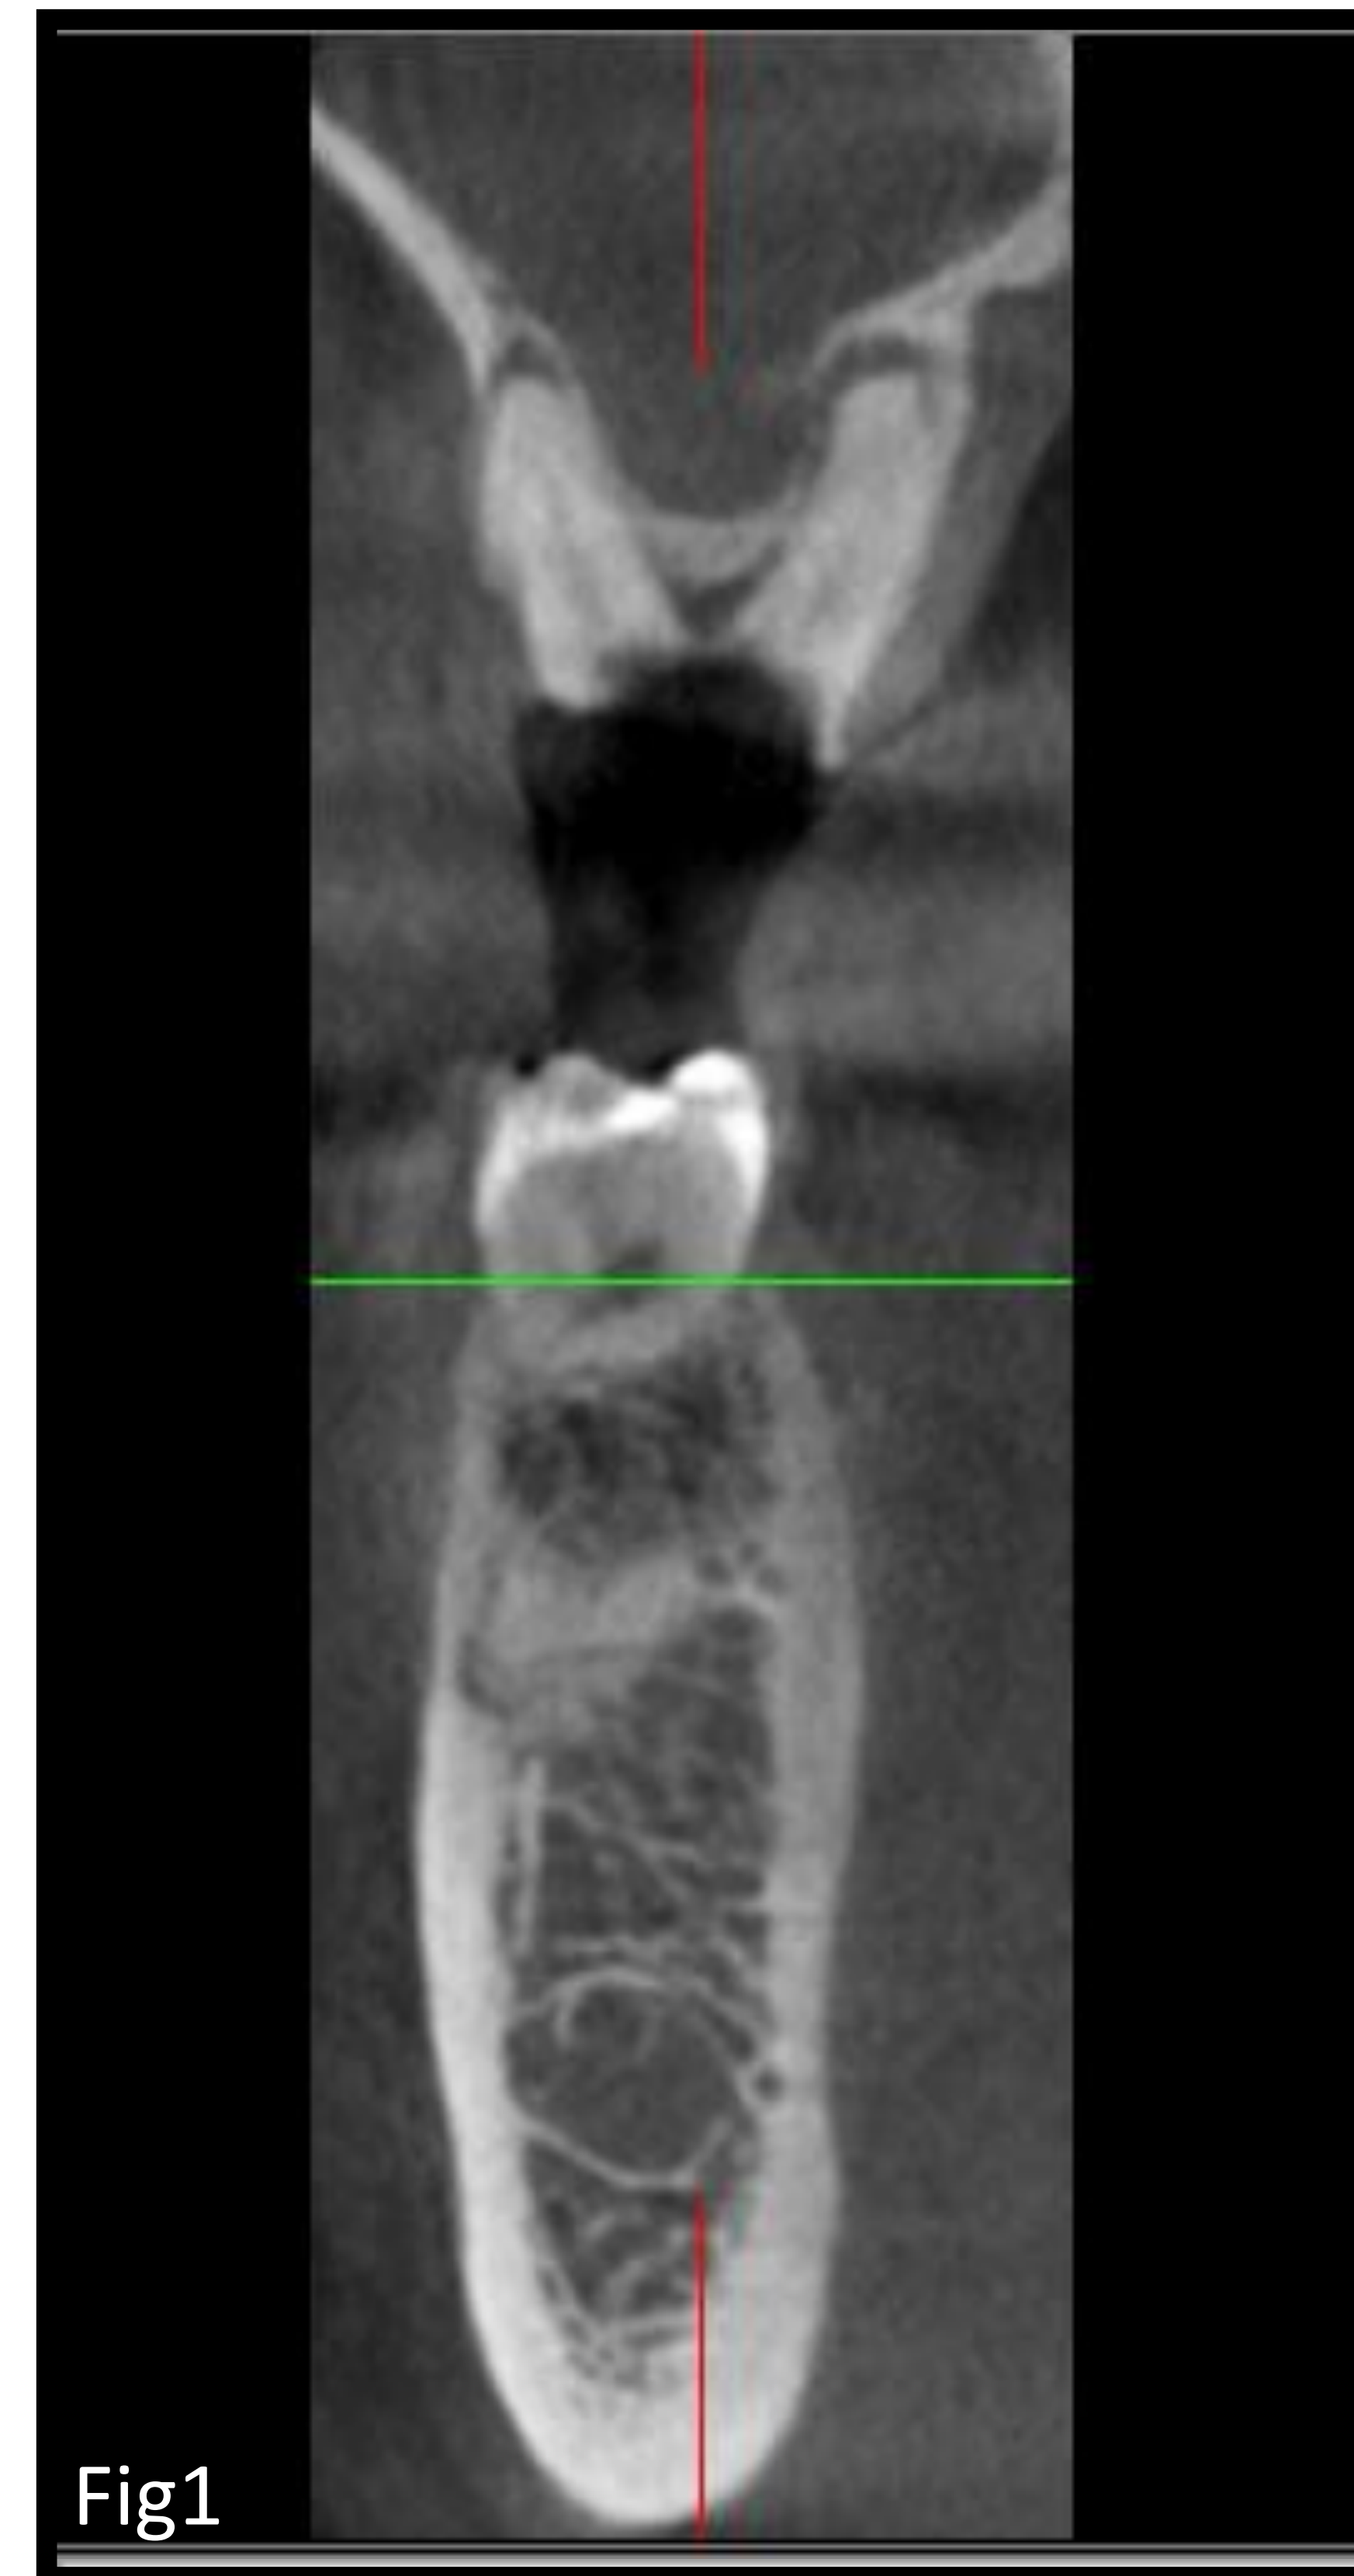
Case 1: maxillar first molar

**Initial Xrays**

The study involved three healthy patients with insufficient alveolar bone in the sockets to anchor implants properly (Fig 1,2). Implants were suspended in the sockets without bone contact and stabilized using zirconia membranes, which were secured to the buccal and lingual walls with screws (Fig 3,4,5a,5b,6,7,8,9,10,11,12 ). Two implants were placed in the posterior maxilla, and one in the posterior mandible. Bovine bone was added to one maxillary case (Case 1), while no grafts were used in the other maxillary (Case 2) or mandibular case (Case 3).

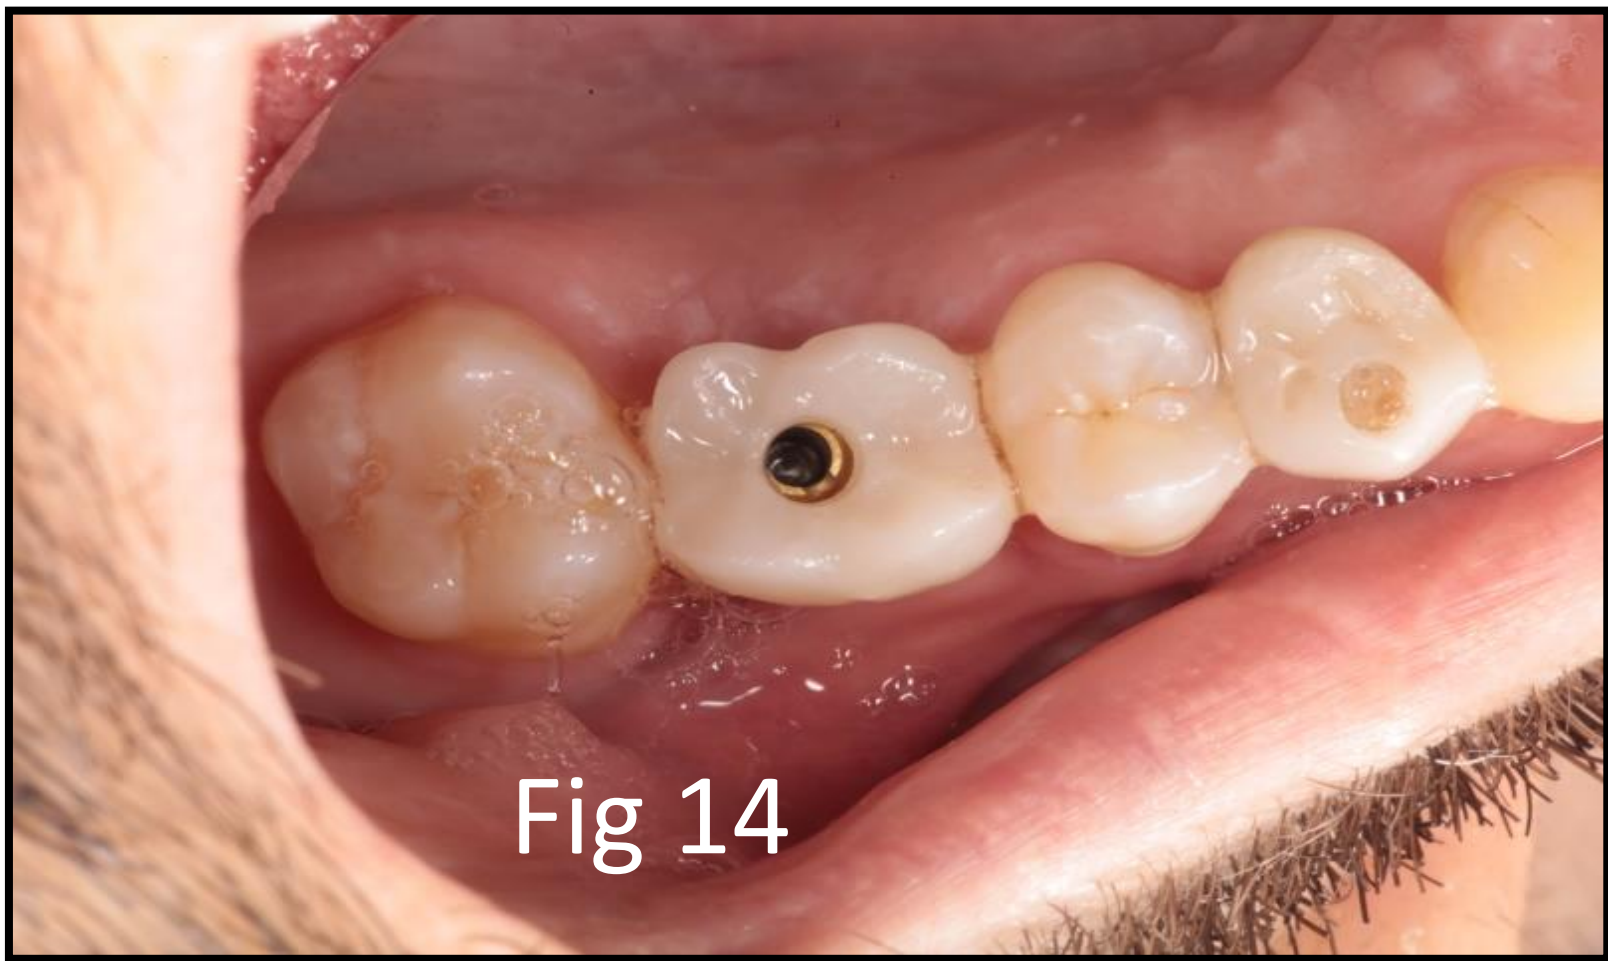
Patient 1 : 1 year recall

**Case 1**(Fig1,13,14): We removed the membrane after 8 months, with no signs of inflammation. A CT scan confirmed that bone covered the entire implant. Upon loading, the patient experienced no pain, and after 1 year, the implant remained healthy and fully functional.
