# From Complication to Reconstruction: Rehabilitation in Atrophic Maxilla. Clinical Case

DDS. PAUL DAVID GUALLPA GUAMAN. DDS. LIZBETH BARAJAS DE LA VEGA

Universidad Nacional Autónoma de México, UNAM.

Faculty of Dentistry High Specialization in Surgical and Prosthetic Oral Implantology

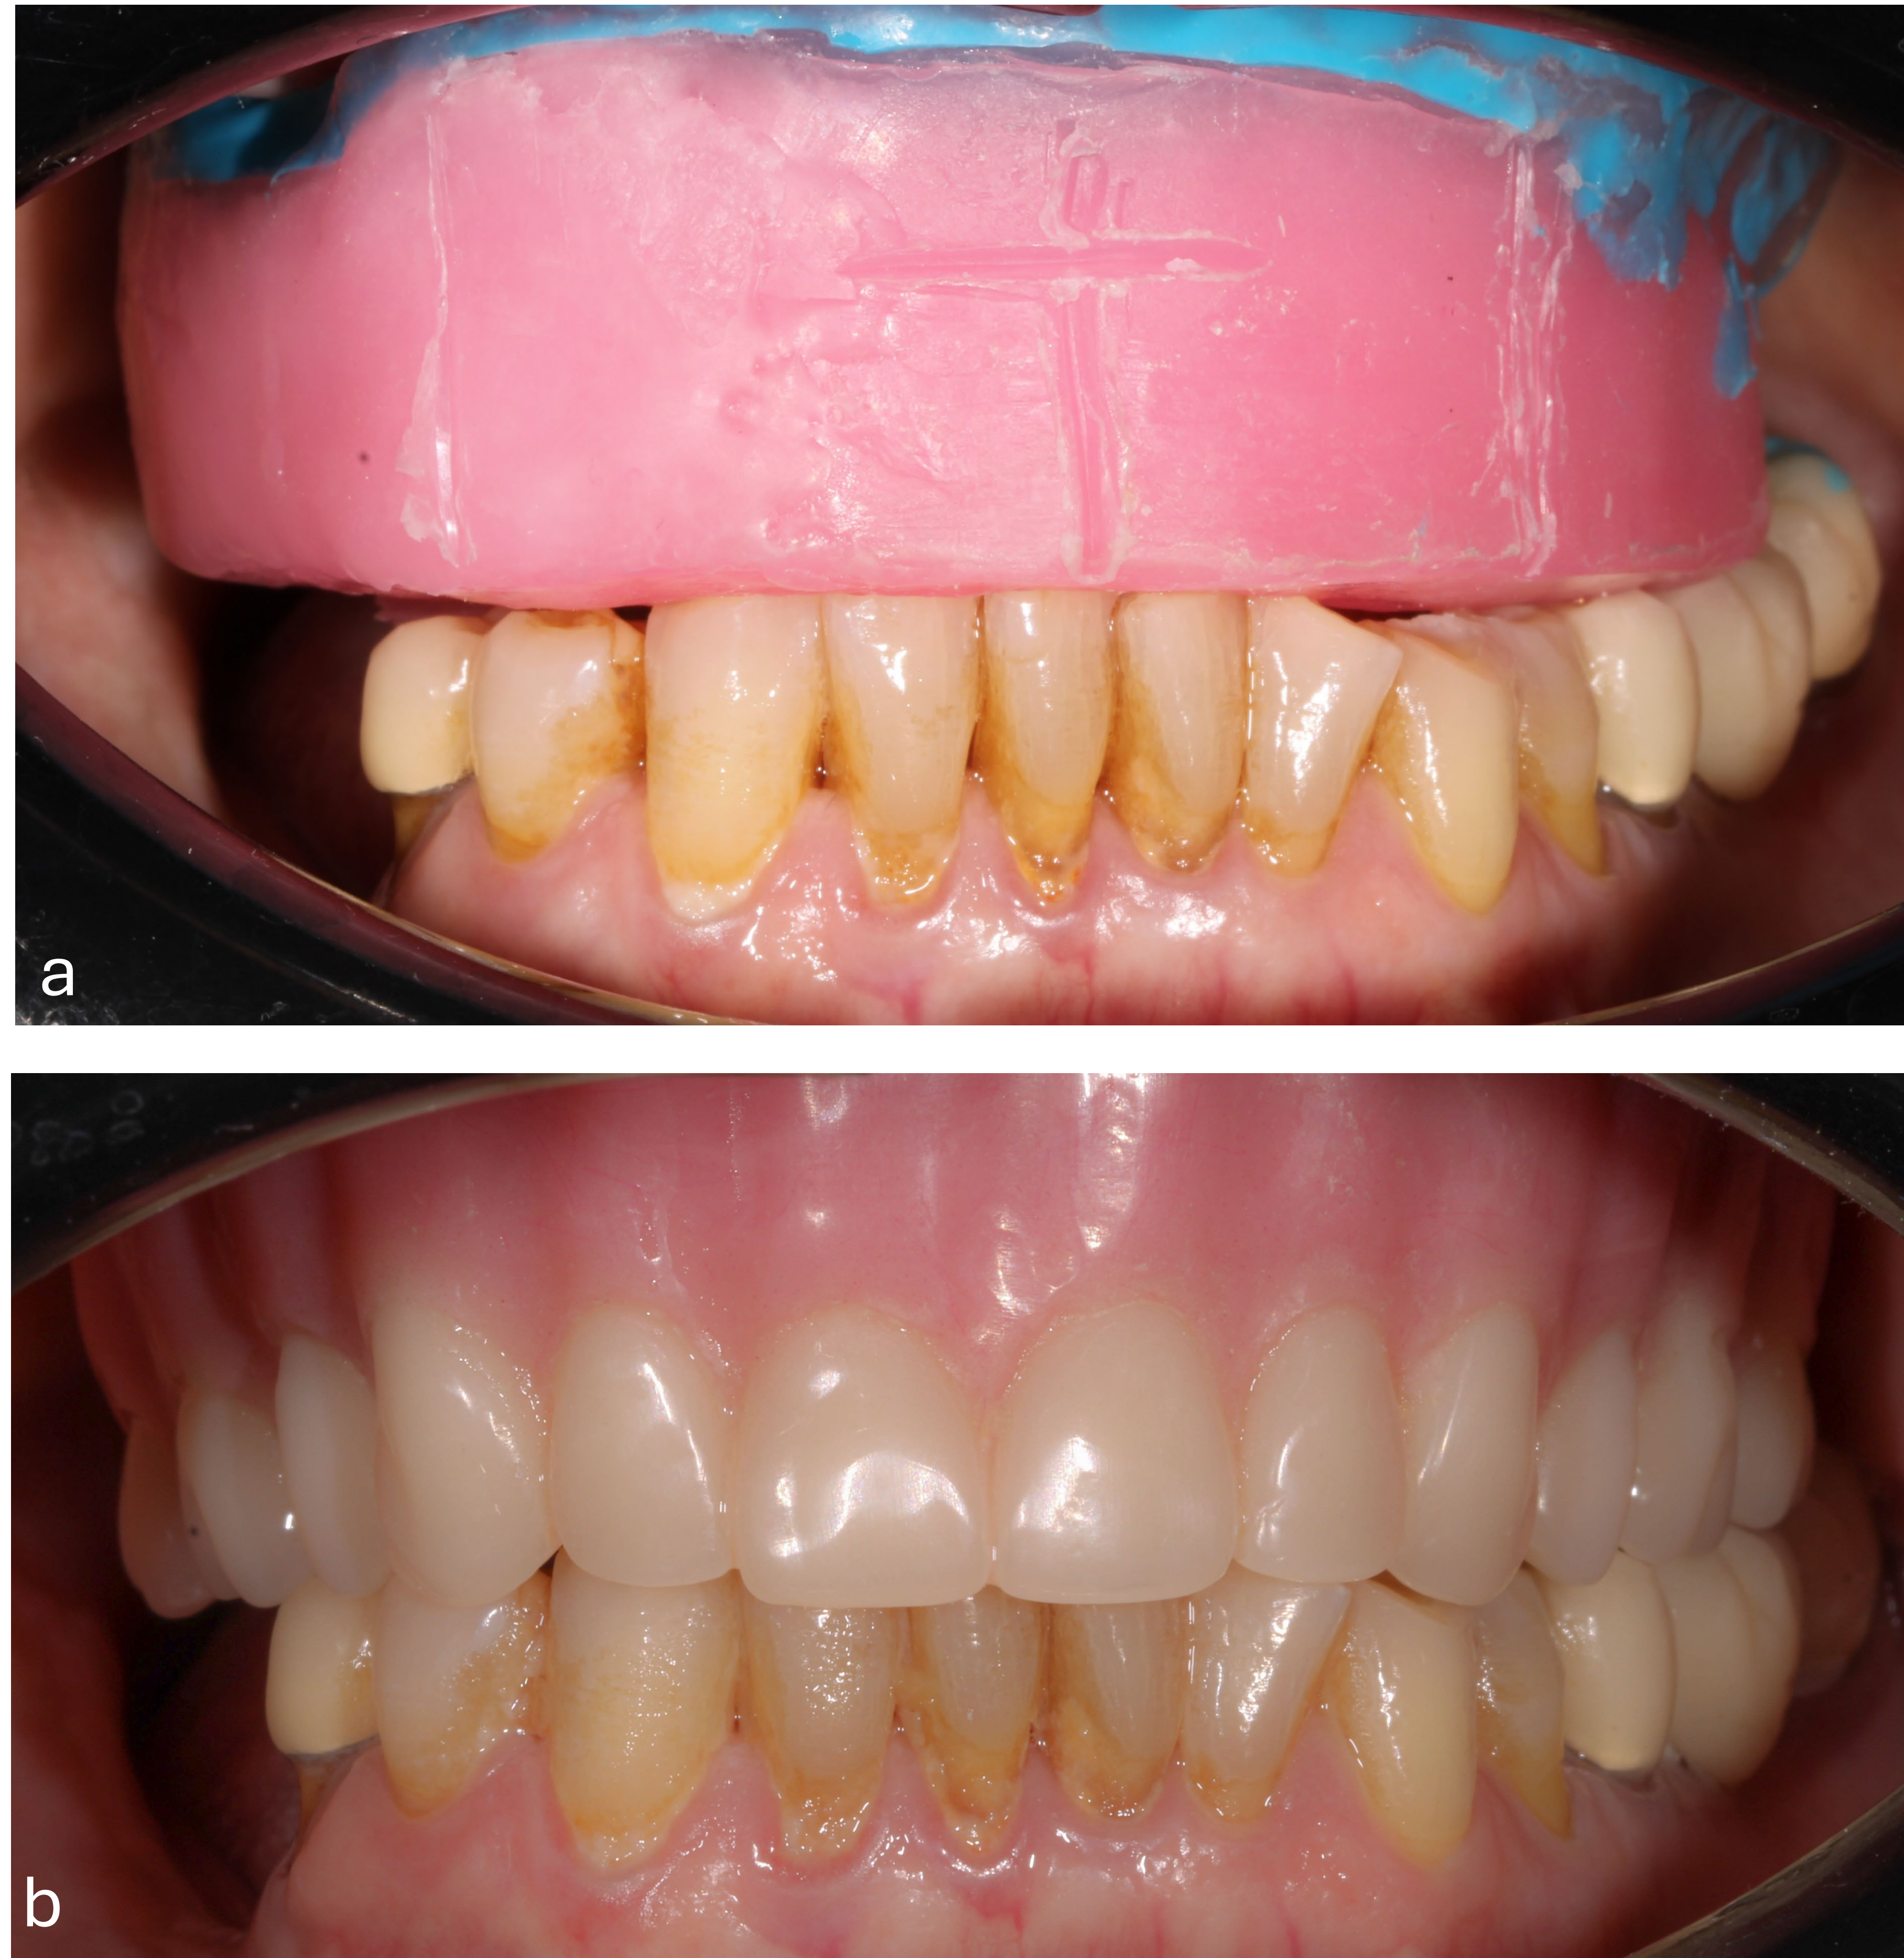
**Figure 4.** Prosthetic procedures for the fabrication of a complete upper denture with a new and correct orientation of teeth, a. Wax try-in of the prosthesis to obtain vertical dimension and aesthetic measurements b. Upper denture to be used as a tomographic guide. Gutta-percha markers will be added to facilitate the correct positioning of the implants based on the ideal tooth arrangement.

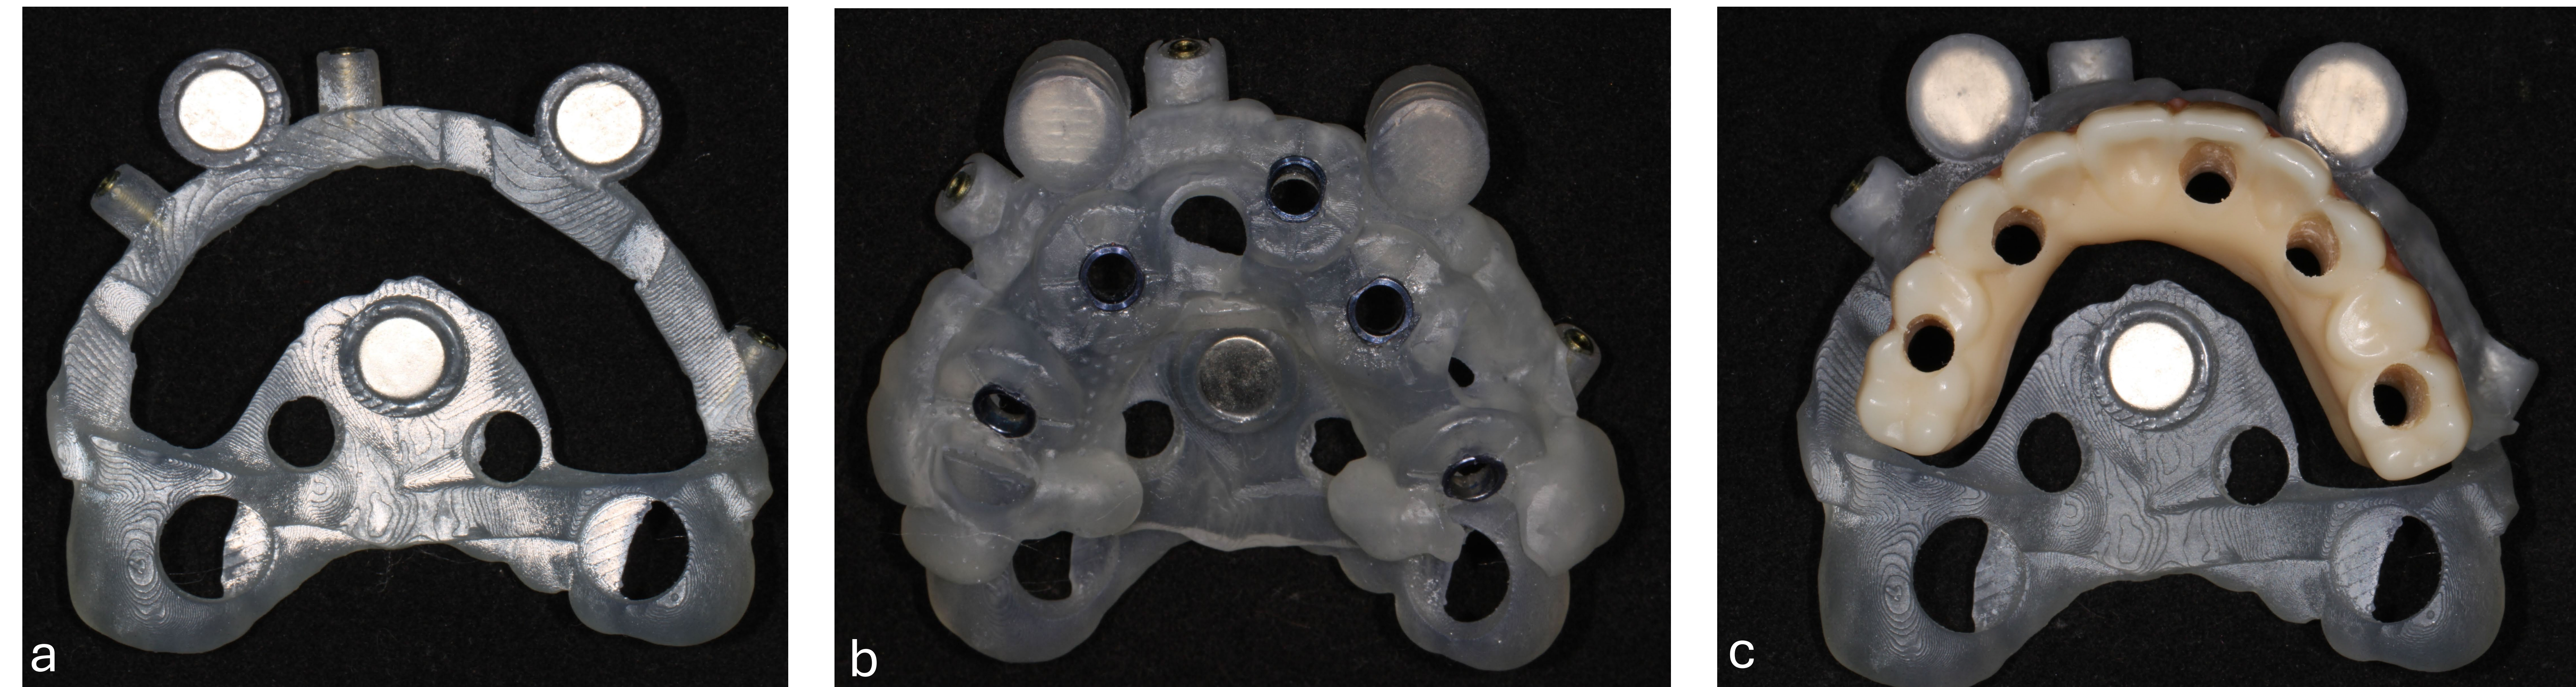
**Figure 6.** Surgical and positioning guides printed in resin, a. Base guide for pin anchorage, b. Guide for implant placement, c. Guide for prosthesis positioning for immediate loading.

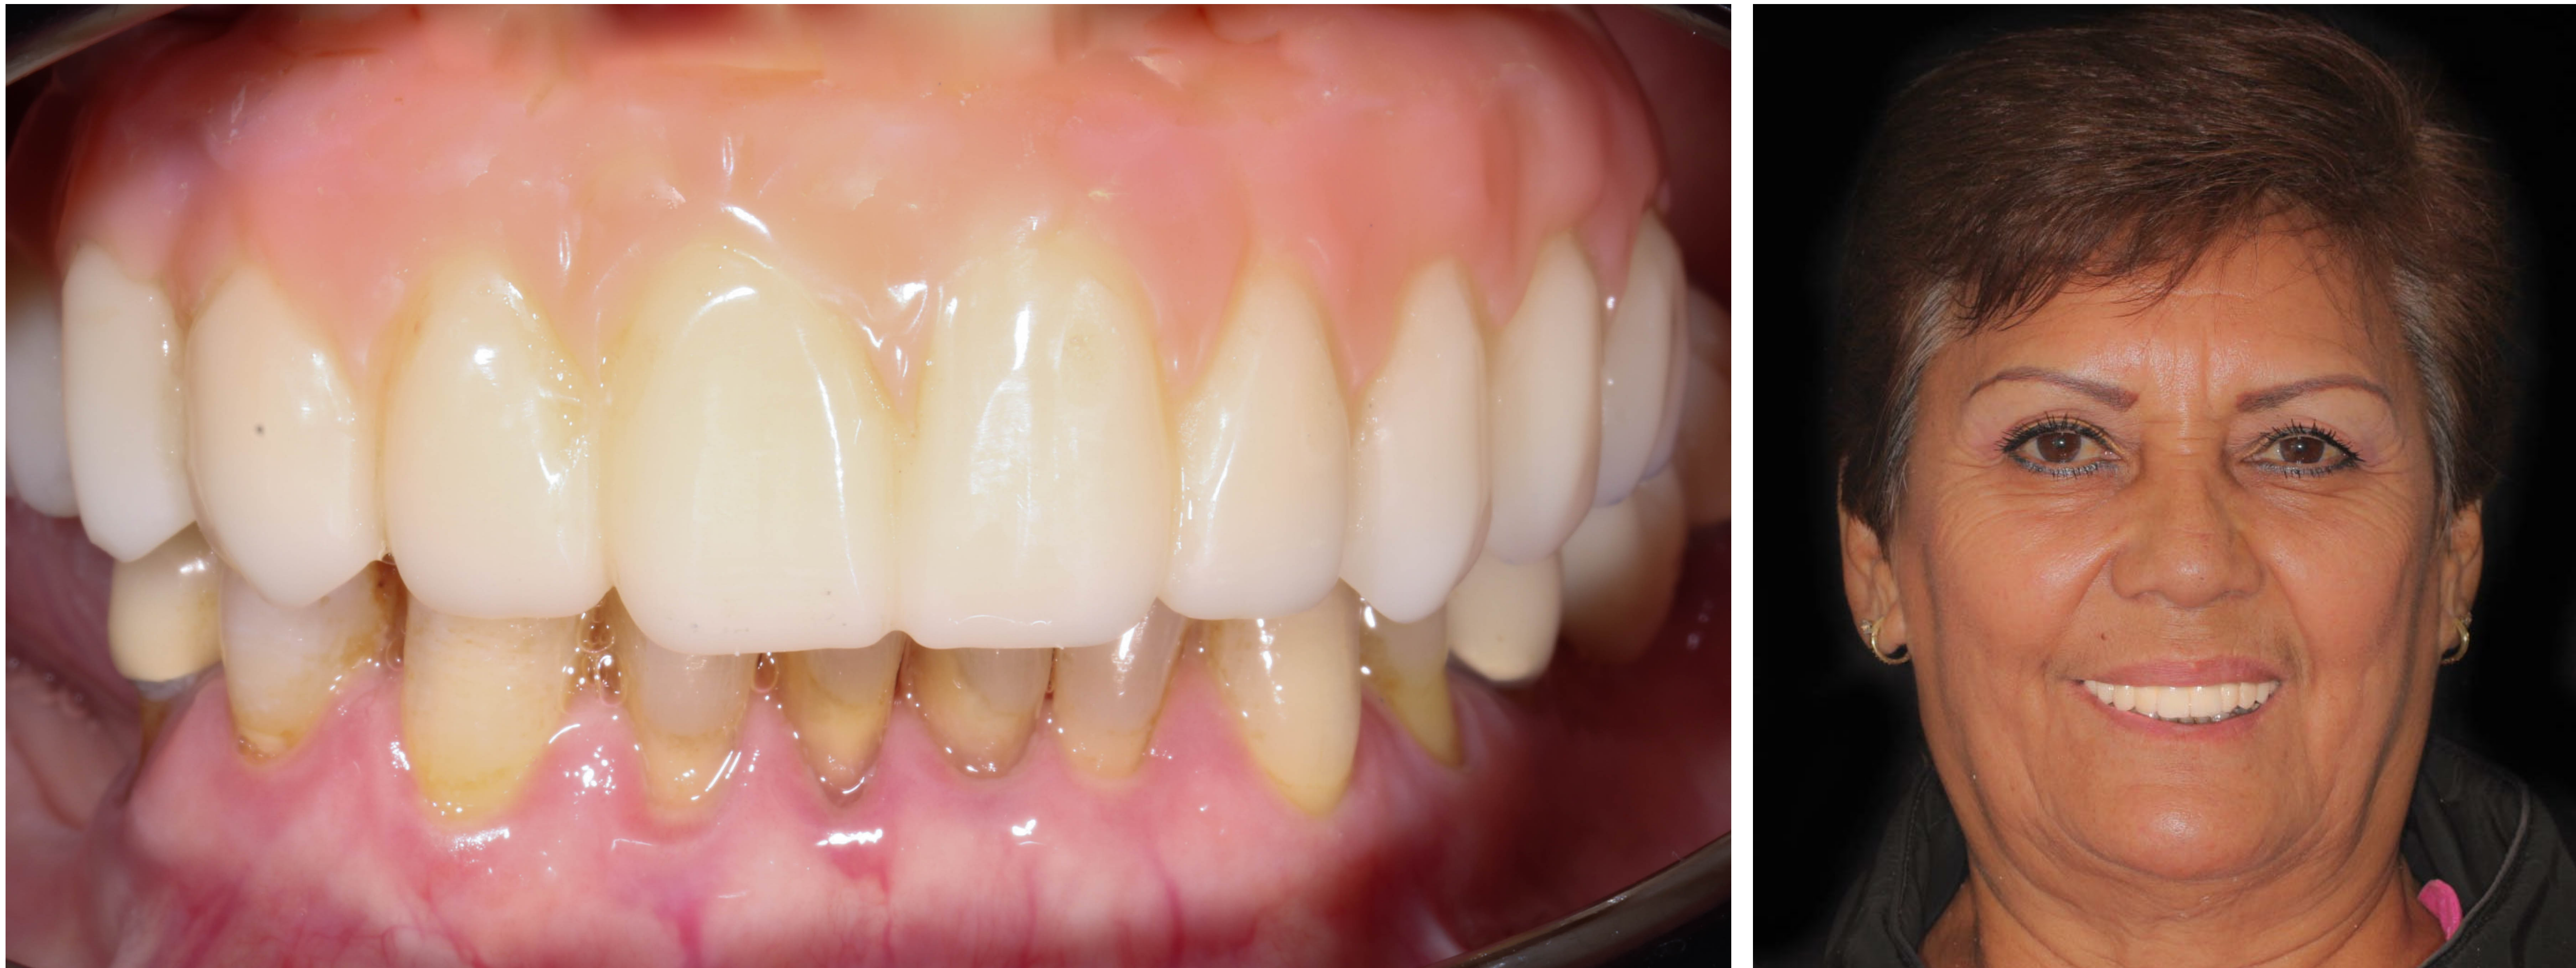
**Figure 8.** Clinical outcomes after intervention, a. Immediate hybrid prosthesis screwed into the mouth, b. Extraoral aesthetics similar to initial situation.

The patient reported significant improvements in comfort, functionality, and the ability to perform daily activities. Aesthetic outcomes were consistent with prior results, with no notable differences between the previous and new prostheses. Patient satisfaction, measured by the OHIP-5 questionnaire, improved from 9/20 pre-treatment to 2/20 post-intervention, with the most notable improvements seen in oral function and psychosocial impact.
