# A Novel Technique to Retrieve Stripped Healing Abutment with Limited Interarch Space: A Case Report

Angela Gullard, DMD, PhD, MDS

Department of Prosthodontics, College of Dentistry, University of Tennessee Health Science Center, Memphis, TN

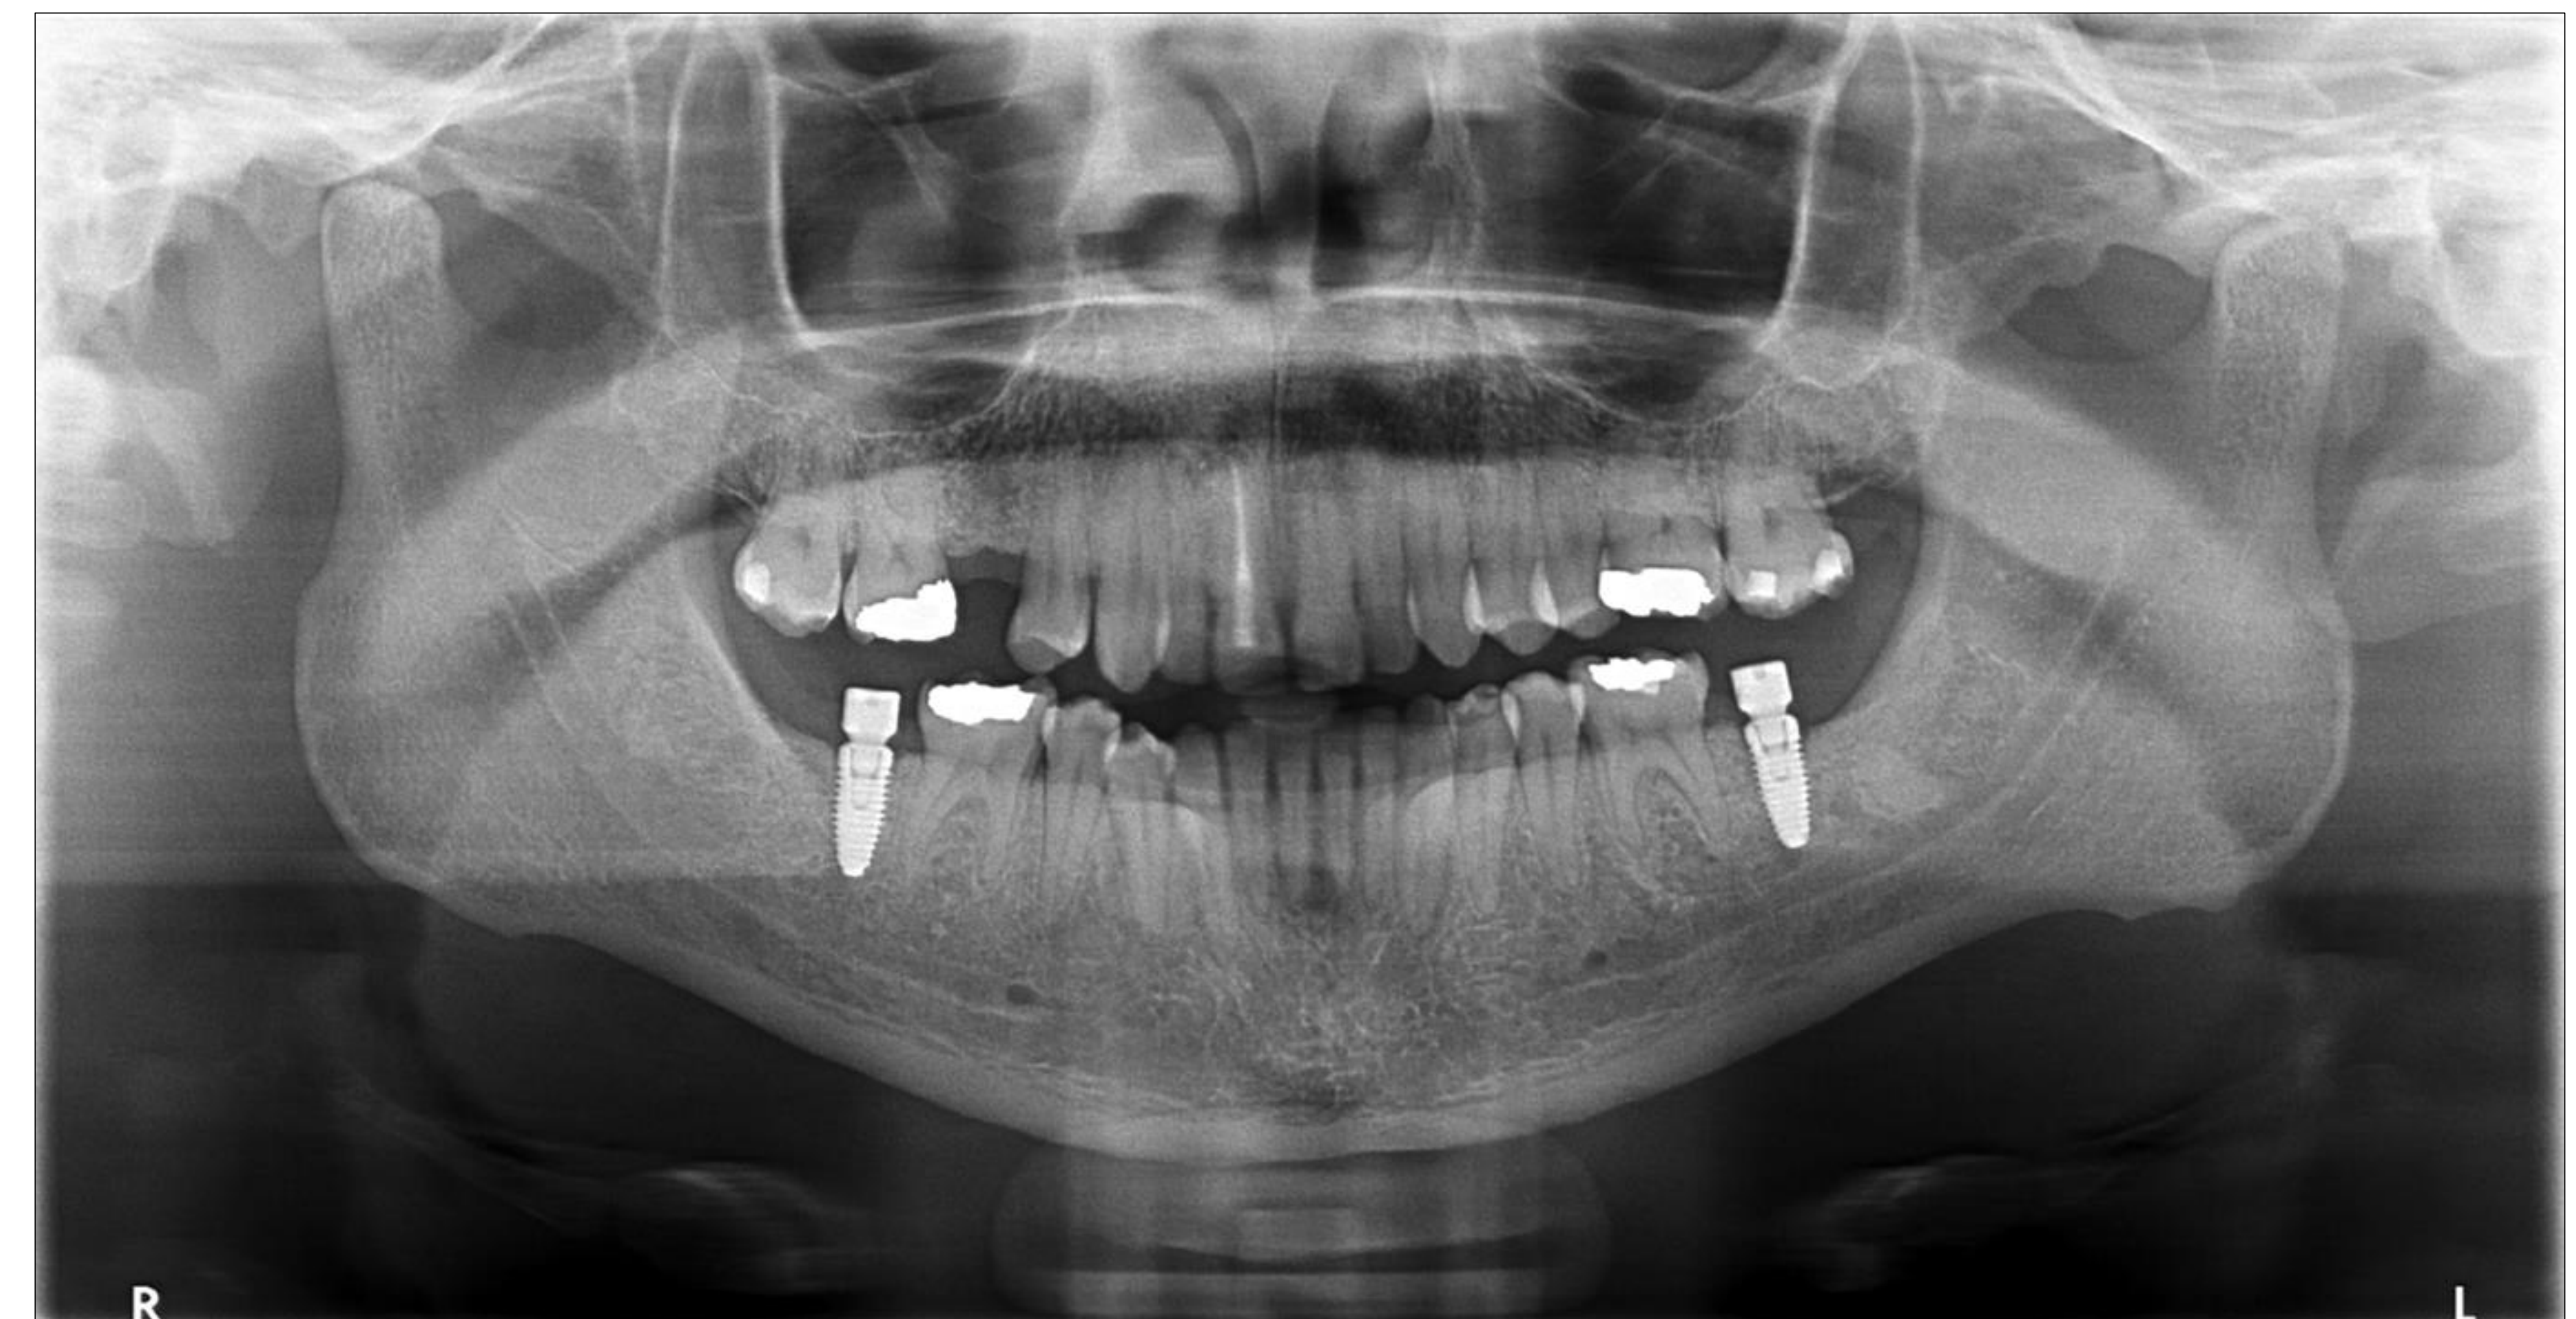
**Figure 1.** Panoramic radiograph obtained after uncovering of implants #18 and 31.

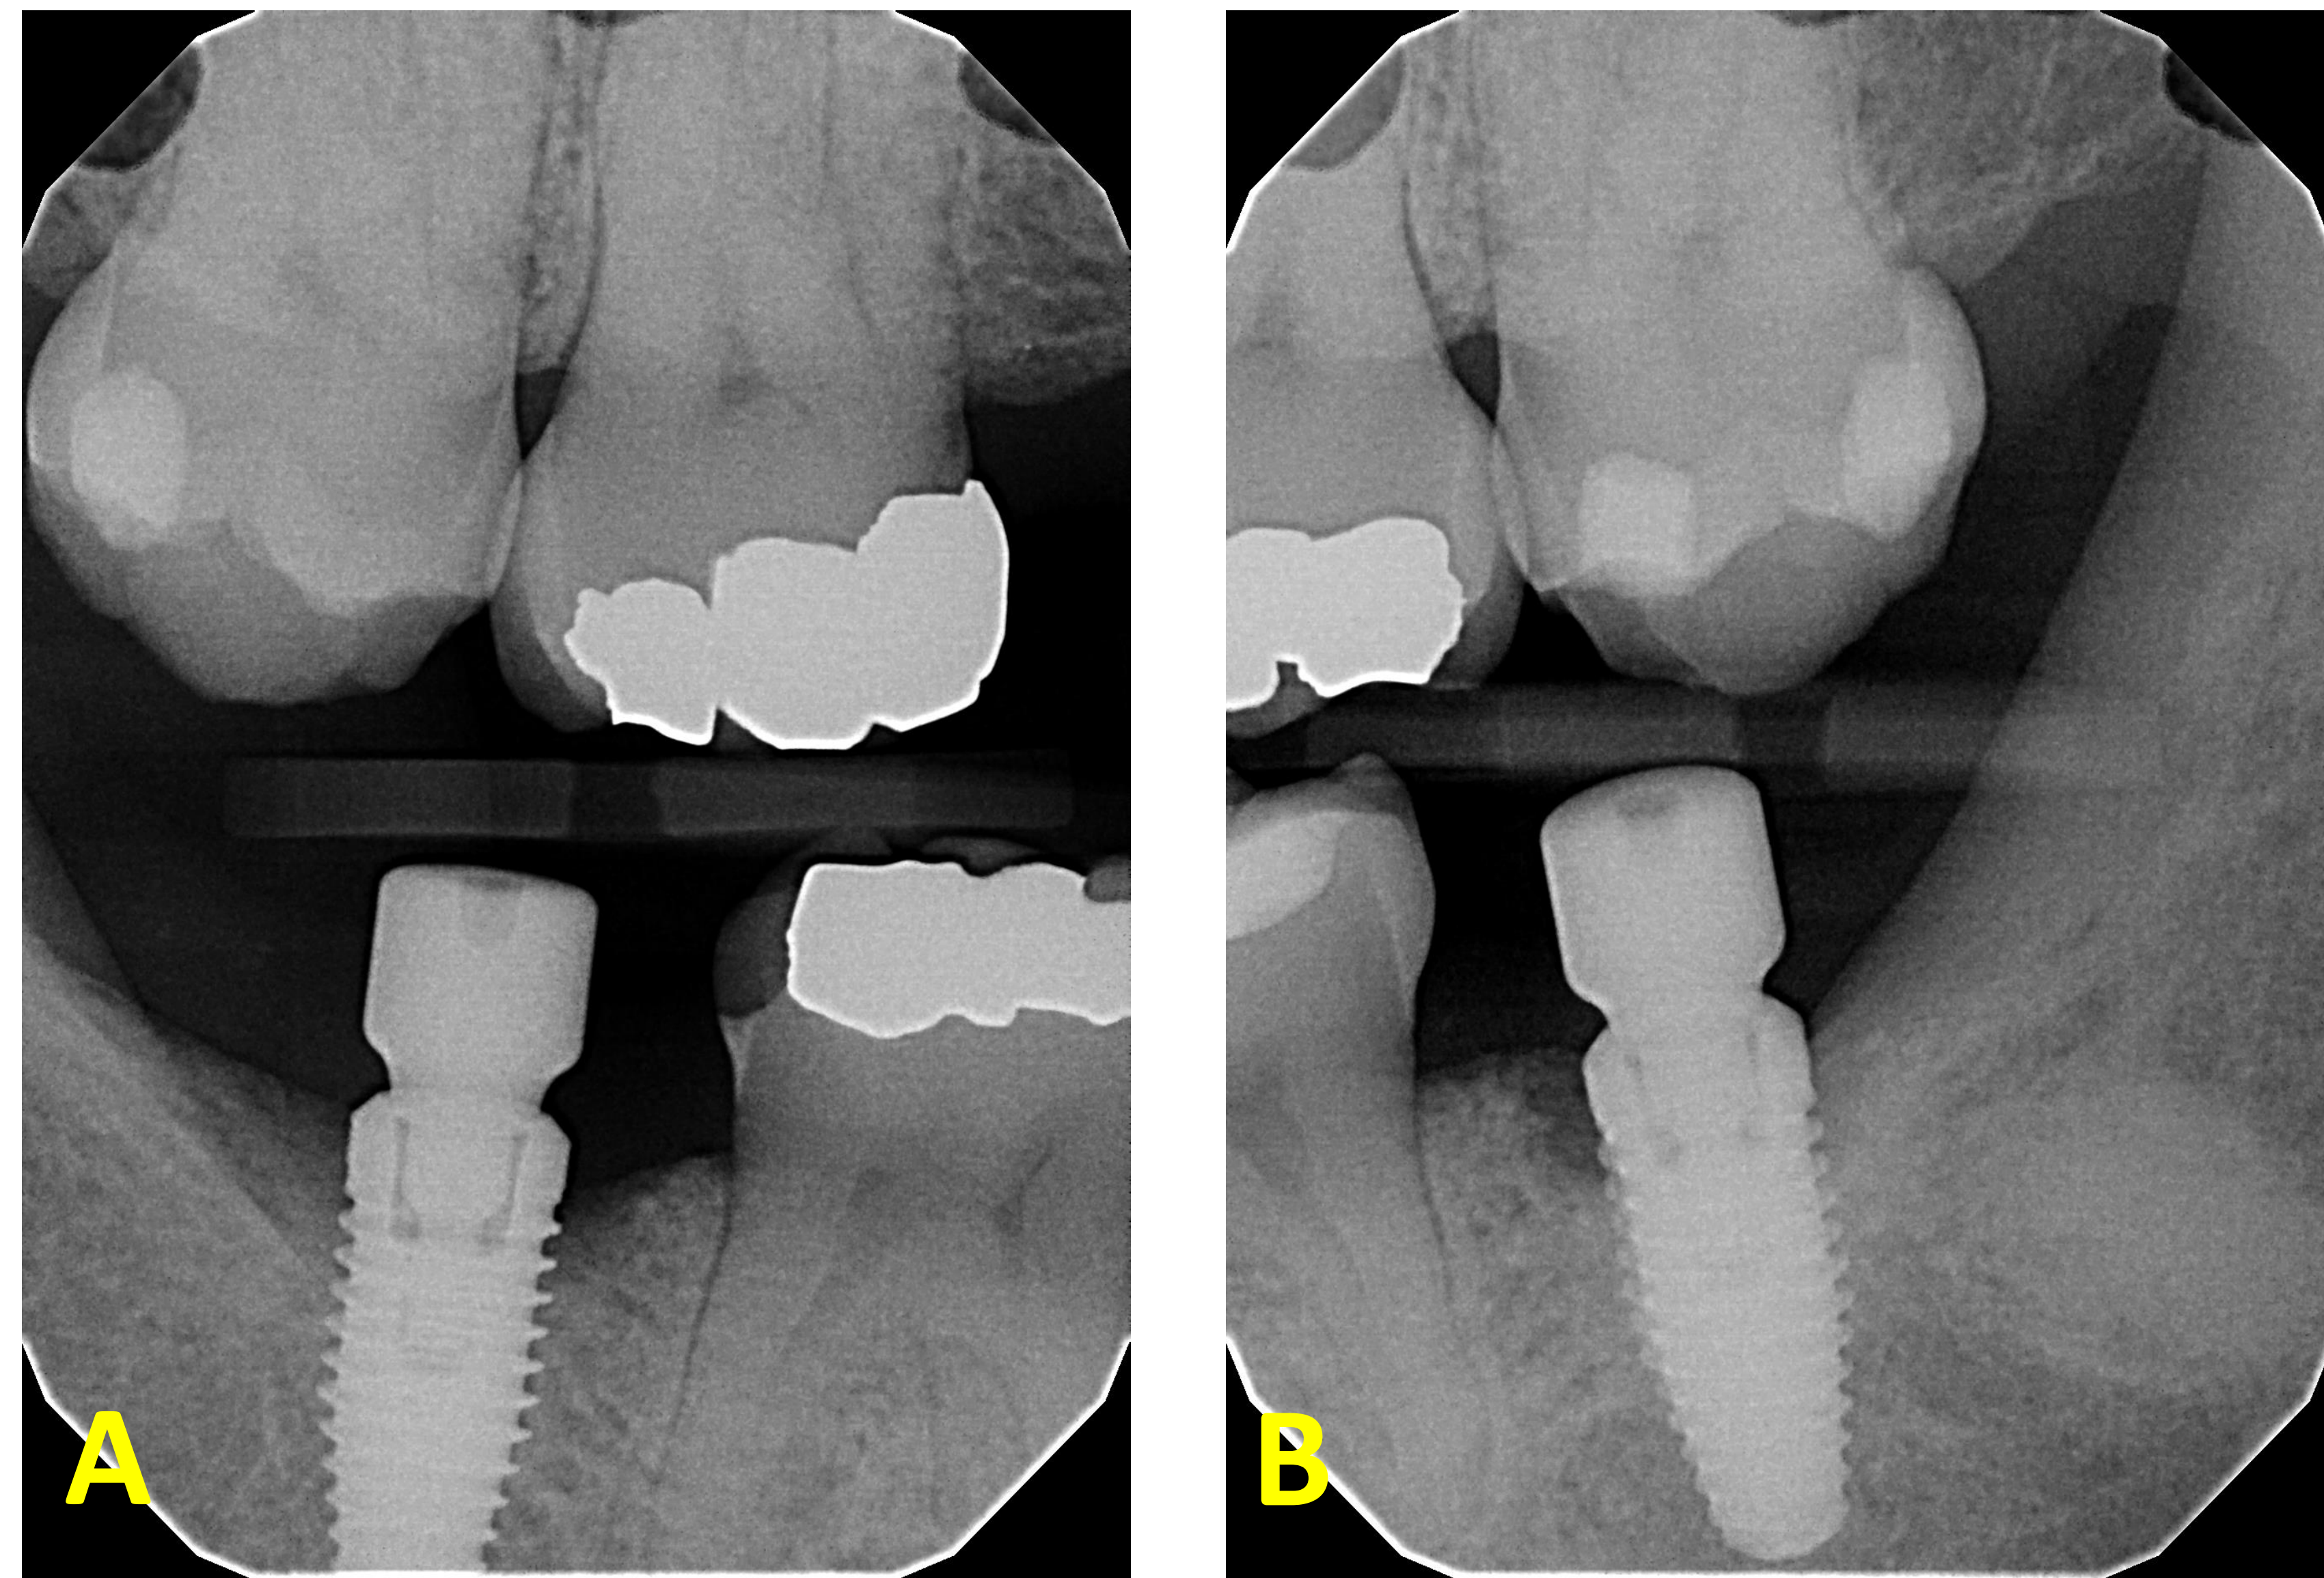
**Figure 2.** Vertical bitewing radiographs demonstrating excessively tall healing abutments at sites #31 (A) and 18 (B).

- Existing implants #18 and 31 with 5mm tall healing abutments (Nobel Replace Conical Connection RP 5x5mm).
- Patient is occluding on both healing abutments.
- Patient demonstrates limited mouth opening (interincisal distance approximately 32mm).
- Engaging feature of healing abutment #18 presents as rounded-out hexagon.
- Healing abutments seem to be cold-welded to implant platforms.
- Suppuration observed upon palpation of implant #31.
- Insufficient restorative space associated with implants #18 and 31.

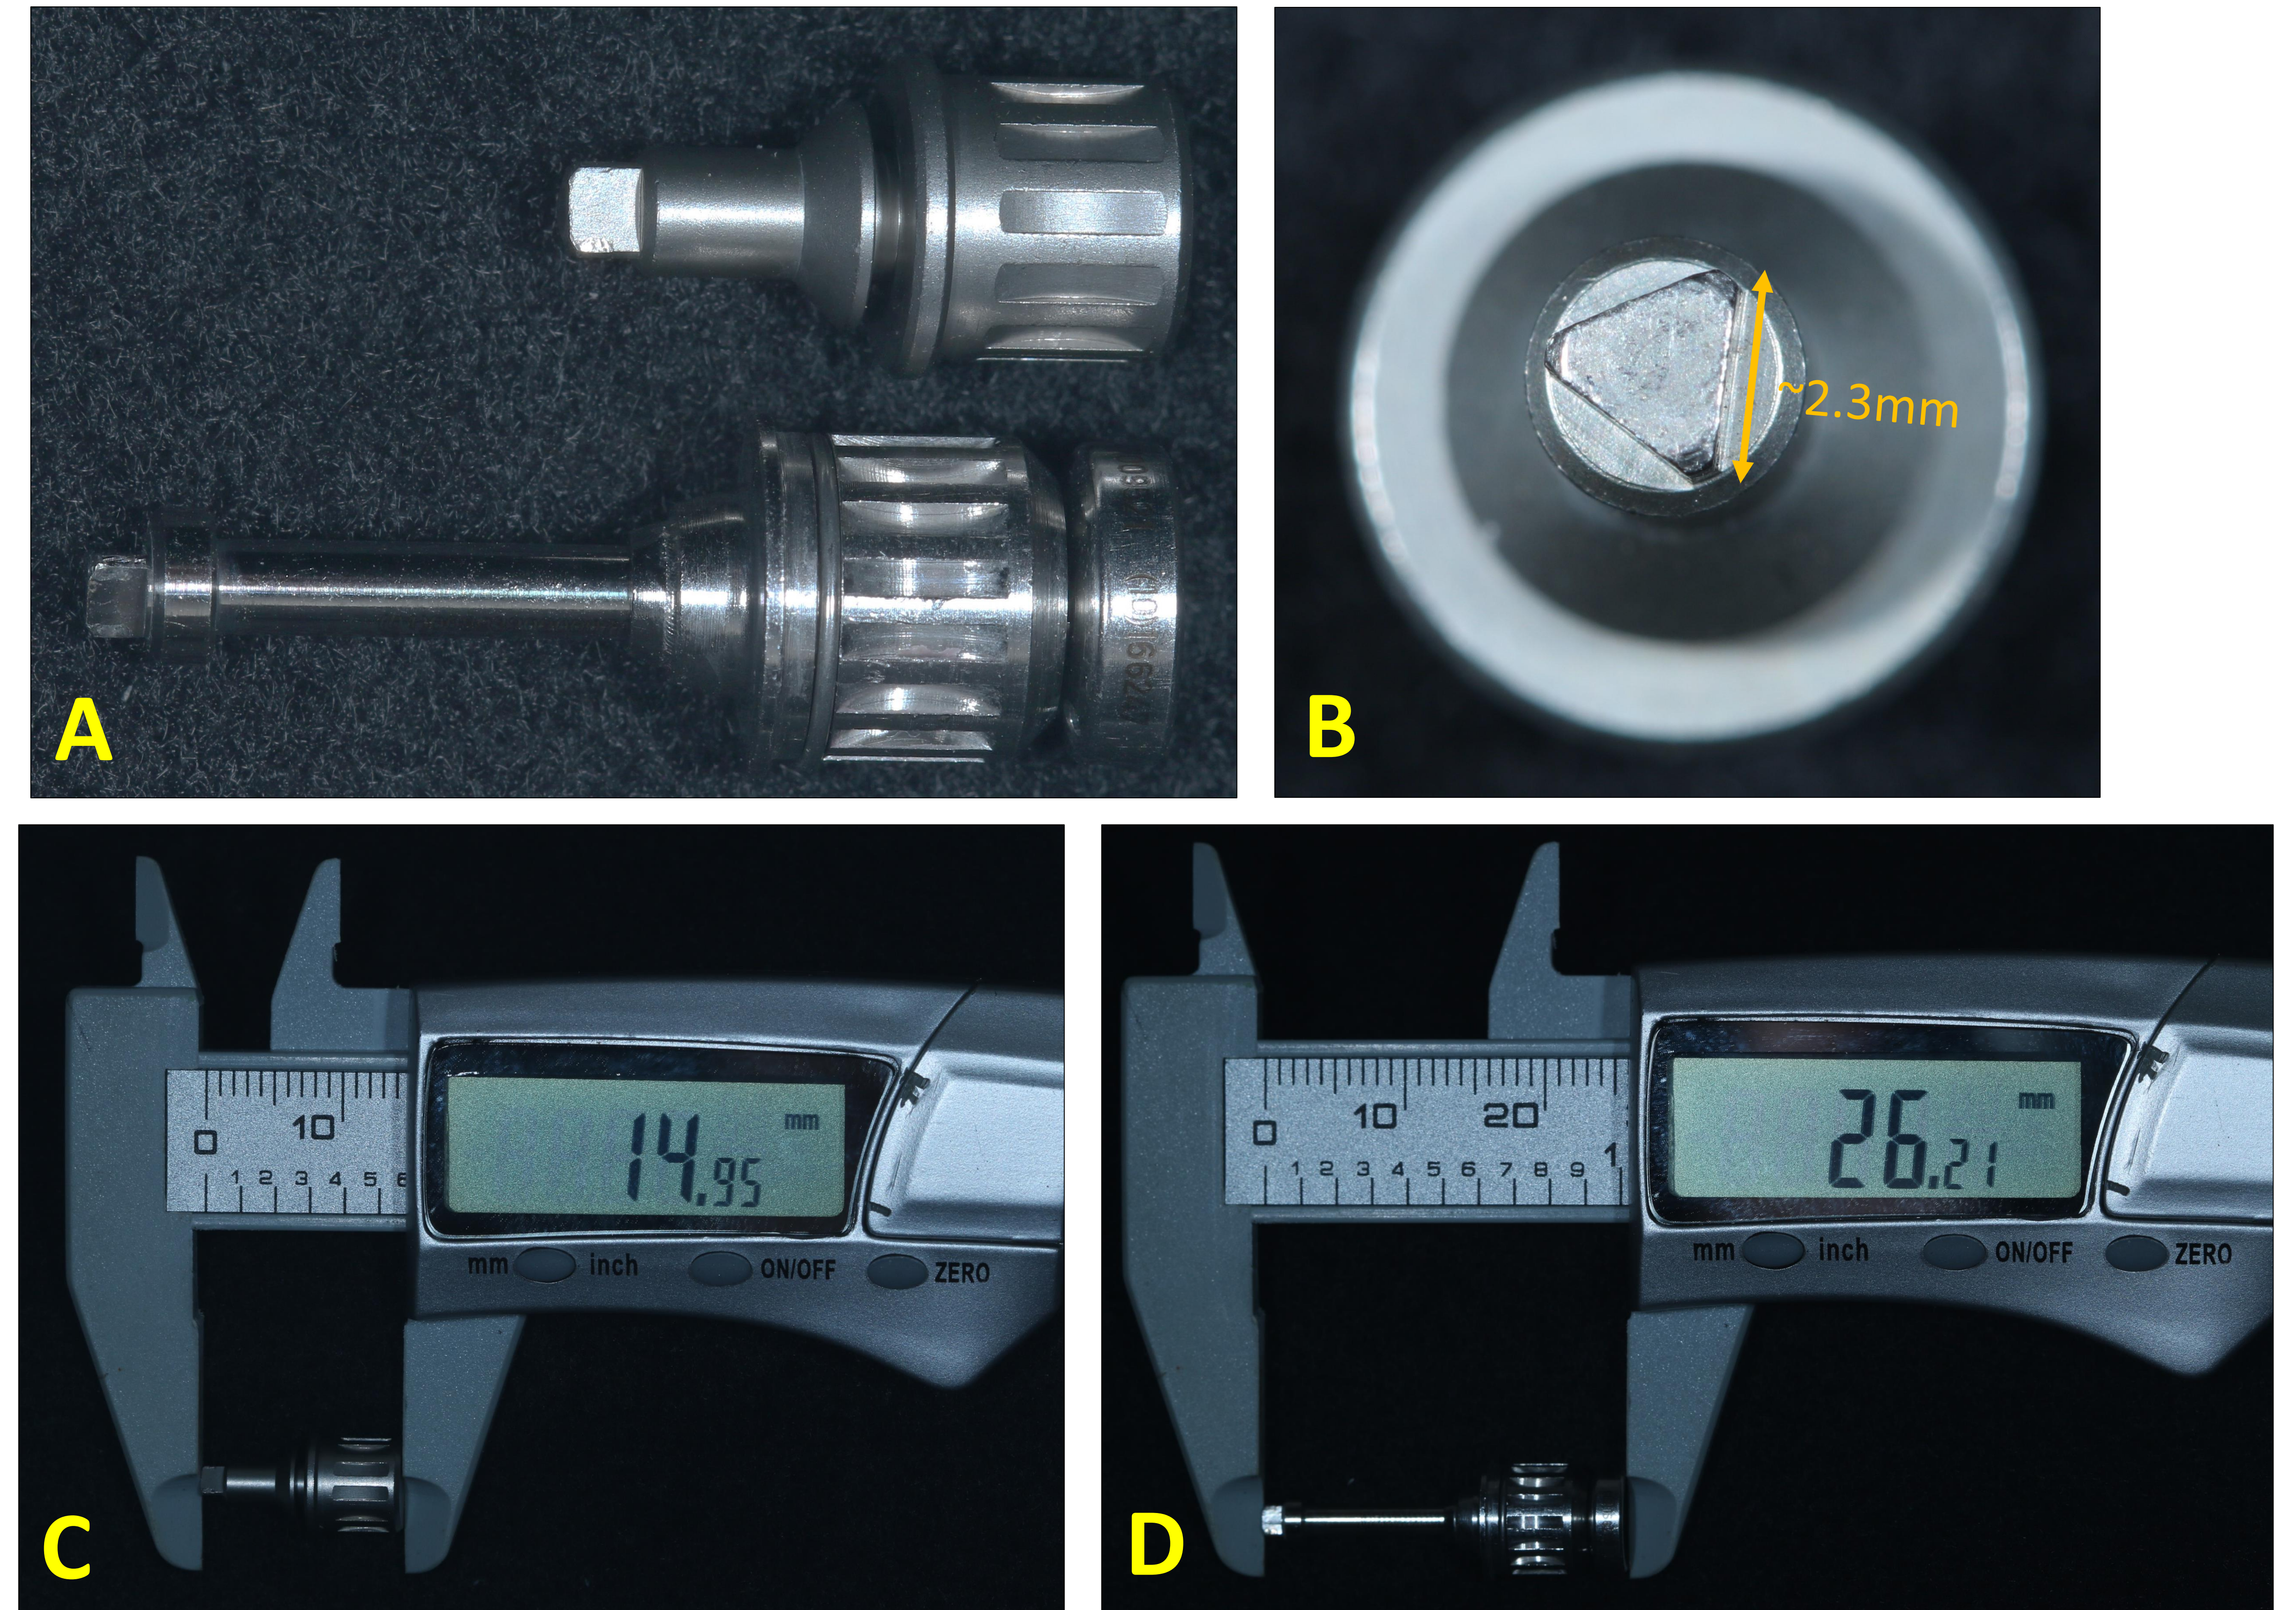
**Figure 3.** Overdenture abutment drivers from 2 implant systems were compared (A). The triangular driver tip resembles an equilateral triangle, with each side measuring approximately 2.3mm (B). The one-piece (Straumann Locator) short driver for ratchet measures about 15mm in length (C), while the two-piece (latch-type Locator driver and Nobel Biocare manual torque wrench adapter, prosthetic) measures about 26mm in length (D).

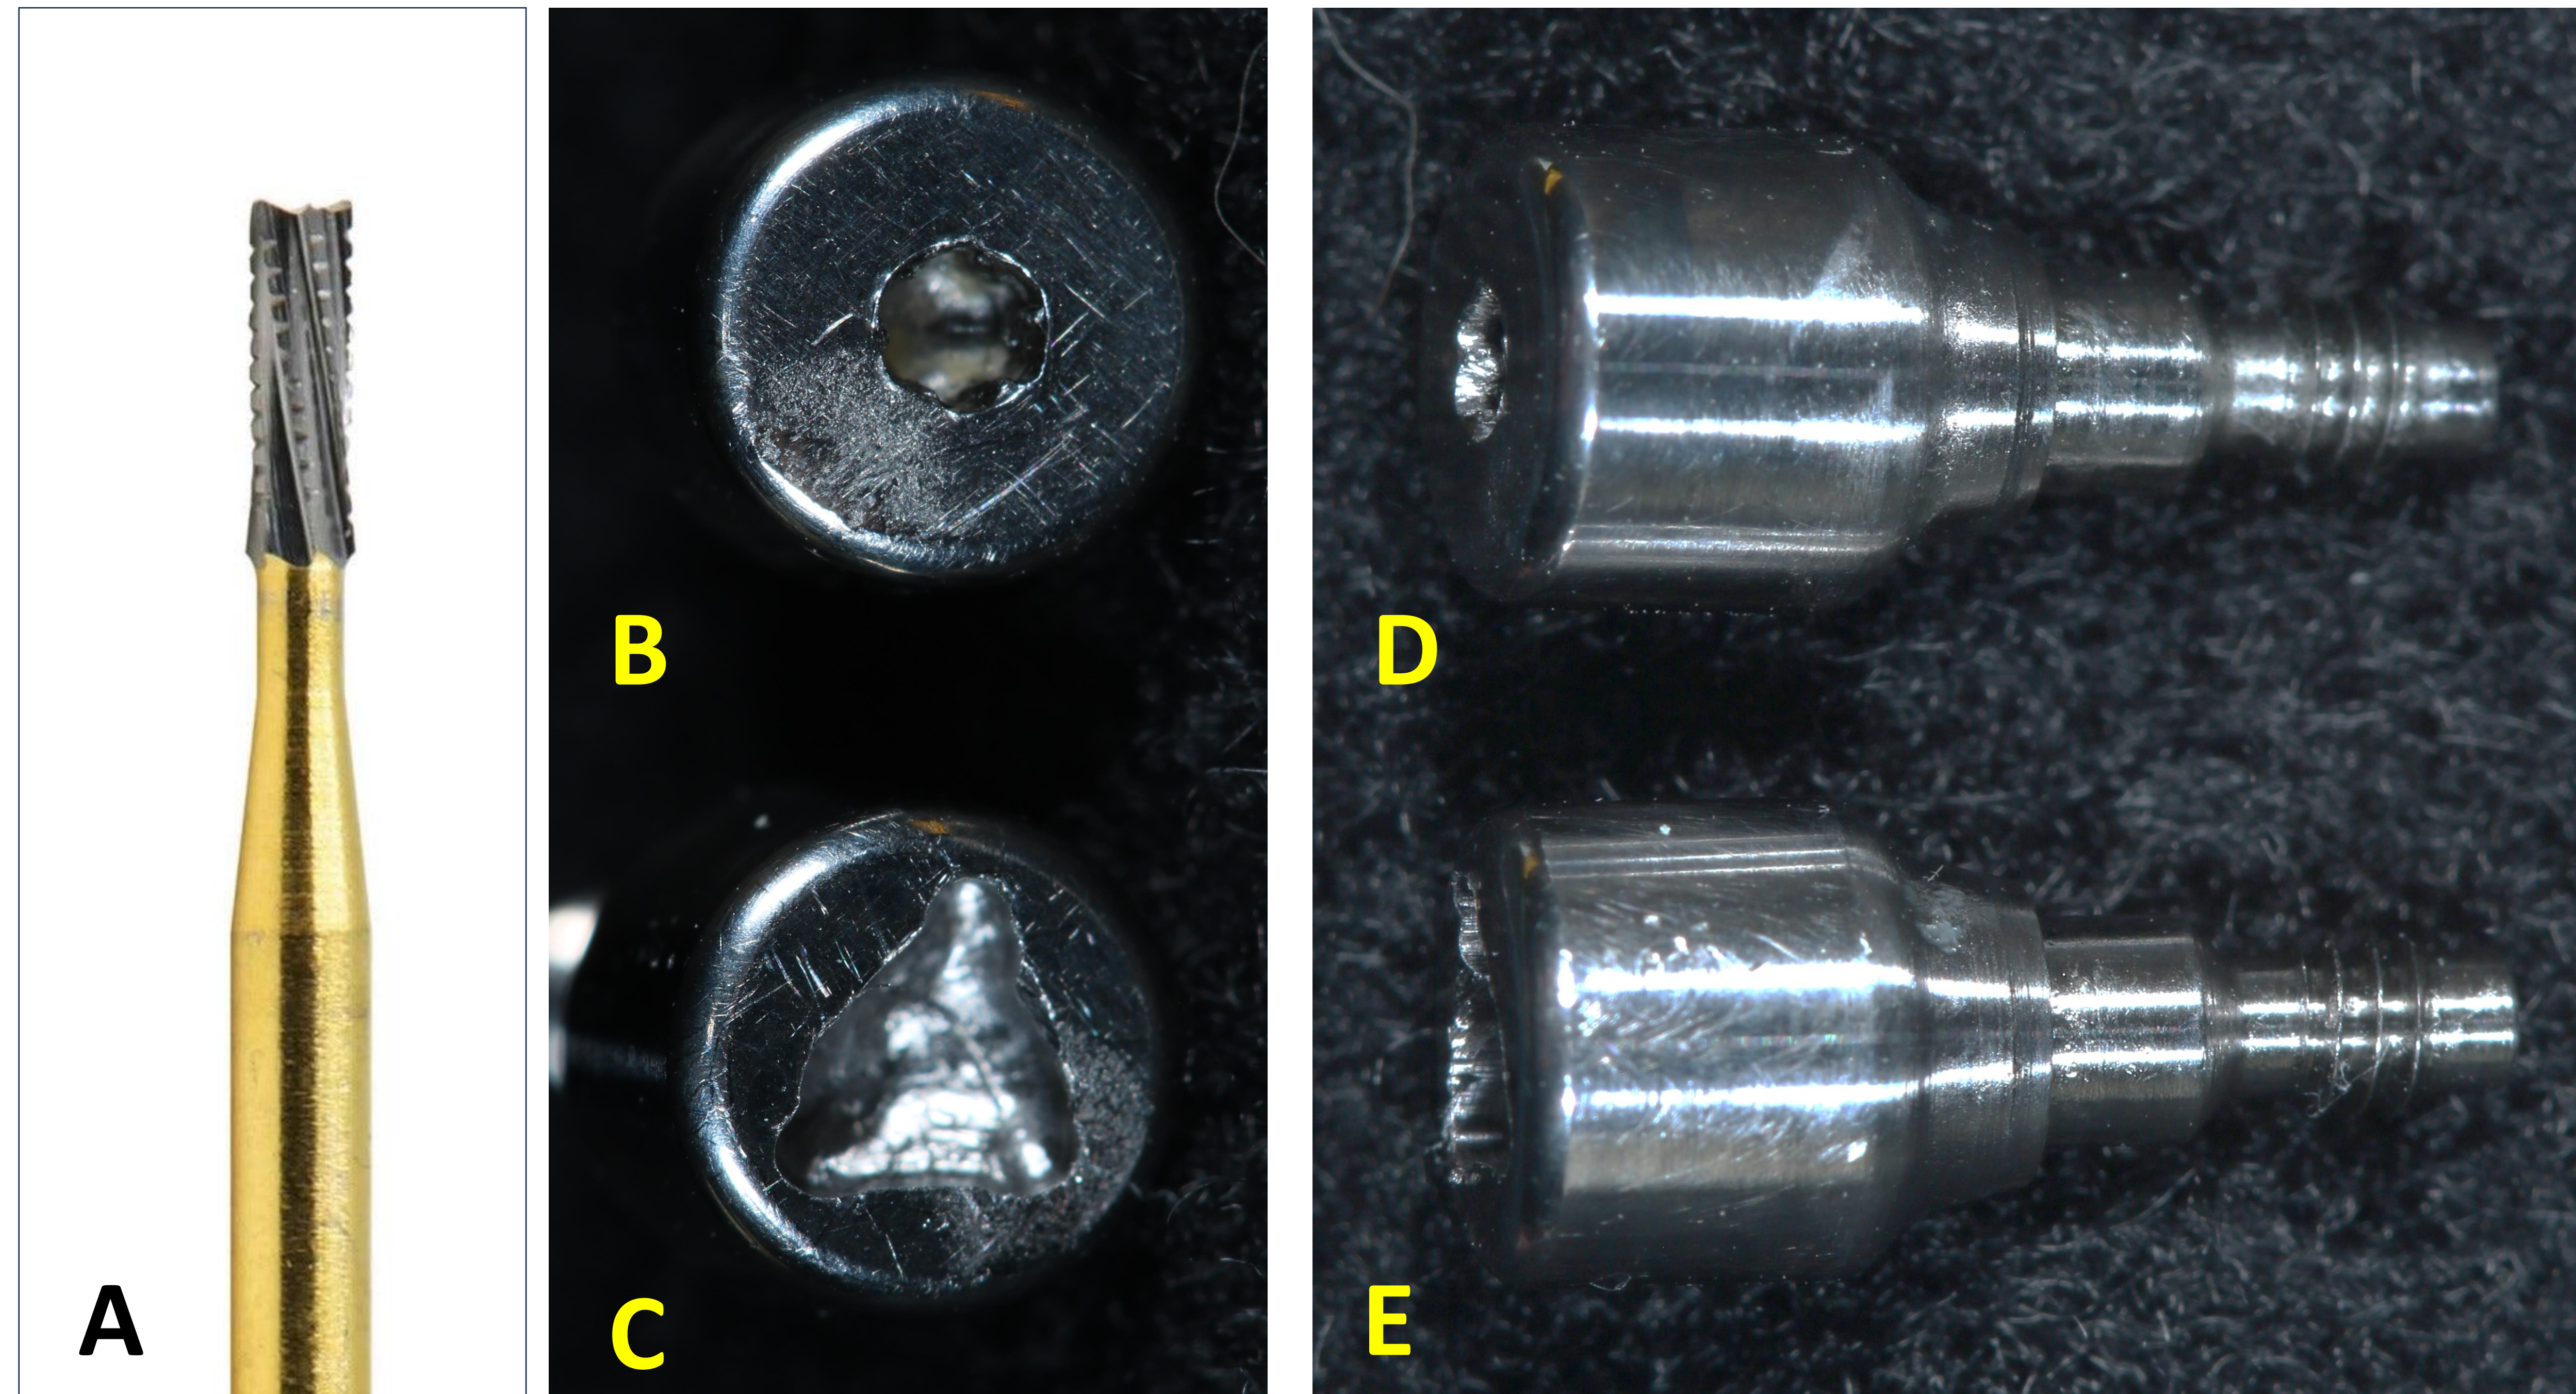
**Figure 4.** A 557 cross-cut metal and crown-cutting carbide bur (A) was used to intraorally modify the internal geometry of healing abutment #18 from a rounded hexagon (B, D) to a triangular shape (C, E) that accommodated the short Locator ratcheting driver.

**Method:** A patient presented with a stripped healing abutment in occlusion with the opposing arch. The working surface of the abutment was modified to accommodate a short overdenture abutment driver and torque wrench.

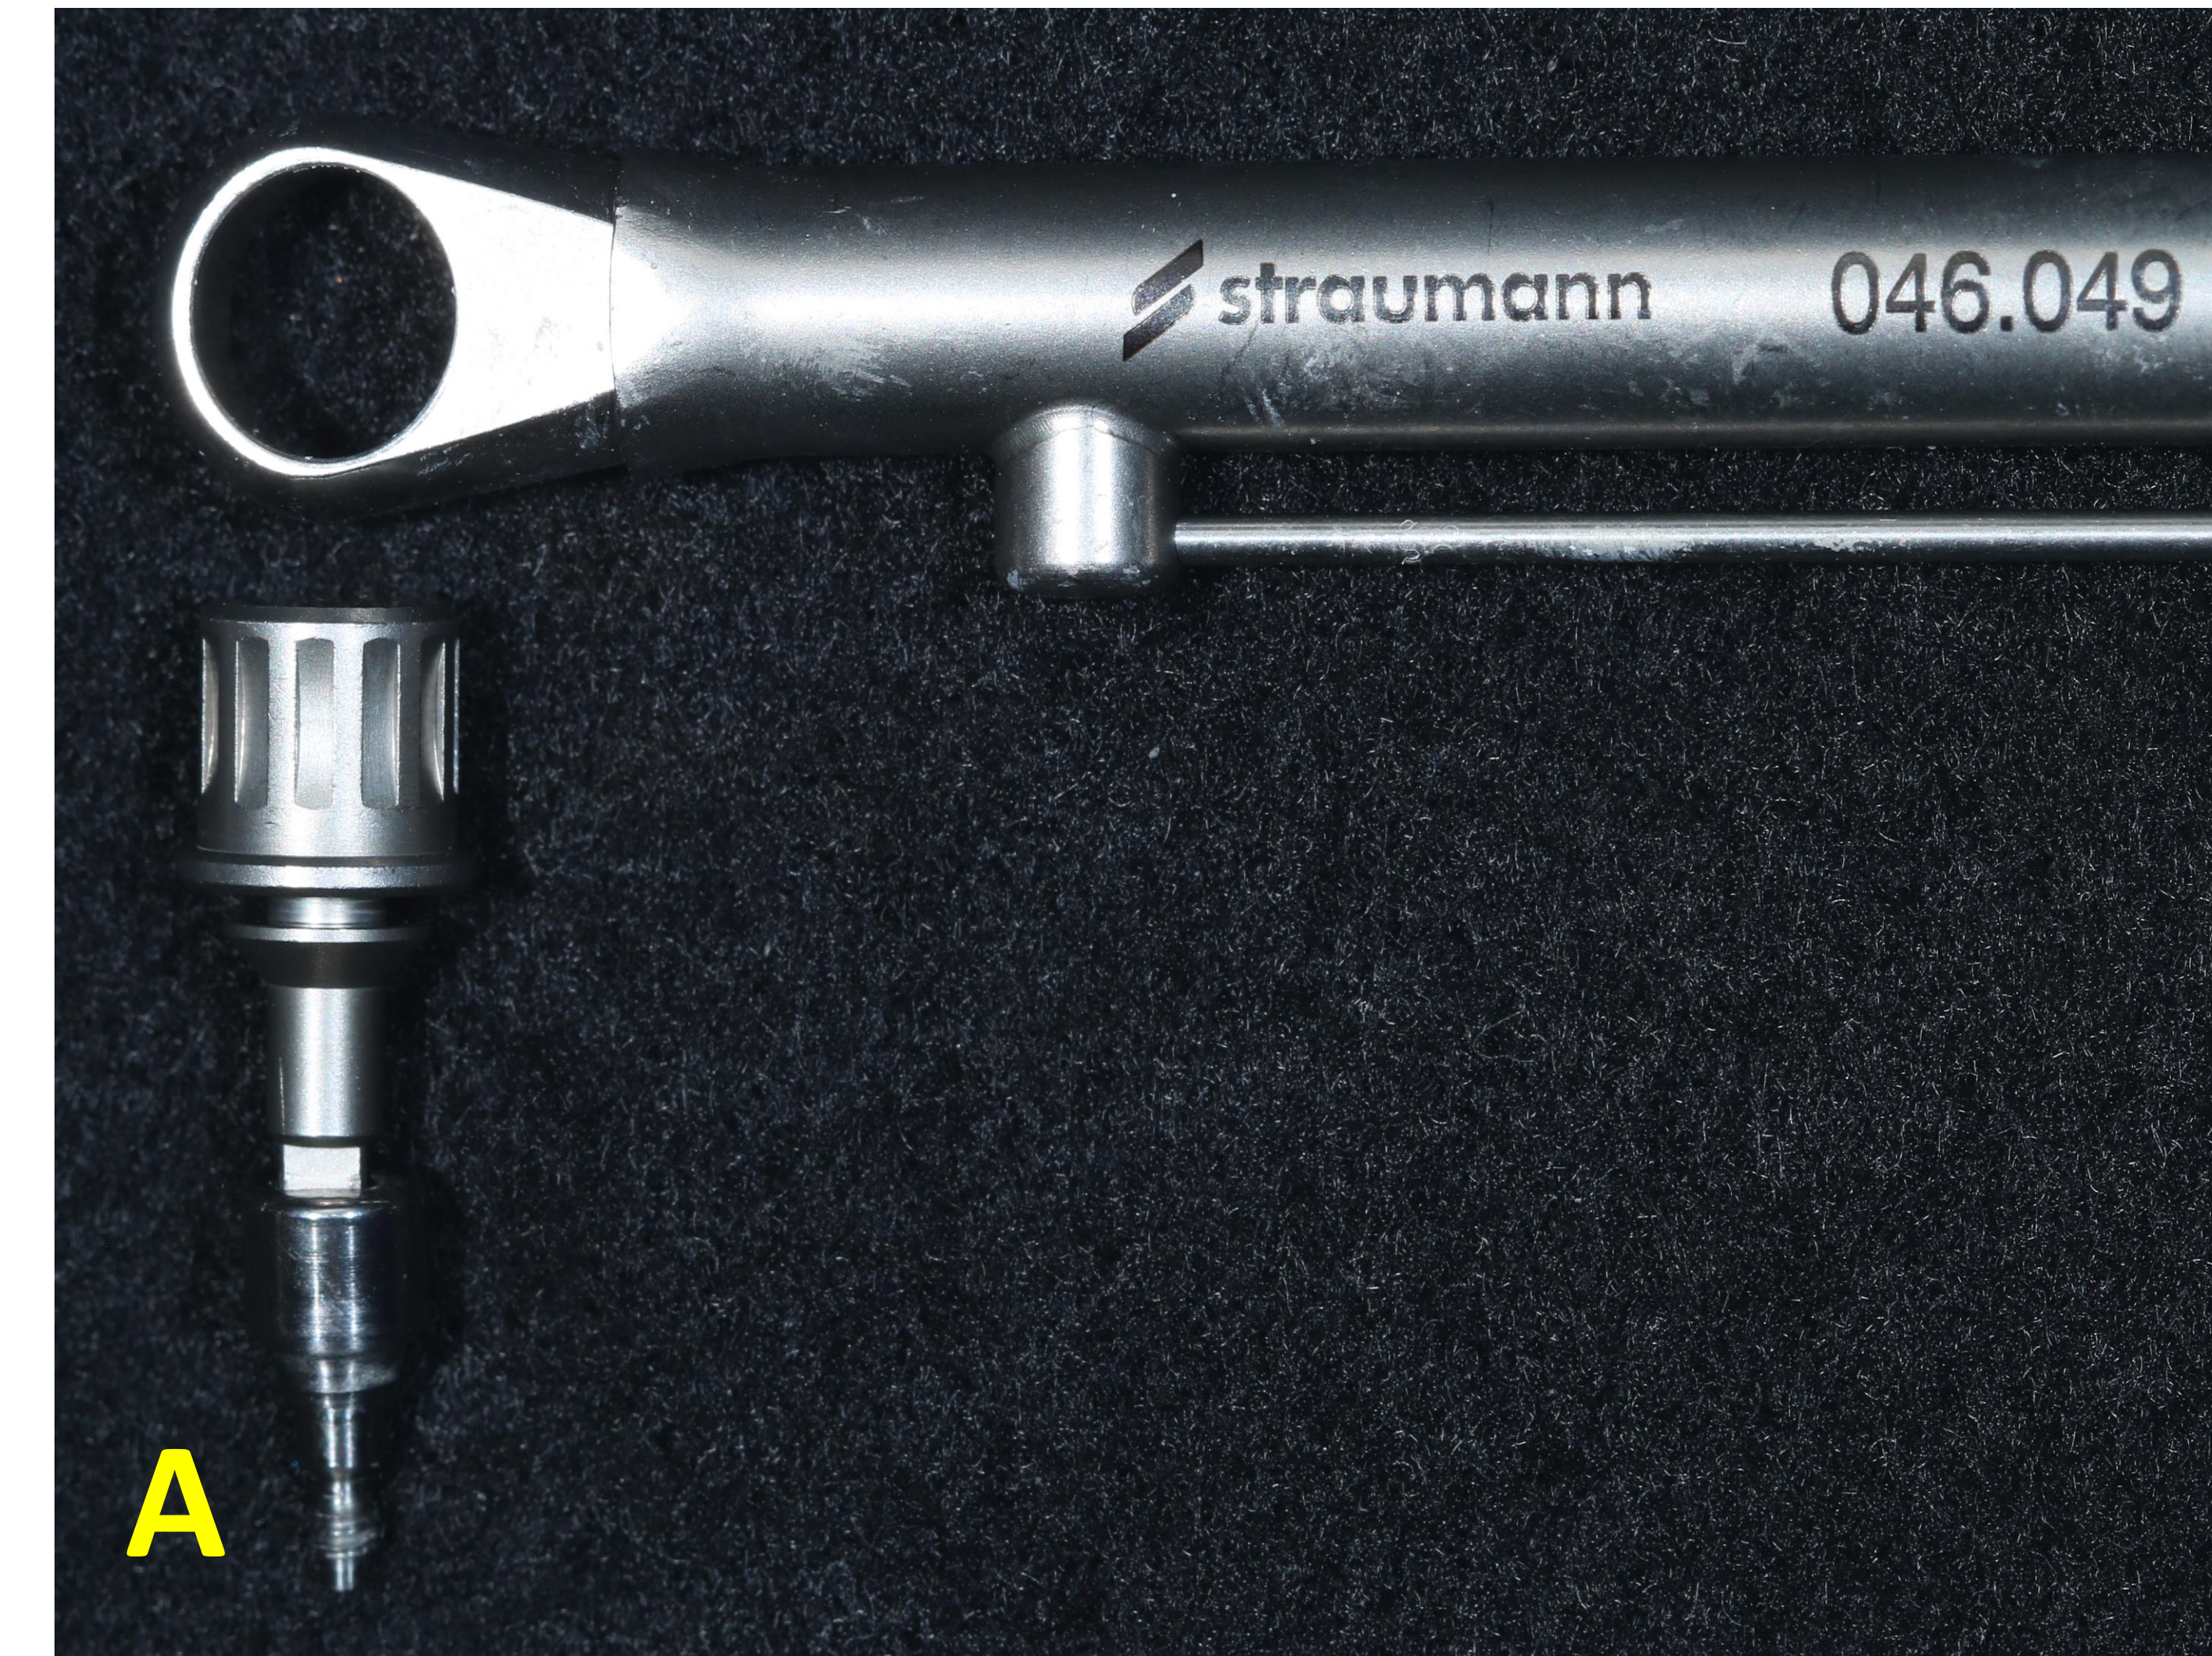
**Figure 5.** The corresponding torque wrench was used to successfully remove the previously cold-welded and stripped healing abutment #18 (A). Shorter healing abutments, 3mm tall, were seated on both implants #31 (B) and 18 (C).

**Results:** Successful removal of the stripped healing abutment was accomplished. A shorter healing abutment was placed to ensure absence of occlusal loading and provide additional vertical space in the working field.
