# Clinical Consideration for Recovering Aesthetic Complications due to Implant Treatment

Tatsuaki Matsunaga<sup>1,2</sup> K. Egashira<sup>2</sup>, M. Arakawa<sup>2</sup>, Y. Nakamura<sup>2</sup>, Y. Kido<sup>2</sup>, H. Kido<sup>2</sup>

<sup>1</sup> Matsunaga Dental Clinic <sup>2</sup> Fukuoka Dental College Dept. of Oral Rehabilitation, Fukuoka JAPAN

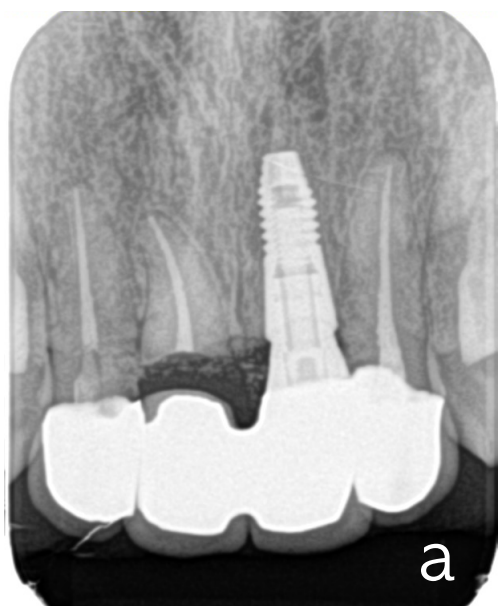
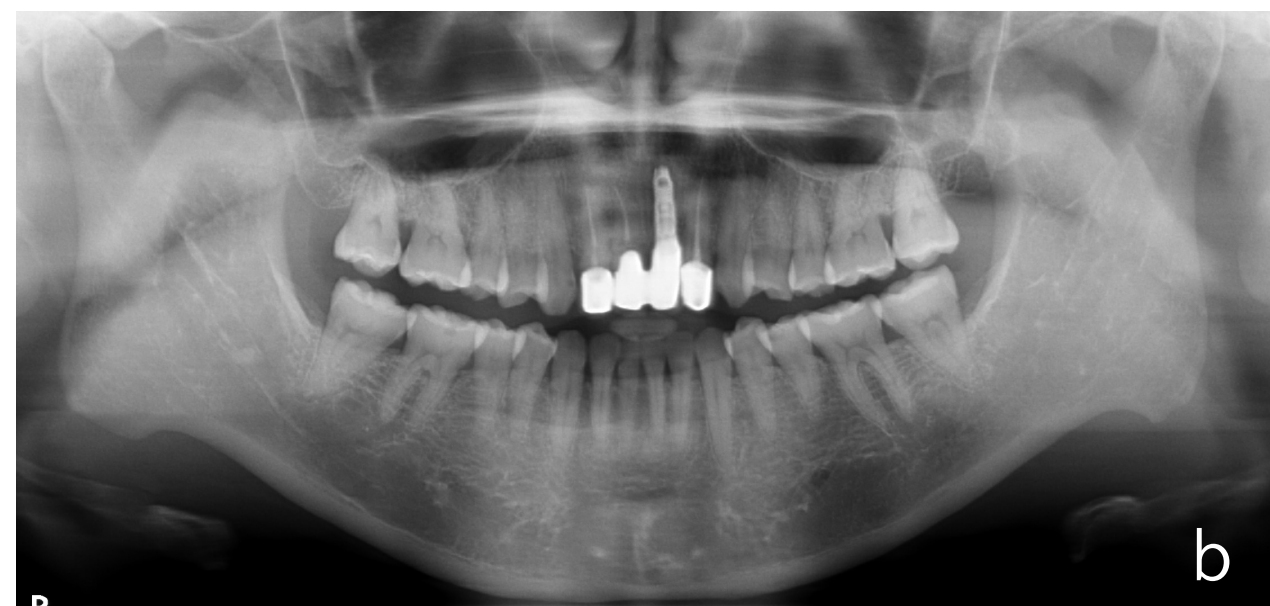
Figure. 2a: Periapical 2b: Panoramic view

The patient was 45 years female had chief complaining of implant exposure and aesthetic problem due to gingival recession of #9<sup>1)</sup> (Fig. 1). The patient's dental history included extraction of tooth number 9 and implant treatment approximately 2 years ago. At that time, tooth number 8 was placed subgingivally as a residual root, and a zirconia crown connecting teeth number 8 and number 9 was delivered (Fig. 2a, b).

Implant #9 showed exposure of the implant body, inflammation of the surrounding tissues, and bone resorption. The implant was placed at a labial angle, with the abutment close to #10. The remaining root of #8 was amputated and positioned to limit bone resorption. The prostheses #7- 10 with the including implants were not esthetic prosthesis.

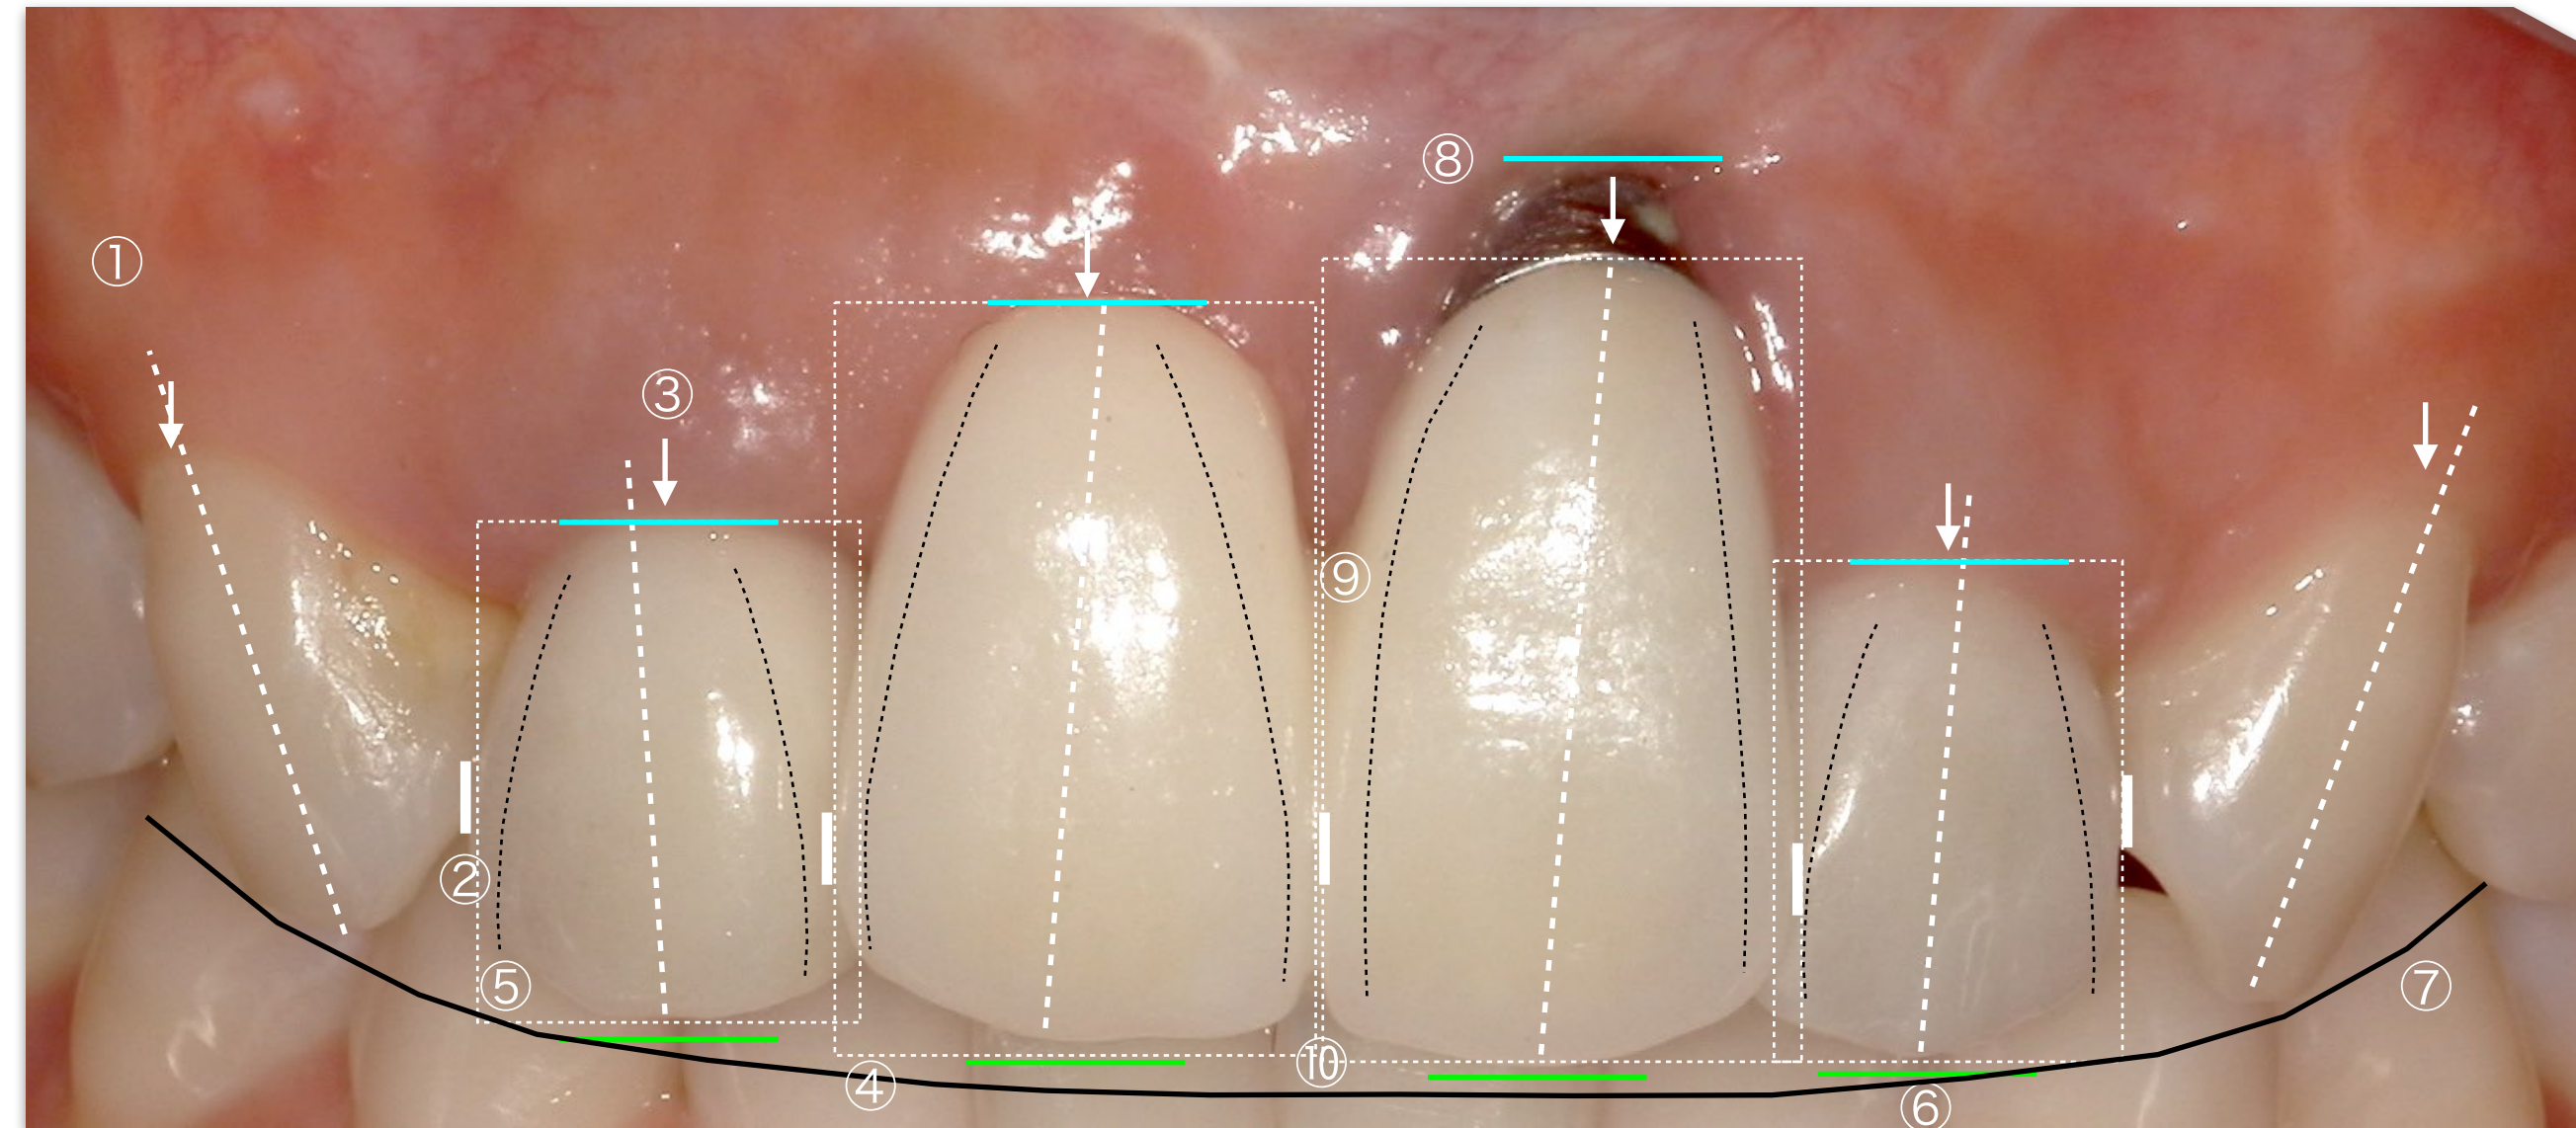
Figure. 1 :Anterior Esthetic Checklist

Four points in the checklist for aesthetic anterior implants were not particularly achieved.

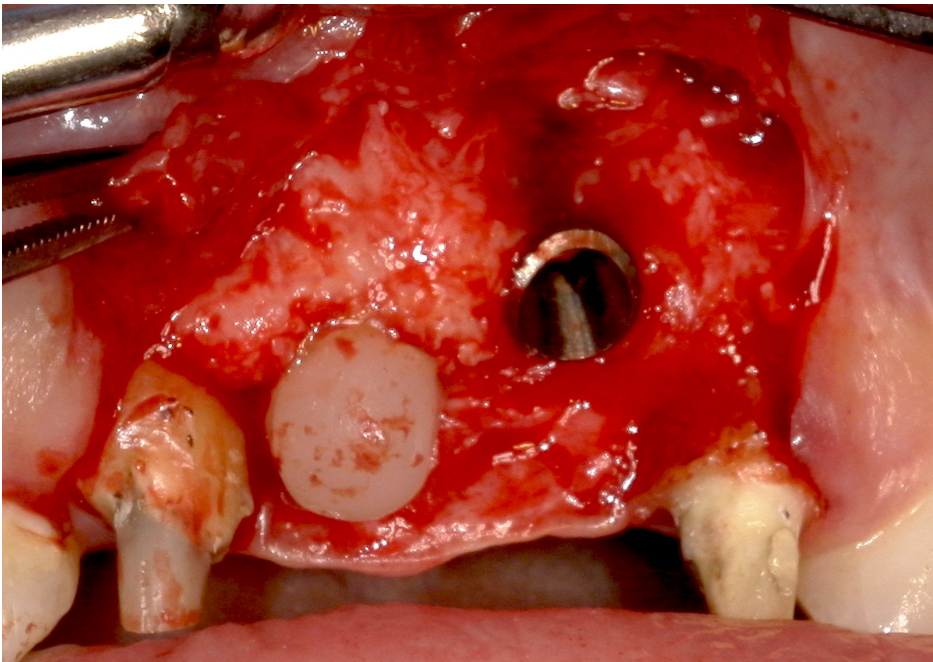
#8 temporary fiber core

Step 1 : #8 temporary fiber core and #9 Implant removal and GBR

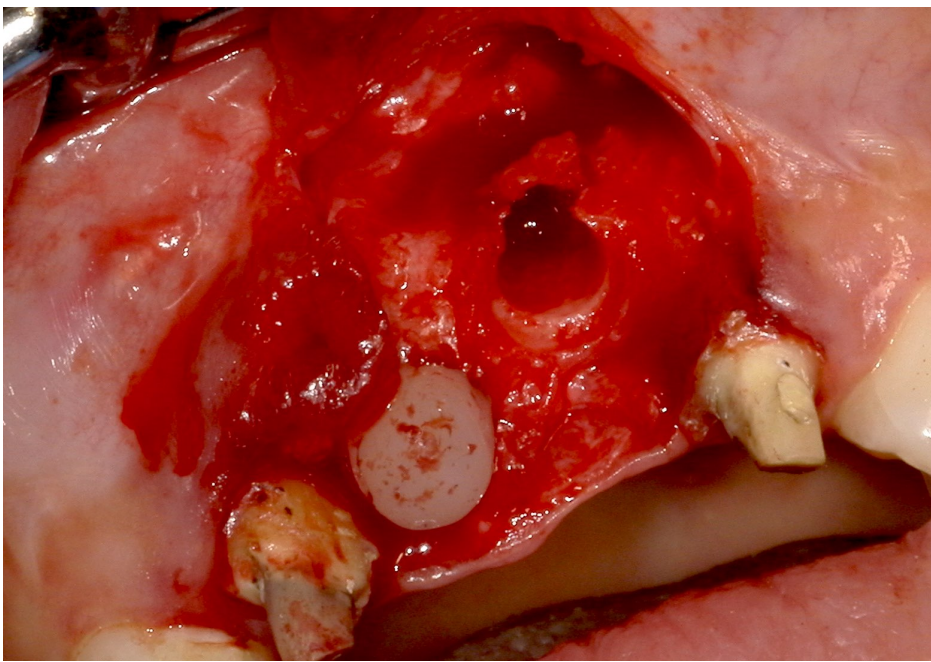
#9 implant removal

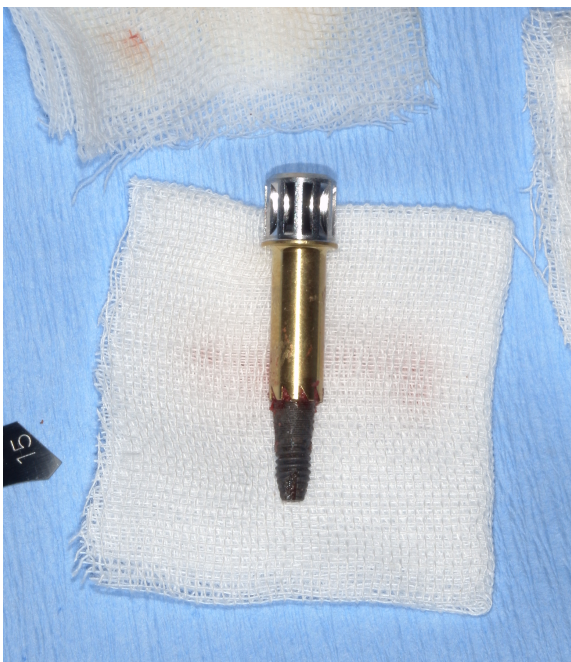
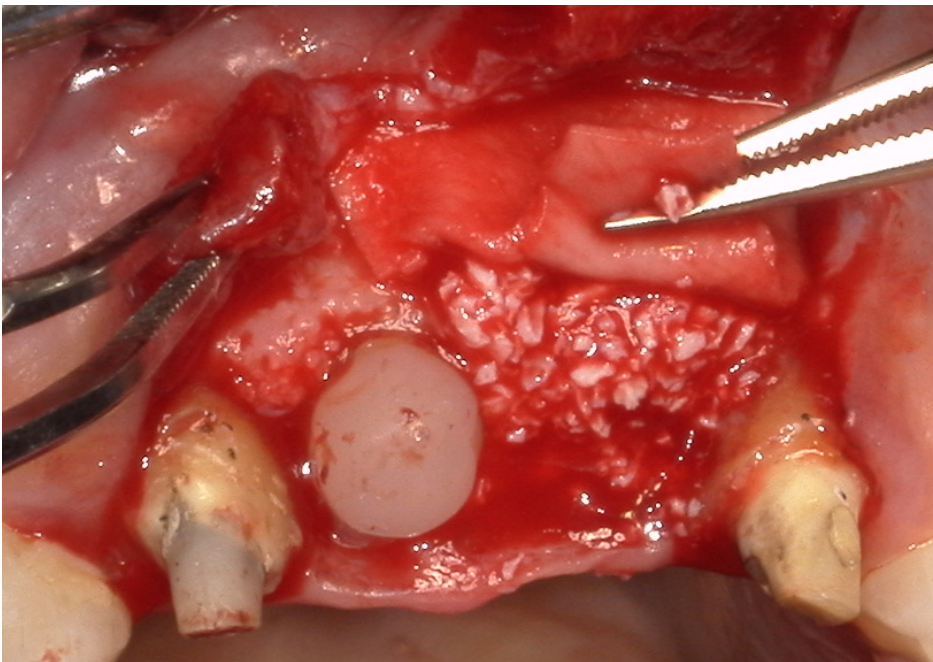
GBR using BiOss and collagen membrane

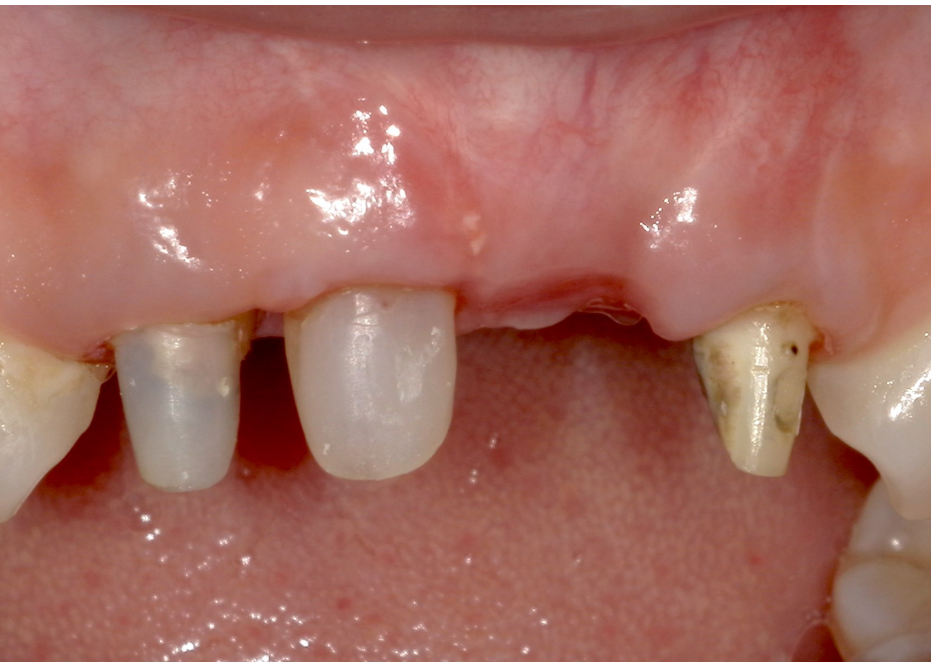
Post 1 month

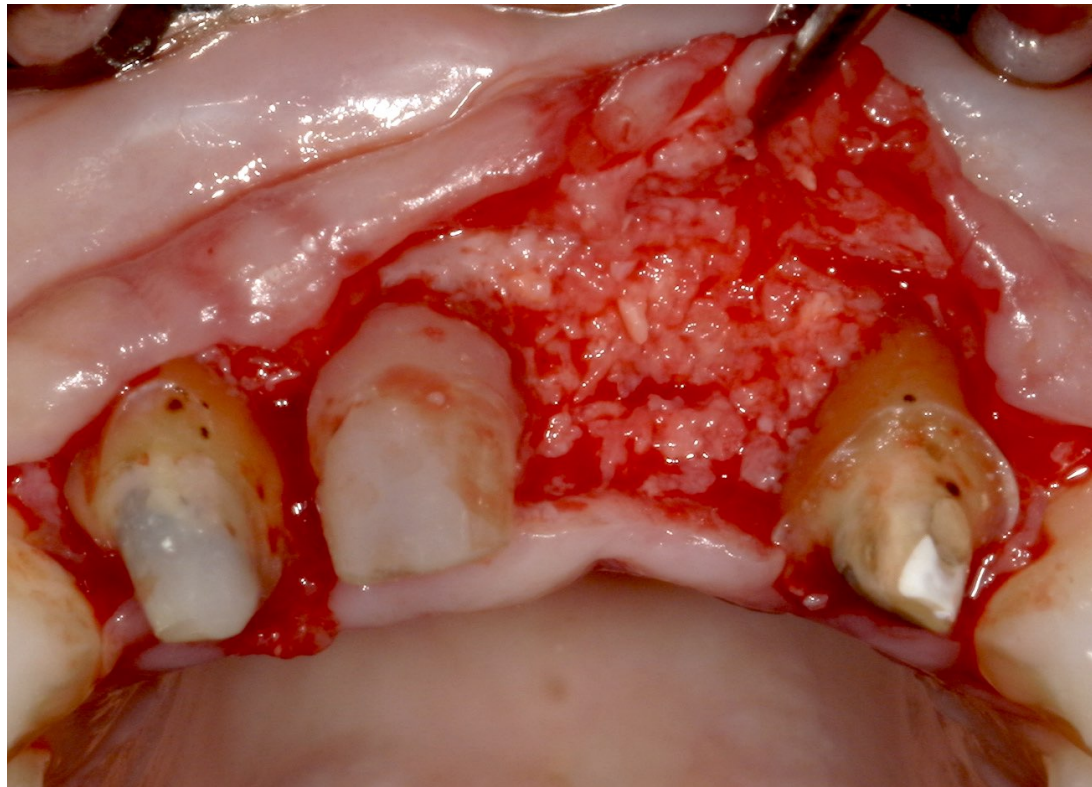
Post 6 month

Allowing sufficient healing time allows bone and soft tissue volume to be gained.

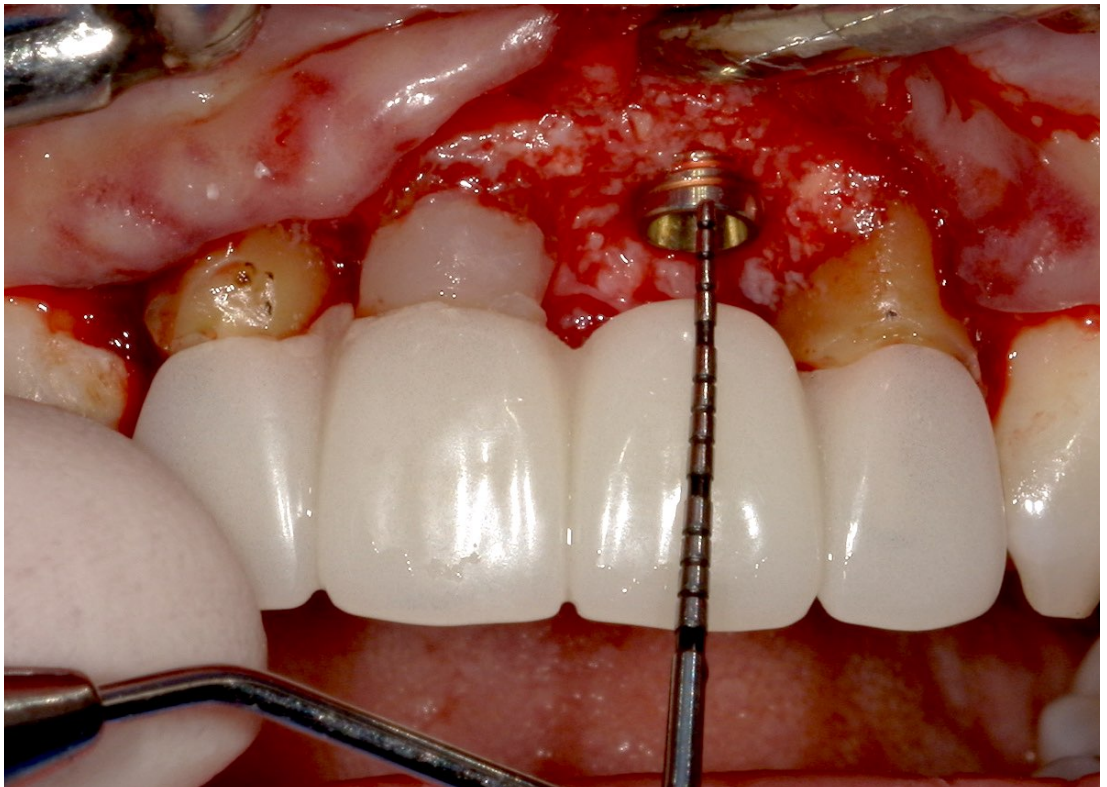
#9 implant placement

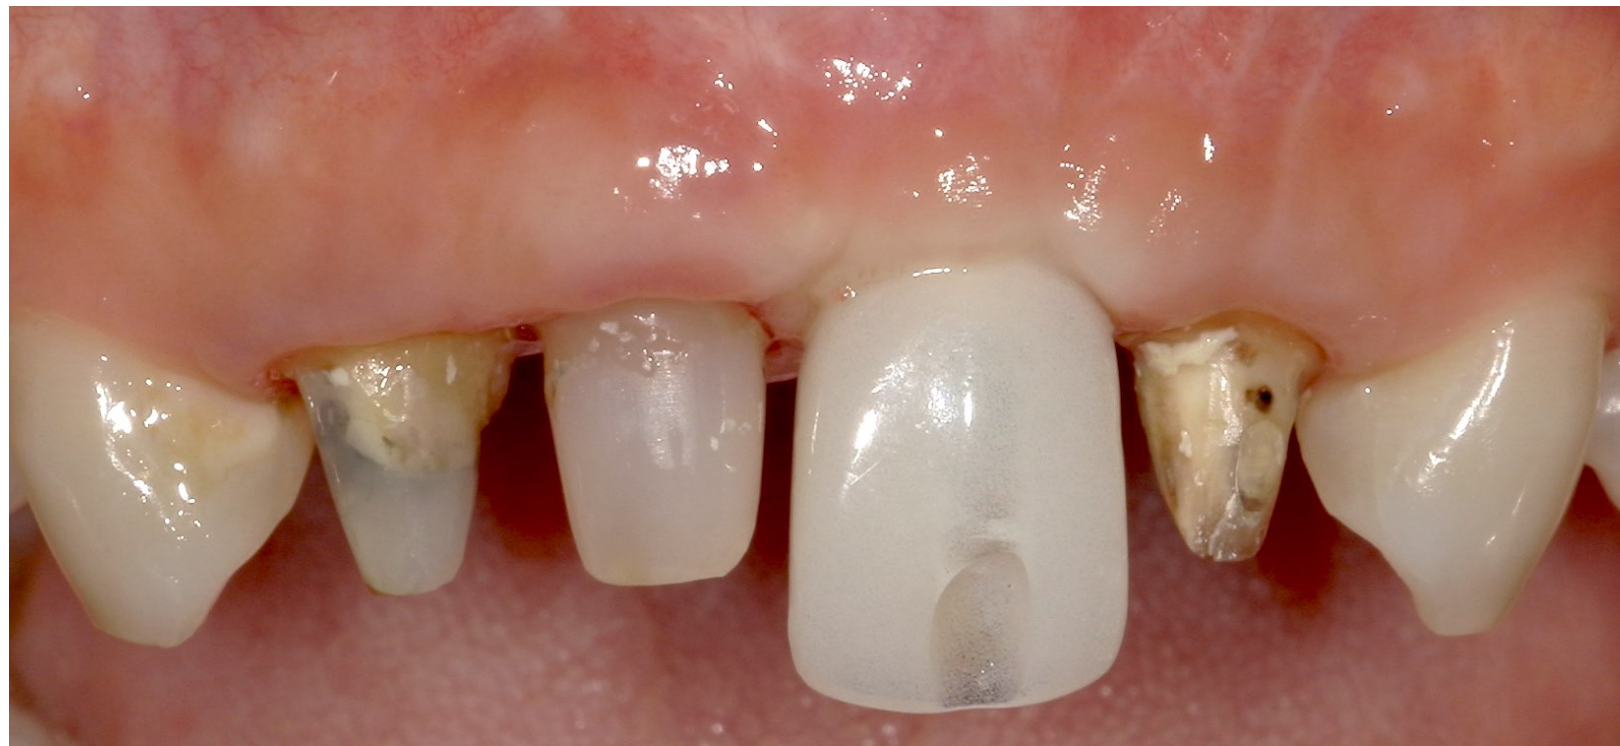
Post 4 month Screw retaining provisional crown

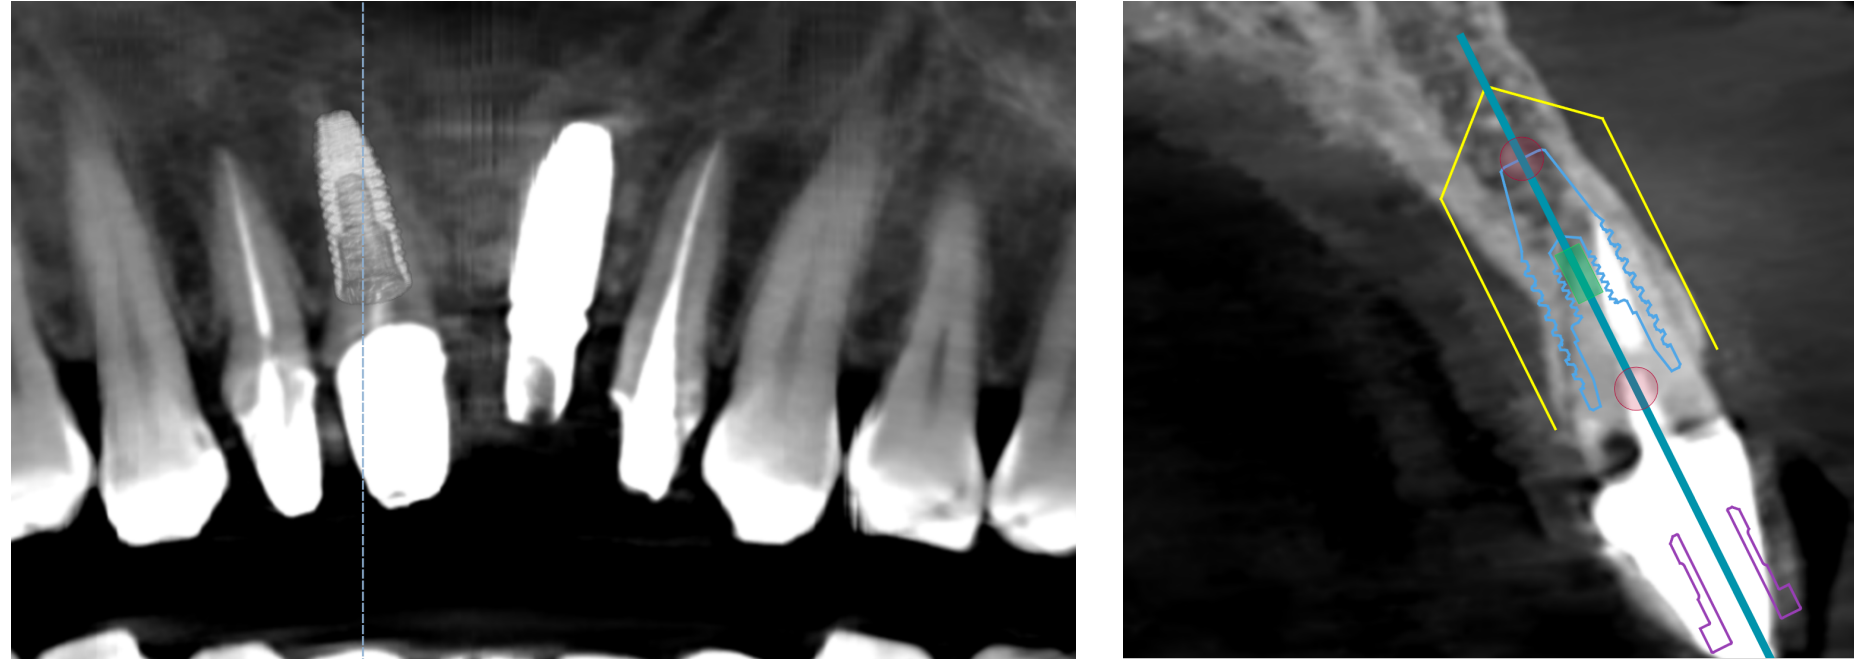
Diagnosis of implant placement ideal position using computer simulation

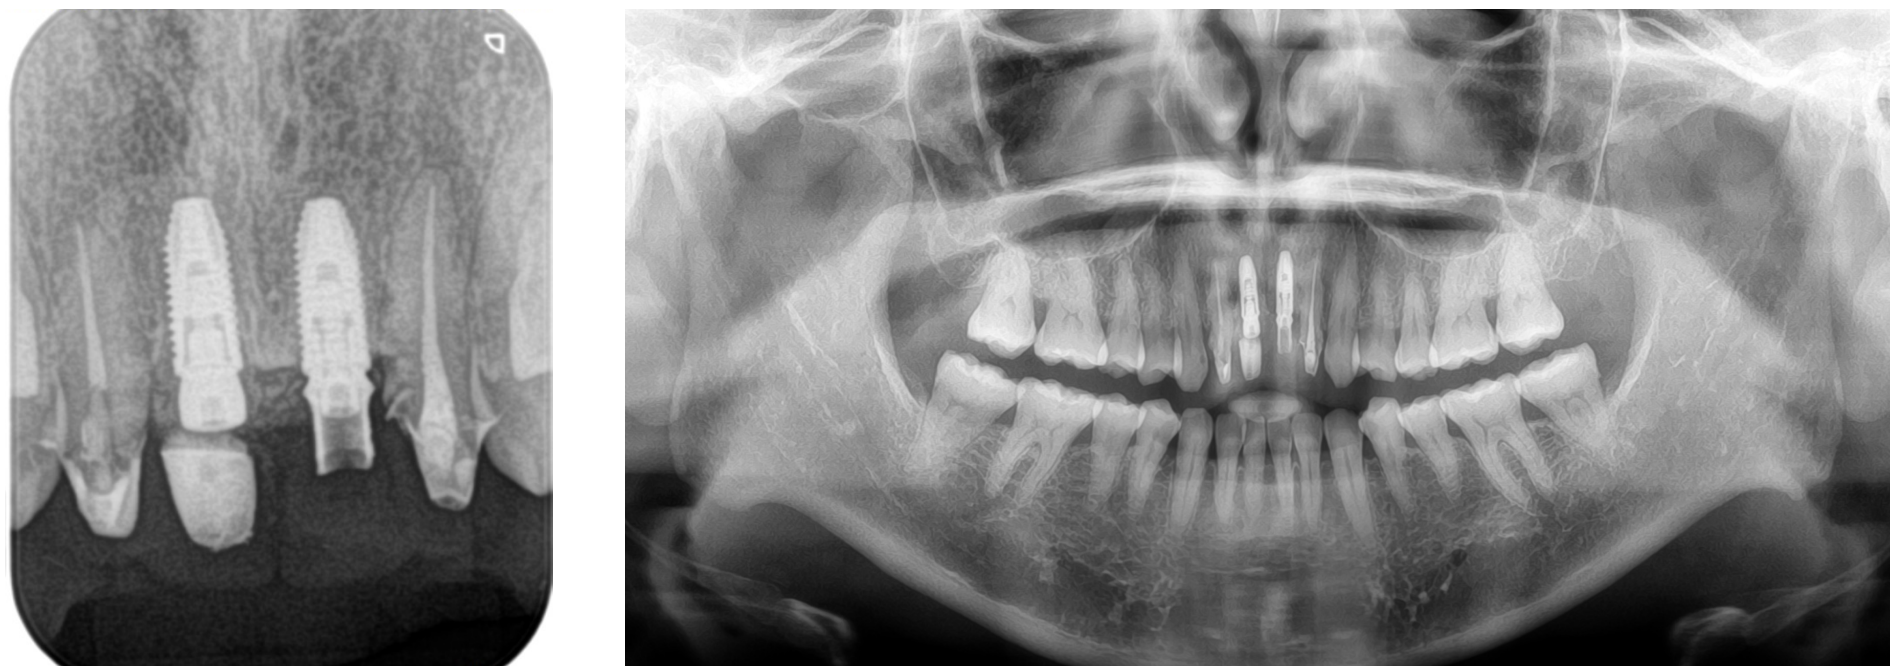
#8 X-ray after implant placement

It is difficult to place two implants in the ideal position consecutively<sup>2)</sup>. Therefore, implant #8 was placed based on the crown profile of implant #9.

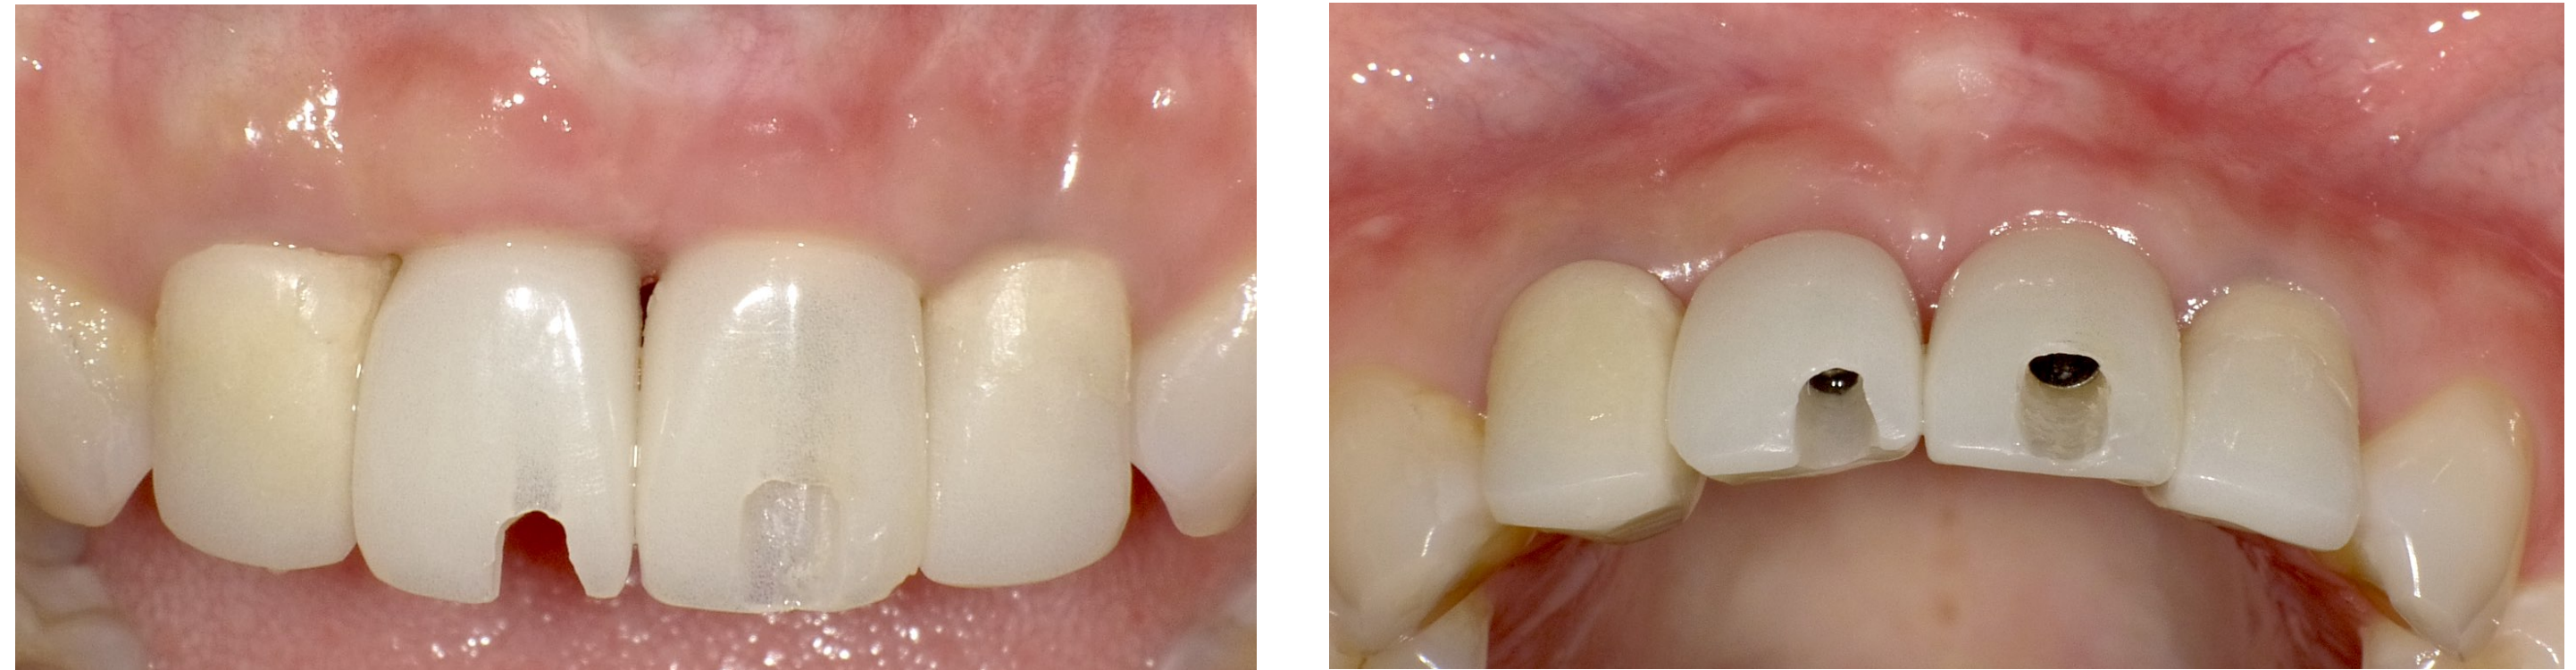
The screw-retained implant provisional will be harmonized with the natural teeth.

The harmony of the provisional emergence profile, contact point position, and gingival line is important<sup>3)</sup>.

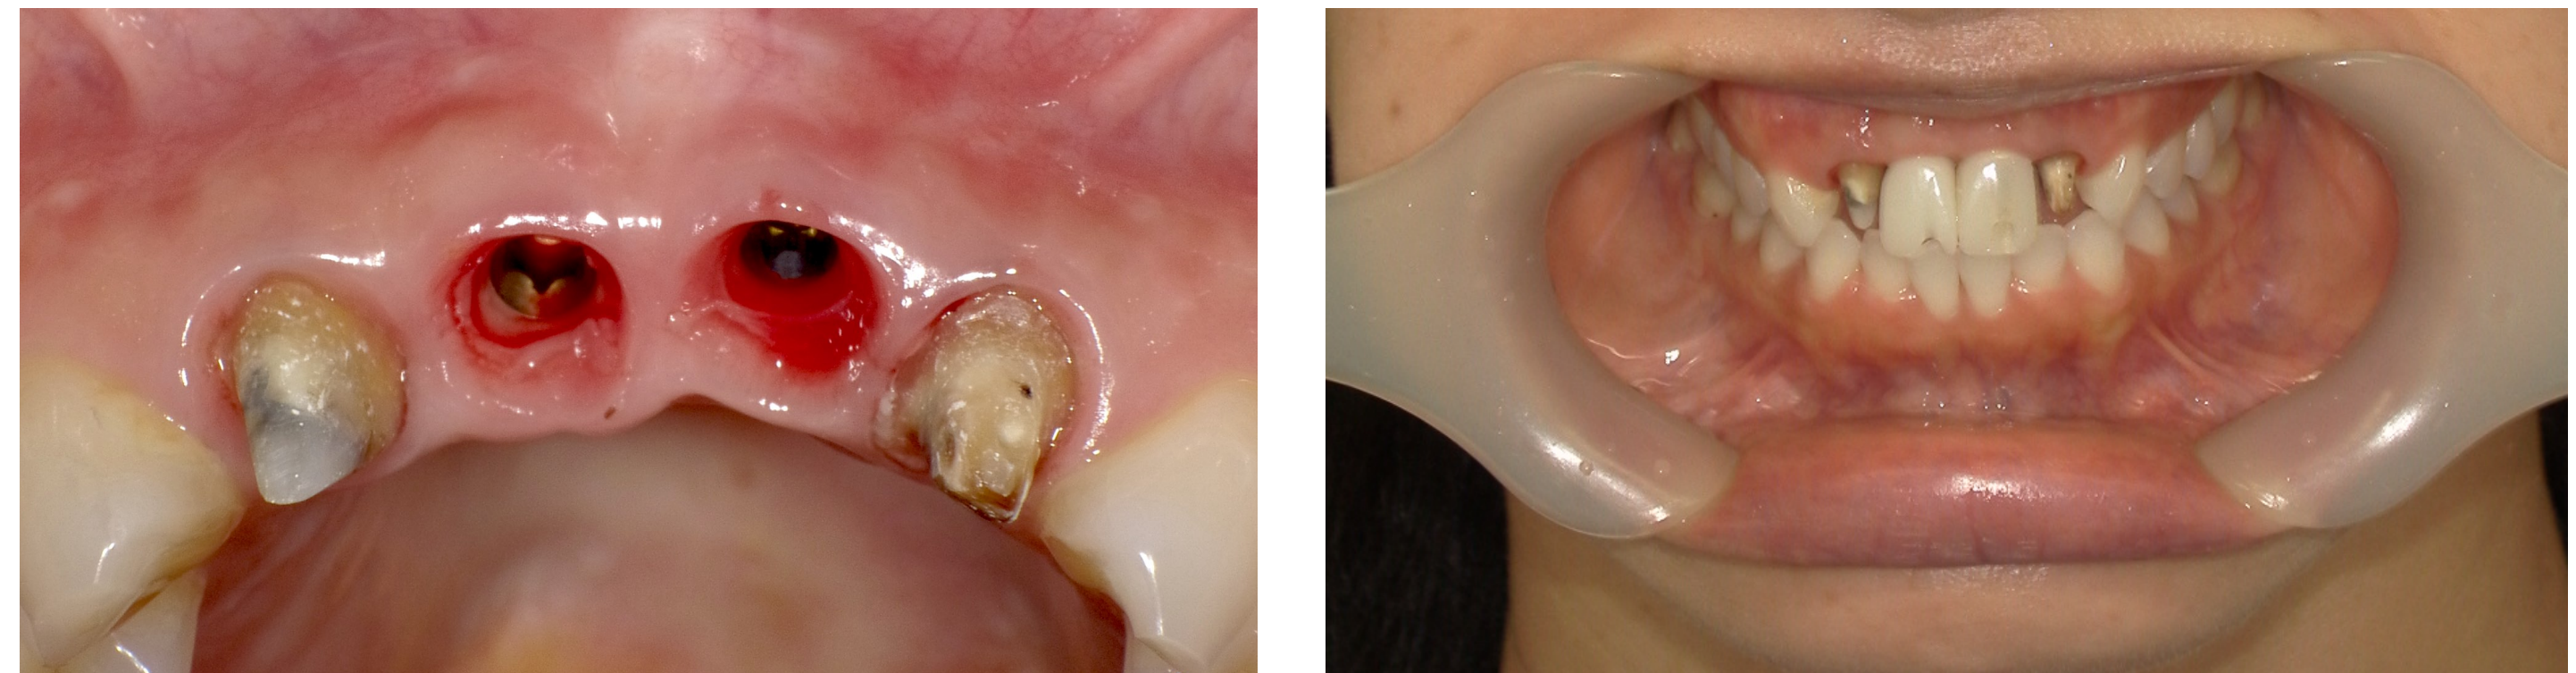
It is important to improve inflammation at the implant trans-gingival area and to achieve harmony between the four anterior teeth.

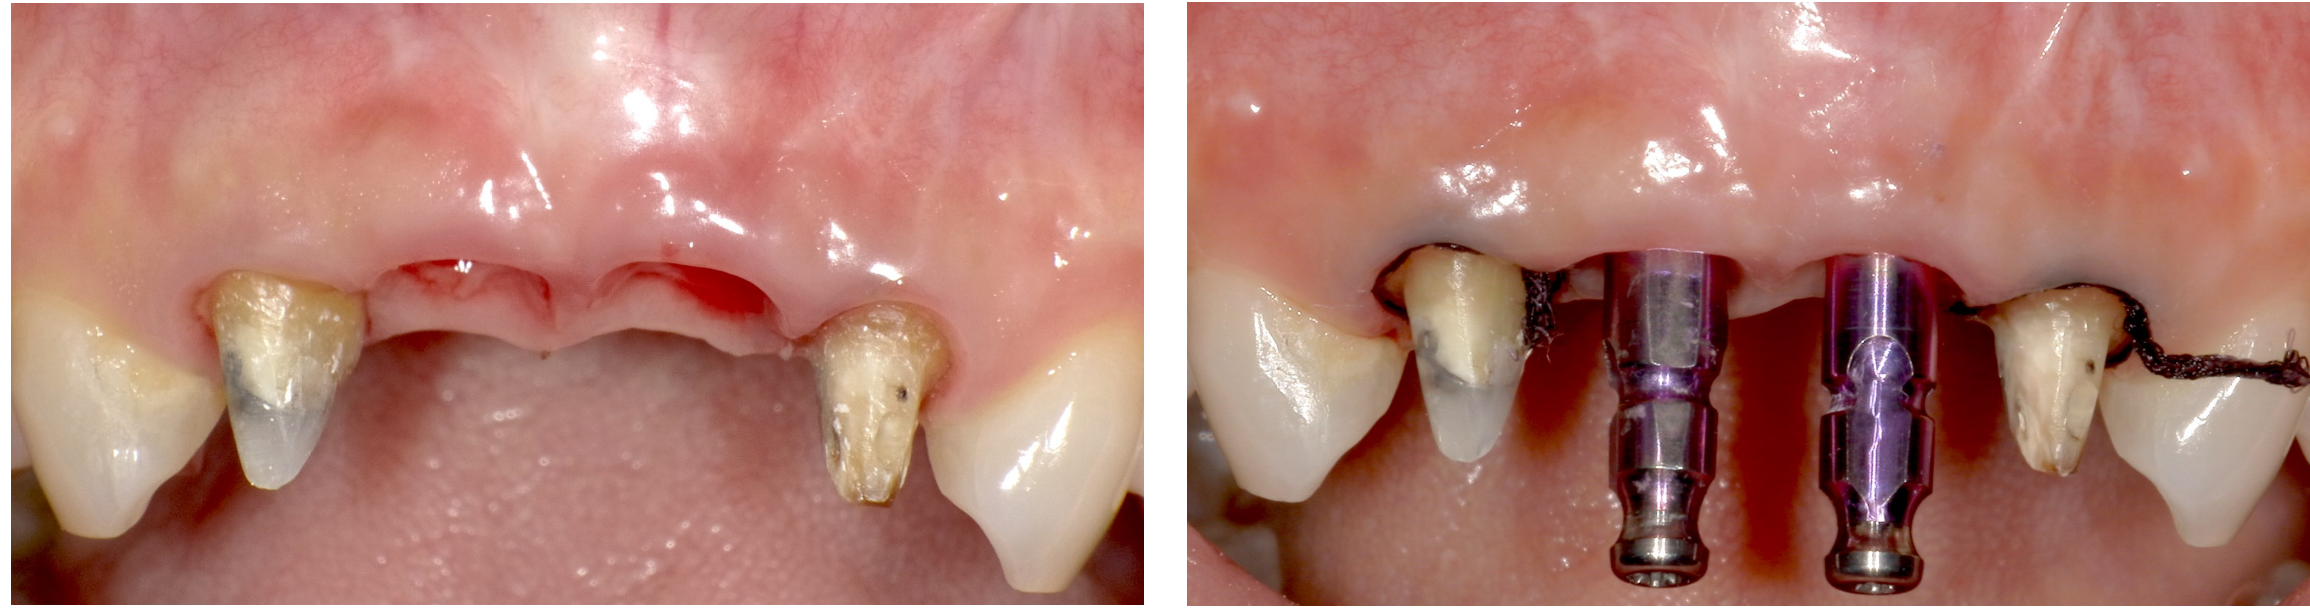
Impressions of natural teeth and implants for final prosthesis fabrication

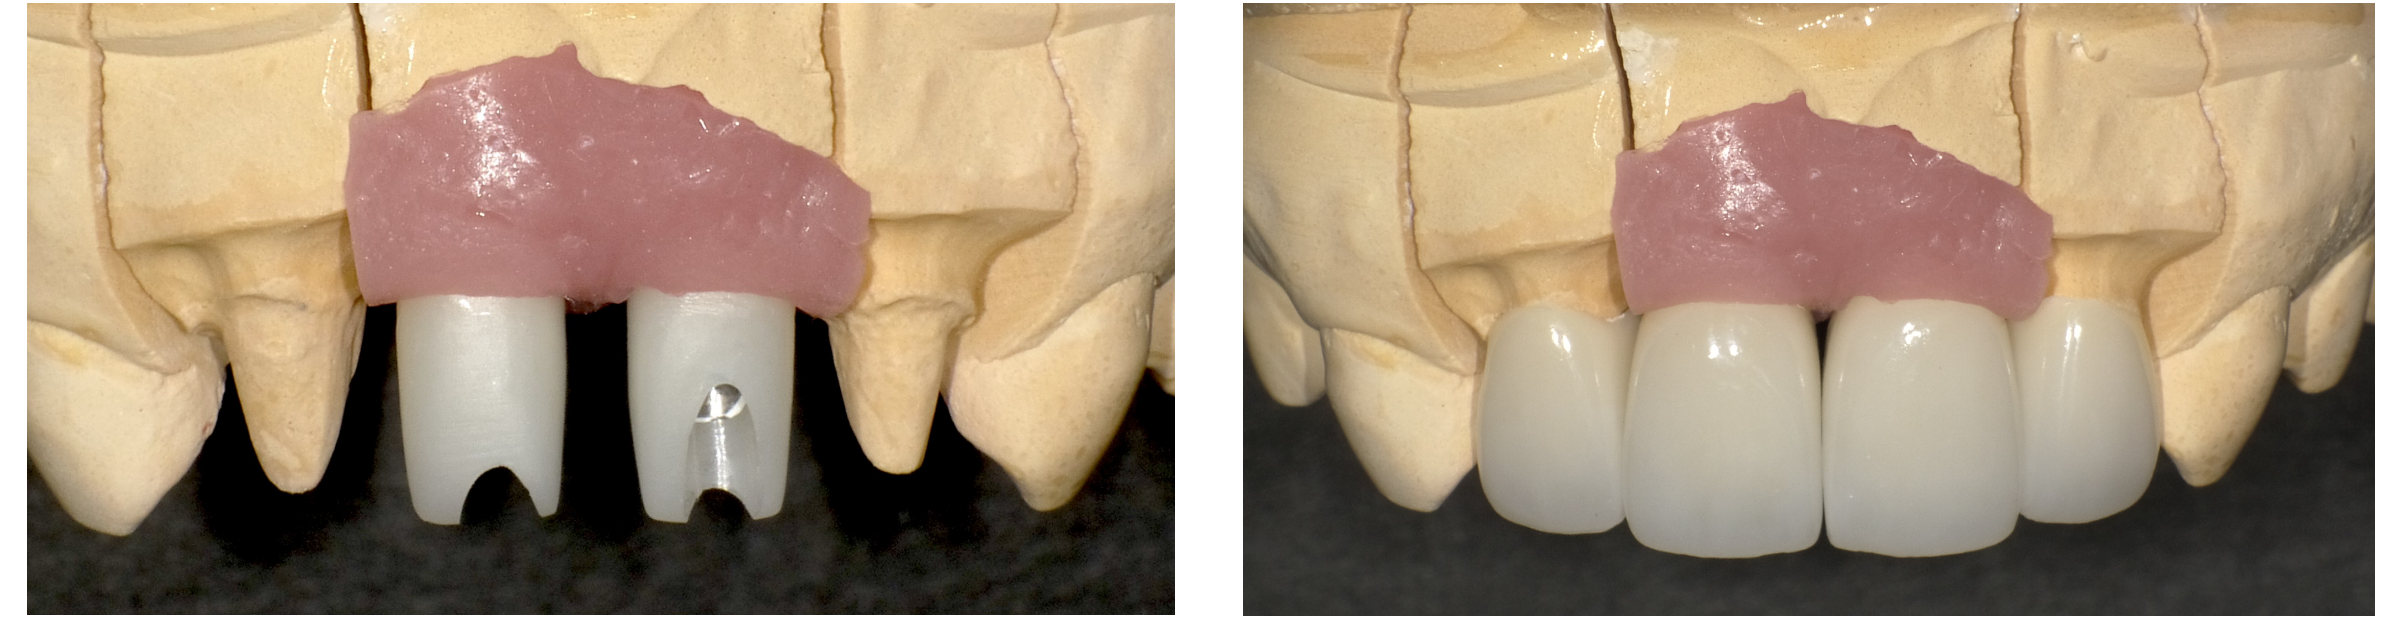
The implant superstructure was cement-retained, and a zirconia layering crown was fabricated

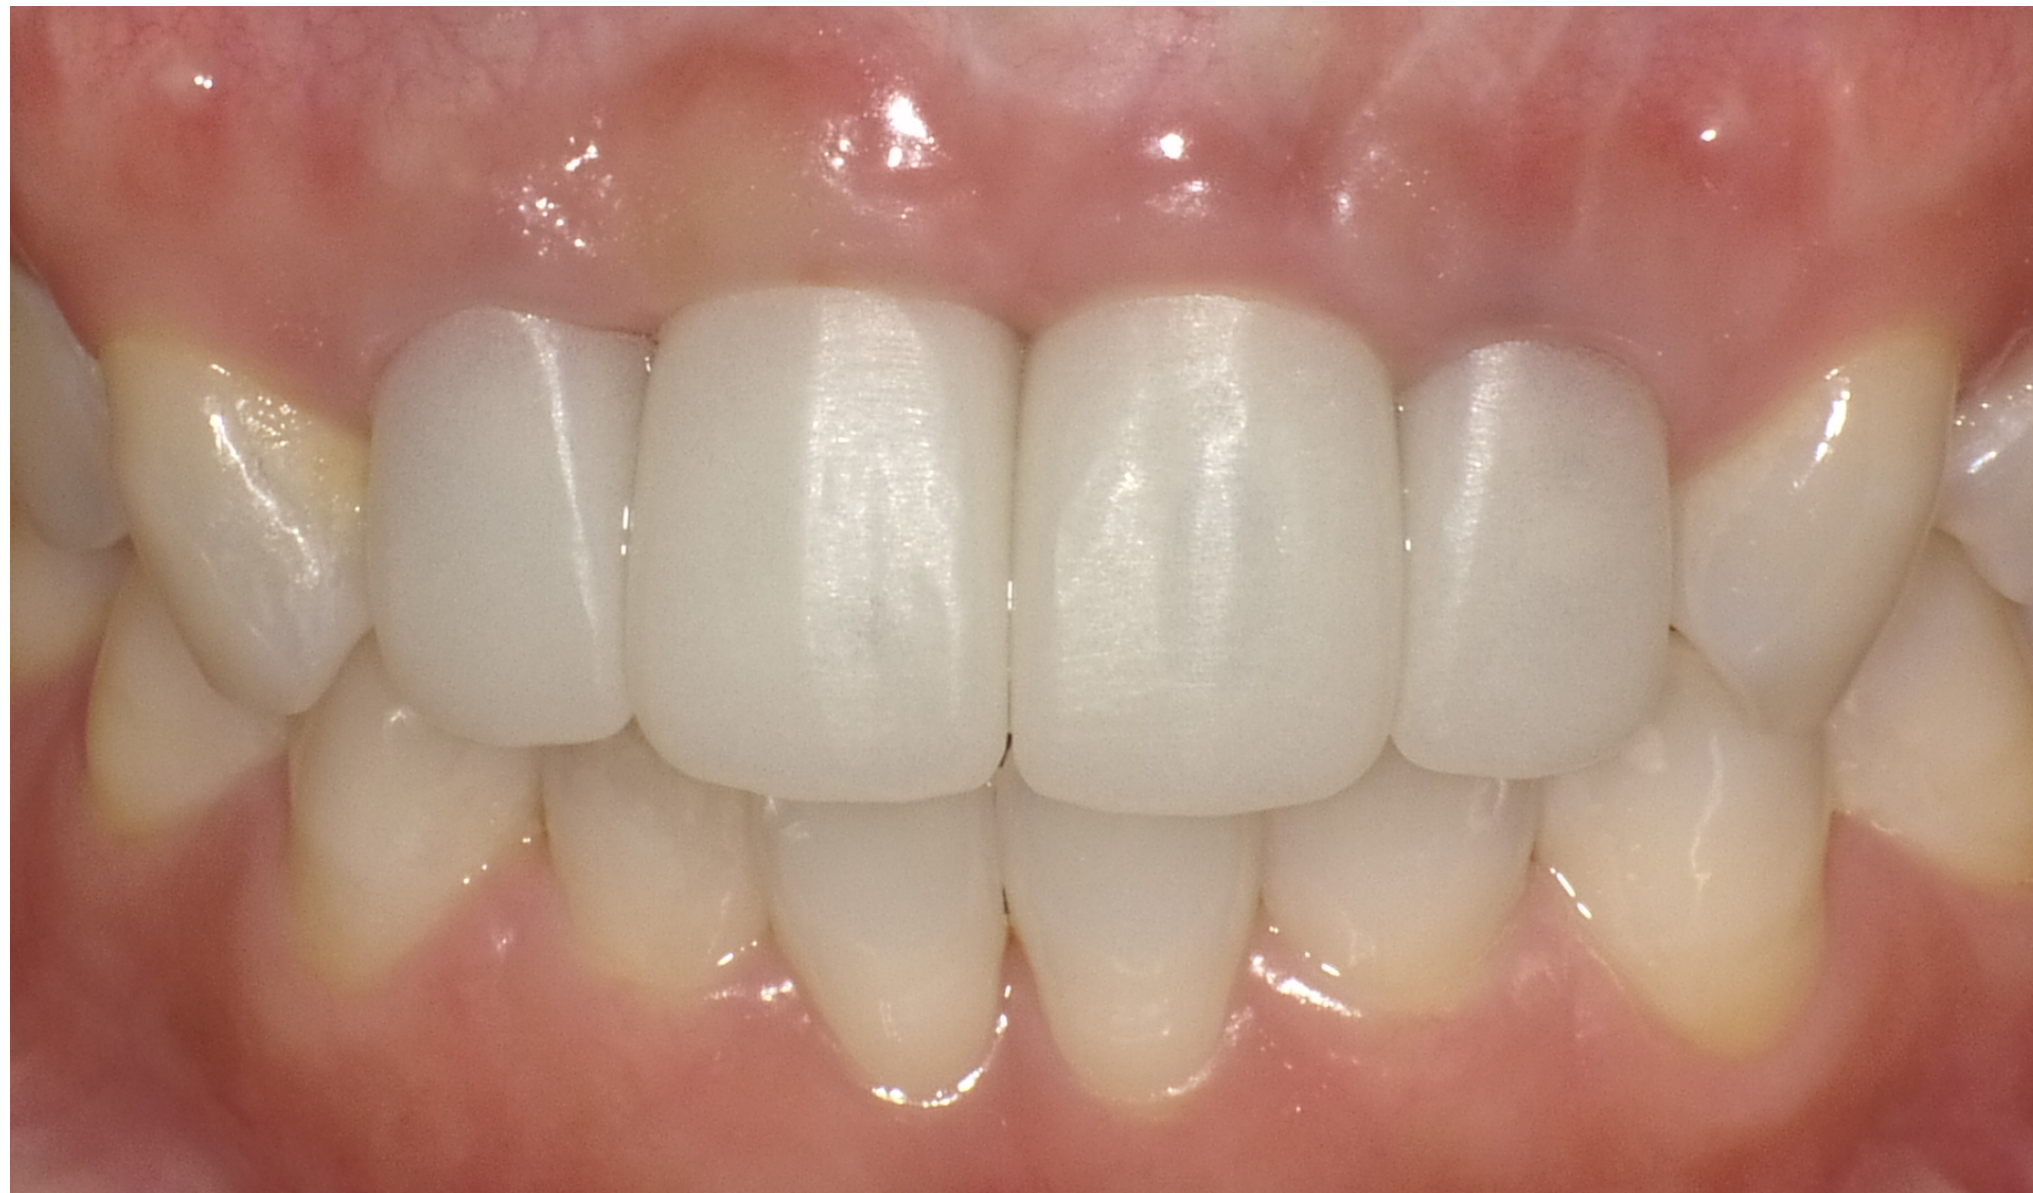
A resin frame was fabricated to clarify the zirconia crown shape
