# Clinical Consideration for Recovering Aesthetic Complications due to Implant Treatment

Tatsuaki Matsunaga<sup>1,2</sup> K. Egashira<sup>2</sup>, M. Arakawa<sup>2</sup>, Y. Nakamura<sup>2</sup>, Y. Kido<sup>2</sup>, H. Kido<sup>2</sup>

<sup>1</sup> Matsunaga Dental Clinic <sup>2</sup> Fukuoka Dental College Dept. of Oral Rehabilitation, Fukuoka JAPAN

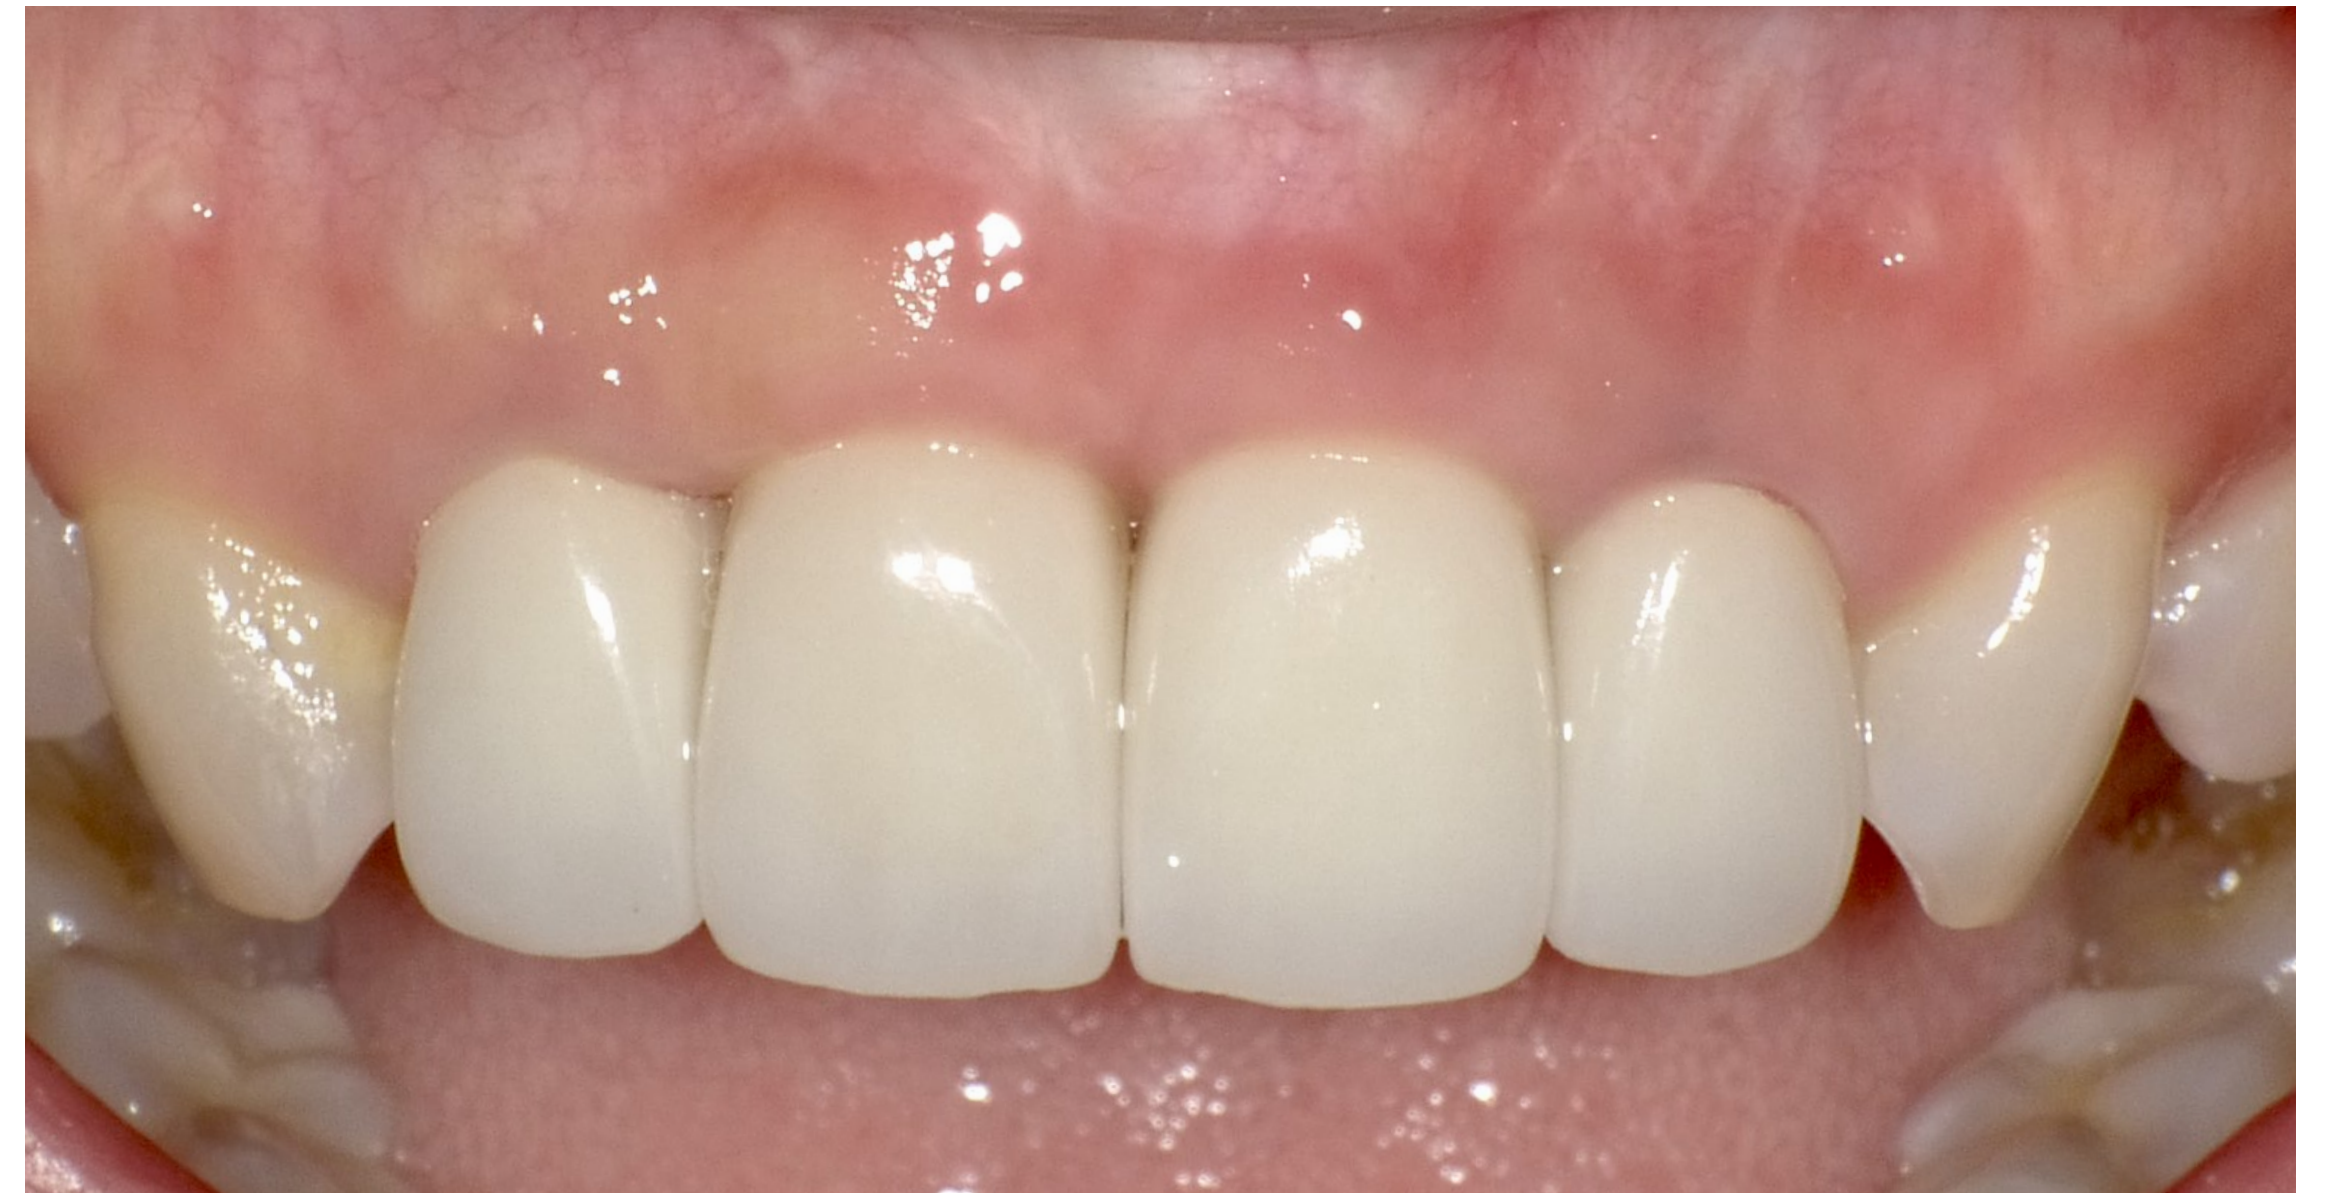
The final zirconia superstructure was delivered.
