# Rebreathing Caused by a Plugged Manifold Filter in the Absorber Insert of a Carbon Dioxide Canister

Taylor Dontino, DO, *Jennifer Labrecque, MS-4*, and Carlos J. Lopez III, MD  
SUNY Upstate University Hospital Syracuse, New York, USA`

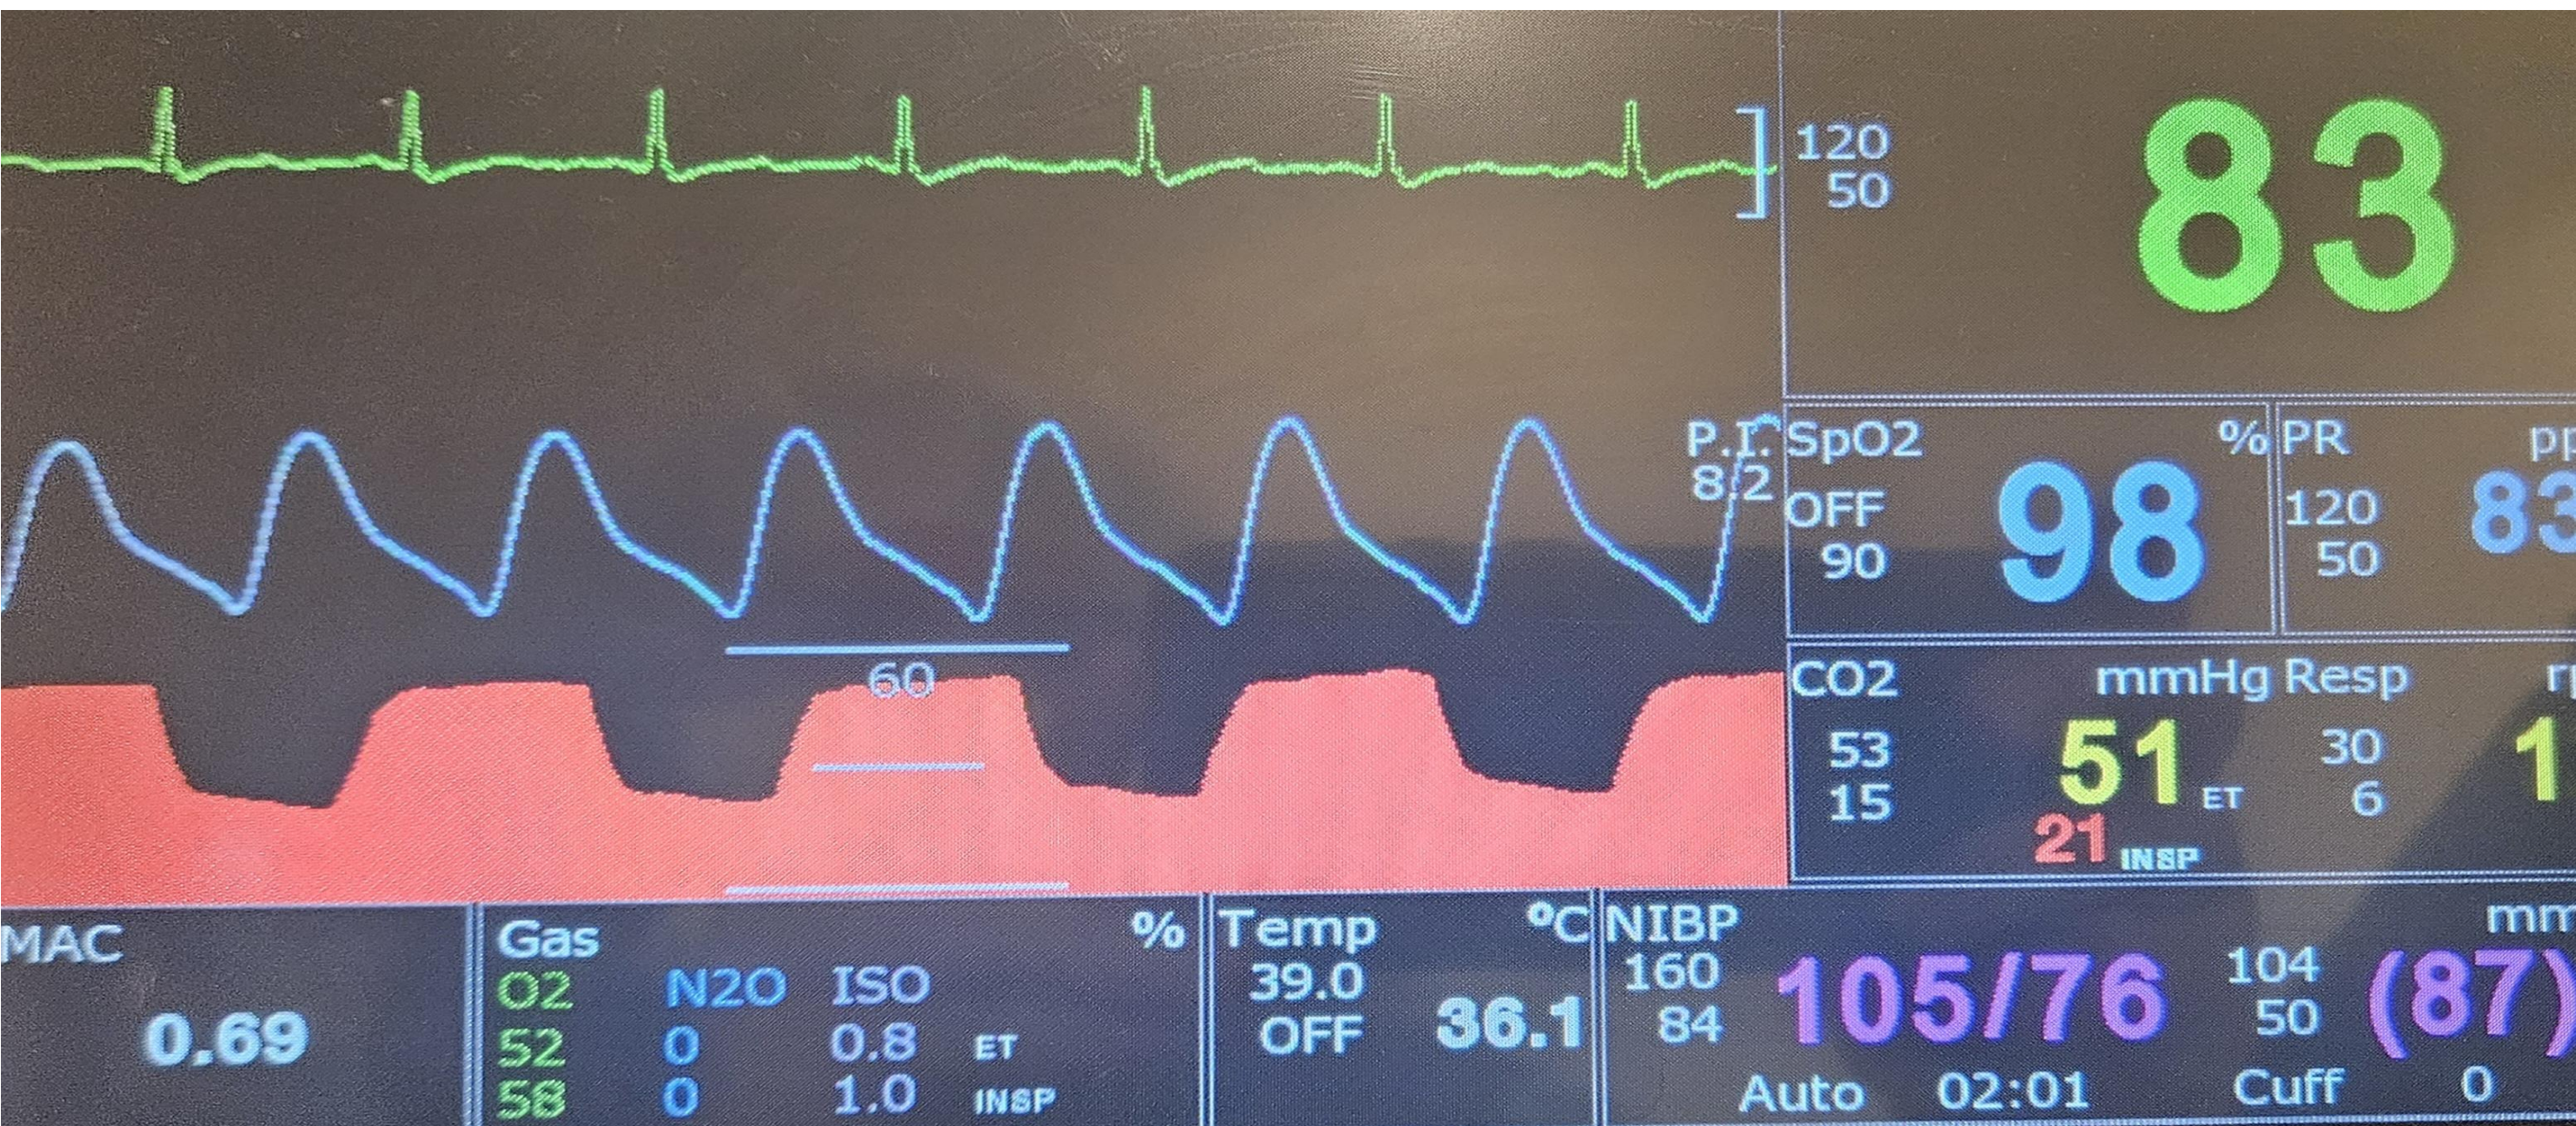
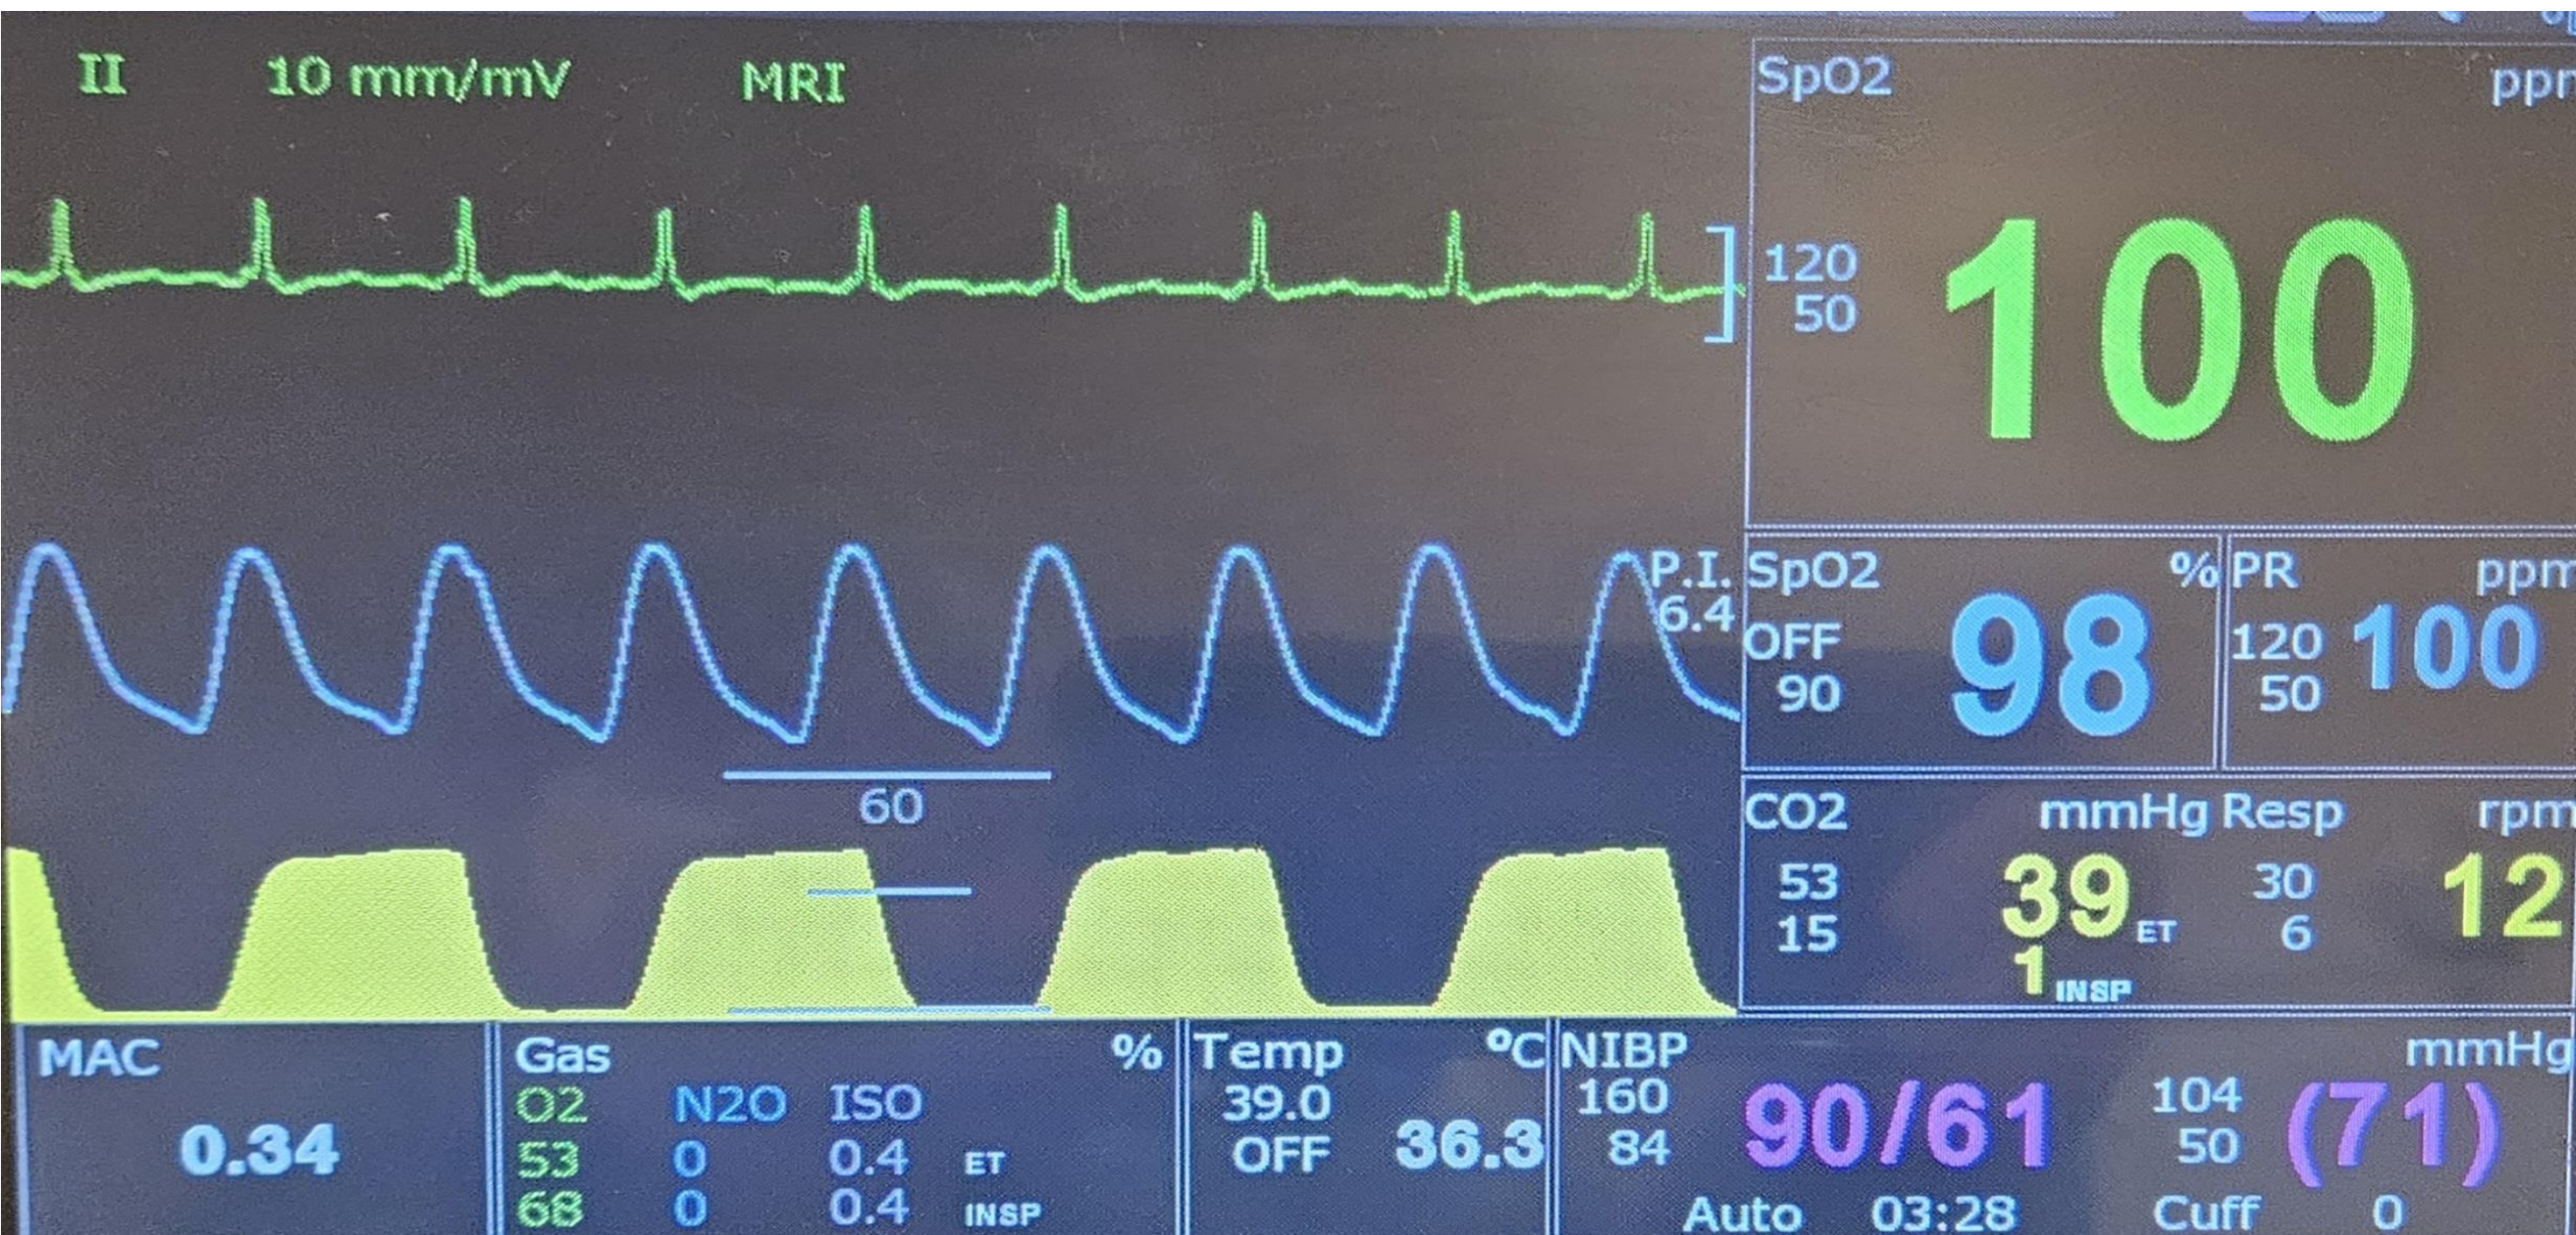
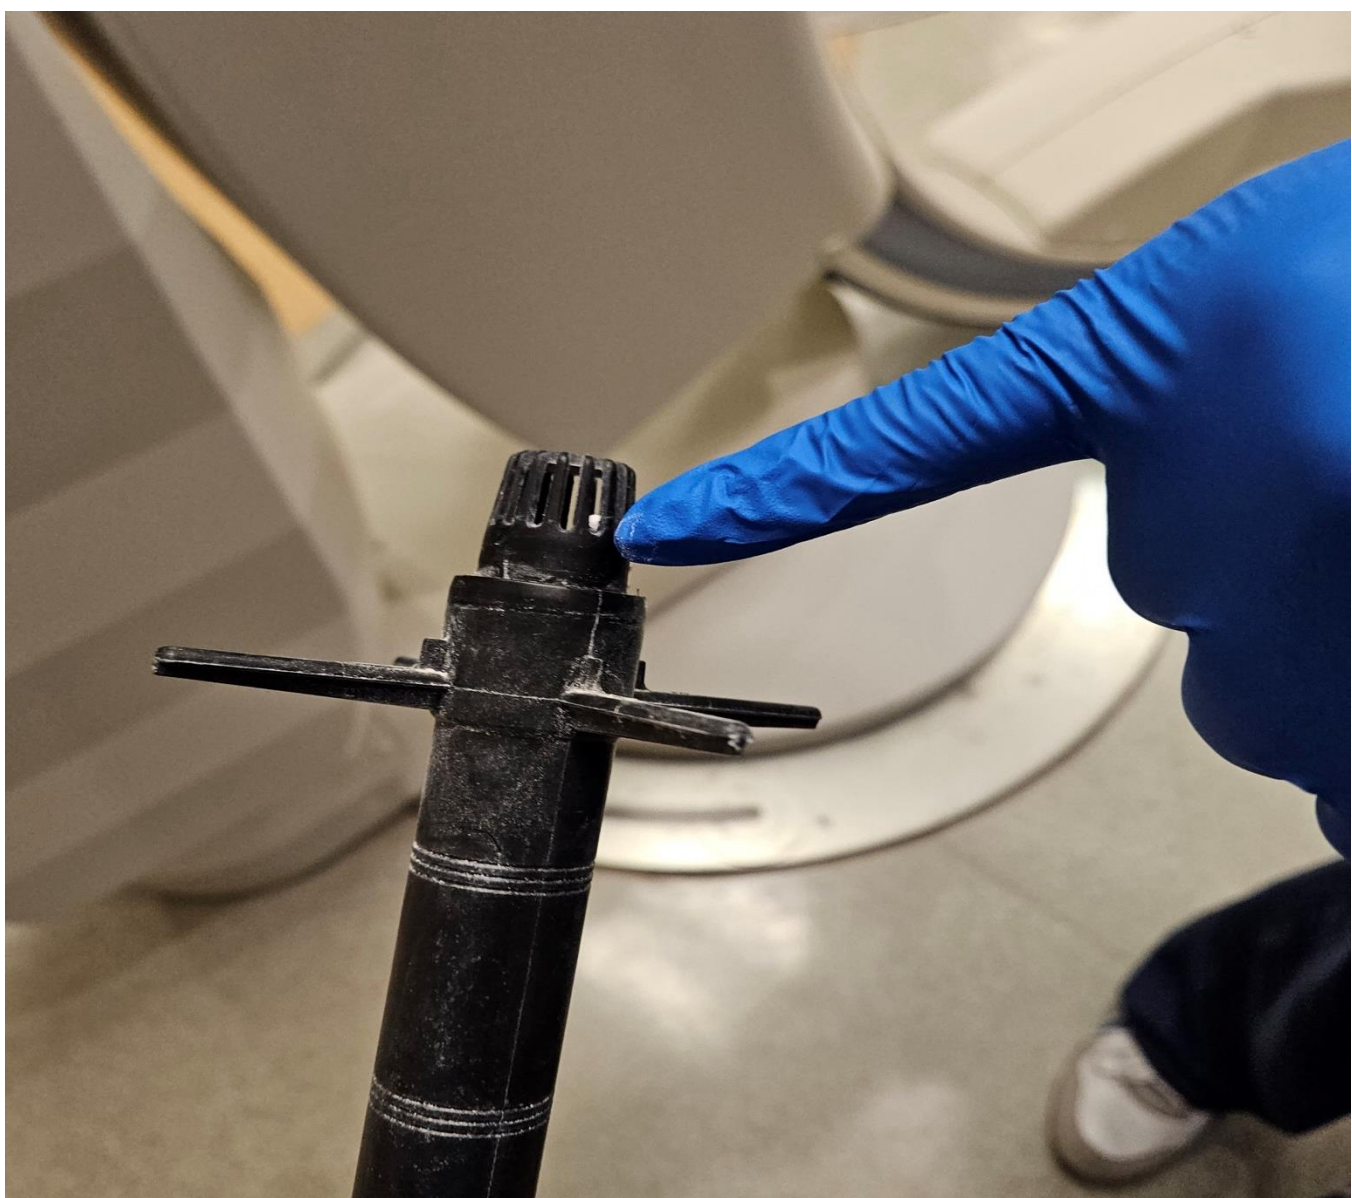
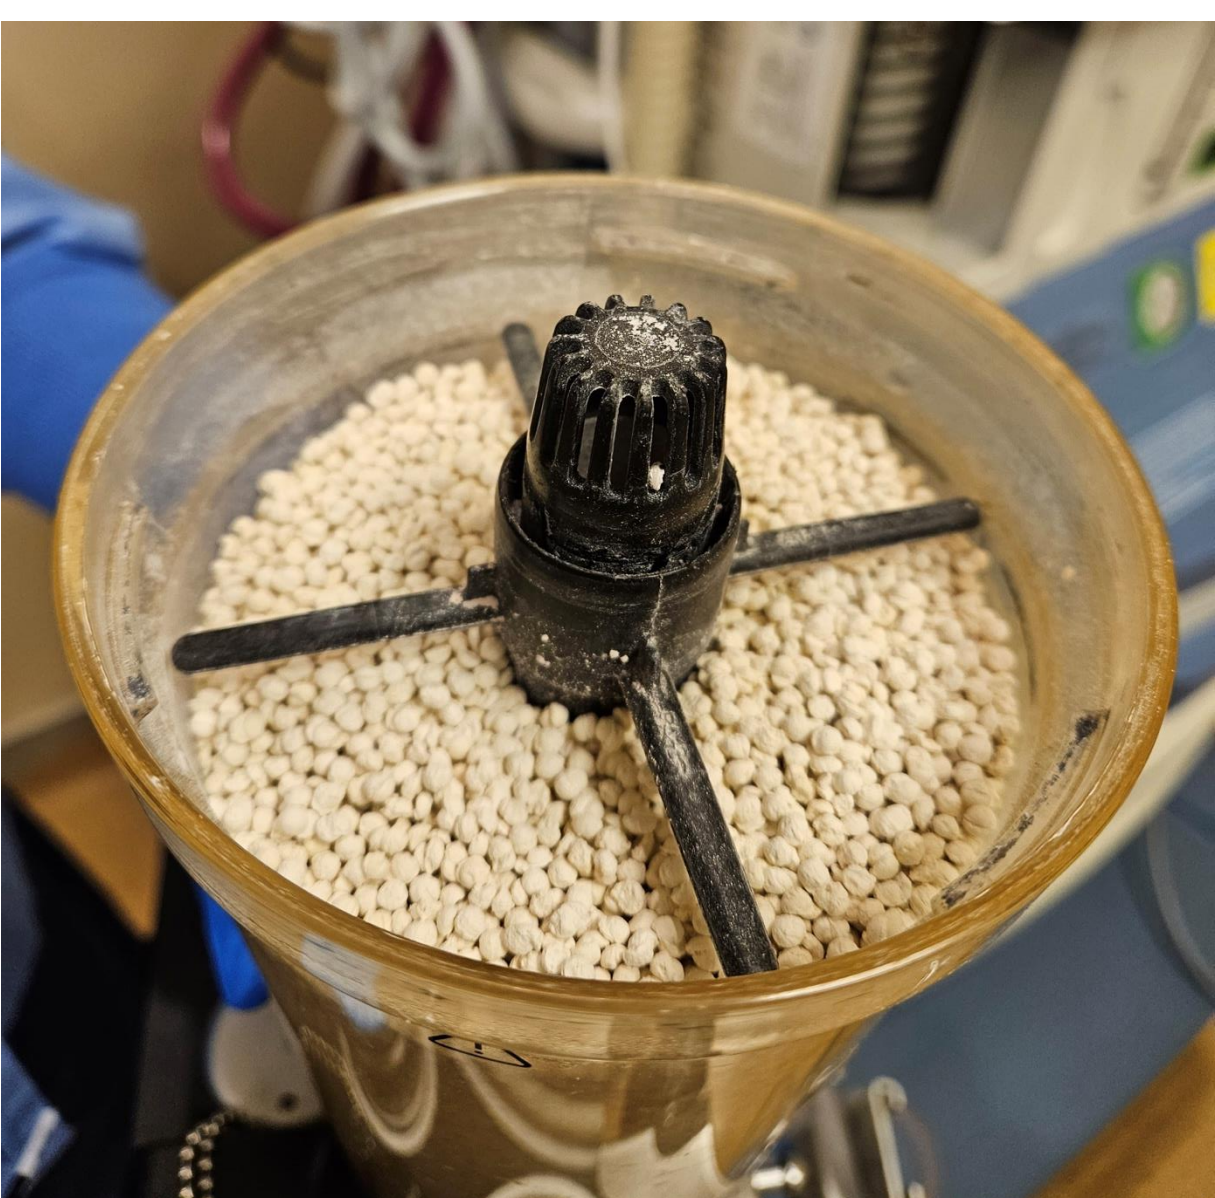
## Monitor & Manifold

A malfunction between the delivery of exhaled gas to the CO<sub>2</sub> absorber and return to the inspiratory limb was suspected. The patient was placed on total intravenous anesthesia, ventilated by hand, and we inspected the delivery system into the CO<sub>2</sub> canister. It was noted that the fenestrated filter at the top of the insert to the CO<sub>2</sub> canister was plugged with absorbent granules. The insert was removed; the granules were scraped off the insert and then reinserted into the canister with the absorbent. The canister was placed back into the anesthesia machine, and after reinitiating gas flow through the circuit, the inspired CO<sub>2</sub> was down to the usual 0 to 1.

In this case, we show how the cause of rebreathing was due to the inability of the exhaled gas to go down the central part of the carbon dioxide insertion tube to the bottom of the canister and subsequently percolate upwards through the carbon dioxide absorbent and then feed into the inspiratory limb. The exhaled gas here was inadequately neutralized and fed straight into the inspiratory limb. This malfunction could have been prevented with proper maintenance and cleaning of the anesthesia machines.

This case demonstrates the importance of consistent servicing and routine maintenance of the anesthesia machines. The manifold filter was plugged with absorbent granules. This prevented CO<sub>2</sub> from being adequately absorbed, and thus exhaled gases with high amounts of CO<sub>2</sub> were able to be sent through to the inspiratory limb, causing hypercapnia.
