# Radiographic image suggesting broken epidural catheter: a case report

Division of Obstetric Anesthesiology, Department of Anesthesiology, Northwestern Memorial Hospital

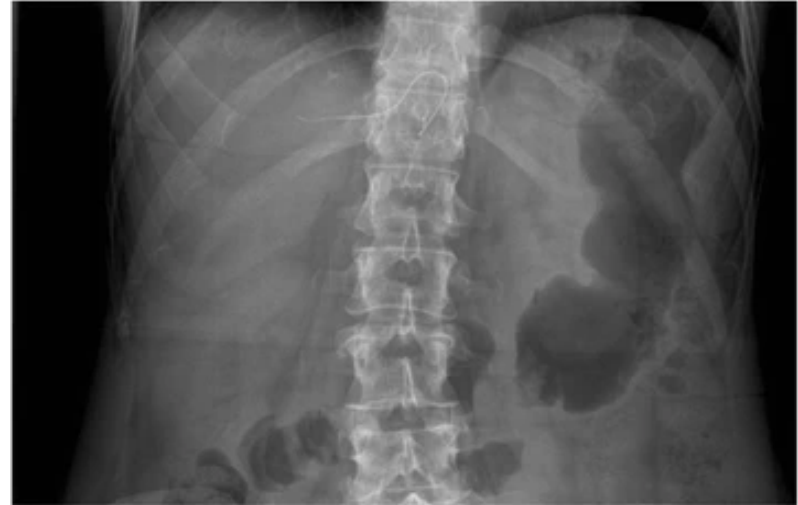
X-ray from case report of retained fractured epidural catheter. Pincioli, R., Fumagalli, R. BMC Anesthesiol 2015.

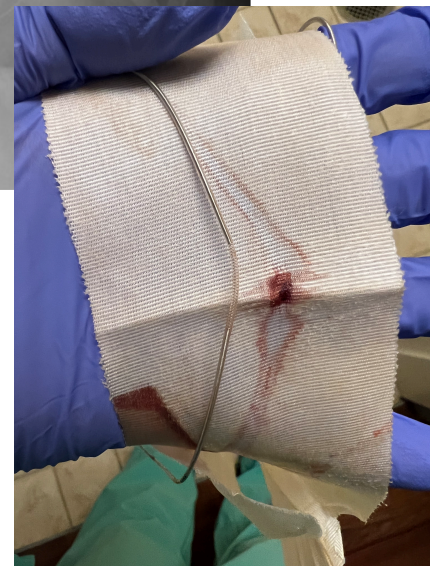
## Closing x-ray

- *“a very small focus of catheter discontinuity in the medial aspect of the left upper quadrant.”*

- Potential catheter breakage while moving of the patient
- Wire-reinforced catheters often have translucent (and radiolucent) window through which aspirated fluid may be viewed.
- Most fractured catheters occur due to traumatic removal.
- Actual incidence of catheter fracture leading to retention is extremely rare/not known.
- Retention from knotting thought to be more prevalent; based on case reports, estimated at 0.0015%<sup>2</sup>
- If in doubt, obtain imaging!
