# PICC rupture as a clinical presentation of pinch-off syndrome

Vertakova Krakovska B<sup>1</sup>, Kunderlik M<sup>1</sup>

<sup>1</sup> St.Elizabeth Cancer Institute, Bratislava, Slovakia

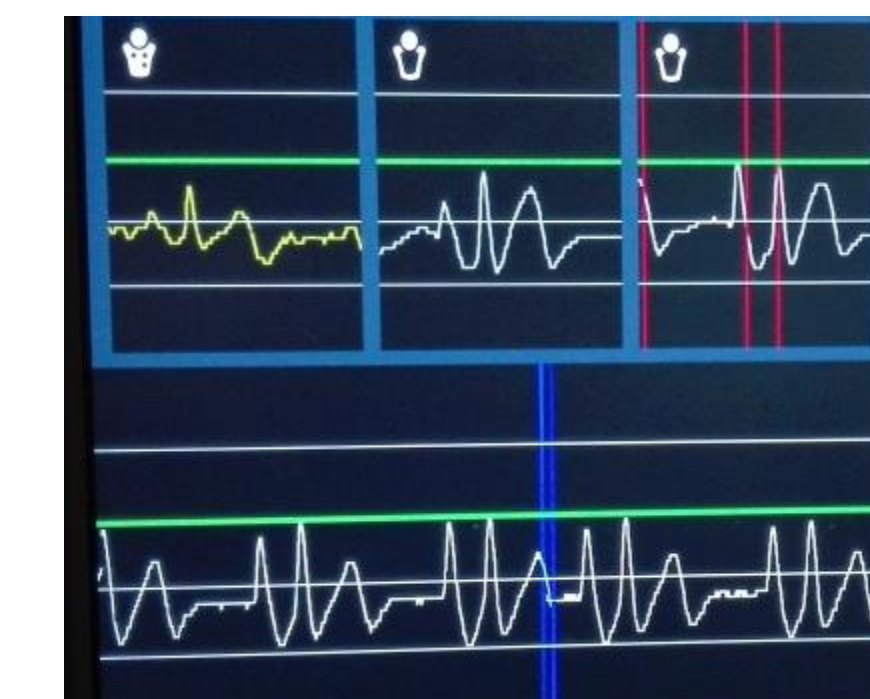
**Picture 1:** ECG navigation showing optimal position - the tip of PICC is in cavo-atrial junction

56- year old female with duplex carcinoma (breast and ovarian cancer), requiring intravenous chemotherapy had her single lumen 4F PICC placed via the left vena basilica in July 2018, ECG navigation (picture 1) as well as chest X-ray (picture 2) showed catheter position in cavo-atrial junction, no complications were described. The PICC line was used for intravenous chemotherapy application for 18 months, with no complications. Later on, in January 2020 (18 months later), the patient experienced a catheter occlusion. When attempting to flush the catheter (not successful), the patient experienced sharp pain under her left clavicular bone. A catheter rupture has been suspected. Chest X-ray and fluoroscopy with intravenous contrast was performed (picture 3 and 4).

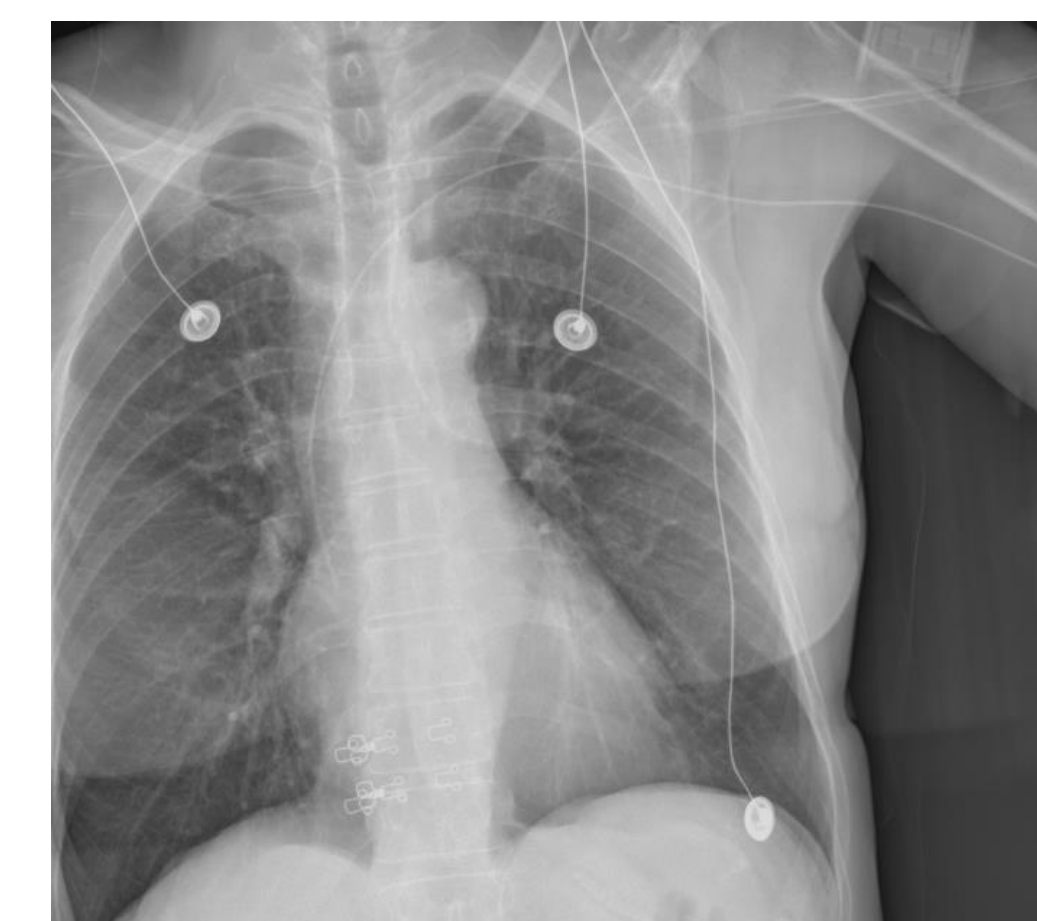
**Picture 2:** X-ray after PICC implantation showing good position of catheter
