# Chlorhexidine and Silver Impregnated Silicone Dressing: Case Report in Patients with Catheter Associated Skin Impairment Risk

To report the use of a CHG and silver impregnated silicone dressing in patients at risk of CASI.

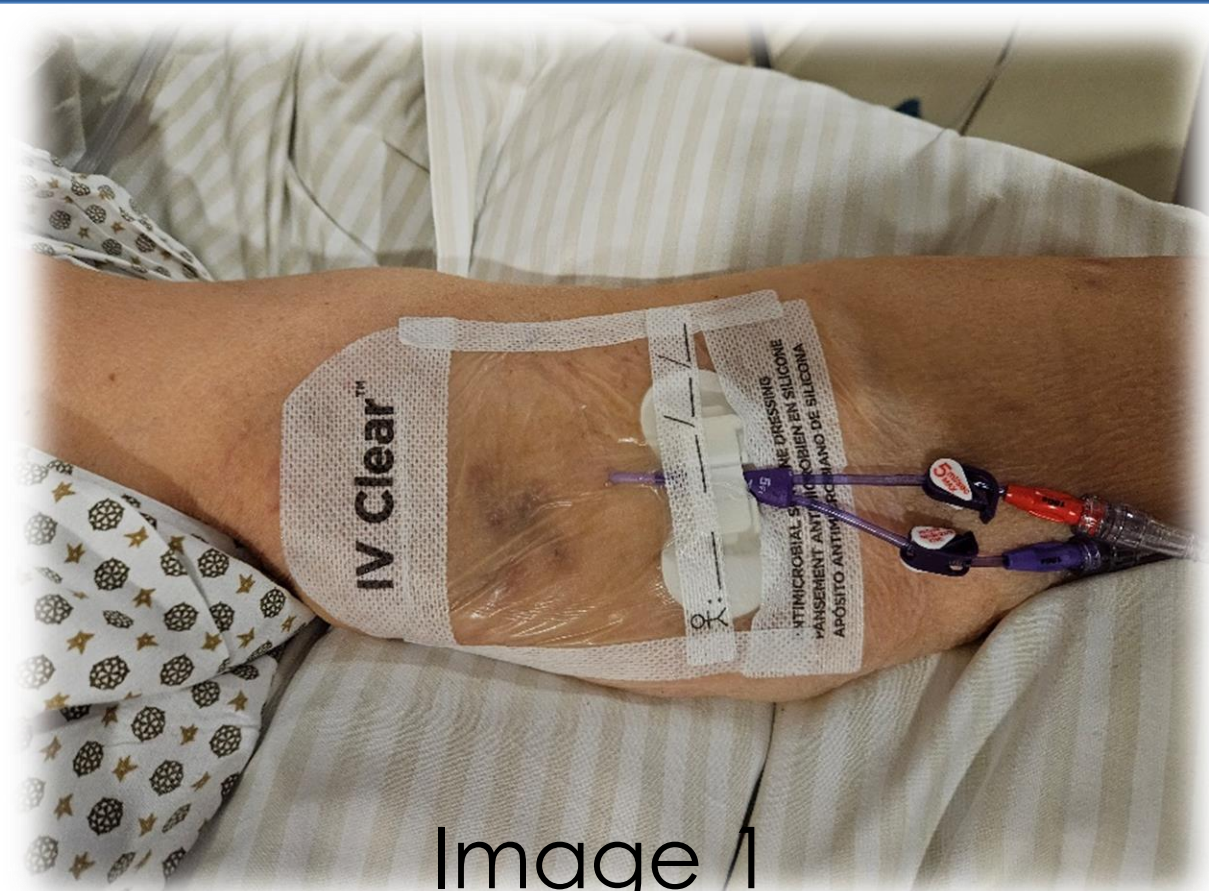
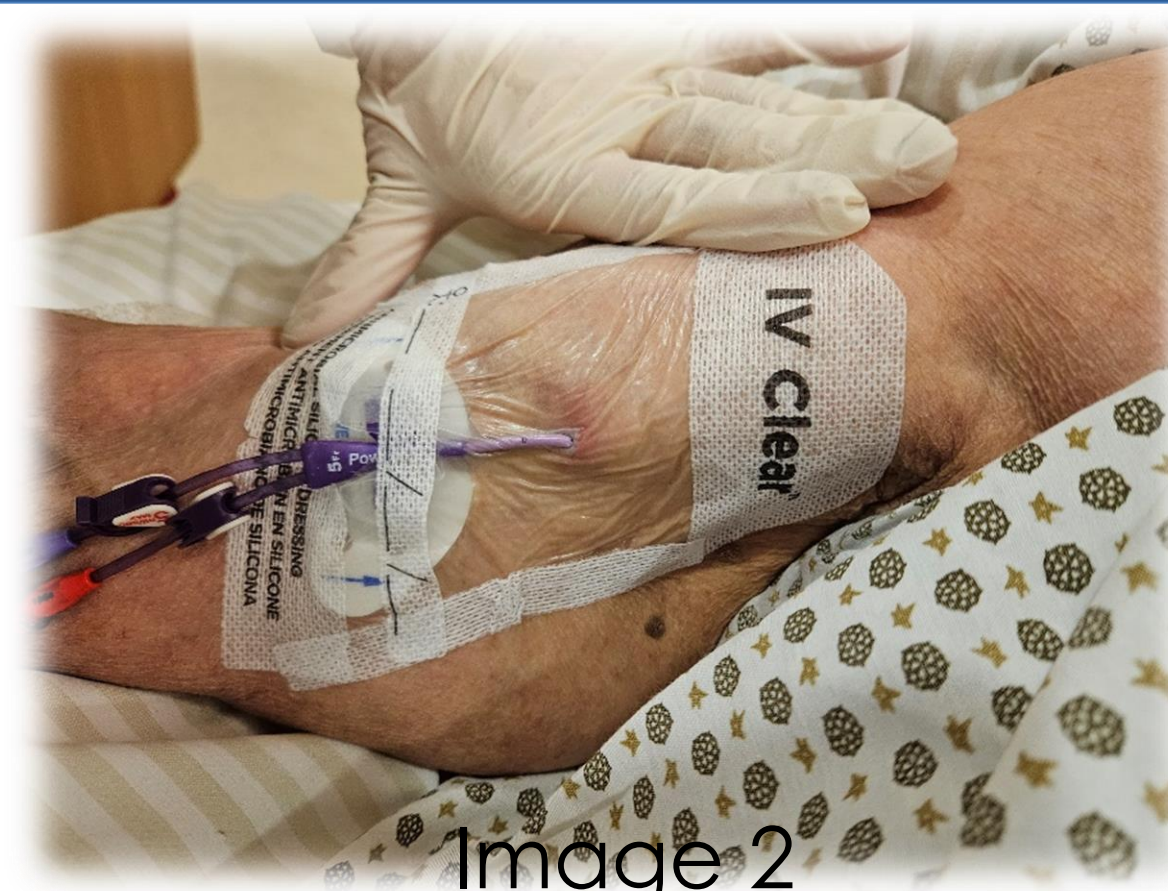
None of the patients had a bloodstream infection related to the PICC or symptoms of inflammation on insertion (Graph 3). The comfort during its removal, was reported. However, it is necessary to manipulate the film to better visualize the insertion due to the lack of adherence in this area (Images 1, 2 and 3)

The dressing showed advantages, such as patient comfort and easy application and removal. A larger area with CHG and silver is on the entire film, suitable transparency for visualizing the insertion, and had no signs of inflammation on insertion or bloodstream infection associated with the catheter. It proved to be a good option for preventing infection and CASI events..
