# Evaluation of Machinability of Feldspathic Blocks Using ISO 18675

## Objective:

To evaluate the minimum required thickness for the success of milled ceramic restorations with a standardized method of preparation and milling procedure and to compare milling damage of Vitbloccs Mark II specimens fabricated using two milling units: Dentsply-Sirona CEREC Primemill and inLab MC X5.

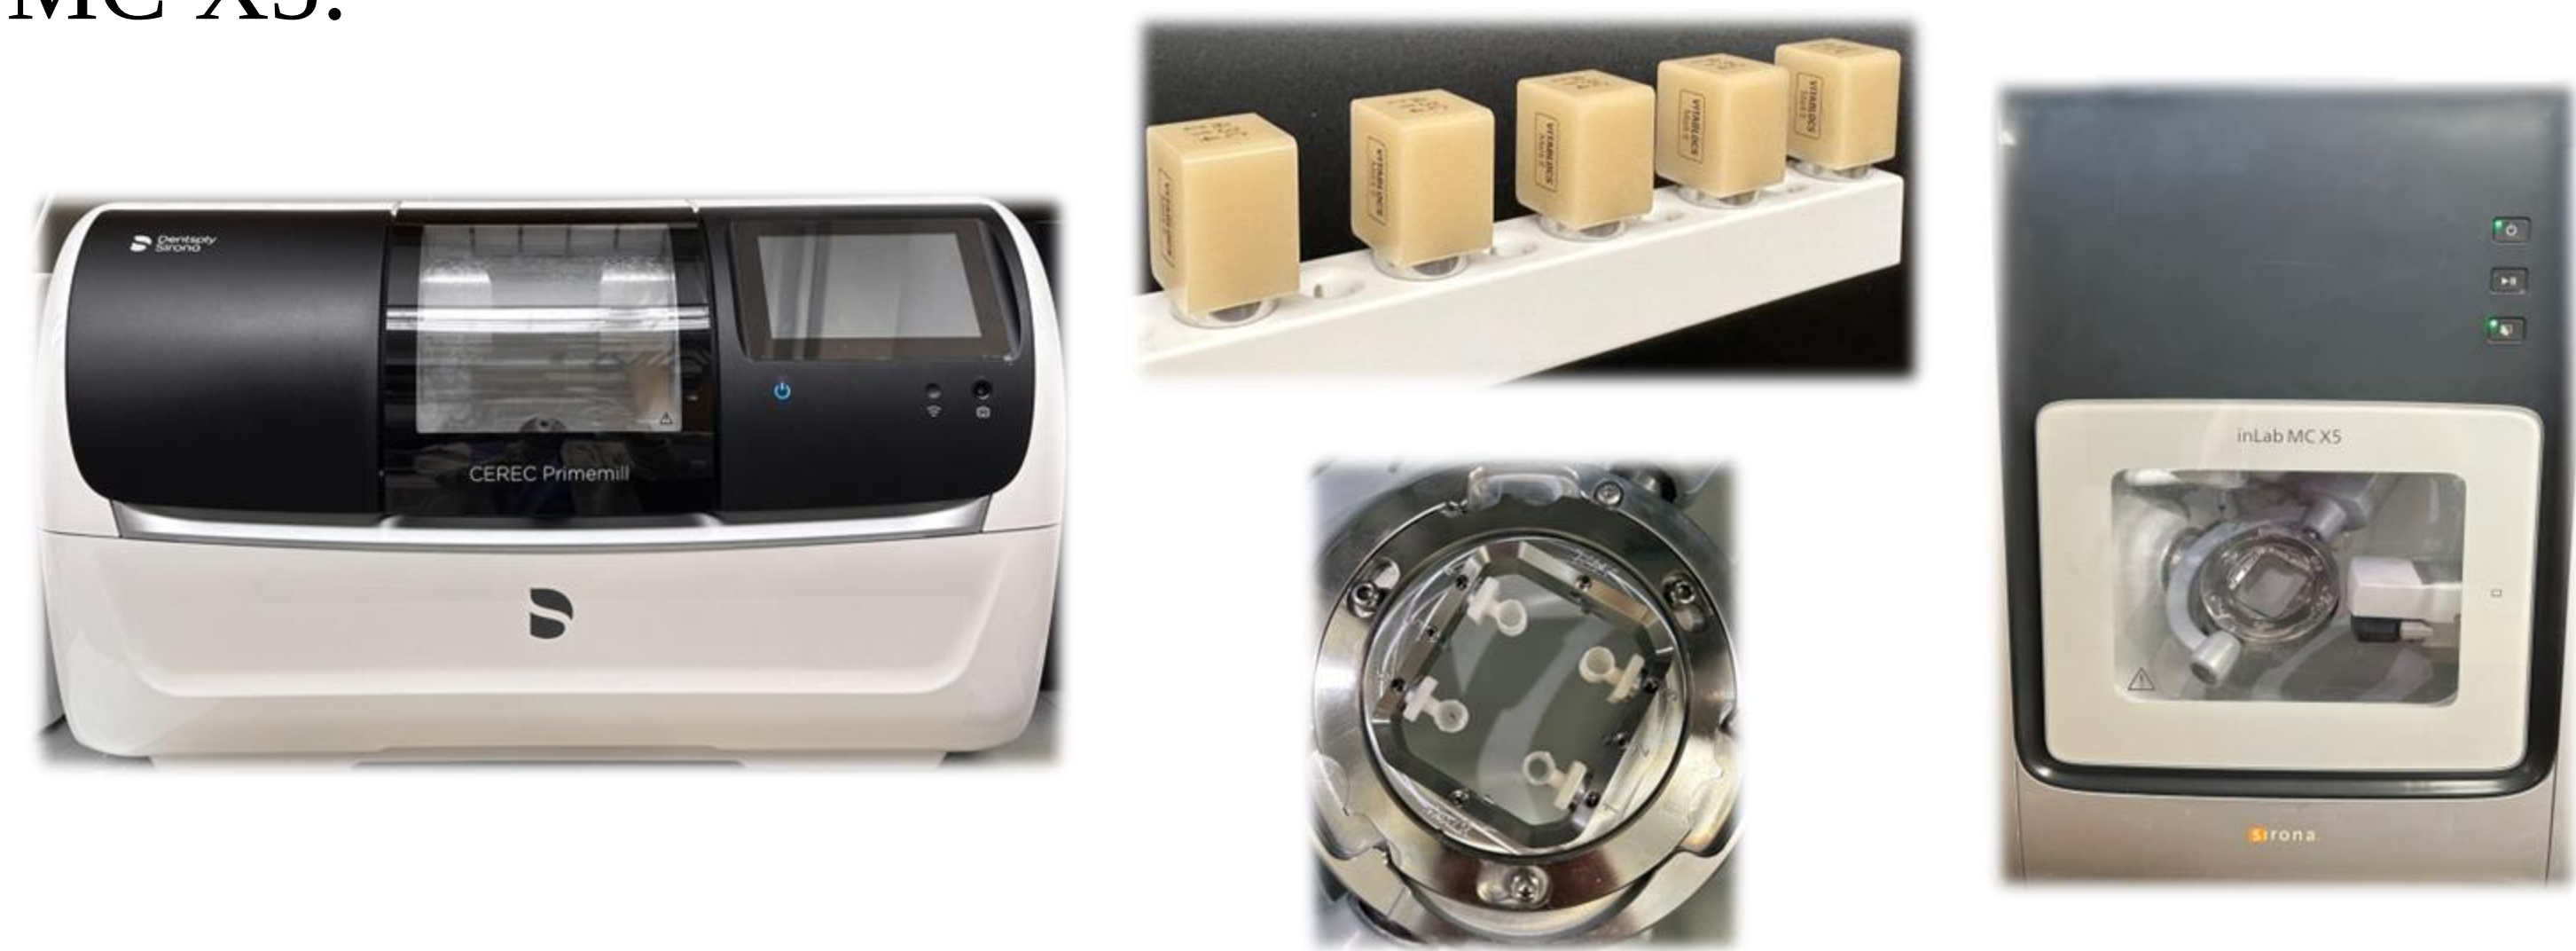
**Materials and Methods:** Fifty (50) VITA Mark II CAD/CAM blocks (size of I-14 and shade 3M1C) were used to fabricate merlon specimens using Sirona inLab MCX5 and CEREC Primemill with specifications according to ISO 18675. Five specimens of each thickness of 0.1, 0.2, 0.3, 0.4, and 0.5 mm were prepared with each milling machine. For VITA Mark II, lot number was 95420 and a reference no. of EC43M1CI14 and of March 2023 manufacturing date.

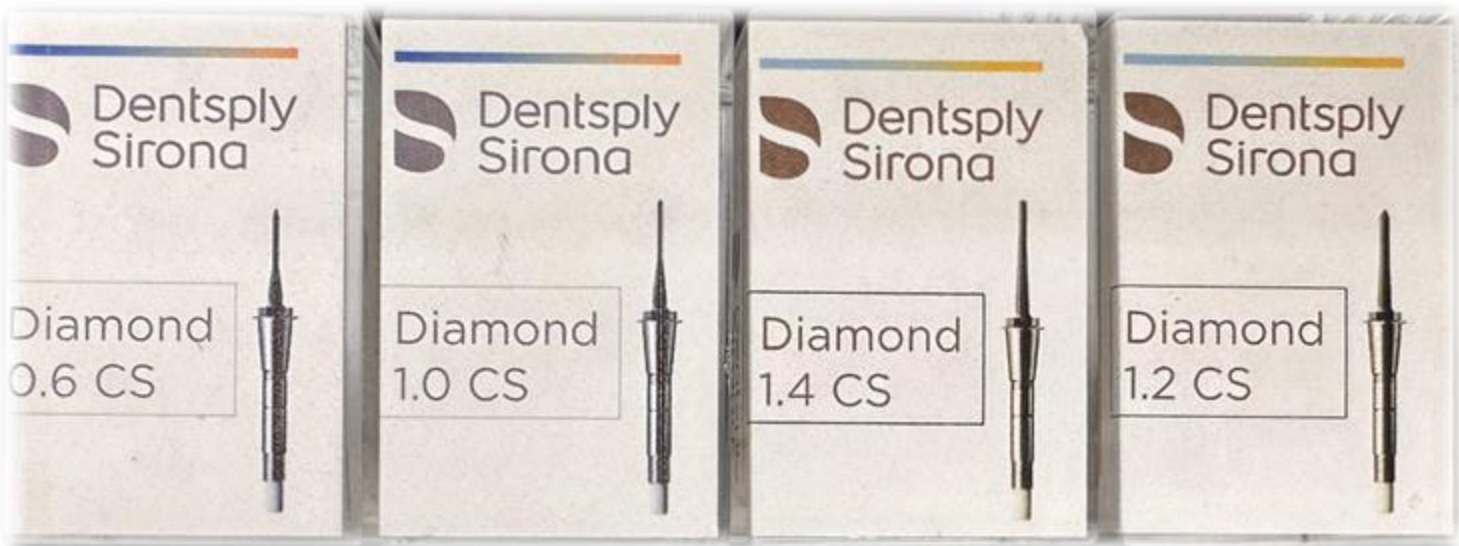
In CEREC Primemill, tools set were extra fine grinding diamond burs (white colored: sizes 1.0 CS, 0.6 CS, 1.4 CS, and 1.2 CS) with a normal speed were used. Milling parameters were inputted by the CAM software of CAD/CAM system. Wet milling was used.

Some burs were changed before the third block milling of group 0.4 mm thickness as the screen showed lower percentage level of function and they were as follows: bur 1.2 mm had remaining percentage of 66% and bur 1.4 mm had 76% of its 100%. There was another burs changing process before the milling of the fifth block of 0.1 mm thickness and they were: 1.2 mm bur with 55% remaining and 1.4 mm bur with 68% remaining

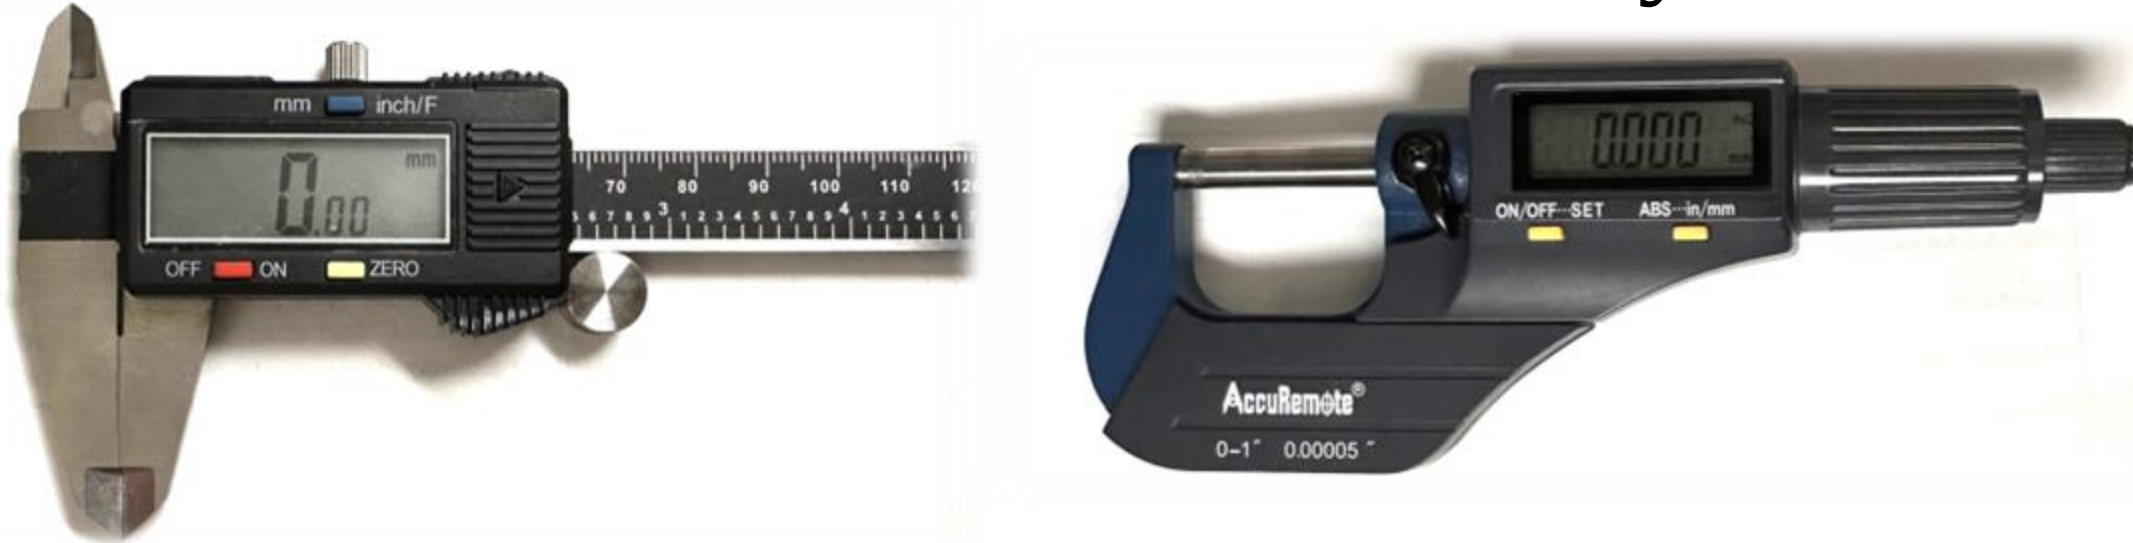
The burs used in MCX5 were diamond grinders or diamond coated grinders. Diamond grinders have a white color-coded size sequence of 0.6, 1.2, 1.4, and 2.2 mm, whereas all others have a yellow color-coded sequence of 0.5, 1.0, and 2.5 mm. After the milling preparation process in CEREC Primemill and inlab X5, the merlon walls and bottoms were measured for thickness. A merlon wall was considered failed if more than one third (1/3) of its top end was not complete seen by naked eye. The bottom was considered fractured if a hole can be visually observed.

Measurements were taken using a Mitutoyo caliper (0.02 mm tolerance) for wall thickness and micrometer (0.001 mm tolerance) for bottom thickness.

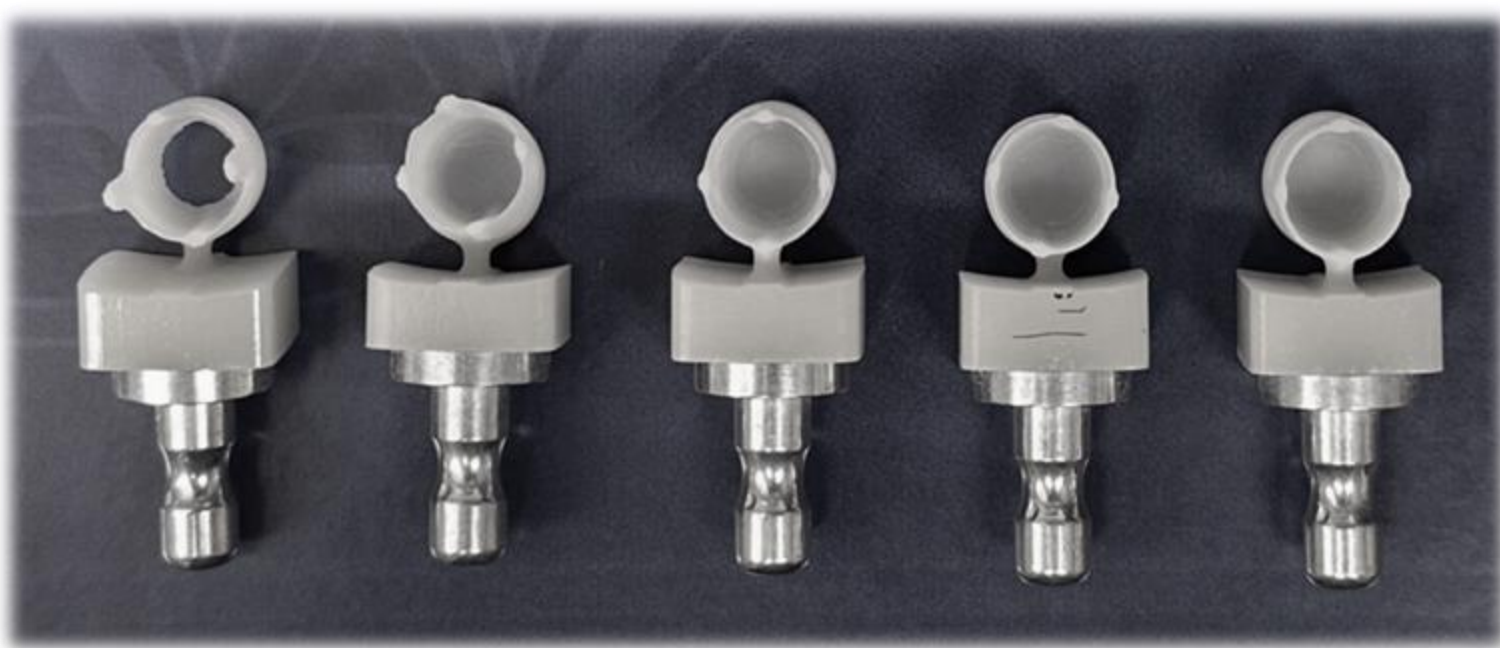
## Bottom and Wall Thickness Success Rate in MC X5 versus Primemill

**Results:** The minimal machine thickness (with a 100% success rate) for the Merlon wall is 0.2 mm for MCX5 and 0.4 mm for Primemill. The minimal machine thickness (with a 100% success rate) for the bottom is 0.5 mm for MCX5 and 0.2 mm for PrimeMill milling machines.

MCX5 has less edge chipping damage than the Primemill milling machine.
