# In vitro and in vivo durability of a noble metal coating

Katrin Ljunggren, Billy Södervall & Tanny Bachrach  
Bactiguard, Stockholm, Sweden

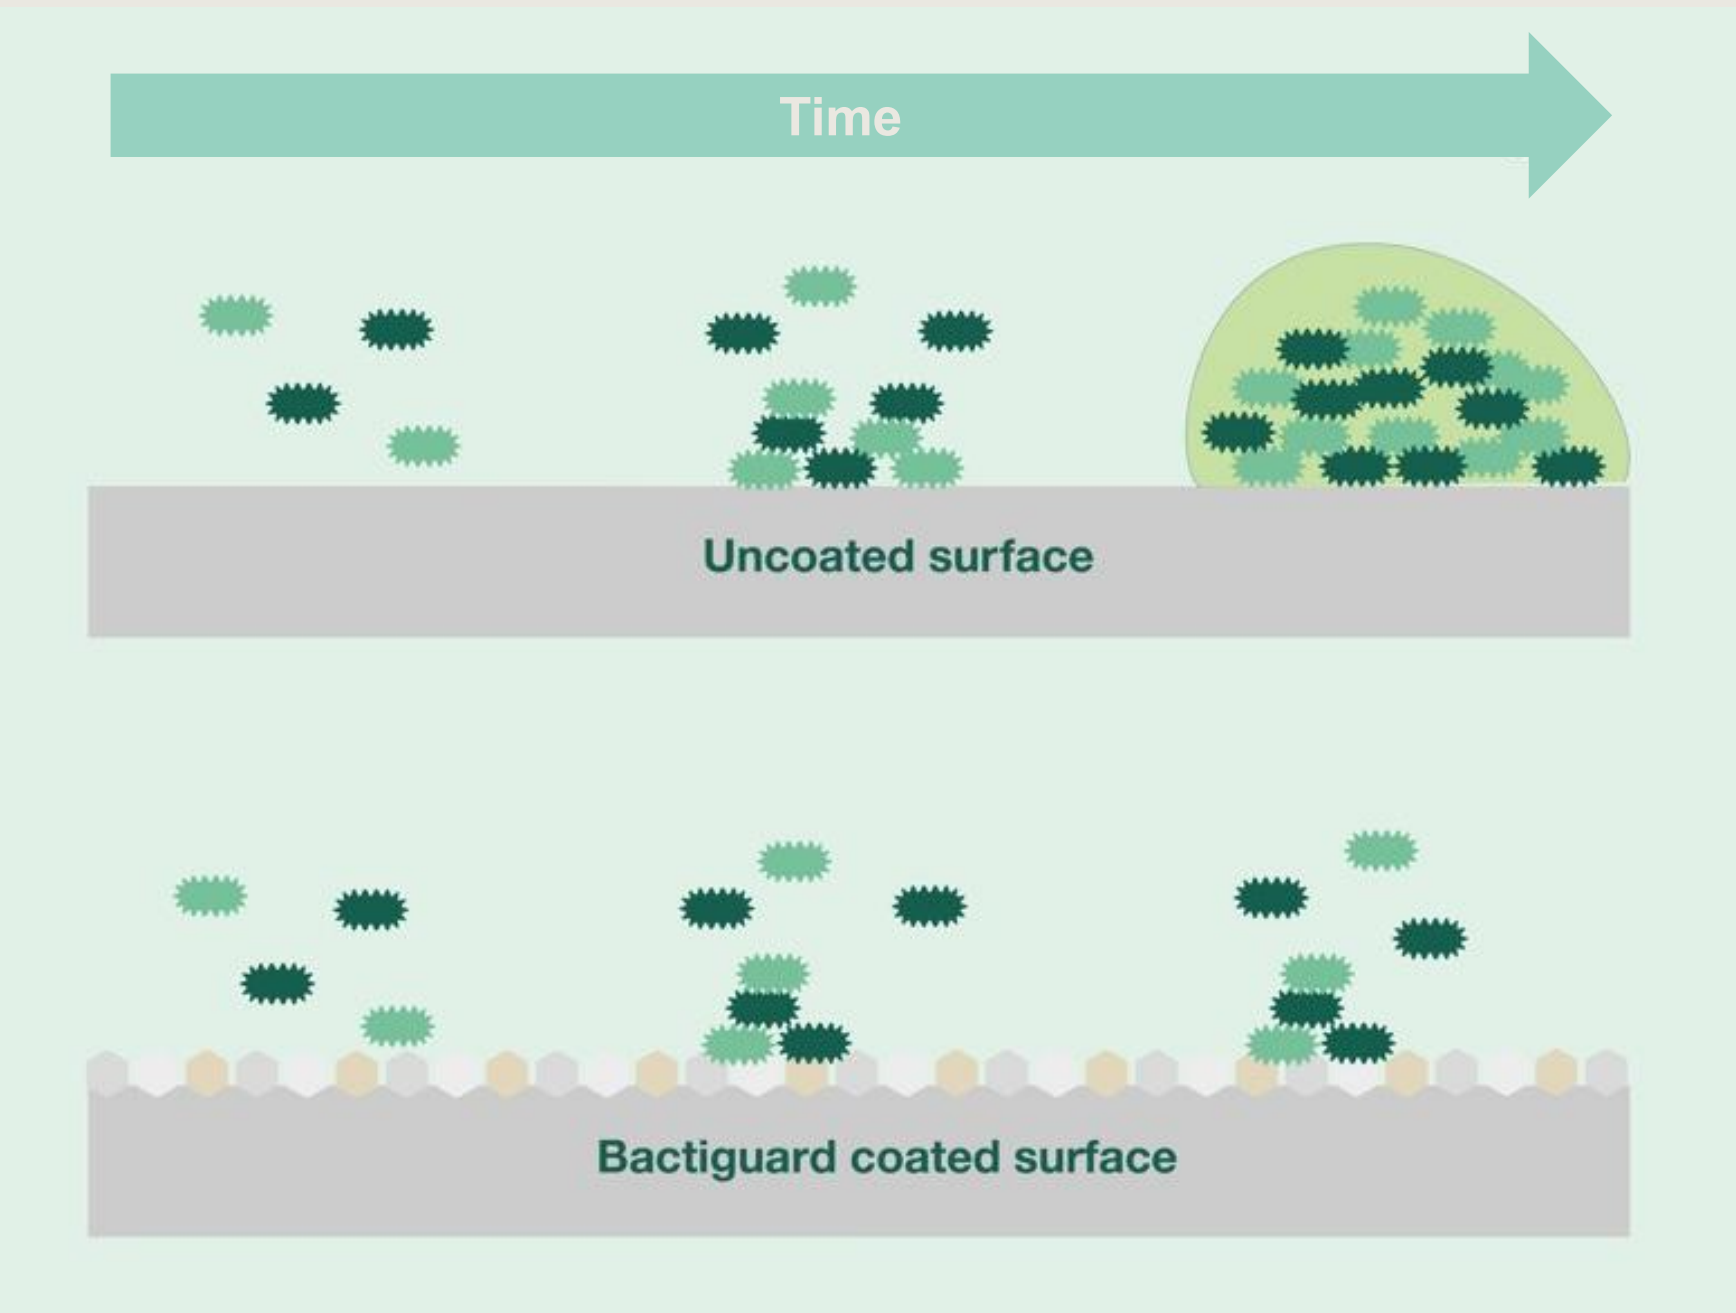
Figure 1: Schematic of microbial adhesion on uncoated vs. Bactiguard coated surface

Applied as a thin surface modification intended to reduce microbial adhesion while maintaining implant function (Figure 1).

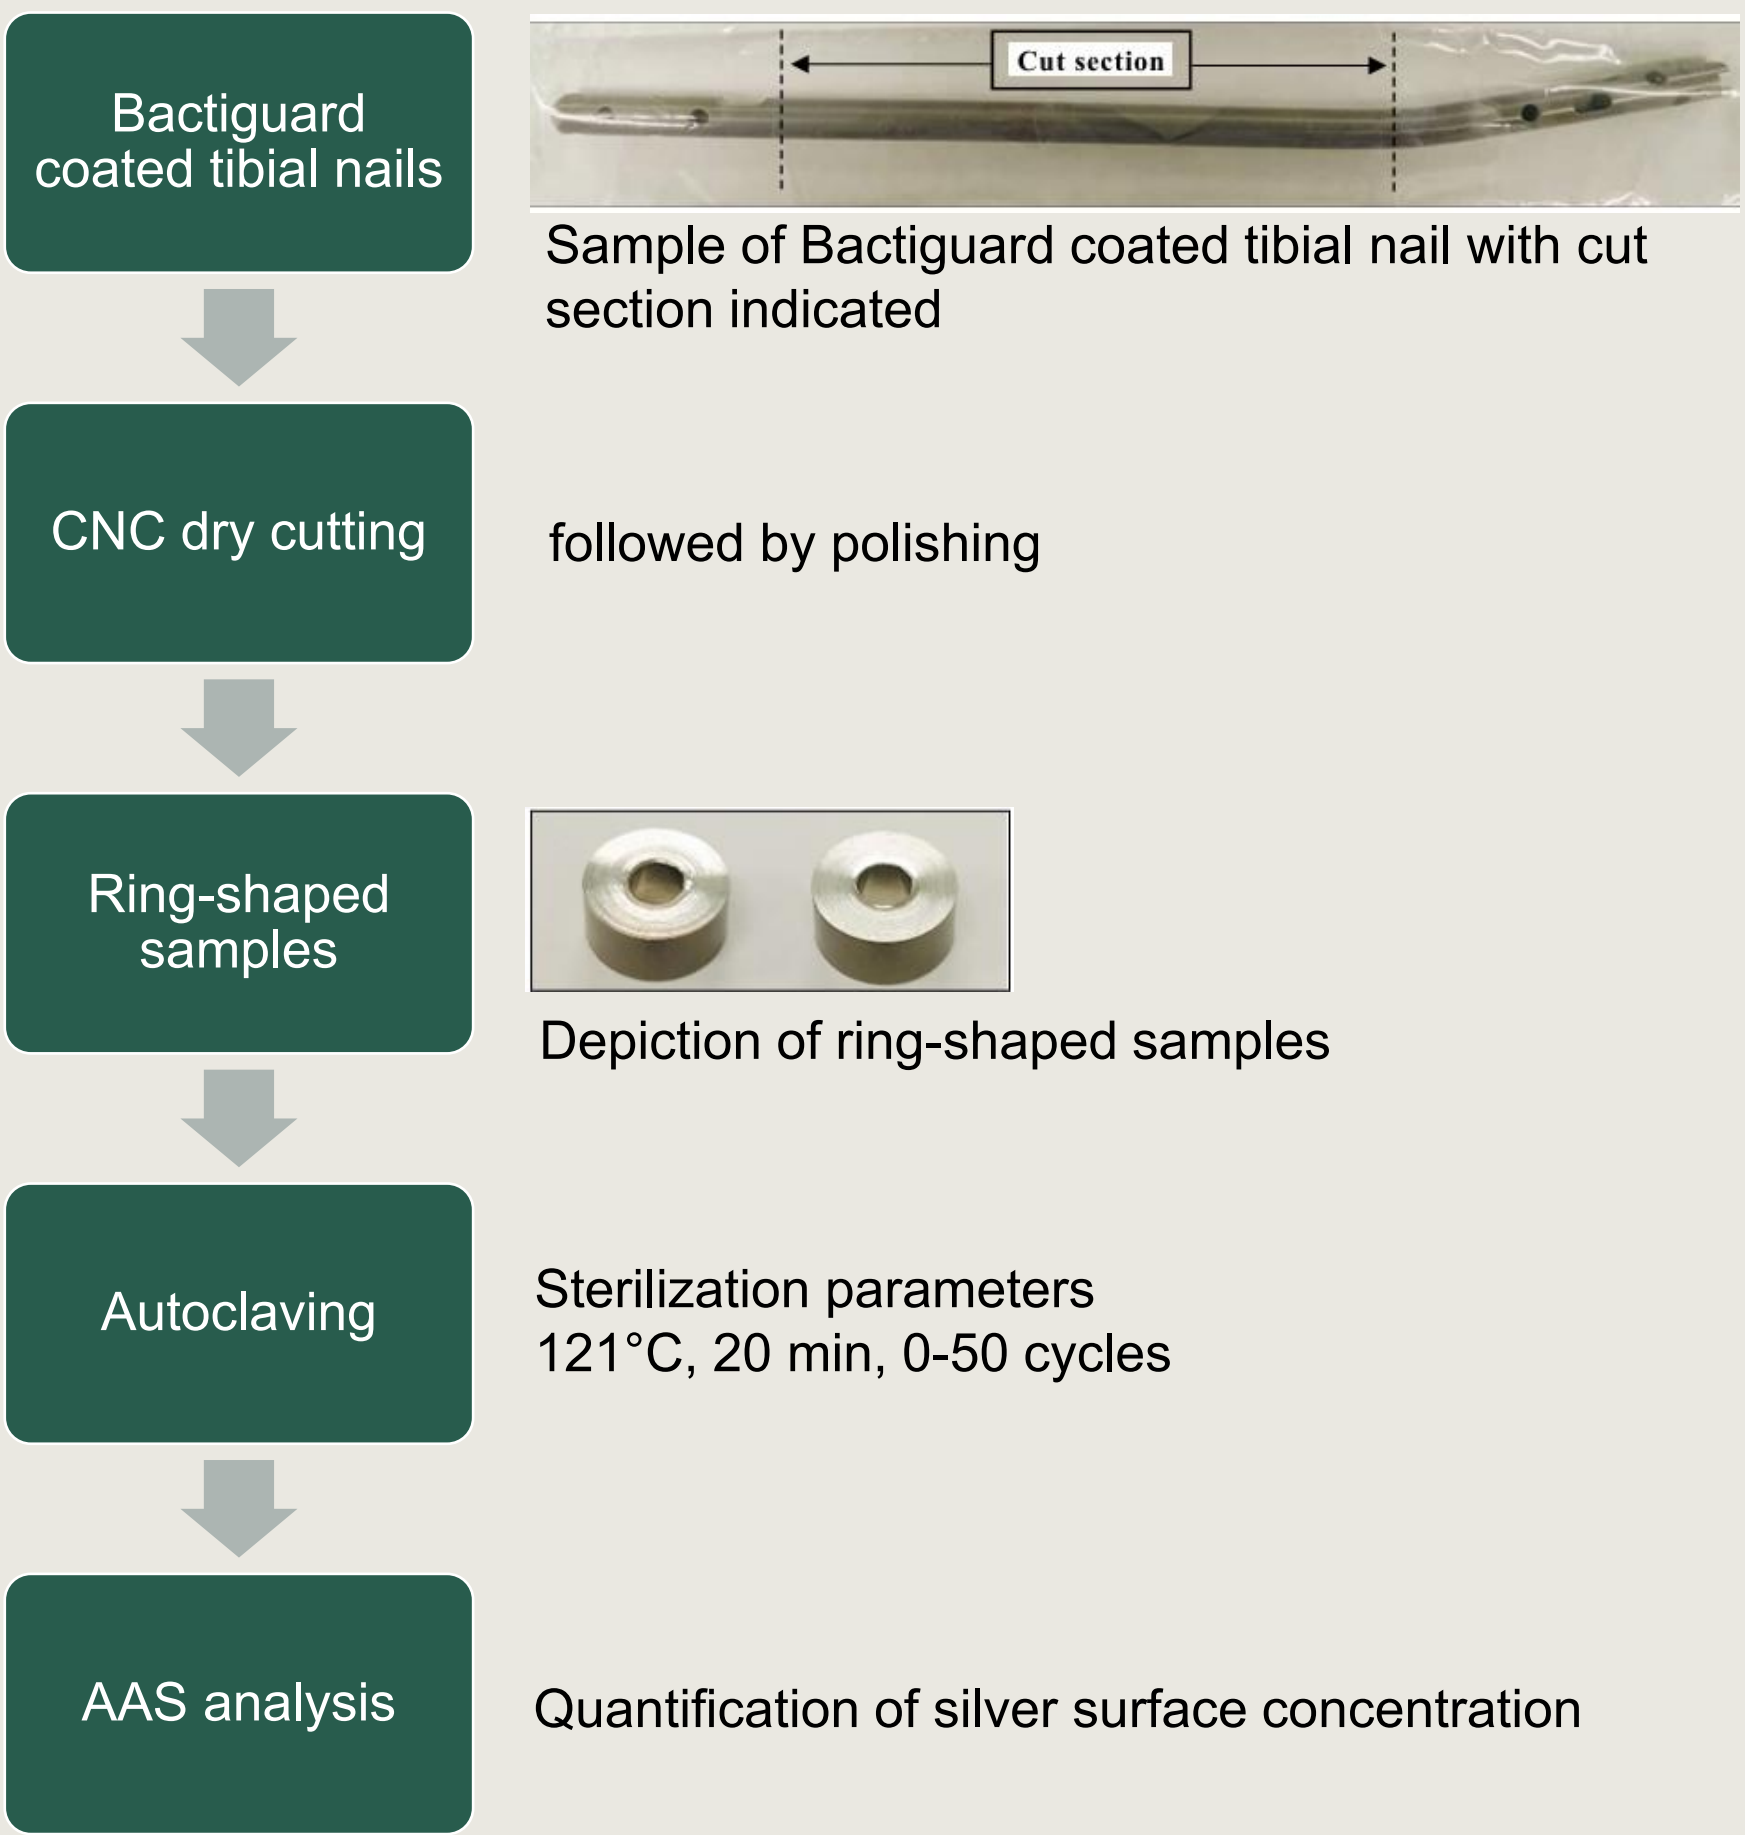
Figure 2: Workflow of *in vitro* durability testing

Three Bactiguard coated tibial nails were cut into 55 ring-shaped samples using Computer Numerical Control (CNC) blade followed by polishing. The samples were then packed in sterilization packs with five pieces per package corresponding to one cycle group each and subjected to 0-50 autoclave cycles (121°C, 20 min). Silver surface concentrations were measured using Atomic Absorption Spectroscopy (AAS) after each cycle group (Figure 2).

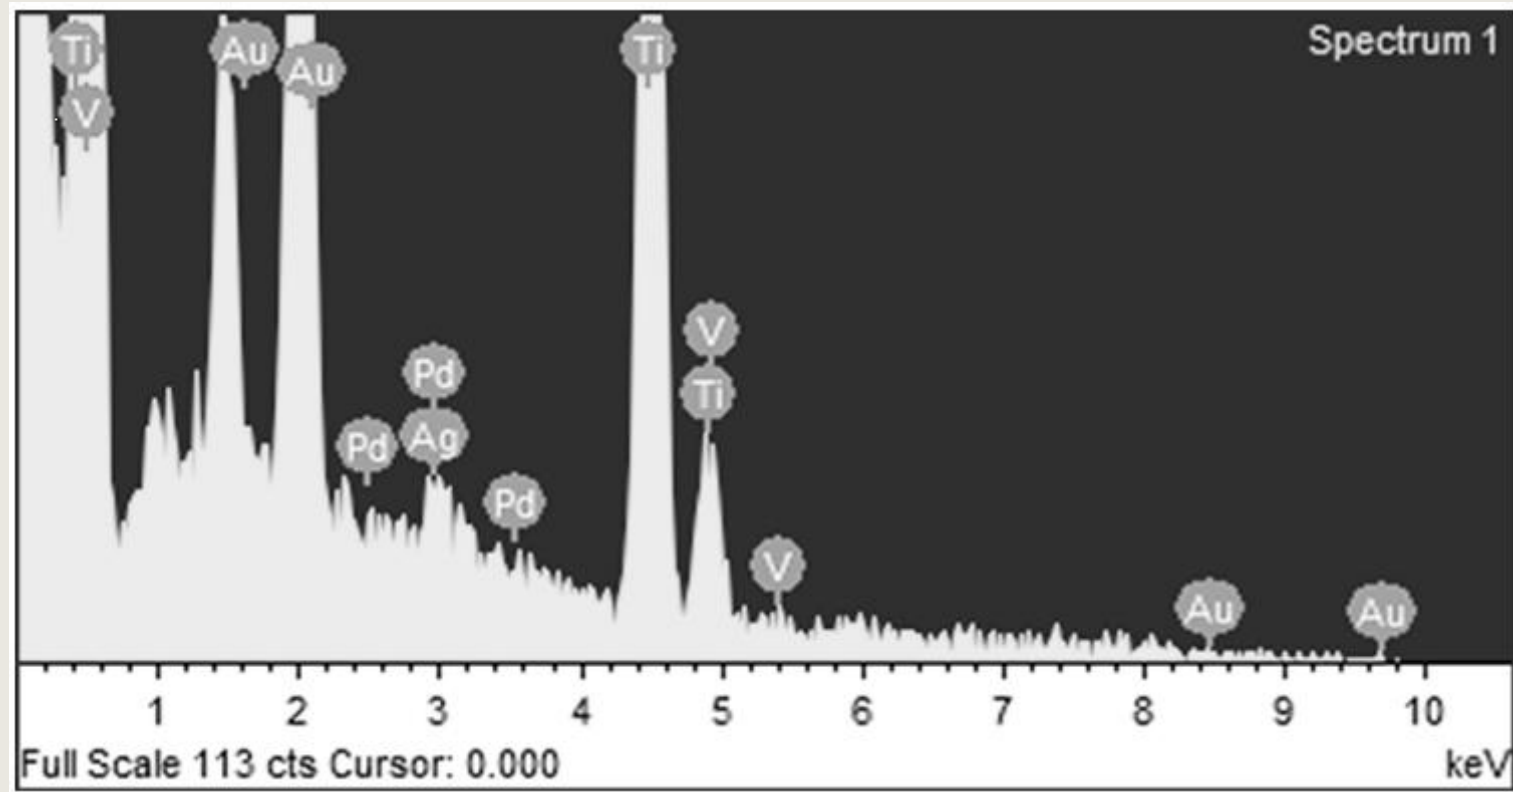
Figure 3: EDS spectrum confirming the presence of Ag, Au and Pd following clinical use

EDS spectra obtained identified:

- Silver (Ag)
- Gold (Au)
- Palladium (Pd)

along with expected substrate alloy elements:

- Titanium (Ti)
- Vanadium (V)

All surface modification constituents remained present after prolonged clinical use (Figure 3).

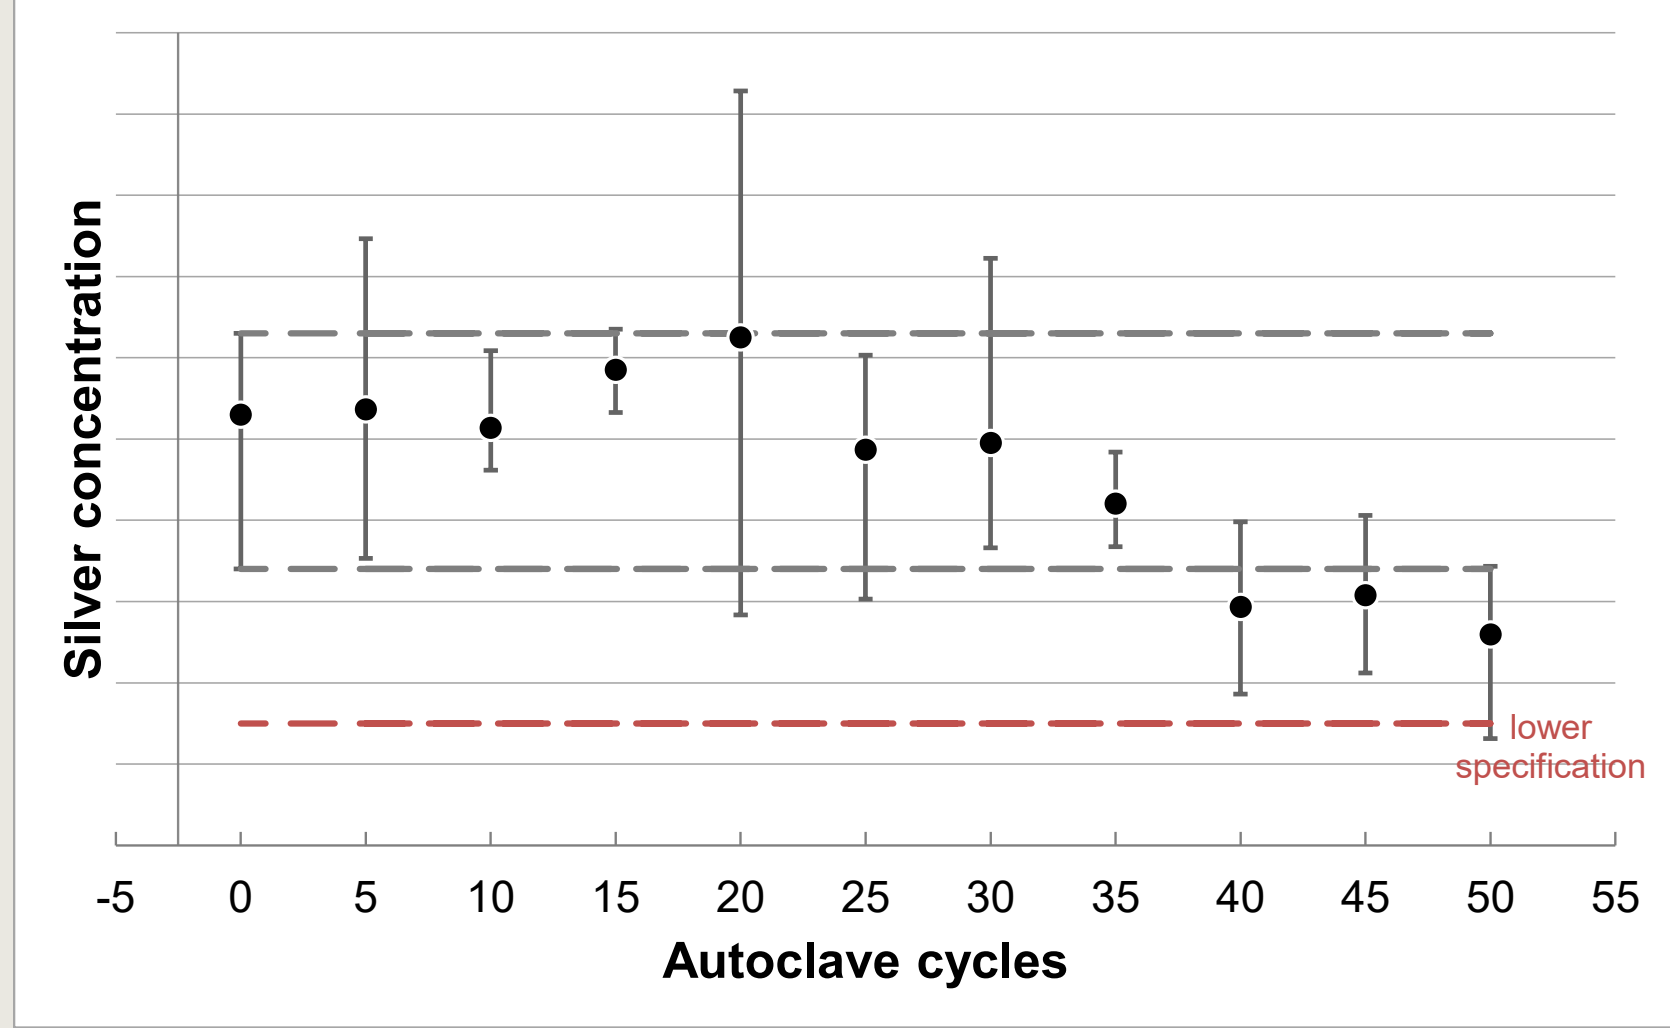
Figure 4: Silver surface concentration following up to 50 autoclave cycles

- Silver surface concentration remained within the target technology specification after up to 50 autoclave cycles
- For up to 35 autoclave cycles, silver surface concentrations remained within the range of concentrations measured for the unautoclaved controls (Figure 4)
