# The challenge of vascular access in a burn patient.

## A case report

Hospital Virgen de las Nieves, Granada (Spain)

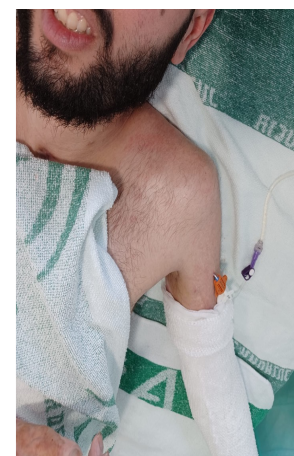
Image 1

- A 9 cm “U shape” tunneling was performed by 14G cannula to the external area of the left arm, taking advantage of the healthy skin window between the left armpit and the beginning of the bandage. Exit site was created in a safe area with no-burn integral skin. Catheter was secured with SecurAcath® (image 1)

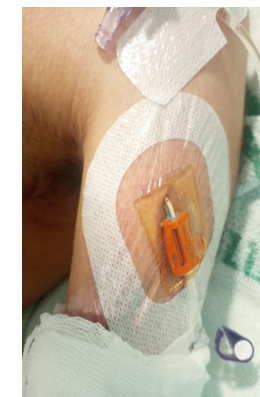
Image 2

- Midline tip was observed by ultrasound in subclavian vein.
- From November 18th, 2023, to the present (24th January, 2024 –abstract submission date-), the line is still in place and working free of complications, a total of 82 days (image 2)
